**HEAVY MOVABLE STRUCTURES, INC.
SEVENTEENTH BIENNIAL SYMPOSIUM**

**Counterweight Trunnion Bearing Rehabilitation
for a Strauss Heel Trunnion Bascule Bridge**

John Williams, PE
Stafford Bandlow Engineering

CSX Bridge QDC 1.71 is a double track Strauss heel trunnion bascule bridge in Buffalo, NY constructed circa 1912. The length of the bascule span from the heel trunnion to the live load supports at the toe end of the span is 124 feet. The total weight of the counterweight is estimated to be 800 tons, producing a reaction at the counterweight trunnion bearings of approximately 1,400 tons total or 700 tons per bearing. The structure spans over the Buffalo River and is operated infrequently for marine traffic. Typically the span is operated mostly in the winter months to permit ice breaking operations on the Buffalo River in an effort to prevent ice jams and resultant flooding in the South Buffalo communities along the river. Openings are also required for periodic dredging operations on the river. The waterway is considered a federal navigation channel and is controlled by both the Coast Guard and the Army Corps of Engineers. Presently CSX operates a single track over the structu

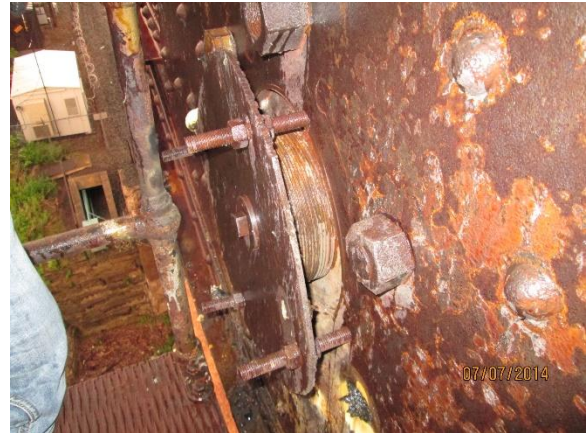
- The north counterweight trunnion pin was missing the large nut at both ends and was restrained axially by the use of thin plates and threaded rods. The bearing pin had moved axially to the south about 1". See Photos 4 and 5.

Photo 4: North Counterweight Trunnion Bearing, Outboard. The pin nut is missing which has allowed the pin to move axially to the south.

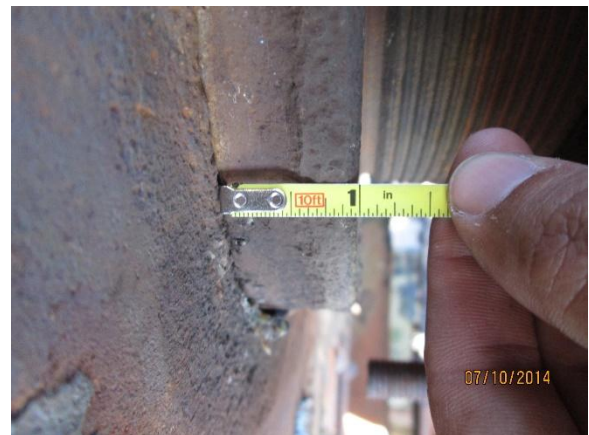
Photo 5: North Counterweight Trunnion Bearing, Inboard. Close up of the bearing pin revealing axial movement 1" to the south.

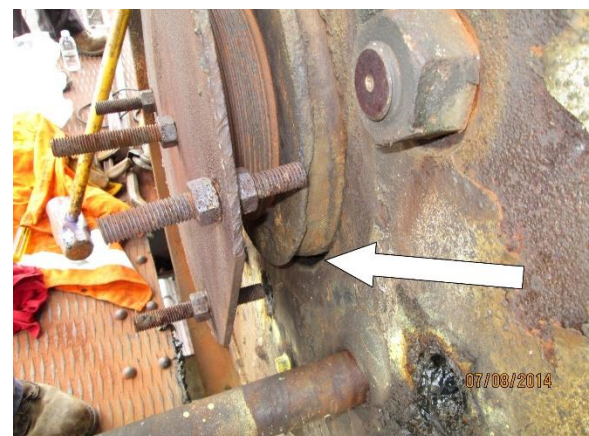
- The pin was intended to have a "driving fit" with the truss according to the American Bridge shop drawings dated 1912. It was clear that the movement of the pin had resulted in significant wear of the truss plates and/or pin as there were large gaps evident. See Photo 6.

Photo 6: North Counterweight Trunnion Bearing, Inboard. View of a large gap between the pin and truss.

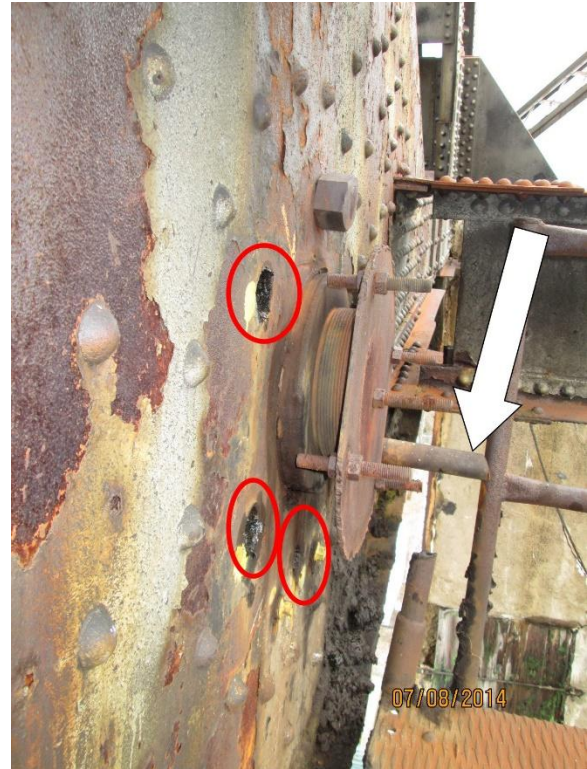
- The north counterweight trunnion sleeve had sheared 5 of the 6 sleeve studs. See Photo 7. The sheared studs are an indication of high friction between the trunnion sleeve and the bearing and/or radial movement of the pin subjecting the studs to dead loads that they were not intended to carry.

Photo 7: North Counterweight Trunnion Bearing. Five of six turned studs which secure the trunnion sleeve to the counterweight truss plates are sheared and are either missing (3 red circles, one not visible) or are protruding from the assembly (arrow).

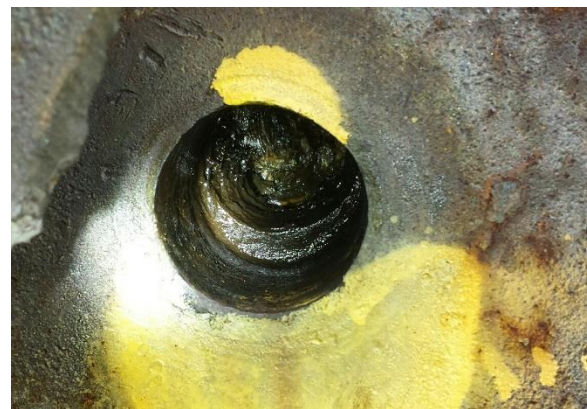
- The north counterweight trunnion sleeve had rotated relative to the truss. See Photo 8. Ongoing, intermittent movement was confirmed at this location during operation. The sleeve was observed and felt to "jump" simultaneous with the banging noises. The amount of rotation observed suggests that all studs must have sheared to an extent that their integrity had been severely if not completely compromised.

Photo 8: North Counterweight Trunnion Bearing, Outboard. The sleeve is visible through the stud hole. It is clear that it has rotated and there is ongoing movement.

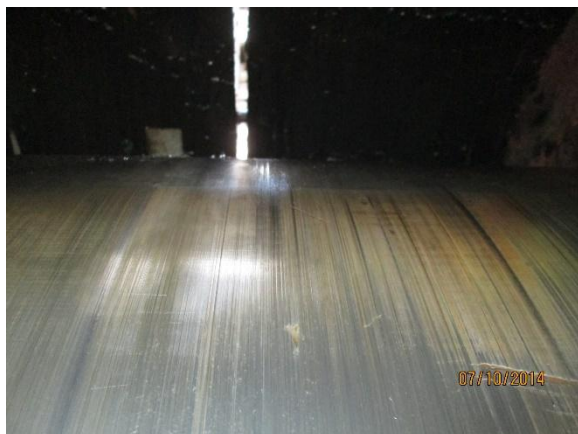
circumferential scoring. There was light bronze embedment and corrosion where the trunnion sleeve is in contact with the lower bushing. See Photo 9.

Photo 9: North Counterweight Trunnion Bearing, Span Open. There is light bronze embedment and corrosion where the trunnion sleeve makes contact with the lower half of the bearing.

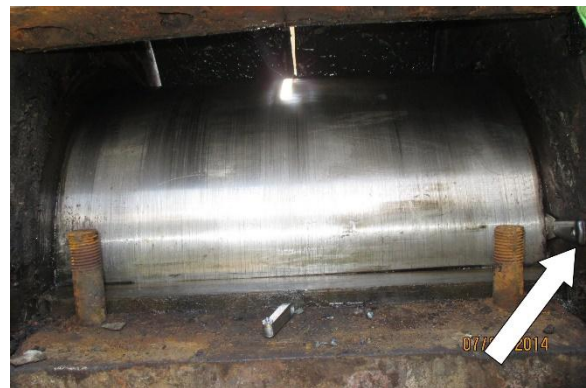
- With the bearing cap removed it was apparent that there were gaps between the sleeve and the truss gusset plates at both ends. This indicated that the failure of the studs and the missing pin nuts had allowed the gusset plates to spread apart. At the outboard end of the sleeve, the gap was more than 0.100". See Photo 10.
- After internal inspection of the sleeve was completed, grease was pumped into the functioning lube port during operation of the leaf. This action was effective at significantly reducing the banging noises emanating from the assembly.

Photo 10: North Counterweight Trunnion Bearing, Span Closed. When viewed from the counterweight side of the bearing, there are gaps between the sleeve and the truss plates. A scraper has been inserted in the gap between the outboard end of the sleeve and the truss (arrow).

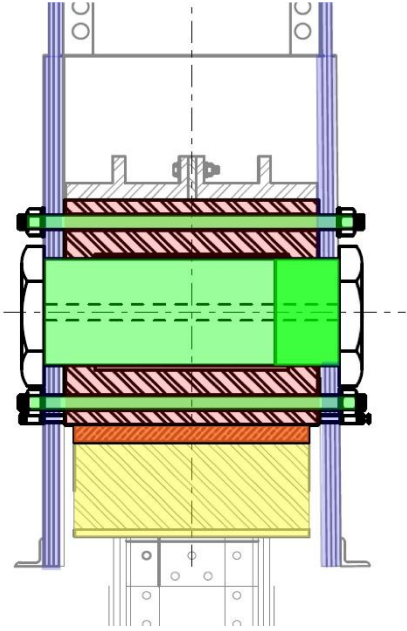
Figure 16: Section through trunnion assembly showing stepped pin.

length of the driving fit was 8" at each end. A critical objective of the project was to re-establish the driving fit to ensure that there would be no movement of the sleeve relative to the pin and truss as the dead load of the truss changed direction. There were several challenges to achieving this objective including the fact that the pin would be installed horizontally and that it would be difficult to heat the truss and sleeve to obtain the necessary clearance to install the pin. The final details of the pin and bore included a stepped diameter with the inboard end 1/16" larger than the outboard end. This would allow for insertion of the pin from the inboard side of the truss with only the final 8" of insertion engaging the fit. An ANSI FN1 fit was selected to ensure that sufficient clearance for installation could be achieved solely from cooling/shrinking the pin and therefore heating of the sleeve and truss would not be required. See Figure 16 for a section illustrating the stepped pin.

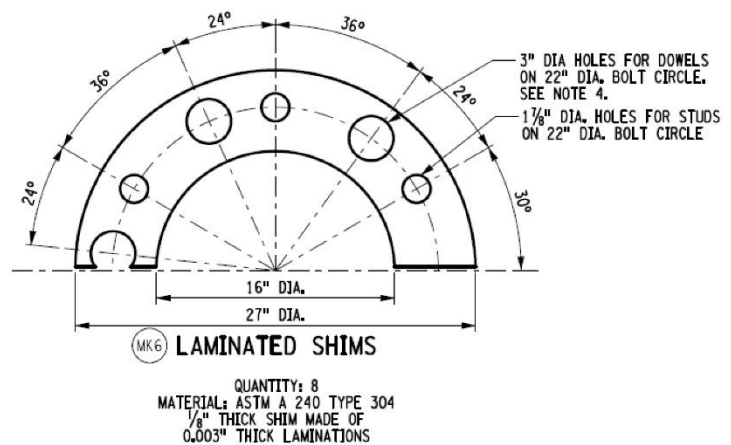
Figure 17: Laminated Shim Detail

design incorporated split laminated shims which would be installed between the sleeve and gussets to fill this gap. This would allow the studs to be tensioned, drawing the gussets tight to the sleeve, while minimizing the displacement of the gussets. During construction, the Contractor requested to reduce the length of the sleeve to facilitate installation and make up this length by increasing the thickness of the shims. This was done to great advantage as the removal of the existing sleeve was very difficult and time consuming as it travelled along its' path between the gussets and the installation of the new sleeve was relatively quick and unobstructed. See Figure 17 for the laminated shim detail.

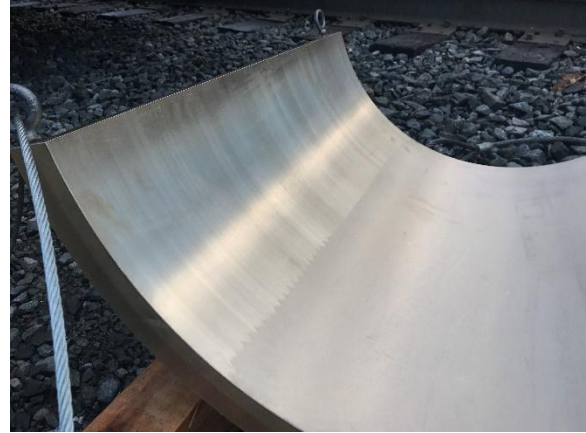
Photo 18: Close up view of the relief added to the counterweight side of the trunnion bearing bushing.

Given the fact that there were only short work windows available and that there was a small amount of movement between the truss and the tower/bearing housing, it was necessary to provide for clearance between the sleeve and bushing for the time period when the sleeve and truss were line bored and the pin installed. It was straightforward to provide for clearance at the bottom of the sleeve; the truss could simply be jacked vertically a bit further and the sleeve held in position with a small amount of clearance at bottom dead center. The issue was that due to the 27 1/2" outside diameter of the sleeve, it would be necessary to raise the sleeve substantially to produce clearance with the bushing at the sides of the sleeve. Since the load on the sleeve was not vertically down but rather 20 degrees from vertical towards the channel, a slight relief was added on the counterweight side of the bushing, the majority of which would be out of the load zone. This relief provided 0.035" clearance between the sleeve and bushing at the sides of the sleeve and concurrently 0.062" clearance between the sleeve and bushing at the bottom. See Photo 18.

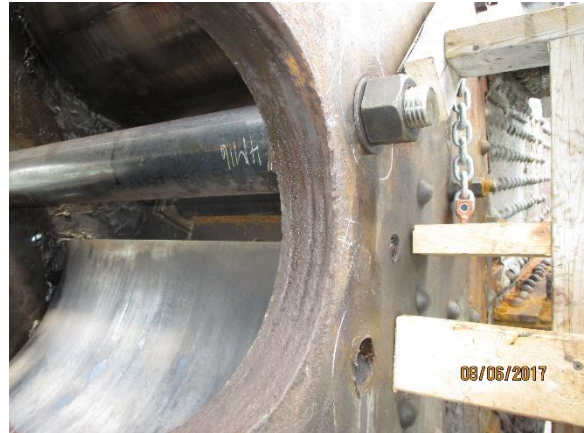
Photo 24: Close-up view of the wear/damage/corrosion on the inboard truss gusset plate where it bears on the pin.

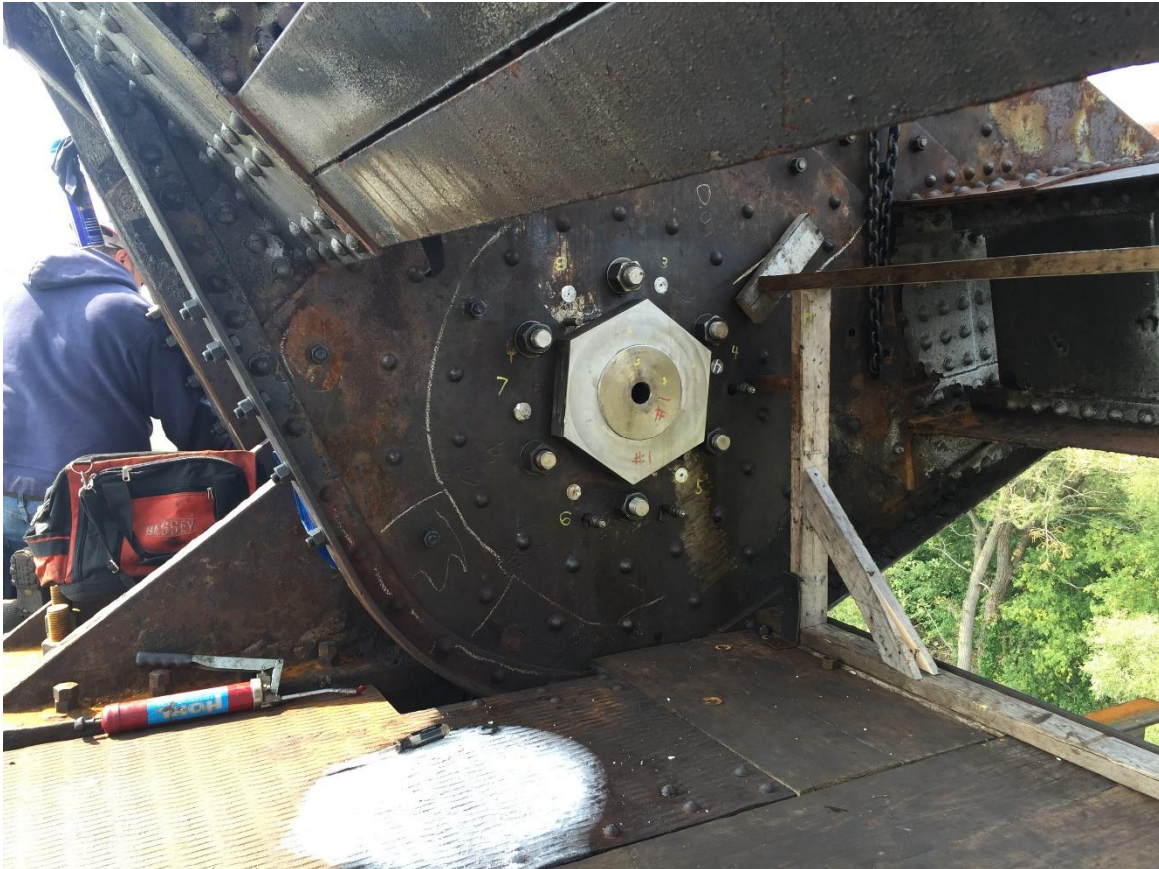
Photo 42: View of completed repair from inboard side of the counterweight truss.
