**HEAVY MOVABLE STRUCTURES, INC.
SEVENTEENTH BIENNIAL SYMPOSIUM**

92nd Street Bascule Bridge Repairs

Brian J. Santosuosso, S.E.

Wiss, Janney, Elstner Associates, Inc.

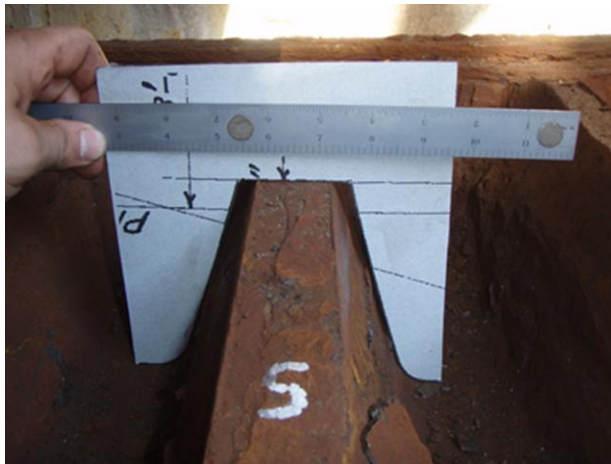
In addition to the basic measurements recorded, photographic documentation of typical tooth wear was obtained. Figures 6, 7, and 8 demonstrate typical rack tooth wear on Rack Teeth 5, 4, and 1 of the north rack, respectively. For comparison, the cardboard template shown in each photograph outlines a full scale cut-out of the as-designed rack tooth geometry. Significant plastic metal flow and geometric change was evident on most rack teeth.

FIGURE 6. Rack tooth wear shown on Tooth 5 of the north rack.

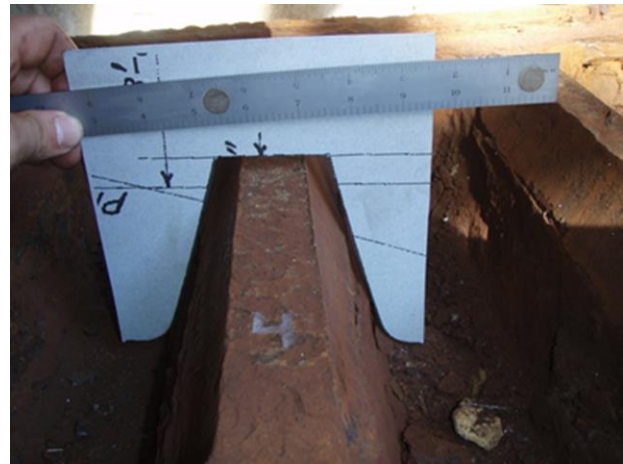
FIGURE 7. Rack tooth wear shown on Tooth 4 of the north rack.

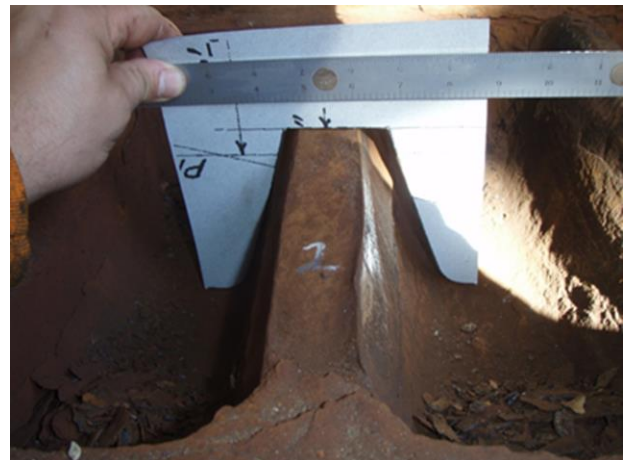
FIGURE 8. Rack tooth wear shown on Tooth 1 of the north rack.

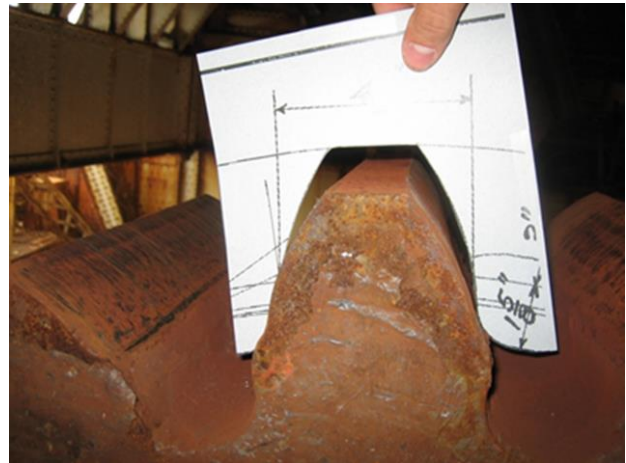
A full scale cardboard cut-out was used to compare the pinion tooth geometry to the as-designed geometry. Figure 10 demonstrates the typical pinion tooth wear on the north pinion. The typical tooth wear exhibited on each tooth includes plastic metal flow from the tip toward the root of each tooth. In addition to wear it was reported by CDOT that there had been at least one incident of a pinion tooth breaking and being repaired by welding it back on.

FIGURE 10. Pinion tooth wear shown on a representative north pinion tooth.

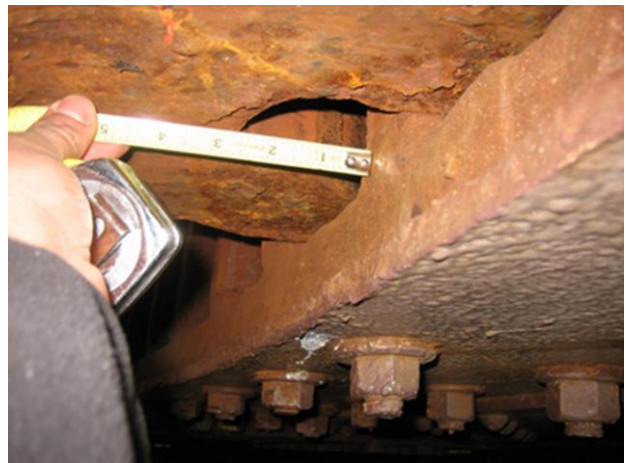
approximately 2 1/2 inches. The design distance for this measurement was 1 inch. Therefore, the pinion was approximately 1 1/2 inches out of position.

FIGURE 11. Root-to-tip measurement for the north pinion with the leaf seated.

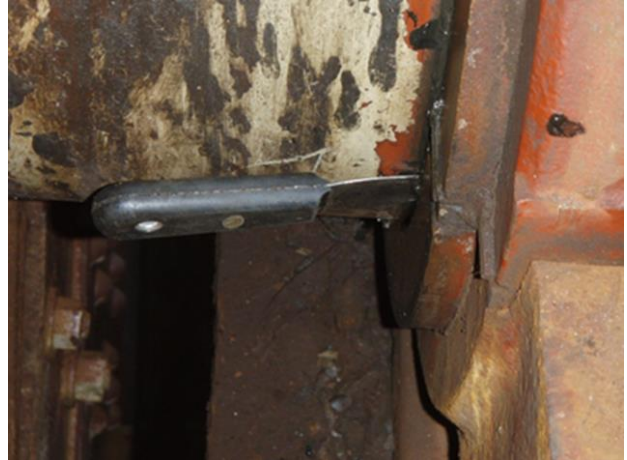
Two conditions of concern were observed. When struck with a 3 lb. hammer, some of the four turned bolts were able to be rotated. Therefore, the bolts were clearly not tight. In addition, it was possible to insert a putty knife horizontally into the bearing sleeve between the shaft and the phosphorous bronze bushing to a depth of about 2 inches. This is shown in Figure 13, and is indicative of advanced wear.

FIGURE 13. Painter's tool inserted between the pinion shaft journal and bearing bushing.

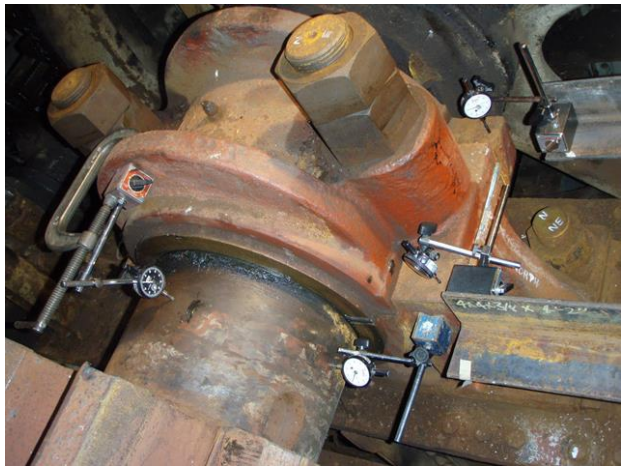
Dynamic measurements were also recorded from a monitored location on the end of the north pinion. The rotation of the pinion shaft/gear did not deviate significantly along the axis of the “best-fit” circle. However, the slight misalignment of the pinion with respect to the established part coordinate system was evident. In addition, significant deviation along the radius of the “best-fit” circle was observed. The maximum recorded deviation range was approximately 1/4 inch while the pinion was operating. This indicated that the pinion displaced approximately 1/4 inch out of position during operation of the bascule leaf. Movement was confirmed during leaf operations by use of dial gauges, shown in Figure 14.

FIGURE 14. Dial gauges installed on north pinion shaft and Journal Block F.

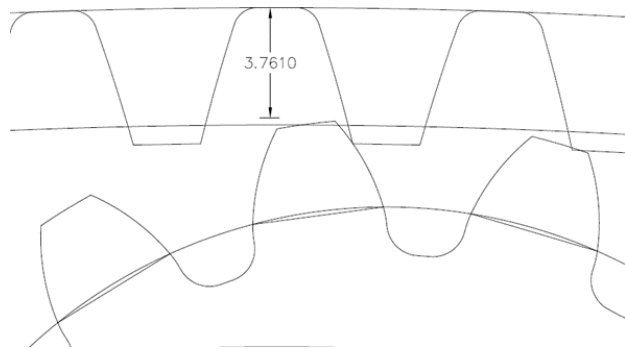
FIGURE 15. Engagement of the original pinion tooth geometry with the worst case existing radial misalignment at the south rack.

It was concluded that there were several major issues with re-using the original pinion tooth geometry at the worst case existing radial misalignment for both racks:

- 1) There was a risk of the tips of the teeth interfering when back driving (which had been previously reported and was an impetus for this repair project).

- 2) The pinion teeth experience single tooth loading close to the tip which created concerns about the bending strength of the teeth and the risk of tooth breakage (which had been previously reported and was an impetus for this repair project).

- 3) The rack teeth were loaded at the tip. While this did not create a bending strength issue due to the design of the internal rack teeth, the contact between the face of the pinion tooth and the corner of the rack tooth would accelerate wear of the teeth.

- 4) The operating pitch diameter of the pinion was so far from the original pitch diameter that there was a large discrepancy in the pressure angles of the tooth faces where they were in contact. It was expected that this would accelerate wear.

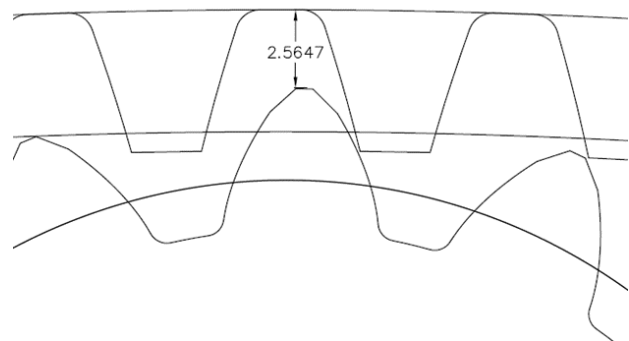
SBE investigated numerous alternatives for modifications to the pinion tooth geometry to mitigate each of the issues caused by the radial misalignment. The geometry proposed in Figure 16 provided the greatest possible benefits, but did not remove the risk of accelerated wear.

The proposed geometry increased the outside diameter of the pinion but maintained the whole depth of the tooth. This would result in a substantially thicker tooth at the base which was much stronger and also move the contact on the pinion teeth further from the tip. Both of these effects would mitigate the risk of tooth breakage. A substantial tip relief was added to mitigate the risk of the tips of the teeth interfering when back driving. Despite these improvements it was not

FIGURE 16. Engagement of the proposed special pinion tooth geometry with the worst case existing radial misalignment at the south rack.

possible to eliminate the contact with the tip of the rack tooth and the large discrepancy in the pressure angles of the tooth faces where they were in contact. The only way to eliminate these issues would be to reduce the radial misalignment.

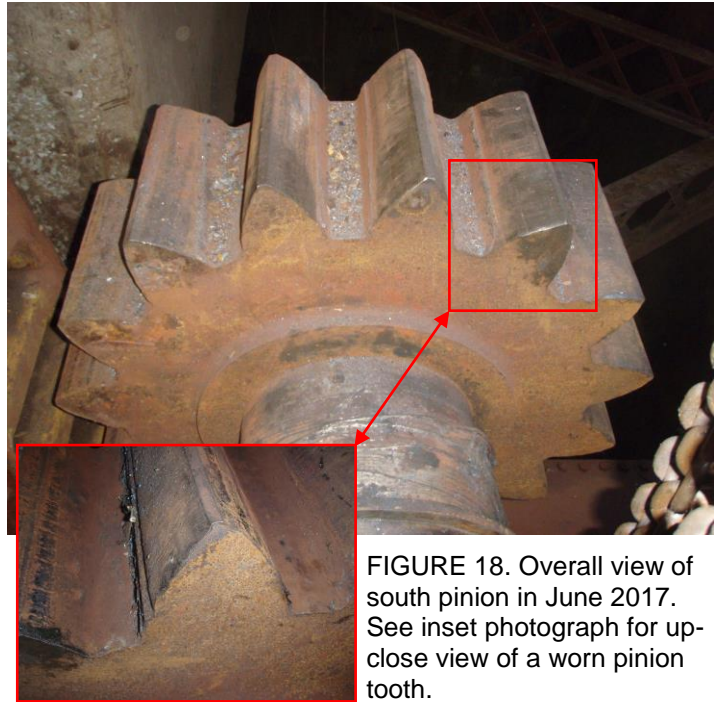
A preliminary visual review of the amount of tooth wear was performed. This evaluation concluded that rack tooth wear was only apparent for a limited number of rack teeth, and was generally confined to the tip of the rack tooth above the as-designed rack pitch circle. There was uneven wear visually evident on the pinion teeth. An example of tooth wear for the south pinion is given in Figure 18. Based on this information a measurement plan was developed:

FIGURE 18. Overall view of south pinion in June 2017. See inset photograph for up-close view of a worn pinion tooth.

It was found that there was significant wear for the pinion teeth that meshed with the rack teeth which exhibited the wear at the tips of the teeth and that these teeth were at the most extreme limits of radial runout (maximum root/tip clearance). Based on a geometry layout of the teeth and these field observations it was concluded that the high rate of wear was directly related to the radial misalignment and that in order to achieve satisfactory performance for this bridge, which operates extremely often, the radial misalignment should be improved.

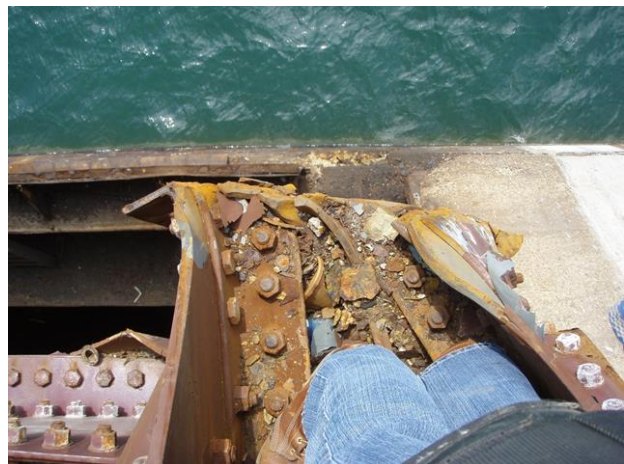
The vessel strike resulted in significant damage to the south truss live load shoe connection that removed the shoe from the truss. Views of the bottom of the truss connection showing where the live load shoe was once attached, and the inside of the truss connection are given as Figures 19 and 20, respectively. Damage was also evident at several truss lateral bracing members and their connections. A follow-up precision survey was performed by IPM on August 2, 2017 to determine if the overall bridge alignment had been affected by the vessel strike.

FIGURE 19. Bottom of the south truss connection where the live load shoe was previously attached. Note severely bent steel gusset plates and stiffening angles.

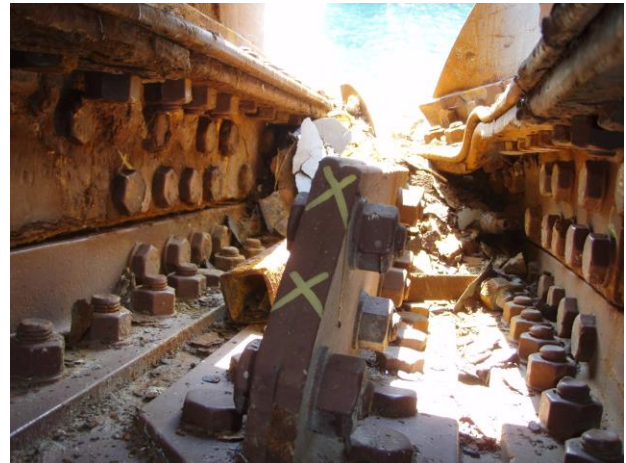
FIGURE 20. View of the inside of the south truss connection where the live load shoe was previously attached. Note bent connection angles.

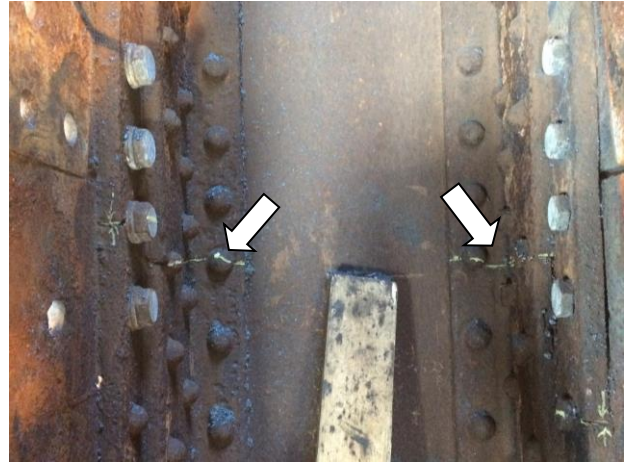
During removal of the existing rack segments, cracks were observed in both truss members that were hidden from view behind the rack segment castings. Figure 22 shows an example of the cracks discovered in the north truss member. Repairs to remove the crack tips and cover plate over the existing cracks were designed and installed. The south truss repair included installation of a 2 inch diameter drilled hole to remove the crack tip and installation of a fill and splice plate on both sides of the truss member web plate. Cracks in the north truss member were more extensive and required installation of four specially

FIGURE 22. Cracks in the north truss member observed after rack segment removal.

fabricated steel angle shapes, two fill plates, and two splice plates over the area containing the cracks. Figure 23 is an excerpt from the repair design drawings showing a section view of the repair specified for the north truss member.

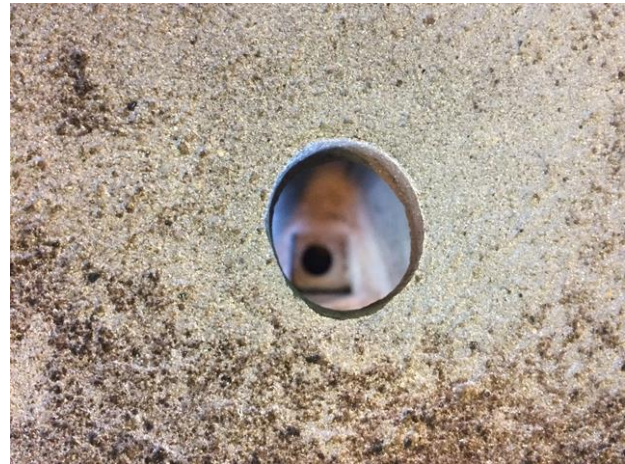
The existing rack segments were removed from the bridge and shipped to a fabrication shop where they were sandblasted to remove corrosion product. Several of the existing turned bolt holes in the rack segments were observed to not be round, as shown in Figure 26. In addition, the holes varied in size from about 1 1/16 inches up to 1 3/16 inches. Each existing hole on the inner radius bolt circle (bolt holes located in the tooth pockets) was therefore drilled out to 1 1/4 inch diameter to accommodate the majority of these imperfections. Outer radius bolt circle holes where the bolt/hole fit was less critical were increased in size as needed to provide a round 1 1/16 inch diameter bolt hole at each location. Specially fabricated centering plugs were used to guide annular cutters to drill the new hole while maintaining the position of the original hole center, since the interior surface of the rack in each tooth pocket contains a square shaped pocket sized just large enough to accommodate the square turned bolt head. In addition, the bolt holes on the outer radius bolt circle were required to accommodate the through bolt alignment.

FIGURE 26. Turned bolt hole in existing rack segment.

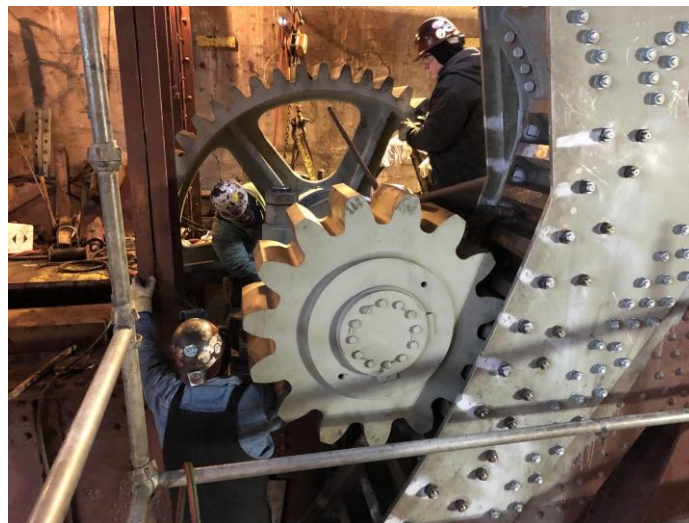
FIGURE 37. Completed repair with proper radial alignment. South assembly shown.

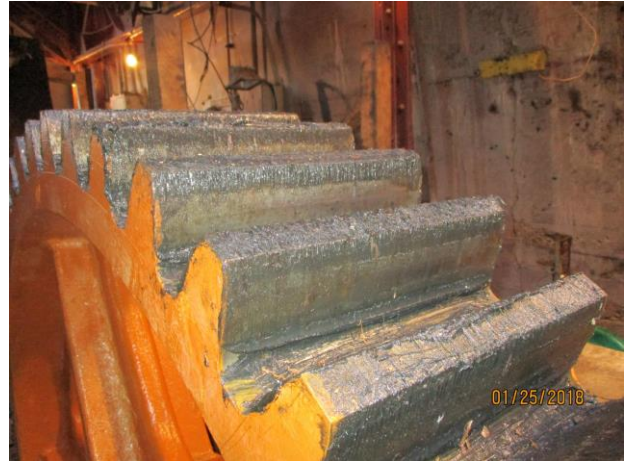
- Good alignment of the B1 and B2 bearings (Journal Blocks F and G in Figure 3) was restored.
- Good contact was achieved at both G2/P2 gear sets (See Figure 40).

FIGURE 40. G2 Gear Contact Pattern.
