**HEAVY MOVABLE STRUCTURES, INC.  
SEVENTEENTH BIENNIAL SYMPOSIUM**

**Span Drive Machinery Vibration  
Hood Canal Bridge**

Ryan Kanagy, P.E.  
Stafford Bandlow  
Engineering, Inc

Duane Stone, P.E.  
WSDOT

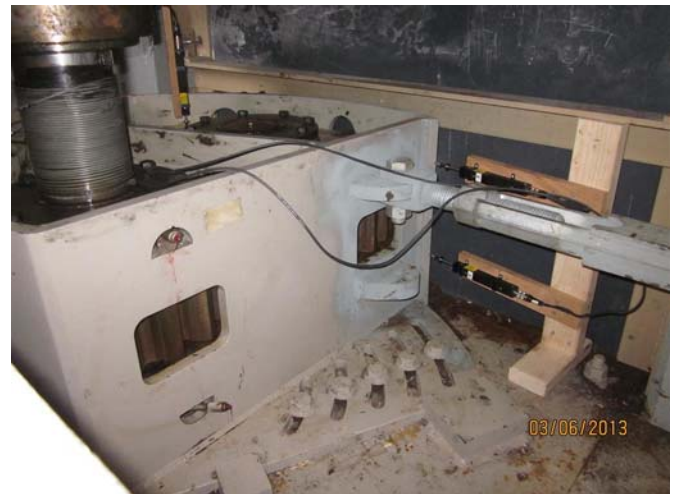
SBE's preliminary vibration investigation of the issue included a review of pinion shaft strain data simultaneously recorded with motor speed and lower gear assembly deflections. See Figure 6.

**Figure 6.** Lower Gear Box Assembly. The assembly is shown with instrumentation for LVDT deflection measurements and strain recordings at the pinion shaft.

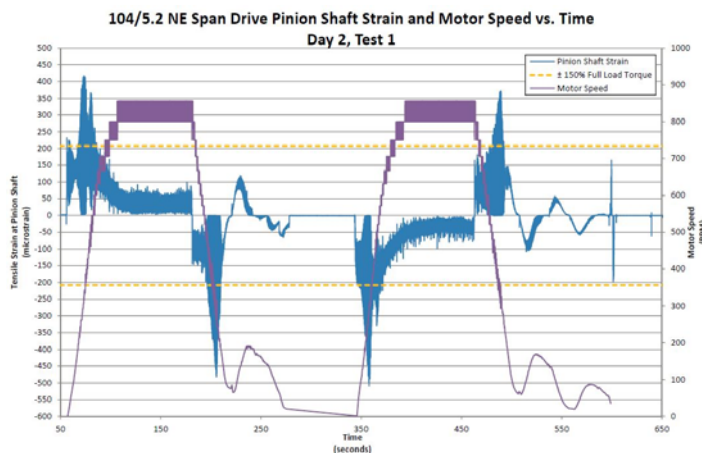
Example charts from the preliminary investigation are shown in Figures 7 and 8. Figure 7 shows a recording of the pinion shaft strain and the motor speed. Figure 8 shows a close-up of oscillations in the pinion strain data.

From the recorded data it was determined that the vibration issue was due to operation near the natural frequency of the system and that the issue was driven by the open gear tooth impact frequency.

**Figure 7.** Chart Showing Recorded Pinion Strain and Motor Speed

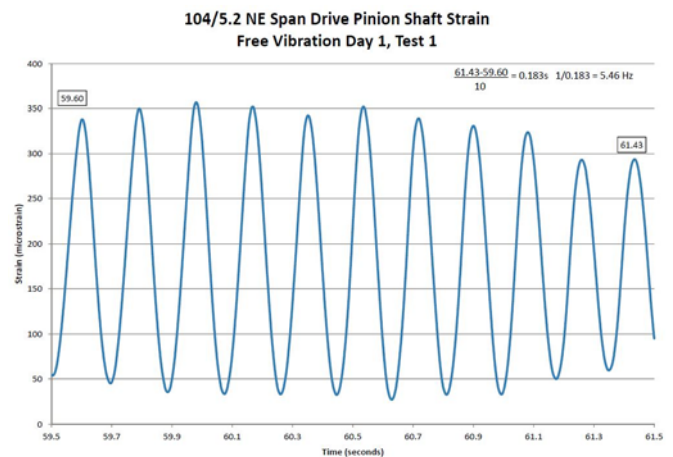
**Figure 8.** Chart with Close-Up of Oscillating Pinion Shaft Strain. The frequency of oscillations were determined from this and similar charts.

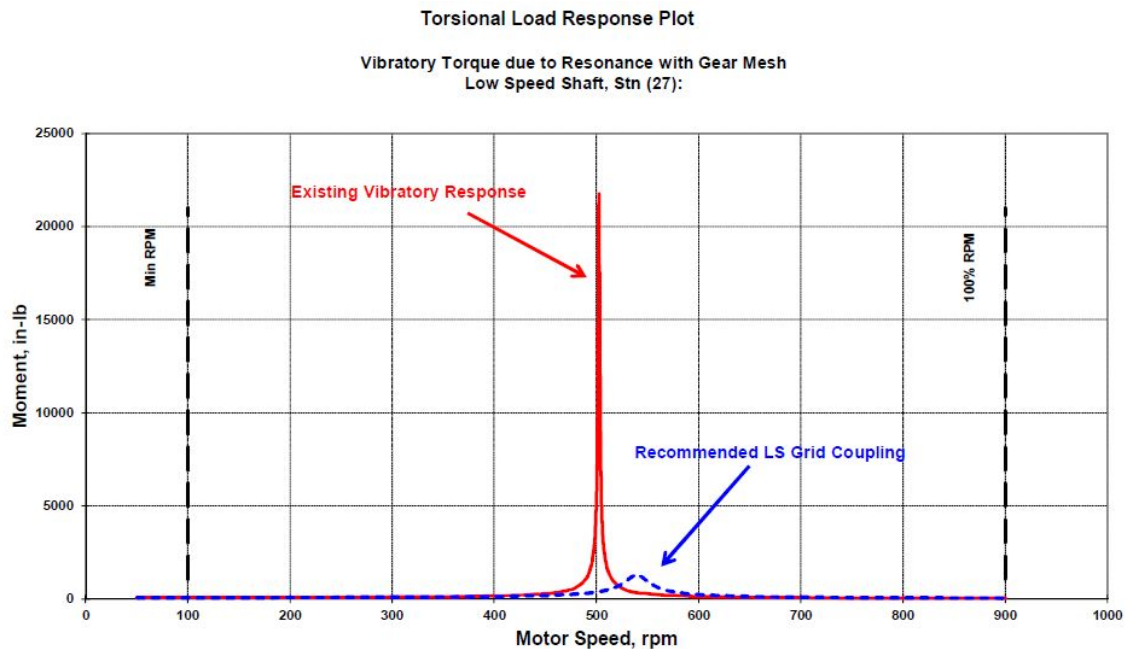
Through their modeling, BETA confirmed that their model matched the behavior of the drive system and positively identified the idler gear mesh as the source of the undesired excitations. Based on their modeling it was determined that it was not practical to modify the torsional natural frequency of the system to a degree necessary to avoid the operating speeds of the bridge. However, based on their work it was recommended to change the upper gear box output coupling from a gear coupling to a grid coupling. This change to a “softer coupling”, combined with an increase in rigidity to the lower gear frame, provided a net effect of a small increase in the torsional natural frequency of the system but did not move it outside of bridge operating speeds. The more rigid gear frame was expected to reduce the magnitude of the impacts associated with the oscillating loads, but the most significant effect impact was the change to a grid coupling which, based on information provided by the coupling manufacturer, was expected to provide a significant dampening effect to the system. See Figure 9.

Note that the recommended change from a gear coupling to a grid coupling is a return to the previous design where vibrations were not noted as a significant issue. The coupling change appears to be the one significant change from the 2009 rehabilitation that could have had a significant impact on the drive behavior.

**Figure 9.** Torsional Load Response Plot Illustrating the Effect of the Upper Gear Box Output Coupling as a Gear Coupling (Existing Shown in Red) Compared to a Grid Coupling (Recommended Shown in Blue).

*Change Low Speed Coupling from Gear Coupling to Grid Coupling.* Based on the modeling the most critical change was to replace the gear coupling at the output of the upper gear box assembly with a grid coupling. This change significantly dampens oscillatory behavior as the bridge speed passes through the torsional natural frequency of the system.

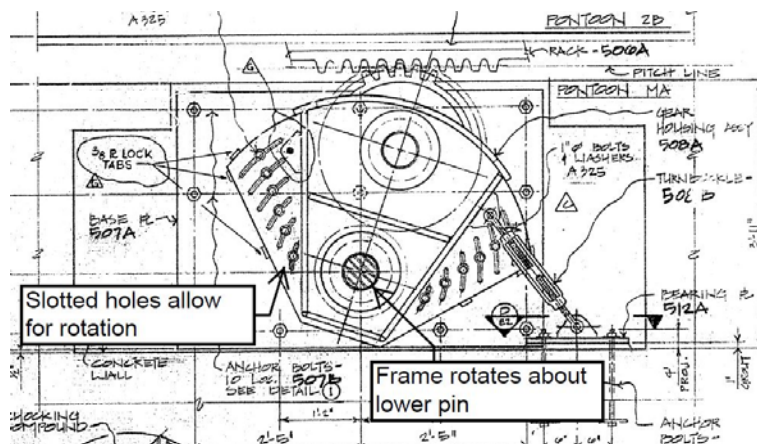
**Figure 10.** Plan View of Existing Lower Gear Box Assembly. The locating pivot and the slotted holes were maintained for the new design.

The replacement lower gear box assembly was designed with some similarities to the existing arrangement, maintaining gear dimensions and component spacing. The new design provides similar gear mesh adjustability to the existing design, which uses a locating pin and slotted holes for the cap screws that secure the mounting plate to the sole plate. The pin and slotted holes allow for rotation of the frame to increase or decrease engagement of the idler gear with the rack mounted to the draw span. See Figure 10.

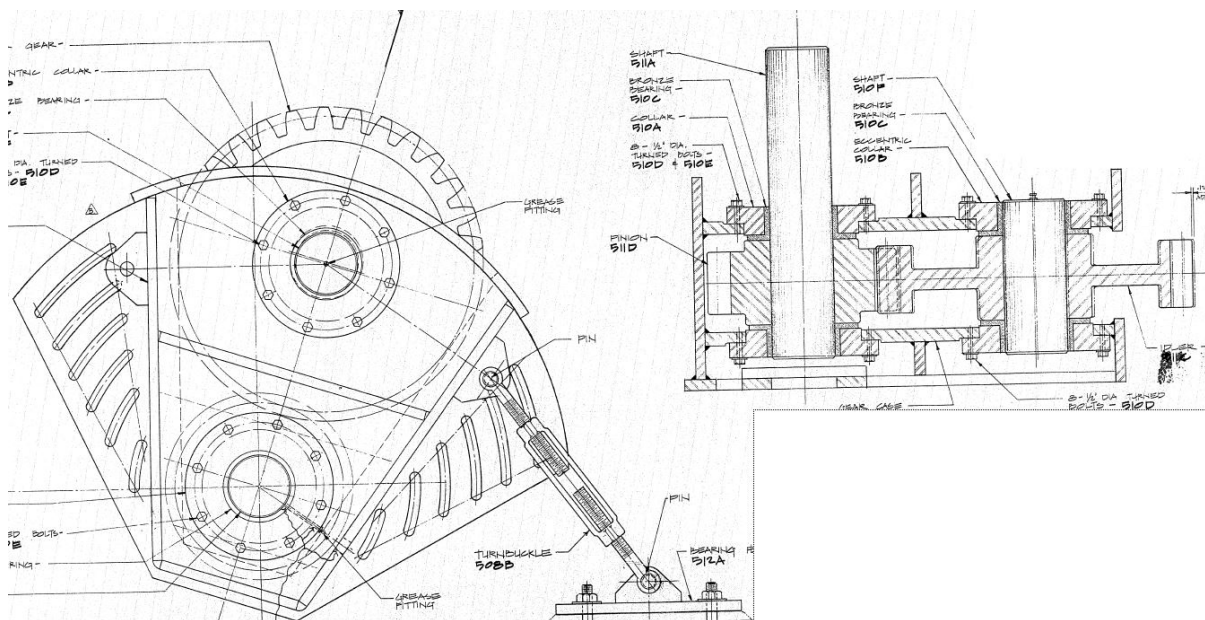
*Improved Maintenance Procedures.* With the existing design it was impossible to remove the pinion, idler, or either shaft without a complete removal of the lower gear frame from the bridge, and removing the lower gear frame from the bridge required movement of the above support for the upper gear box, motor and brake. In addition, for the existing lower gear frame, only the upper idler gear bushing could be replaced with the machinery in place. All others required complete removal.

**Figure 11.** Plan View and Section View of Existing Lower Gearbox Assembly (Upper Gear Box Output Coupling Not Shown). The frame assembly allows for only limited access to the gears for inspection and maintenance.

*Change to Bearing Lubrication Provisions.* The existing design had a single lube fitting on top of the shaft fed two bearings through a common lubrication port. With this arrangement the lower bushings were not provided with adequate grease which led to excessive wear. The replacement assembly provides the ability to directly lubricate each bearing through dedicated lubrication ports.

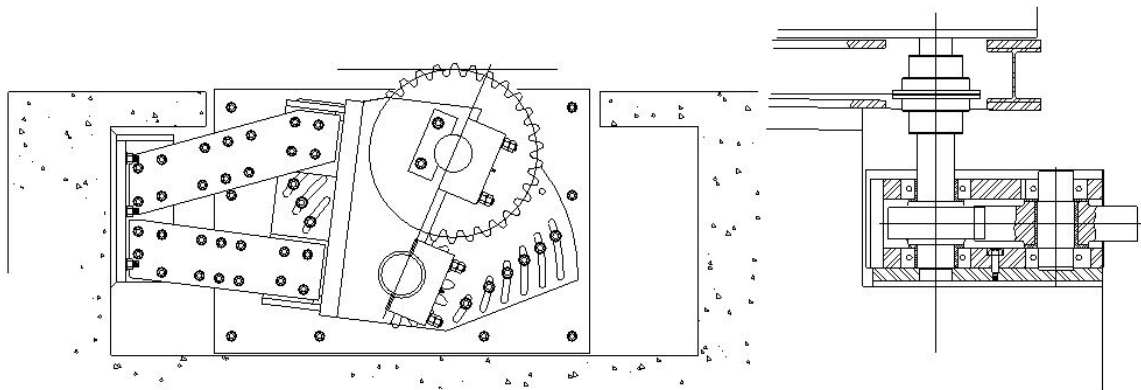
**Figure 12.** Plan View and Section View of the New Lower Gearbox Assembly. The assembly is open on the side opposite the brackets, allowing for access to the gears for inspection and maintenance.

In contrast, the new assembly, using conventional pillow block bearings, permits replacement and adjustment of the bearings, shafts and gears without having to remove the lower gear box frame from the bridge.

*Inspection and Maintenance Access.* The replacement frame provides enhanced access to the pinion and idler teeth for inspection and maintenance by leaving the gear frame open on one side as the needed rigidity is supplied by the base plate and brackets on the opposite side of the frame.

*Increase in Rigidity of the Lower Gear Box Assembly.* The new lower gear box frame is provided with increased rigidity that will reduce operational deflections and impact loads for any future oscillating loads.
