**HEAVY MOVABLE STRUCTURES, INC.  
SEVENTEENTH BIENNIAL SYMPOSIUM**

**Machinery Repairs to Maintain Operability  
of an 1890's Swing Span**

Robert J. Tosolt, P.E.  
Stafford Bandlow Engineering, Inc.

Bridge DM-84.35 carries a single railroad track over the Nanticoke River in Seaford, Delaware. The movable span of the bridge is a 172-foot-long through girder center bearing swing span. The bridge provides a 48-foot-wide navigable channel when opened.

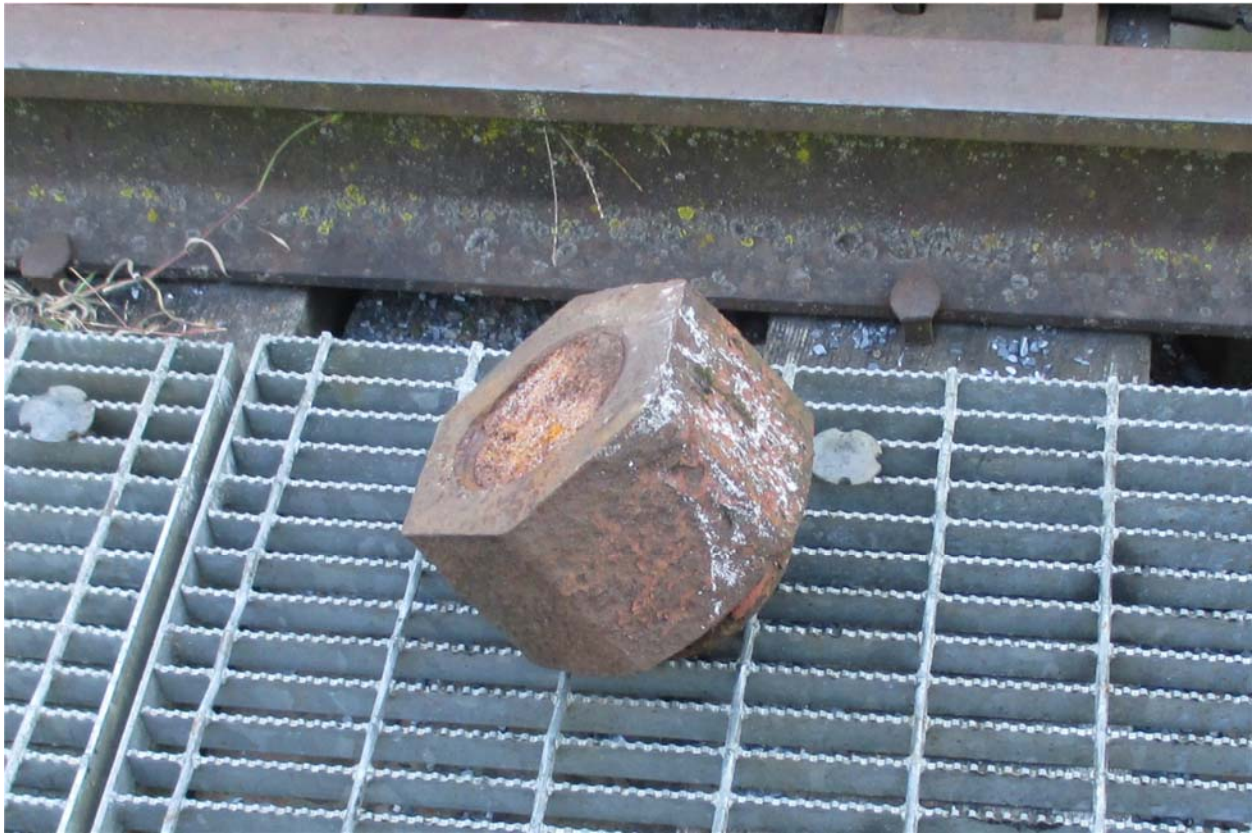
In a sense, the essence of this paper can be distilled down to the statement that as part of an emergency call-out to this 1890s vintage swing span to assist troubleshooting an operational problem at the end wedges, we found the failed end of a 4 $\frac{3}{4}$ " diameter bolt.

**Figure 1 - View of failed end of 4  $\frac{3}{4}$ " diameter bolt. Bolt is resting on standard walking grating adjacent to track for reference of size.**

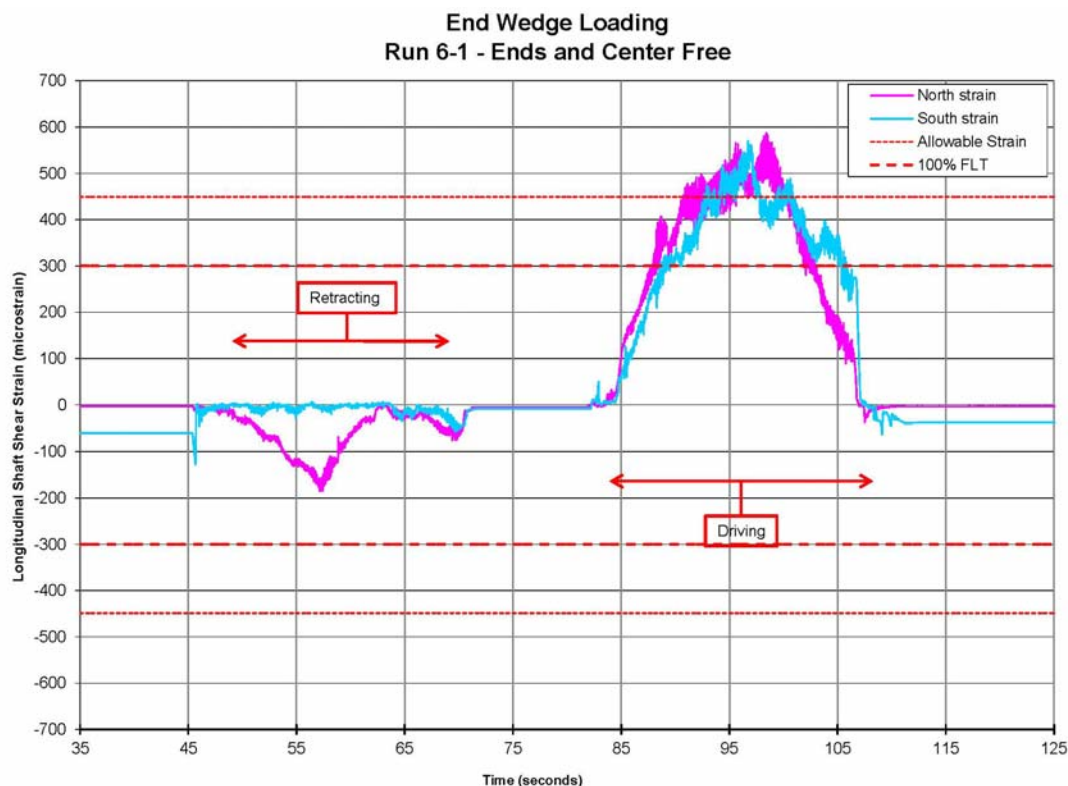
Figure 5 - Strain Recordings for Wedge Drive System following initial repair.

As illustrated in Figure 5, the strain recordings yielded very high loading when driving the wedges. The loading not only exceeded full load torque of the drive motor, but also exceed allowable strain levels for the machinery.

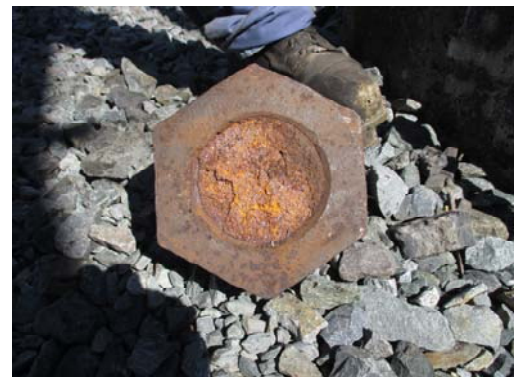
While discussing these items, another finding was brought to our attention in passing. Maintenance was interested in having us look at a failed bolt which they had found. The failed bolt in question was a 4¾" diameter bolt. While it is not atypical to see large machinery on movable bridges, the use of extremely large fasteners is fairly uncommon and notable. The failure of such a fastener should raise significant concerns over not only how the fastener failed but also how the load intended to be carried by this fastener is now being redistributed through the structure.

**Figure 7 – Failed Bolt. As found at siding. The workman's boot behind the nut at top provides a reference for size.**

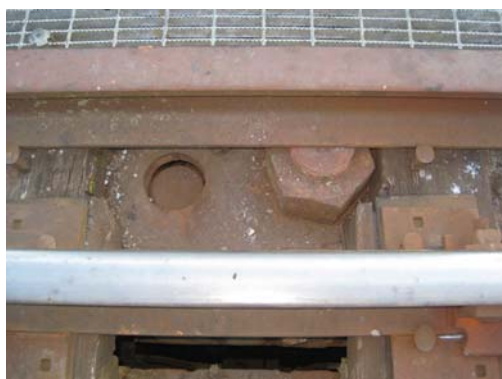
**Figure 8 – The bolt to the right of the open hole was also identified to be failed.**

which was visible from track level at mid-span. The failed bolt was one of four such assemblies at this location. A rudimentary check was performed to sound the nuts at the remaining three locations to check integrity. A concern was quickly identified at the nut adjacent to the failed bolt. A track jack was installed to lift the rail and gain clearance over the nut and a track bar was used to pry to corner of this nut. The nut and accompanying bolt thread was able to be lifted within the available clearance, indicating that this bolt had also failed. The remaining two nuts located under the adjacent rail could not be moved and appeared sound.

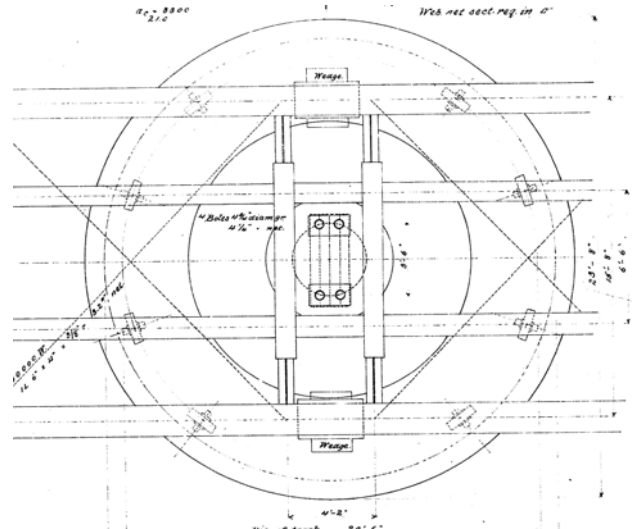
**Figure 9 – Plan View at Center Span.**  
*Excerpt from 1890s Design Plan.*

As illustrated in Figure 9, the 4 studs are symmetrically located around the center bearing assembly to provide a balanced system and uniform loading of the assembly. Failure of one or more of the bolts compromises the symmetric load transfer and must contribute to a shift of the grillage on top of the center bearing similar to an unbalance bar scale. The load normally taken by the failed bolt(s) must either redistribute through the grillage resulting in an overload of the remaining bolts or transfer through the structure into the balance wheels and center wedges, which components were not intended to carry the dead load of the structure. At some point, failure of the bolts will result in a complete loss of support at the center bearing and compromise the stability of the bridge.

As found, 2 of 4 bolts had failed. As a result, half of the weight of the structure had redistributed to areas not intended to carry this load. Re-evaluating the end wedge failure and observed bridge behavior in light of this finding, it can be surmised that the redistribution of loading resultant from the bolt failure contributed to: overloading of the end wedges, extreme loading at the balance wheels, and a shift in the position of the center bearing contributing to bridge orbit during operation. Without correction, it can be expected that deterioration would progress until the swing span would have dropped off the center bearing. Whether this occur under rail traffic or during operation, the result would have been unacceptable.

- Cribbing was installed under the center cross girder to provide additional support to the span in the closed position.
- Bridge openings were curtailed. The problem was identified at the end of the navigation season and the bridge is normally closed for the winter, so this did not present a significant obstacle to the marine community.
- The integrity of the balance wheel axles were assessed through ultrasonic inspection prior to any additional openings to ensure that overload had not compromised the integrity of the wheel axles.
- A shop detail was prepared to replace the failed carrying studs.

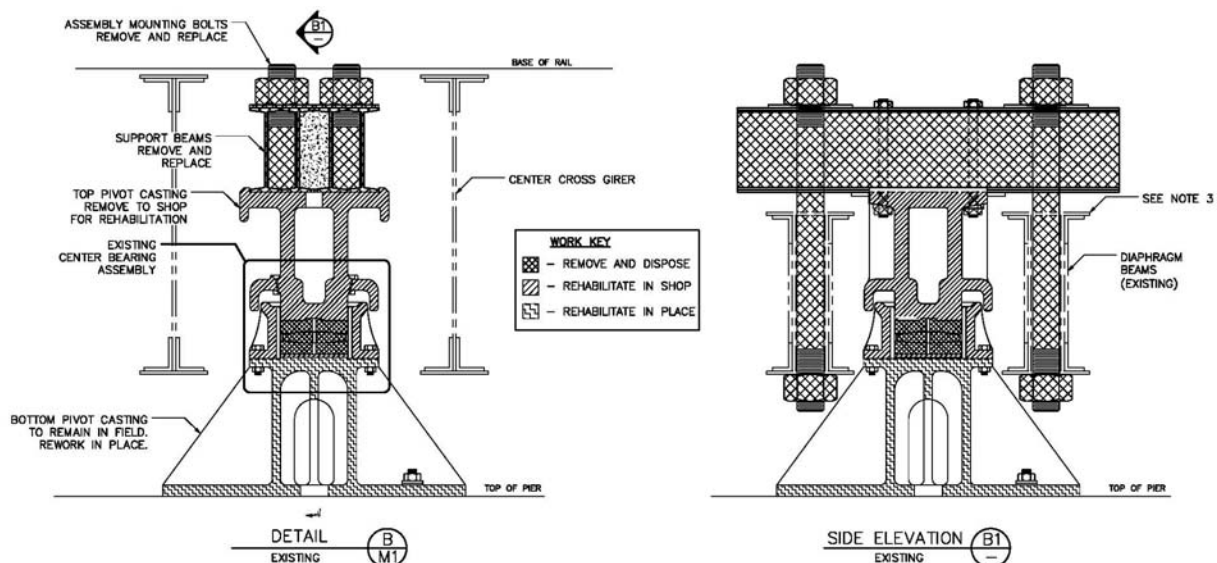
Figure 11 – Rehabilitation Plan for Grillage, Diaphragms Carrying Studs and Center Bearing

Maintenance personnel had previously identified issues with the machinery including suspected excessive wear at the center bearing. Noted issues included orbiting of the span during operation resulting in pinion/ring gear engagement issues and interference with the balance wheels and track/rack installation, heavy wear and damage at the rack/track segments, and evidence of heavy contact at the balance wheels. As part of field verification to verify these issues, it was identified that the support structure for the center bearing, including the upper grillage as well as the structural diaphragms which frame in to the cross girders, was heavily corroded and deteriorated. Therefore, the repair effort was expanded to encompass complete replacement of the center bearing grillage and diaphragms as well as the mounting studs.

As the center bearing had to be unloaded to perform this work, the center bearing was to be replaced. New rack and track segments were provided in the operating range of the bridge and were reset to achieve the proper operating pitch diameter. The balance wheels were refurbished and adjusted to provide the proper clearances with the track.

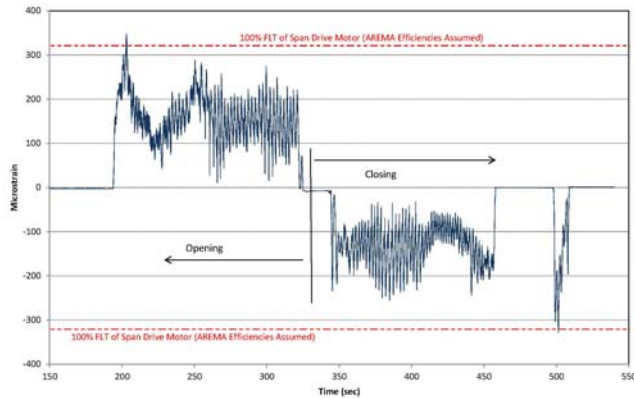
Figure 12 – Span Operating Loads at Outset

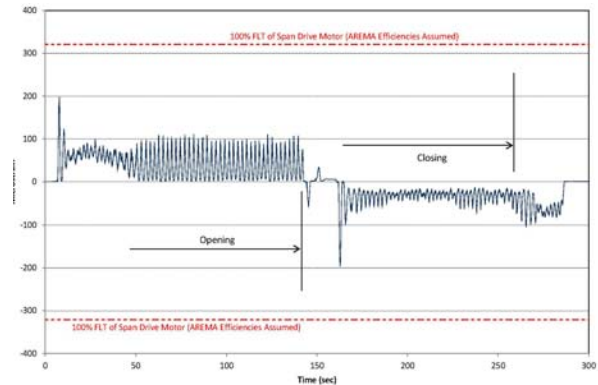
Figure 13 – Span Operating Loads at Completion

For physical confirmation of this numeric load reduction, the bridge operator indicated that whereas the drum controller had previously required near full power to operate the bridge, it now operated in its second power point.

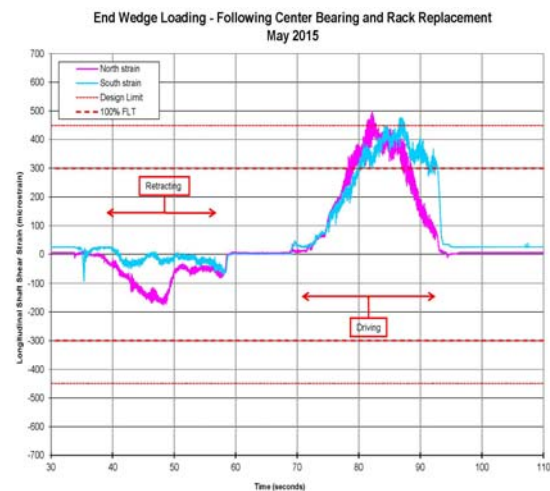
Operating loads were also monitored in the wedge machinery at the completion of the work, which had been the original source of the call-out. The wedge machinery loading does not present as compelling a comparison as the span drive operating loads. While there is in fact a reduction of at least 100 microstrain off the peak loading, which is not insignificant and brings the loading within machinery allowable stresses, the nominal loading during wedge driving remains high and exceeds normal full load motor torque. The wedge drive system is largely original and was not addressed as part of this rehabilitation. There is evidence of deterioration throughout the system including worn bearings and gears and deformed shafts and cranks. Gage placement was fairly far back in the system so the recorded load likely reflects the inefficiency of this aged operating system.

Figure 14 – Strain Recordings for wedge

Rehabilitation of the wedge drive system is necessary to improve the performance and reliability of the wedge drive system and to prevent future failures, which can be expected with the present machinery.

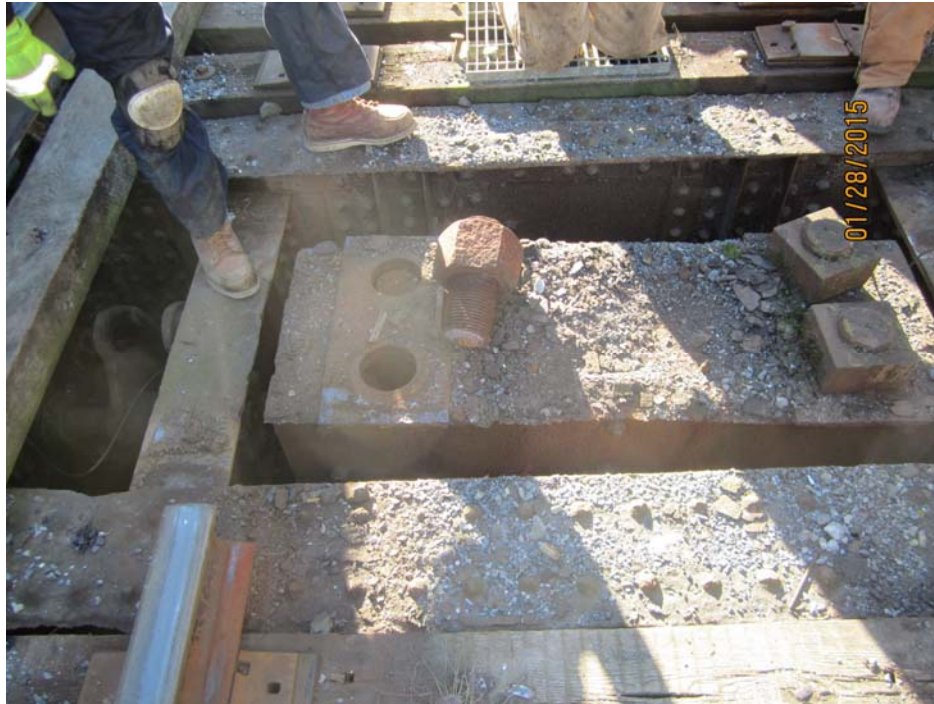
**Figure 15**  
**As-Found Condition of**  
**Center Support Assembly.**  
*(after removal of rail and ties)*

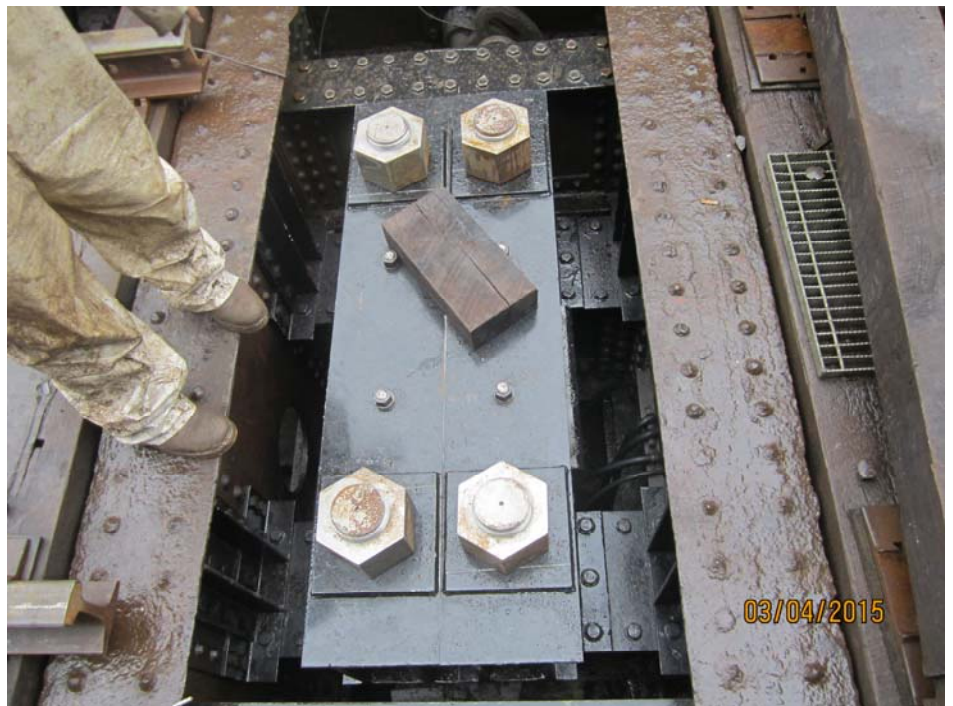
**Figure 16**  
**Condition after Replacement of**  
**Center Support Assembly.**
