**HEAVY MOVABLE STRUCTURES, INC.
NINETEENTH BIENNIAL SYMPOSIUM**

106th Street Bascule Bridge Repairs

Brian J. Santosuosso, S.E.

Wiss, Janney, Elstner Associates, Inc.

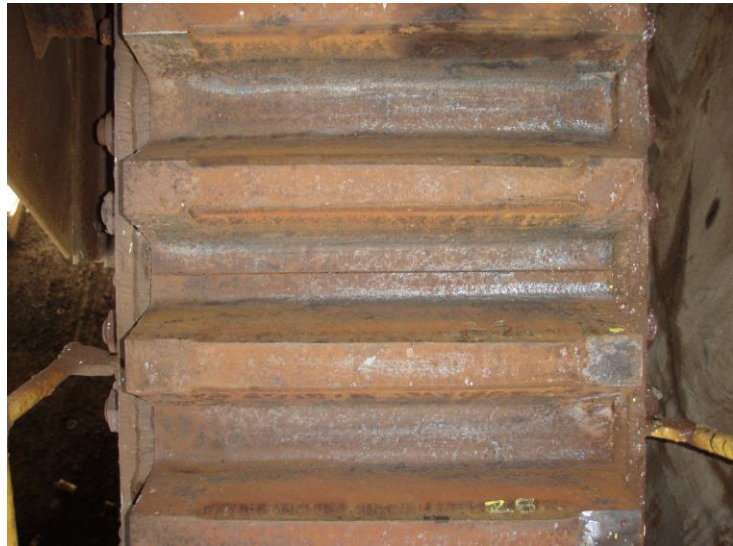
- No major cracks or large casting defects were observed on any of the rack segments. Typical rack tooth wear in areas other than the bottom ten teeth of northwest rack is shown in Figure 4.
- The interference between the northwest rack and pinion caused severe damage to the rack teeth toward the bottom of the rack. RT4 appeared to have suffered the worst damage. However, RT2 through RT8 showed evidence of significant recent tooth wear/damage as a result of the incident, as shown in Figure 5.

FIGURE 4. Typical rack tooth wear.

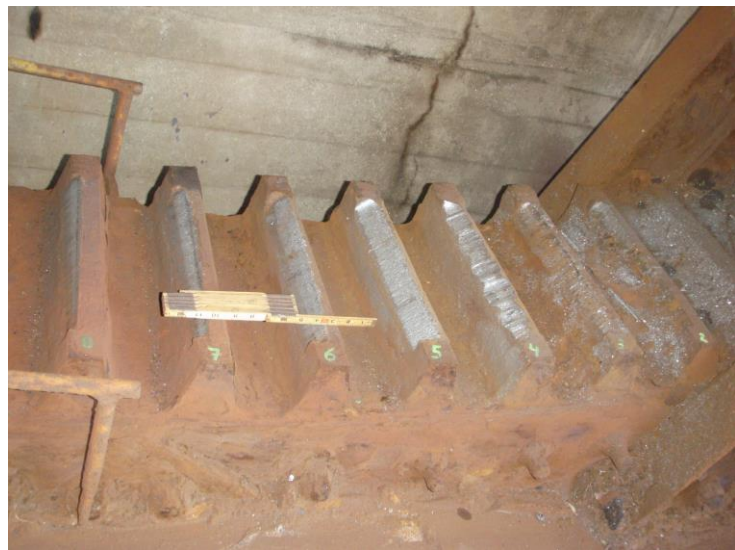
FIGURE 5. Severe northwest rack tooth damage.

The collected measurements at the north rack and pinion location indicate that the root to tip clearance in the vicinity of RT4 was 3-1/4 inches resulting in an engagement depth of 11/16 inches compared to a design engagement depth of 3-5/16 inches or 21% of the originally specified engagement. This combined with the rolling action of the gears and gear tooth wear were sufficient for the rack and pinion to disengage. Design rack and pinion geometry is shown in Figure 9.

Existing wear on the northwest rack teeth was repaired by depositing weld metal on the faces of each tooth to build up the section past the original geometric profile, and then hand grinding back down to the desired original tooth design profile. The process of welding on existing cast steel teeth originally construction in the late 1920s required a review of the material chemistry, which was performed using shavings obtained from representative areas of the casting segments in the field. A welding procedure was developed using this information and best practices learned from experience on past similar projects. The welding procedure required that shielded metal arc welding (SMAW) or “stick” welding was utilized due to the ability of the process to create good penetration and the tolerance of embedded impurities. An elevated preheat and interpass temperature of 300 Degrees Fahrenheit was required, with a maximum interpass temperature of 400 Degrees Fahrenheit. A 2 hour bake-out at the preheat temperature was also required to encourage migration of any hydrogen trapped in the new welds. A series of templates cut to the original tooth profile of several consecutive teeth were used to ensure that the welding process did not affect the pitch of the teeth along the length of the rack.

Once the teeth were built up using the welding process, they were ground back down by hand to the desired profile. This process used electric power driven grinders with stone wheels to achieve rough results, followed by sanding disks that were used to finish the tooth profile and result in acceptable surface finish. Finishing templates were used to ensure that the correct tooth profile and pitch were achieved as the finished product (Figure 22).

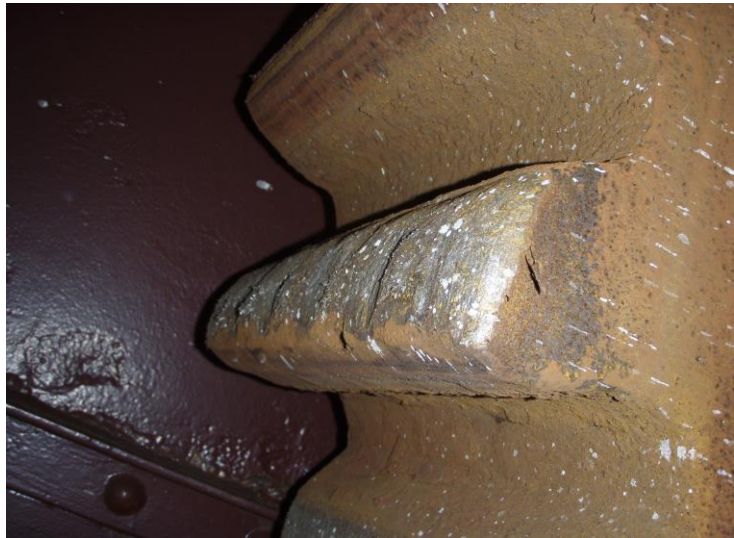
- The northwest pinion tooth that appeared to mate with RT4 also exhibited significant damage and is shown in Figure 6. Typical northwest pinion tooth wear is shown in Figure 7.

FIGURE 6. Significant damage to northwest pinion gear tooth.

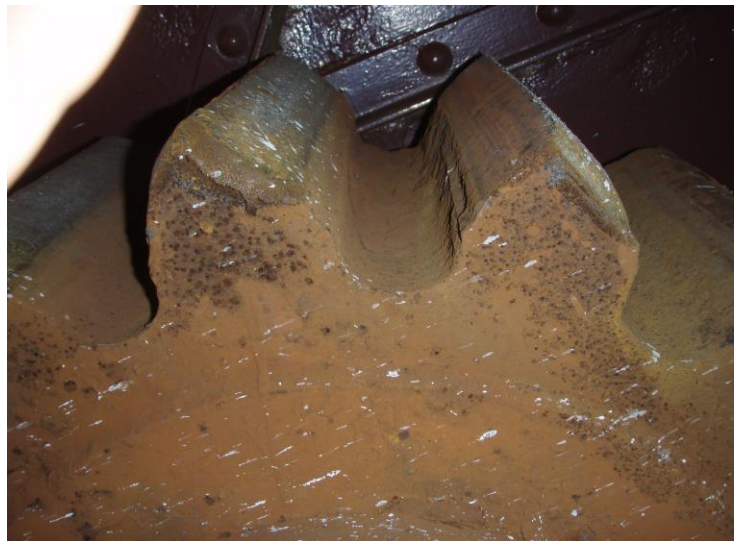
FIGURE 7. Typical northwest pinion tooth conditions.

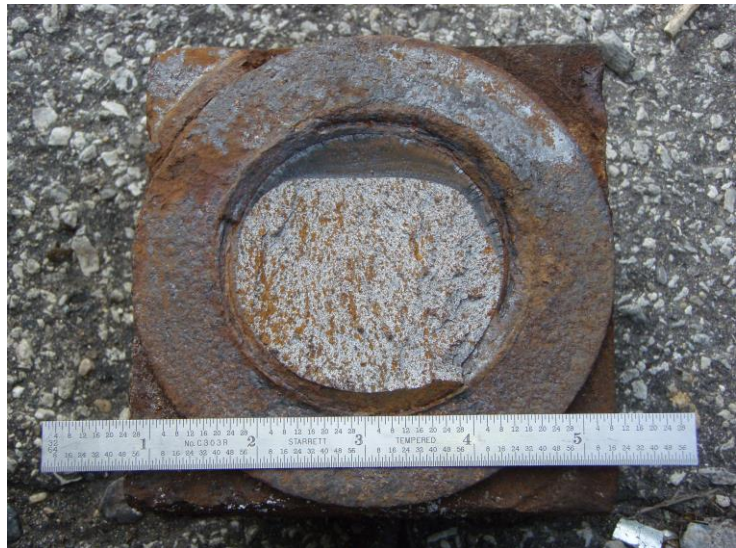
- The B1 bearing for the northwest pinion shaft exhibited a broken southeast bearing cap stud. The stud fractured at an existing fatigue crack in the threaded region at the bottom of the stud, at the interface between the square nut and the bottom of the housing assembly. The fracture surface appeared to have been recently exposed since it exhibited a limited amount of surface corrosion, as shown in Figure 8. No other B1 bearing cap studs or base bolts were observed to be broken; however, several inches of each bolt/stud length were occluded from direct view. Nondestructive testing was not performed to investigate the volumetric integrity of these items.

FIGURE 8. Failed B1 bearing bolt.

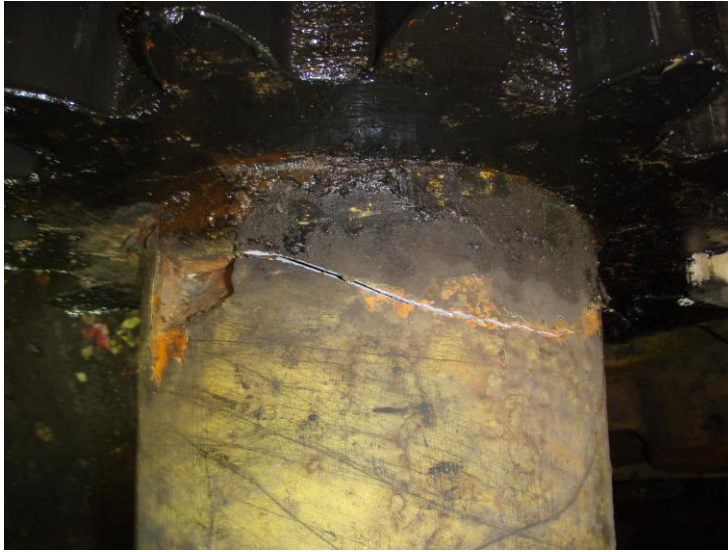
With the northwest rack pinion out of service, CDOT continued to operate the west leaf of the bridge using only the southwest drive machinery. Compared to operating the machinery with both drives, the loads in the southwest drive were roughly twice as high as they would have been with both drives operating. This proved to be too much for the machinery to handle and on or about November 26, 2018, the southwest drive machinery experienced a catastrophic failure.

FIGURE 11. Southwest drive train failed shaft.

Photos taken by WJE on November 27, 2018, show a complete fracture of one of the machinery shafts and failed bearing bolts. A large crack in a machinery shaft is shown in Figure 11 and a failed bearing mounting bolt is shown in Figure 12.

- Replace failed shaft and bearing mounting bolts at the southwest quadrant.
- Replace the northwest machinery frame with the machinery frame owned by CDOT. This frame was procured years ago as a replacement for the northwest machinery frame and was never installed.
- Weld repair the northwest rack teeth.
- Counterweight modifications to reduce machinery loading.

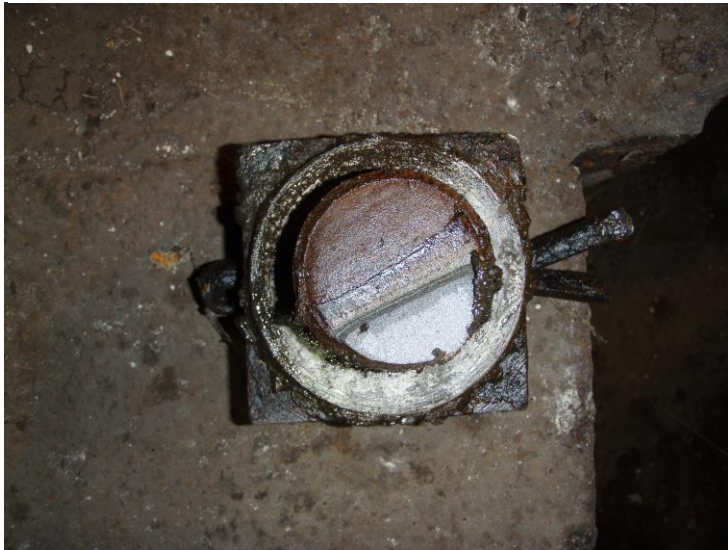
FIGURE 12. Southwest drive train failed bearing bolt.

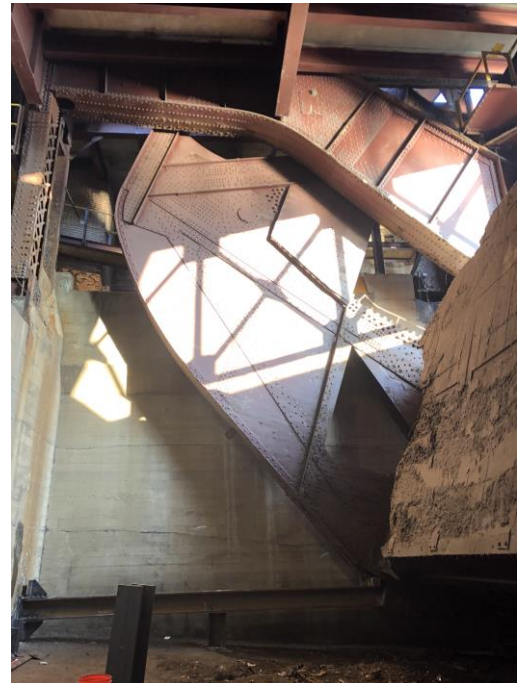
This failure left the bridge in the closed position and inoperable which was unacceptable to marine traffic. In order to keep marine traffic flowing, a decision was made to use the similar shaft from the northwest span drive machinery and relocate it to the southwest span drive machinery to restore operation of the west bascule leaf. This work was completed, and the west leaf was then operated and secured in the raised position by December 10, 2018. The bridge remained in the open position with the roadway detoured until all emergency repairs were complete. See Figure 13.

FIGURE 13. Strut holding bridge open

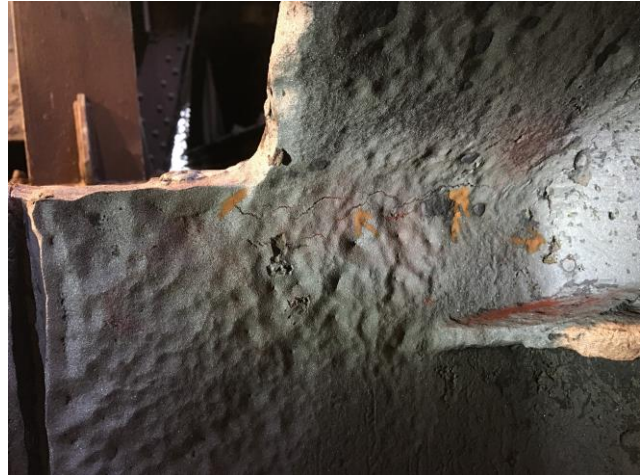
A detailed inspection of the existing northwest machinery frame was completed to assist in the assessment of its fitness for future service. The frame supports three open gear shafts, the drive motor, and brake components as shown in Figure 2. Visual and nondestructive testing of the frame were completed following cleaning by sandblasting. Visual inspections were aided by Magnetic Particle Testing (MT) to investigate any visually identified defects. In general, widespread cracking, pitting, and minor to severe section loss was observed (Figure 14). Cracks in the frame components were typically observed at the transitions in the casting between vertical stiffeners and the frame bottom and/or top flanges in the area of the B1 Bearing and along the frame segment closest and parallel to the seawall. Cracks were also observed in the casting around the base of the B1 Bearing. In

addition, several repair welds observed on the frame were judged to be of poor quality. However, these repairs were found to be largely intact. The result of these findings was a recommendation to remove the existing deteriorated machinery frame from service due to its condition. However, alignment data for and within the frame was also obtained for further evaluation.

FIGURE 14. Machinery frame cracks and pitting.

Given the poor condition of the northwest machinery frame documented through physical inspection as well as a precision survey, WJE strongly recommended that the northwest machinery frame be replaced with the frame that CDOT had available. Based on CDOT's desire to leave the racks in place, the frame replacement would be combined with weld repairs to the northwest rack segments to restore the rack teeth to their original profile.

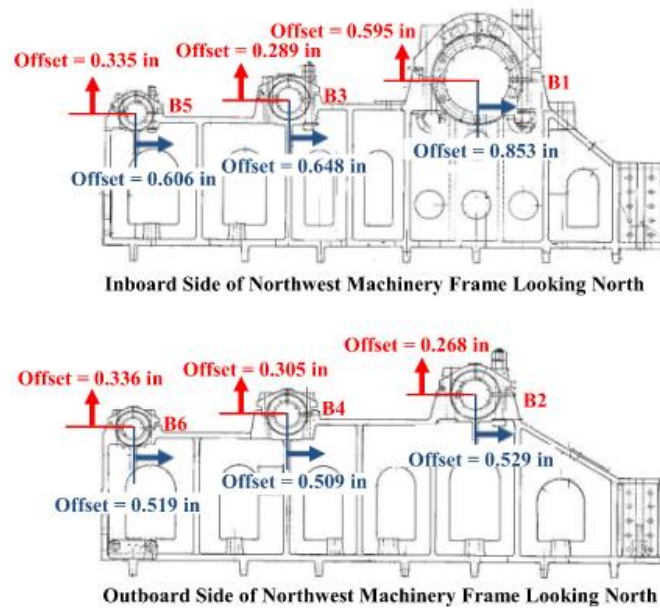
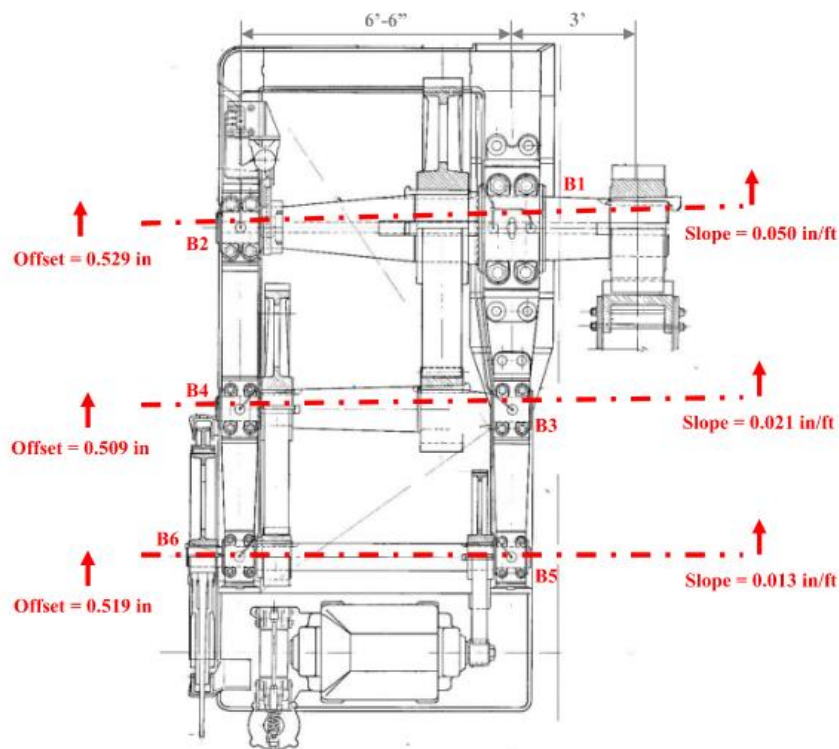
The survey showed that the northwest machinery frame was globally both higher and closer to the river than indicated on the original design drawings. Based on the data it appears that the horizontal offset may have been about 0.5 inches and the vertical offset about 0.3 inches. This may have been due to original rack and pinion alignment considerations. The survey also shows significant variations in the frame itself which are well outside of machine shop tolerances, indicating distortion of the frame since original installation.

Figures 15 and 16 show the variations in the machinery frame. While there is some distortion evident at all shaft/bearing locations, the most obvious distortion is at the rack pinion shaft bearing B1 where the survey shows a horizontal shift of 0.853 inches and vertical shift of 0.595 inches. Both of these variations are more than 0.200 inches greater than the variation of the other bearings at this side of the frame. Additionally, the horizontal and vertical slopes of the rack pinion shaft are 0.050 inches per foot or more than twice the slope of the other shafts in the machinery frame in both directions. The distortion of the frame is consistent with the force vector that would be resisted by the frame during a major rack and pinion tooth interference event.

FIGURE 15. Variations in machinery frame geometry.

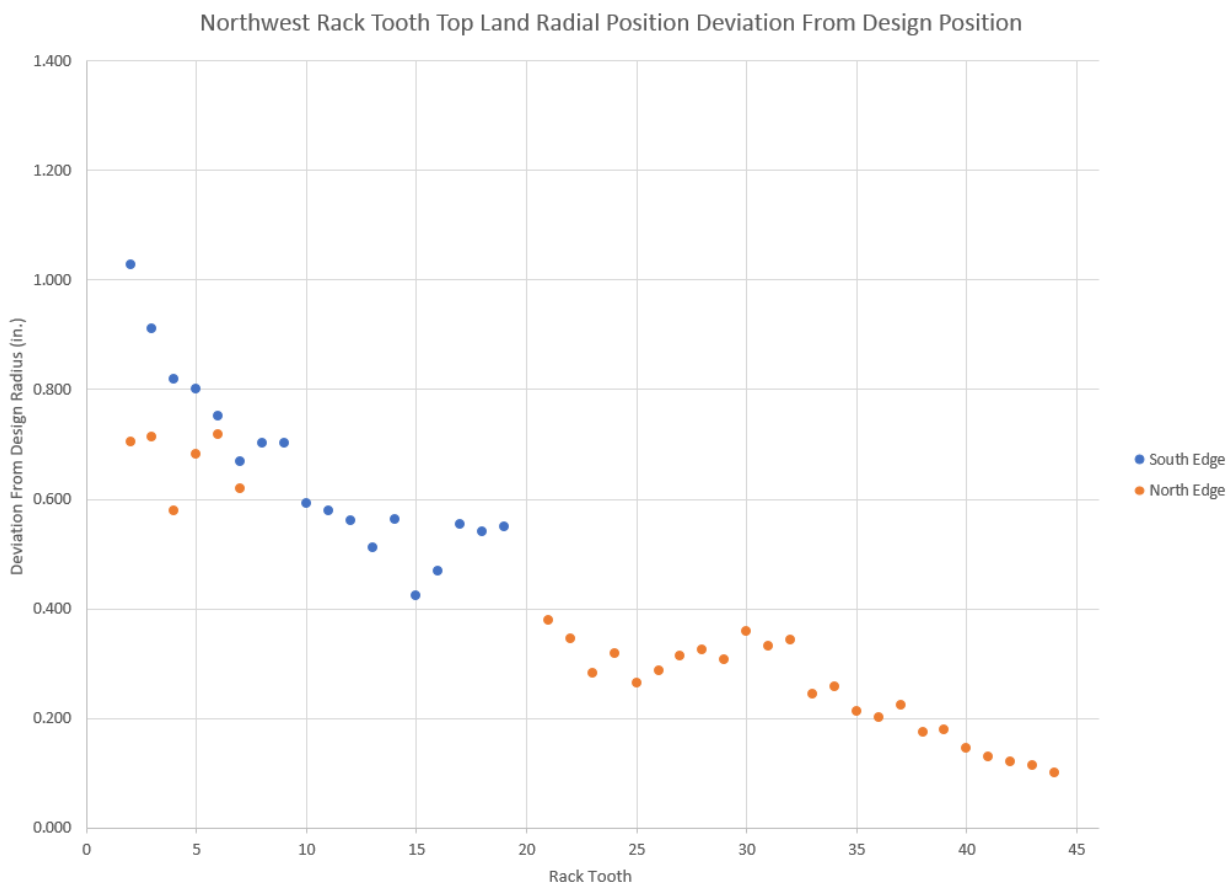
The survey showed that the position of the northwest rack pinion was 1.227 inches closer to the trunnion than indicated on the original design drawings. Since the pinion is internal to the rack, this results in greater separation of the rack and pinion than intended.

The survey of the northwest rack included RT 2 (near the closed position) through RT44 (near the open position) with measurements being tracked at the top land of the teeth. Where accessible measurements were taken at both ends of the teeth. Figure 17 shows the deviation of the location of the rack teeth compared to the design drawings. The teeth nearest the fully closed position were approximately 1 inch farther away from the trunnion reference line than indicated on the design drawings while the teeth near the fully open position of the rack were nearly the same as shown on the design drawings. Therefore, at the fully closed position the rack and pinion teeth were separated by about 2 inches more than shown on the original design drawings.

FIGURE 17. Northwest rack tooth radial position deviation from design.

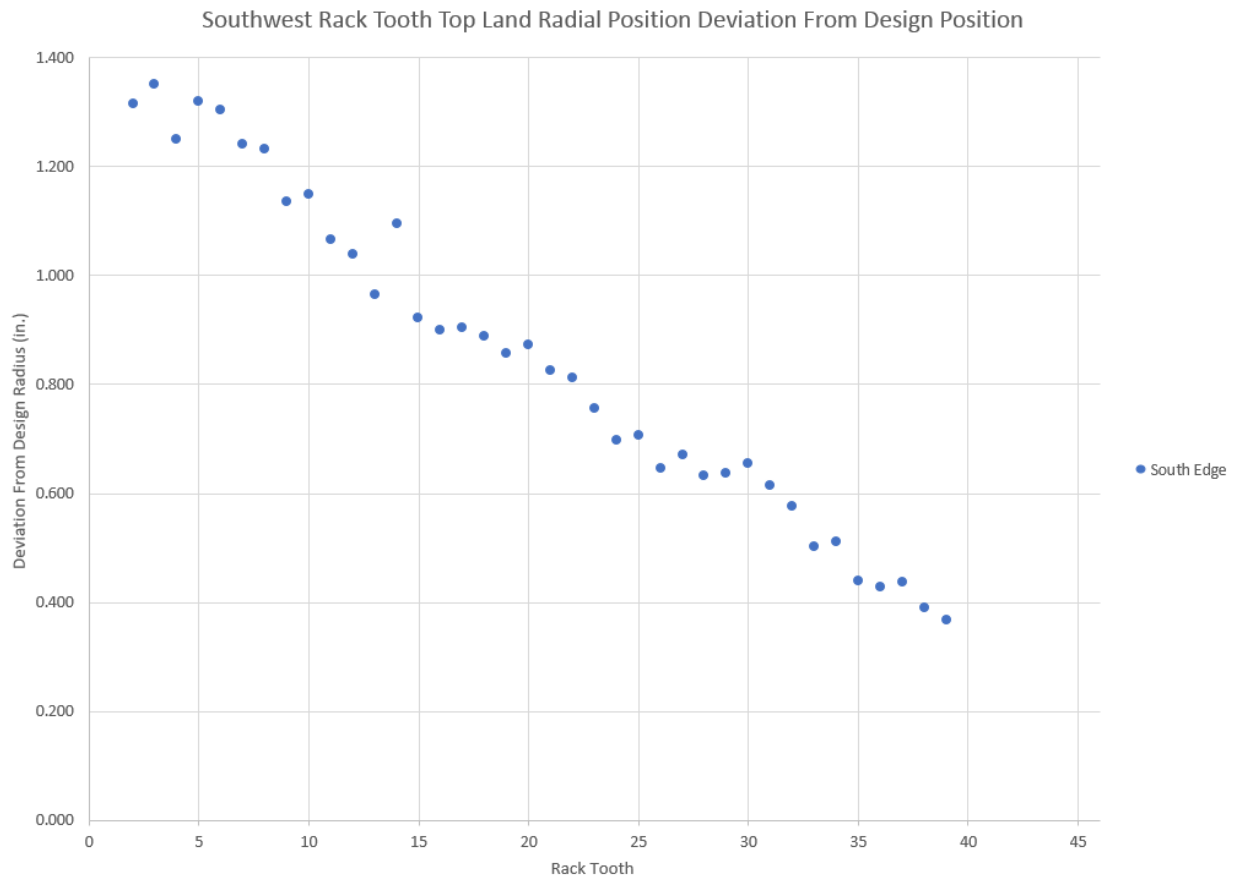
The survey of the southwest rack included RT2 (near the closed position) through RT39 (near the open position) with measurements being taken at the top land of the teeth. Measurements were taken at outboard ends of the teeth. Figure 18 shows the deviation of the location of the rack teeth compared to the design drawings. The teeth nearest the fully closed position were approximately 1.3 inches farther away from the trunnion reference line than indicated on the design drawings while the teeth near the fully open position

of the rack were about 0.4 inches farther away than shown of the design drawings. Therefore, at the fully closed position the rack and pinion teeth were separated by about 1-1/4 inches more than shown on the original design drawings. This resulted in the southwest rack pinion having 3/4 inches more engagement than the northwest rack pinion.

FIGURE 18. Southwest rack tooth radial position deviation from design

Because of restrictions related to emergency repair work, repairs to the southwest rack and pinion could not be justified and WJE recommended no repairs at the southwest rack and pinion at the time but indicated it would be prudent to address the problem in a future capital project.

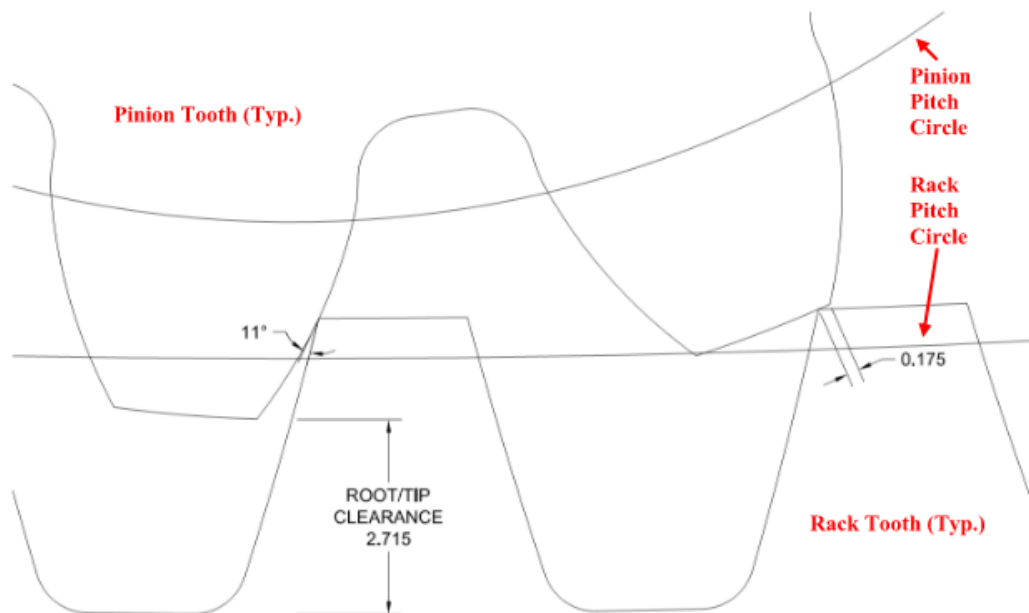
Based on the results of the survey an analysis of the worst possible northwest rack and pinion mesh was undertaken. The root to tip clearance was modeled as 2.715 inches as shown in Figure 19. This allowed for enough tooth engagement that with the pinion driving the rack, interference at the top land was not an issue however under a back driving scenario (rack driving the pinion) interference was likely. This was not acceptable.

FIGURE 19. Rack and pinion mesh model.

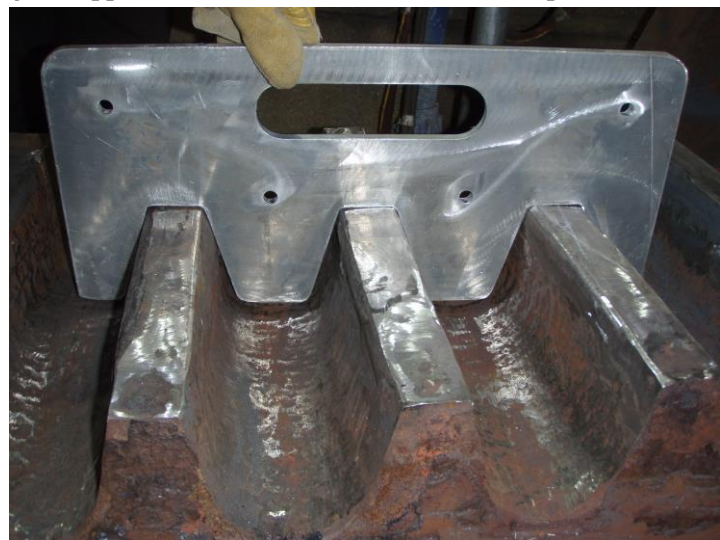
FIGURE 22. Rack tooth template.

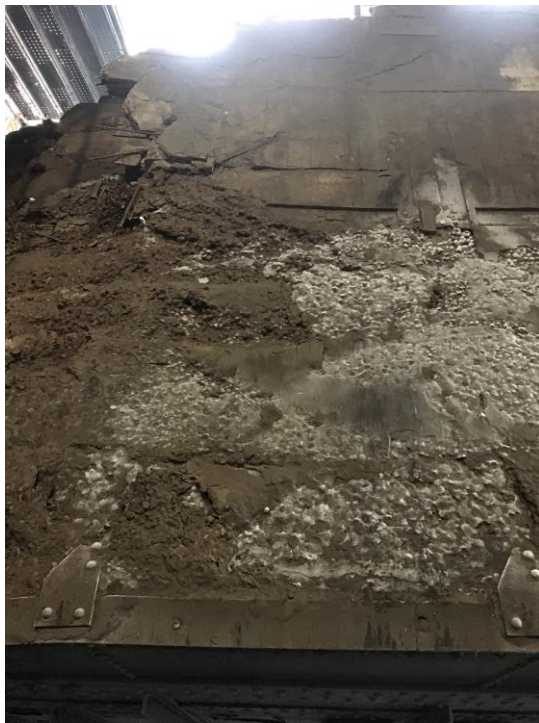
Representative concrete conditions are shown in Figure 24. In general, the composition concrete mixture was typically loose, and exhibited deterioration consistent with freeze/thaw damage, as well as possible poor proportioning of the original mixture, whereby the density of the steel punchings was too great, and the cement

paste was not able to adequately fill the voids between the punchings. The lead slag concrete mixture was found to be in comparatively better condition at the surface with less evidence of freeze/thaw damage, but exhibited large concrete spalls, delaminations, wide cracking, and poor consolidation. Due to the nature

FIGURE 24. Typical counterweight concrete conditions.

and extent of the existing deterioration, it was recommended that selective demolition to remove loose and damaged areas of the concrete counterweight be completed and that an innovative approach to both encapsulating vulnerable concrete and raising the counterweight center of gravity be developed.

Following removal operations, formwork was installed, and the upper forward portion of the counterweight box was restored to its approximate original dimensions. Following this work, a series of steel topping plates were installed, and field welded together to result in a solid steel “roof” for the concrete counterweight box. These plates served to encapsulate the remaining exposed original concrete on the top surface of the counterweight box and also to raise the counterweight center of gravity which was advantageous for the leaf balance. Once the steel topping plates were installed, a cementitious grout material was pumped to fill any voids between the new topping plates and the concrete surface below. To allow effective further future weight adjustment, a series of stiffened angles were welded to the top of the

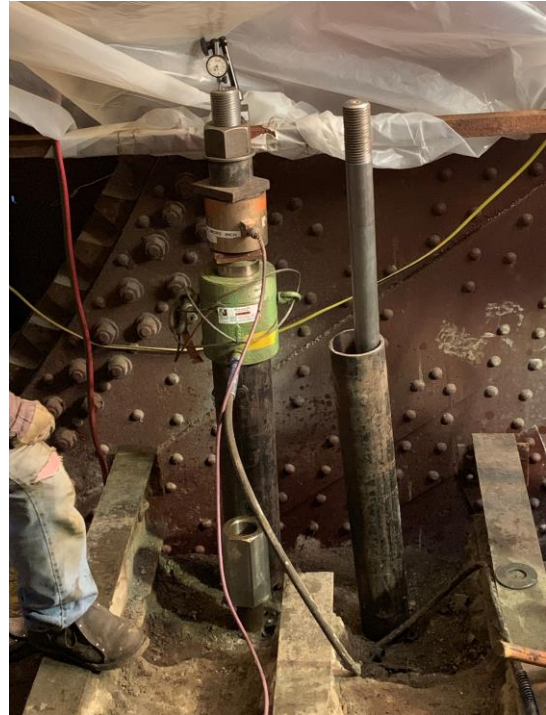
The existing damaged northwest machinery frame was removed from the site and scrapped. Once the cast frame was out of the way, partial demolition of the supporting concrete was undertaken. One goal of the partial demolition was to remove enough concrete to allow installation of the new frame at a lower elevation to promote better engagement of the new pinion gear with the existing rack teeth. Another goal was to expose the existing machinery frame anchor bolts to a depth that would allow them to be cut off and threaded. A coupler nut and anchor bolt stub were later installed to accept the new machinery frame. This allowed reuse of the embedded portions of the anchorage within the existing foundation and eliminated the corroded portions of the existing anchor at its attachment to the old frame. Each anchor bolt and coupling nut were tested in situ by proof loading the anchors using a center-hole hydraulic ram (Figure 25). Load and displacement were monitored during each test.

FIGURE 25. Machinery frame anchor bolt proof testing using center-hole hydraulic ram, load cell, and displacement measuring device.
