**HEAVY MOVABLE STRUCTURES, INC.  
NINETEENTH BIENNIAL SYMPOSIUM**

**CSX New River Bascule Bridge  
Emergency Coupling Replacement**

Robert Algazi P.E., Amaka Anderson P.E., David Nyarko P.E, Roger Khouri P.E.  
WSP USA, FL, NJ, and NY, USA

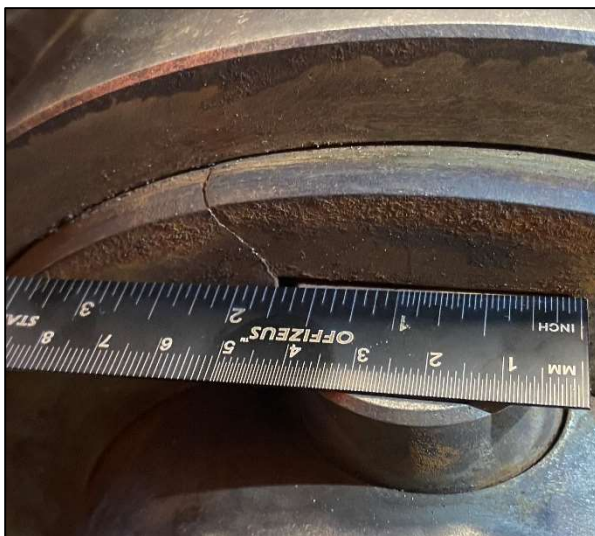
During the 2020 annual mechanical/electrical inspection performed by Stantec and Hardesty & Hanover (H&H), a crack in the eastern main pinion shaft coupling hub was discovered. A similar crack in the western main pinion shaft coupling was also discovered. The cracks were emanating from the corner of the coupling keyway up through the body of the hub. Over time the cracks propagated until the entire hub was split in half.

Photo 3: Crack in Coupling Hub

As a result, FDOT hired HNTB to design a temporary collar which was installed on both couplings to help prevent the hubs from separating. Bridge operation times were increased and closing of the span for rail traffic was limited to reduce the loading on the couplings and reduce the risk for catastrophic failure without impeding freight rail traffic. It was understood this would be a temporary solution with a permanent coupling replacement required. Also, since construction of the bridge was recently completed, a review of the cause of failure and prevention of future issues was mandatory.

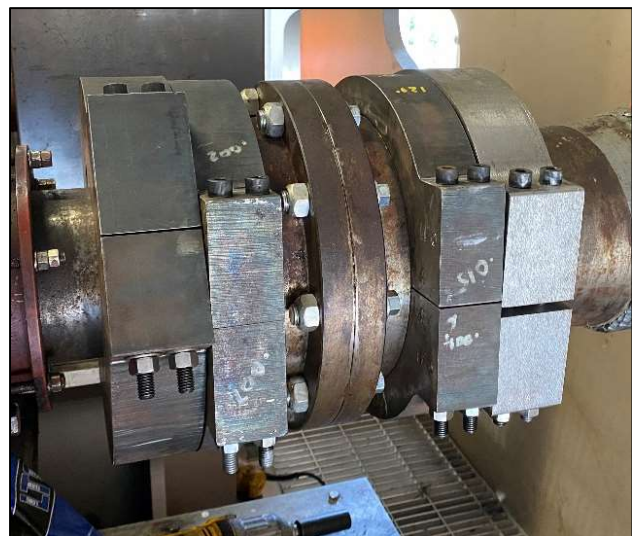
Photo 4: Collar assembly on the pinion coupling.

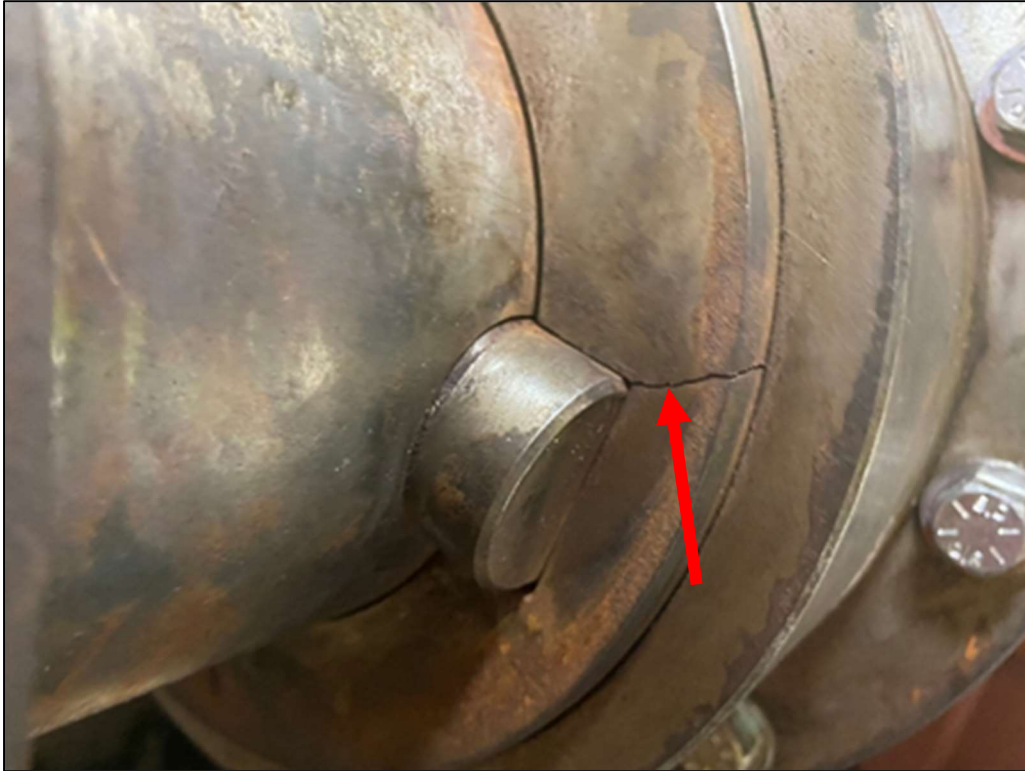
The design and construction teams performed an initial inspection of the existing bridge and all components, including the couplings, to identify potential causes of the failure. Inspection of the existing pinion couplings confirmed the cracks were emanating from the corners of the hub keyways. Each keyway corner was cut at a hard angle with no radius provided. Side clearances were present at the keyways allowing the keys to move freely under hand contact. Additionally due to the split in the coupling hub, the interference fit required at the hub-shaft interface was lost.

Photo 5: Hub crack during bridge operations. Note gap between hub and shaft

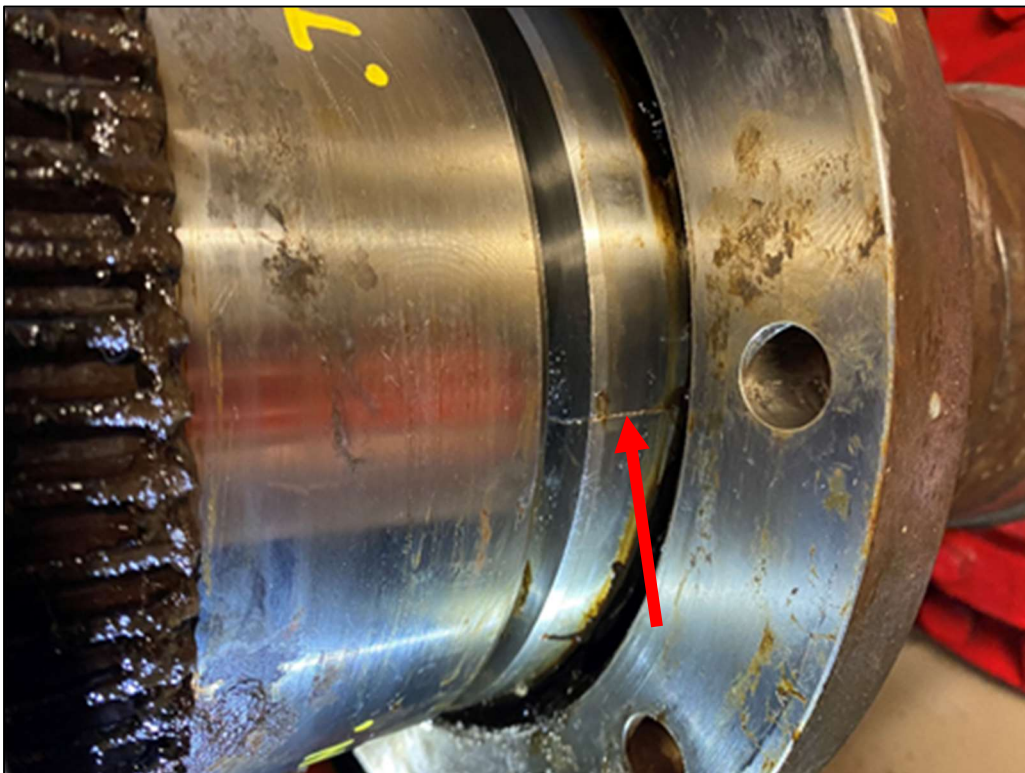
Photo 6: Note crack through pinion hub (radially and longitudinally) at coupling center.

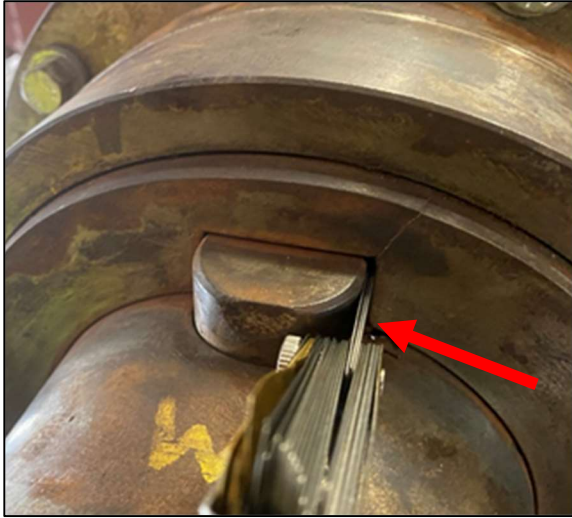
Photo 7: Clearance between west pinion hub key and keyway. Note crack at SW corner

A clearance was measured between the cracked pinion hub and shaft at both couplings (See Photo 7). The cracked and loose pinion hub would move against the pinion shaft during bridge operation. The excess hub clearance was not reported until after the coupling hub cracked and is likely a result of the hub cracking; however, as there are no as built records, this cannot be confirmed.

There were relatively large clearances present between the original coupling keyways and corresponding keys on both the pinon shaft and reducer shaft hubs. Additionally, on the pinion side hub, the key would “rock” in the keyway and the crack in the hub would “open” up noticeable during opening and closing of the movable span. Per the as-built drawings, an FN2 (forced) fit was required between the key and keyways sides. All keyway side clearance measurements taken during field investigations varied from 0.012” to 0.080” and confirmed that the designed specified FN2 fit was not present. Additionally, clearance measurements varied, suggesting that the existing keyway may be tapered and not seat parallel.

Due to the amount of clearance that exists, it was very likely that the required FN2 fit may not have been provided at installation, however, this cannot be confirmed since no construction quality control documents were available. Without an effective fit, the torque may not be transmitted properly by the coupling key to the shaft as required by AREMA 6.5.22.B. This will also cause the transfer of torque to be dependent on only the FN2 force fit between the hub and the shaft, which per our analysis below was not adequate to transfer the full 150% FLMT.

*Keyway dimensions of the existing shafts were taken at disassembly and the keyway, and were field machined as required. The replacement keys were specifically made to conform to the FN2 fit requirements based on the final field measured dimensions.*

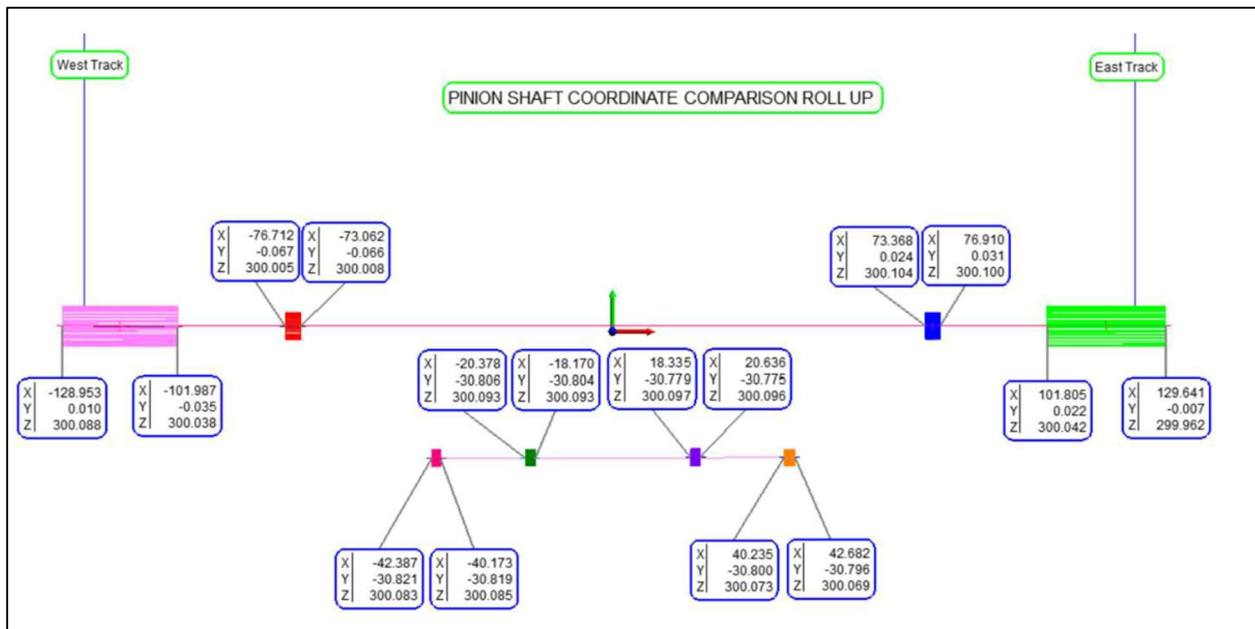
WL3 Solutions performed a laser alignment scan of the span drive machinery shafts and positioning of the pinion shaft centerline/center of roll with respect to the curved tread plate at various bridge angles of opening. The results of the alignment survey identified the pinion shafts were not in line with each other and additionally they were not parallel. This was expected because the pinion bearing bores in the girders were not line bored together during original fabrication. Even with the parallel offset of the pinion shafts, the alignment of the east and west pinion couplings, which connects the pinion shafts to the secondary reducer output shafts, were all within operational tolerances.

Figure 2: Existing Machinery Alignment Laser Survey Results

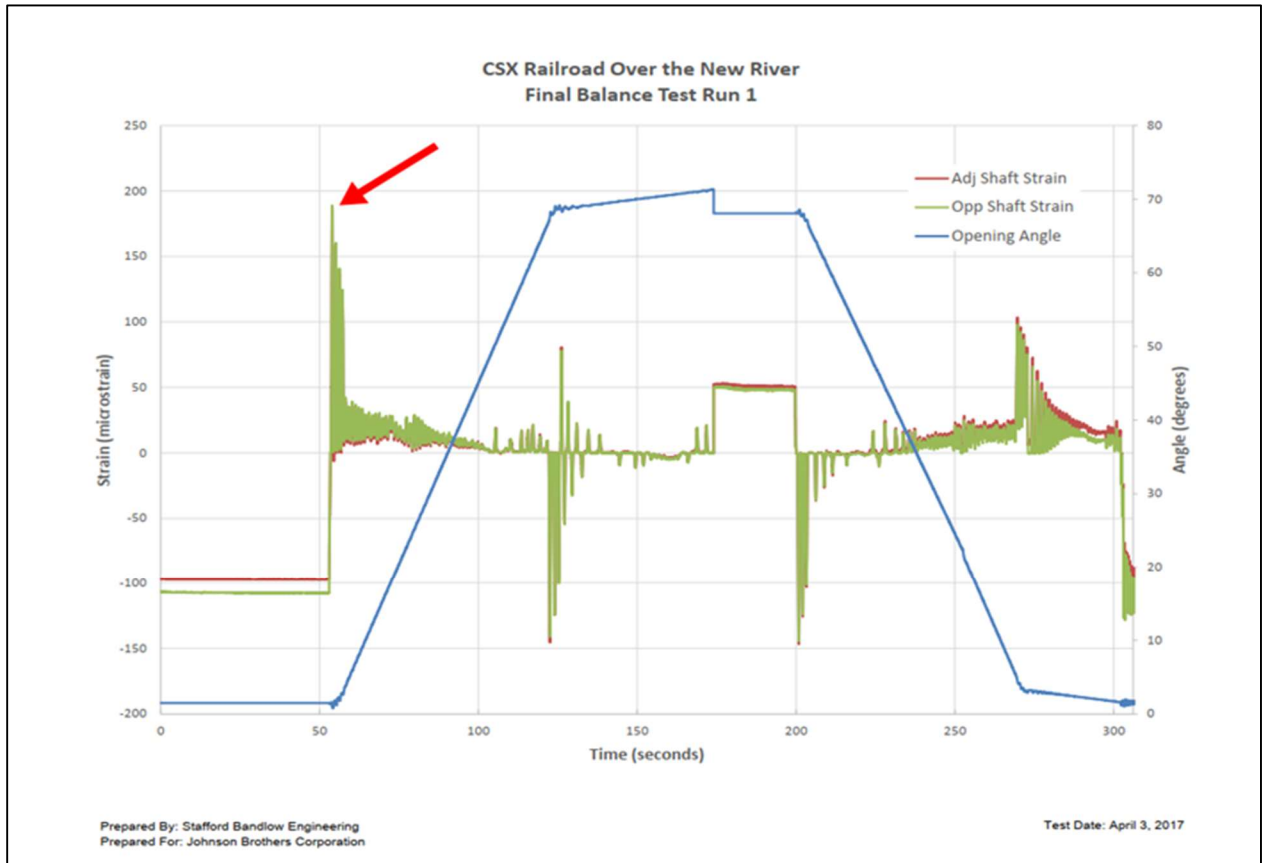
speed in order to reduce loading on the couplings. Testing revealed the bridge was well balanced with fairly equal load sharing between east and west pinions; however, several spike loads were present at the starting and deceleration phases of operation. When the results were compared to the 2017 final construction span balance report, it was found the spike loading in the 2017 report was above the AASHTO allowable 150% motor torque rating. It is not clear how long the bridge was operating under these high peak torques.

Figure 3: 2017 Construction Balance Report Strip Chart

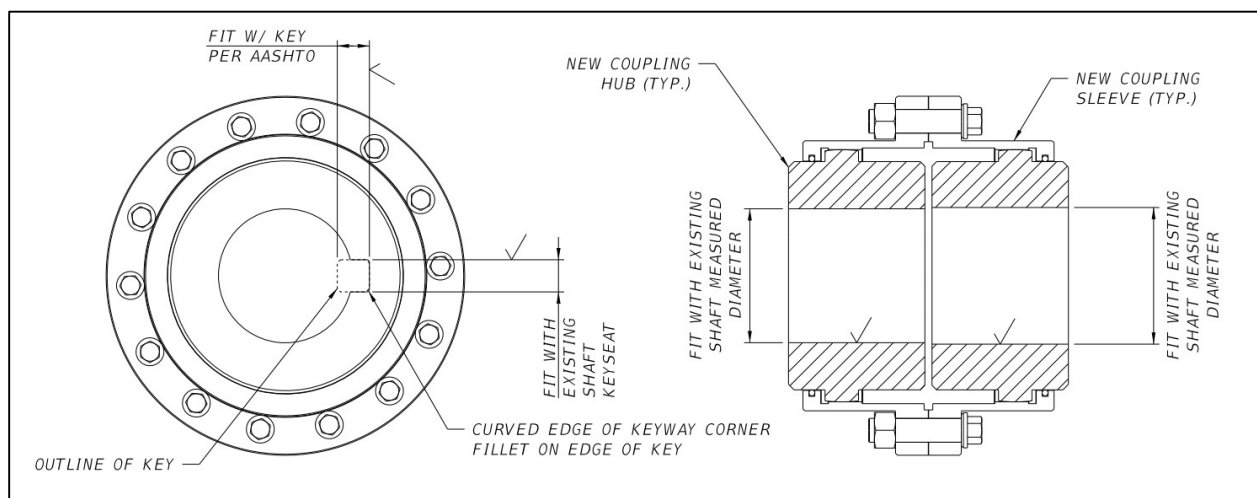
Upsizing the new coupling to increase the torque rating was essential to ensure this failure did not repeat again and was necessary based on the loading seen in the strain gage testing. The maximum peak torque measured during the opening acceleration phase was approximately 196% of the full load motor torque (422.2 kip\*in). This is above the machinery 150% Full Load Torque (FLT) of the Motor rating per AASHTO/AREMA. Increasing the original coupling size from a Falk 1045 G20 to a Falk 1055 G20 increased the torque capacity by approximately 75%.

Figure 4: Sketch of Coupling Design Considerations

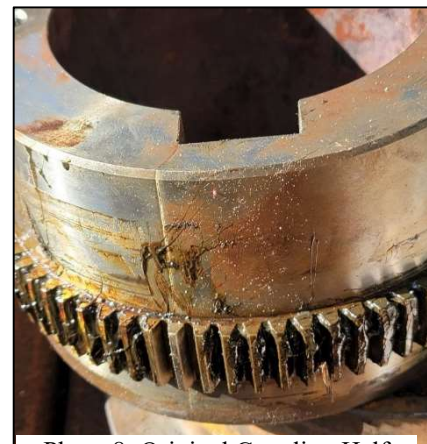
Photo 8: Original Coupling Half  
After Removal

Once the couplings were ready for removal, the coupling cover was pulled back and the existing hubs were pulled off the shaft. All temporary collars installed on the couplings were also removed. It was clear once the existing couplings were removed that the whole hub had completely split indicating a complete failure of the component.

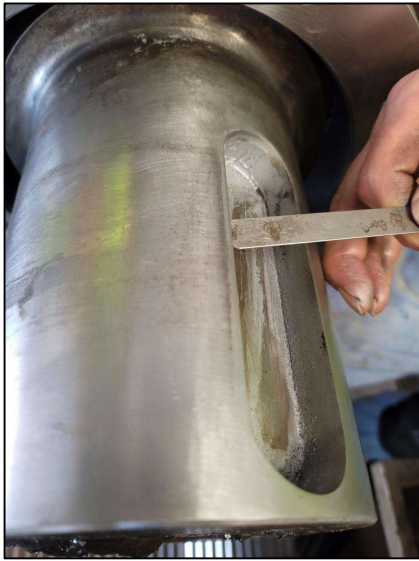
Photo 9: Existing Shaft Keyway Measurements

In order for the coupling replacement to be successful, it was crucial to provide the required fits at the shaft and keyseats. To do this, the existing shaft diameters and keyseat dimensions were measured at several location. Differences in the measurements could prevent the required fits to be achieved and would need to be machined in the field. In addition, a visual inspection was performed to check for any damage. Luckily there was no major damage and only minor hand surface refining work to the shafts was required. The keyways had to be machined in the field due to the tapered wear of the walls.
