**HEAVY MOVABLE STRUCTURES, INC.
NINETEENTH BIENNIAL SYMPOSIUM**

**Emergency Response: Bascule Bridge
Drivetrain Failure**

Ralph Giernacky, P.E.
Wiss, Janney, Elstner Associates, Inc.
rgiernacky@wje.com

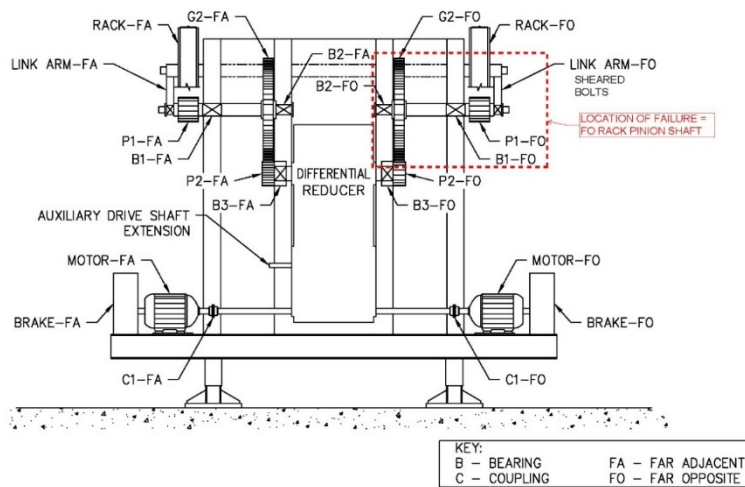
Figure 2. Hopkins frame span drive machinery layout.

assembly, which is clevis-mounted to the bascule pier. Outboard of each rack pinion shaft there is a link arm that connects the rack pinion shaft to a shaft at the counterweight side of the Hopkins Frame assembly at a position colinear with the axis of rotation for the leaf. The span drive machinery is depicted in Figure 2, and includes identification of the location of the failure.

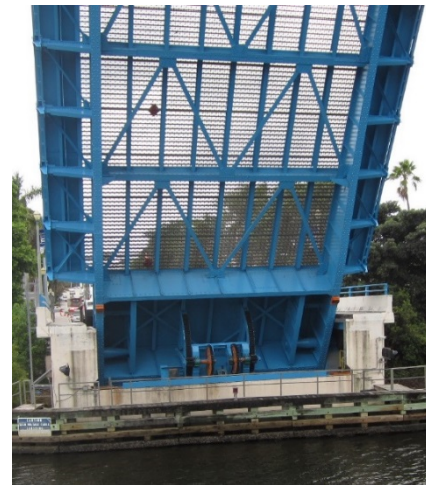
Figure 1. Representative leaf in the open position with Hopkins frame span drive machinery.

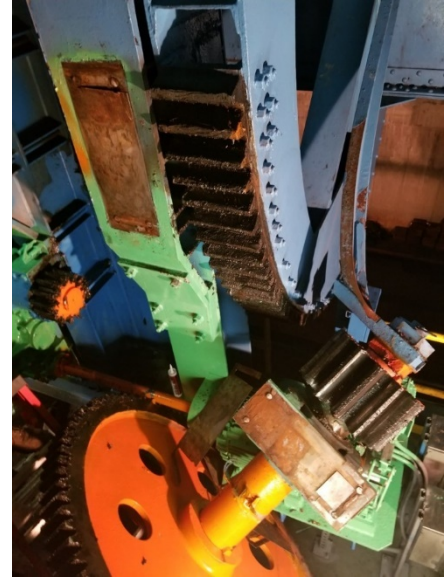
On the afternoon of Sunday January 27, 2019, the far leaf of the bascule bridge experienced a span drive machinery failure that resulted in loss of control of the leaf. The failure occurred on a Hopkins frame span drive machinery arrangement. See Figure 3. The failure originated at the far opposite rack pinion shaft bearing (B1-FO). See Figure 2. Upon failure of the B1-FO it appeared that the B2-FO mounting bolts failed resulting in the unsupported rack pinion disengaging with the rack. This resulted in the loss of control of the leaf and the rack pinion shaft falling, deforming the Hopkins frame link arm that remained connected to the shaft. The arrangement of the Hopkins frame relies on a central differential speed reducer and brake assemblies located at the motor shafts. The design of a differential allows the output shafts to rotate at different speeds to provide load sharing. The downside of this arrangement is that if an output shaft fails or is otherwise disconnected from the drive, the motors and brakes at the input shaft of the differential become ineffective. As a result, the leaf was unable to be controlled when the rack pinion disengaged from the rack. It was assumed that the far leaf impacted the live load supports upon loss of control.

Figure 3: Unsupported rack pinion shaft resting on the motor, attached to the deformed Hopkins frame arm.

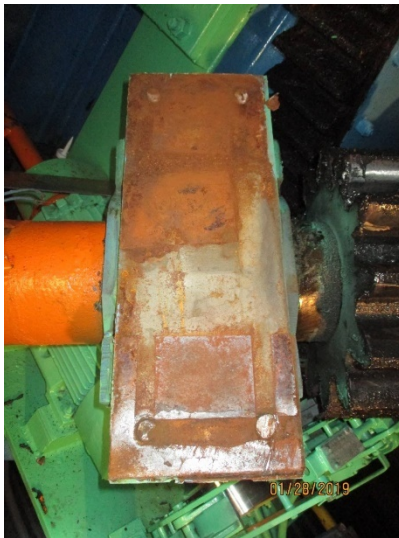
Figure 4: Bearing B1-FO. View of the failed mounting bolts remaining in the bearing base.

Inspection of the failed mounting bolts for the B1-FO bearing indicated that one bolt exhibited corrosion in the fracture plane, indicating the bolt failure initiated prior to the operational failure, while the remaining three bolts also had evidence of crack initiation although to a lesser extent.

A review of the machinery loading compared to the strength of the bearing bolts was also conducted. The review concluded that the bolts, as installed did not meet AASHTO machinery design requirements. Subsequently, rehabilitation plans were reviewed and the intent of the bearing mounting was that the bearing bases were to be mounted with the combination of bolts and dowels to provide the required resistance to meet the intent of AASHTO machinery design. As shown in Figure 4, no dowels were noted to be installed and as a result the bearing mounting shear capacity did not meet the

requirements of the rehabilitation plans. The installation provided 30 years of service until the bolts were ultimately subjected to loading that resulted in failure.

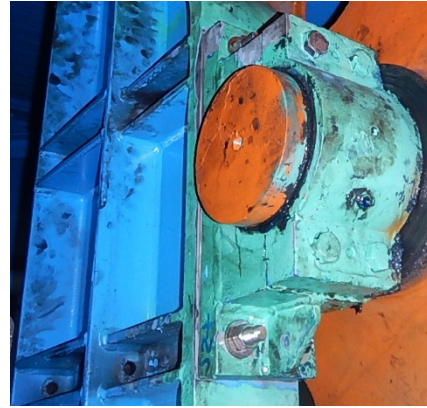
Due to this failure, the far leaf remained in the seated position, enabling vehicular traffic to be unaffected by the failure. To facilitate marine traffic, the near leaf remained in service and operated routinely for vessels. Due to the root cause of the failure being the lack of bolt shear capacity as compared to the design intent per the rehabilitation plans, the integrity of the near leaf bearing mounting bolts were in question. Upon visual inspection, no physical signs of damaged bolts was evident and no movement during operation was noted at the bearings. The near leaf bearing B1, B2 and B3 mounting bolts were evaluated using the ultrasonic test methods. The result of the testing was that several bearing bolts had an indication of crack initiation. Near leaf operations were halted until the bolts in question could be replaced. The replacement of the questionable bolts at the near leaf needed to be performed in an expedited manner to restore operation of the movable bridge to facilitate single leaf operation. Calculations were performed to replace the existing bearing B1, B2 and B3 bolts on the near leaf one at a time with temporary bolts. The temporary bolts were designed to secure the bearings under machinery loading developed when operating the leaf in wind speeds below 25 mph.

Figure 5: Bearing B2 installed with temporary mounting bolts.

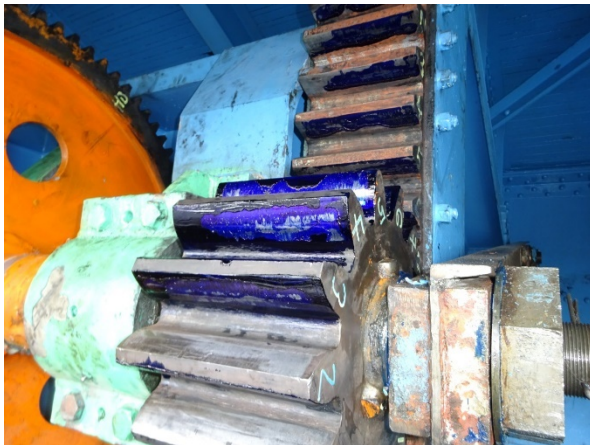
Figure 6: Far opposite rack and pinion contact on the opening face. Machinery secured with temporary bolts.

Once the near leaf was operational, efforts were made to restore operation to the far leaf. The bearings, bull gear, shaft and pinion were still intact and reusable. All of the span drive machinery components were visually inspected, the gearing was inspected using Magnetic Particle testing and the Hopkins pipe was ultrasonically tested. The Hopkins frame link arm was damaged and needed to be replaced. A temporary Hopkins frame link was designed and installed to replace the damaged link arm. The machinery was reinstalled using temporary bolts and both movable leaves were operational using

temporary mounting bolts. The motor was limited to a predetermined amperage to prevent the machinery from operating at wind speeds above 25mph. This was accomplished by February 14, 2019. Both movable leaves were operational within 18 days of the failure.

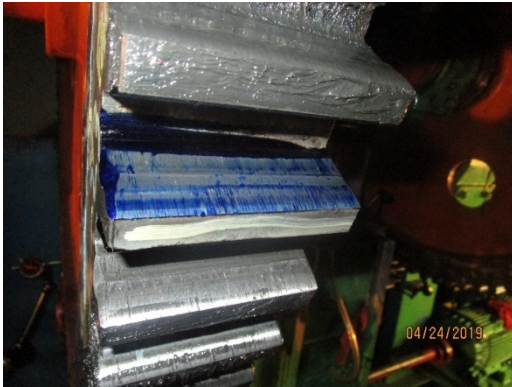
Figure 7: Contact at the Far Adjacent G2/P2 with a taper in the backlash of 0.000"

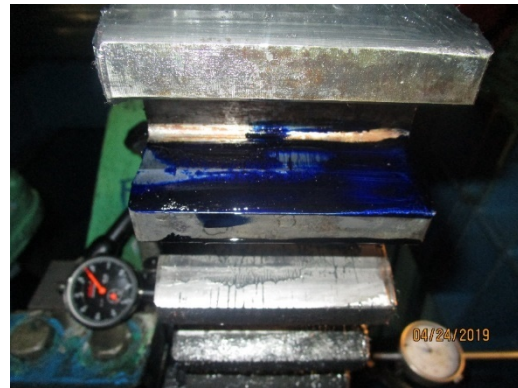
- The far opposite G2 gear was warped. Measurements with a dial indicator at the rim of the gear demonstrate a run-out of approximately 0.150" during operation. Note that this issue was not noted at the far adjacent G2 gear. It is possible that this is damage from the time of the failure when the gear and shaft assembly disengaged from the drivetrain. A visual inspection performed of the gear prior to temporary re-installation did not indicate any significant damage.

Figure 8: Contact at the Far Opposite G2/P2 with a taper in the backlash of 0.005"
