**HEAVY MOVABLE STRUCTURES, INC.
NINETEENTH BIENNIAL SYMPOSIUM**

**Movable Bridge Operational Testing
Strain Gage and Electrical Load Recordings
Case Studies and Lessons Learned**

Ryan Kanagy, Ralph Giernacky, Yang Zheng
Wiss, Janney, Elstner Associates, Inc.

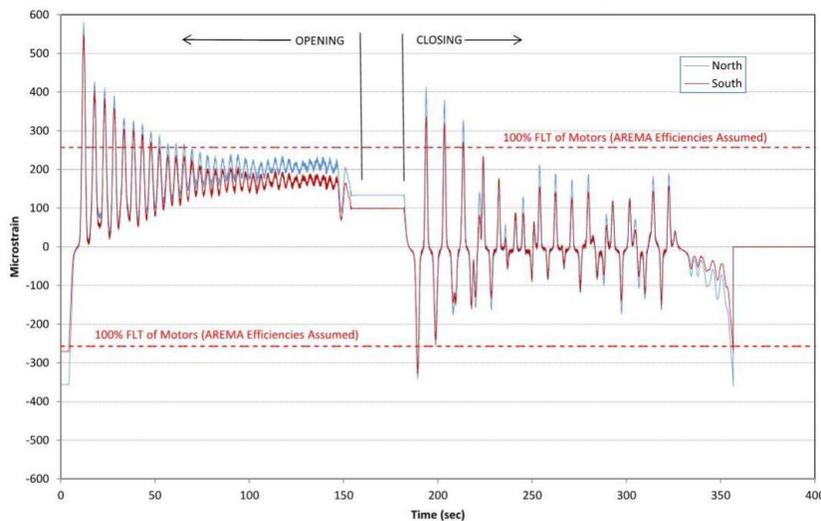
FIGURE 3: Lorain Lift Bridge. Baseline Strain Gage Recording.

Strain gage recordings from the baseline operating condition are shown in FIGURE 3, which documents the excessive load oscillations noted at the instrumented shafts.

This behavior was most severe during lowering of the lift span with the rope tensions oscillating between completely taut and completely slack conditions end to end of the lift span. The operation of the lift span could be described as a “see-saw” movement; one end of the span would stop while the other end lowered, then the ends would reverse with the opposite side stopping. This behavior imparted significant impact loads to the operating ropes and to the machinery.

The load oscillations evident with the strain gage measurements had similar characteristics as seen in the electrical recordings. The magnitude of the load oscillations when raising the bridge at full speed appeared to represent that of an underdamped control system but eventually damped before the bridge reached full open. When lowering the bridge, the magnitude of the oscillations did not diminish and damp out with time but were maintained until the speed of the bridge was

Based on the initial review, there were noted issues that were identified as possible contributors to the bridge operational issue apart from tuning the drives including excessive imbalance, and misadjusted span drive operating rope tensions. The adjustments to the imbalance and the operating rope tensions were performed prior to any of the drive adjustments, with strain gage and electrical recordings performed before and after each adjustment to verify their impact.

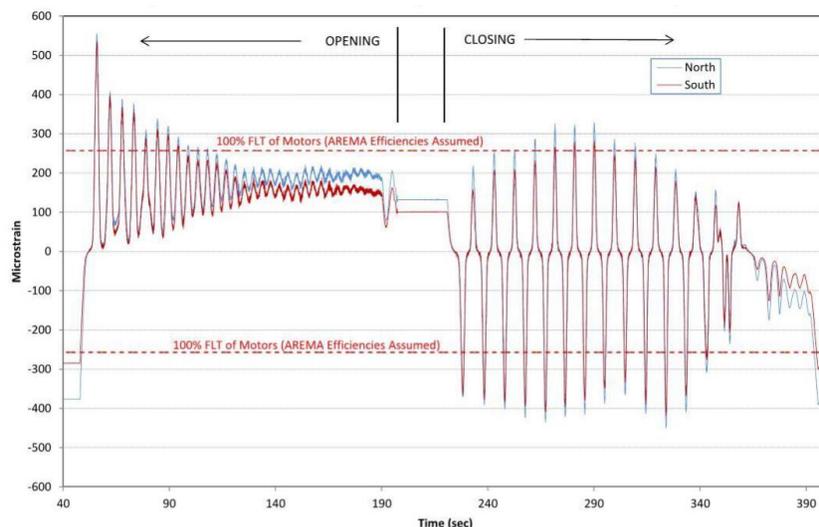
FIGURE 4: Lorain Lift Bridge. Strain Gage Recording Following Balance Change and Rope Tension Adjustments.

Operating rope tension adjustments had no discernable impact on the behavior of the lift span. The imbalance was reduced by adding counterweight ballast to the counterweight pockets. The imbalance was successfully reduced however the balance change did not improve the load oscillations or the uneven operation of the bridge. In the raising direction, the change had minimal effect. In the closing direction, the imbalance was nearly equal to system friction, and the result of the change increased the magnitude load oscillations (see **Error! Reference source not found.**). Although the modifications did not improve the operation of the bridge, a return to the heavier span imbalance was not recommended as this would increase the loading on the machinery and reduce the capacity for the system to handle additional design loads (wind, snow, ice, etc.) as required by AREMA.

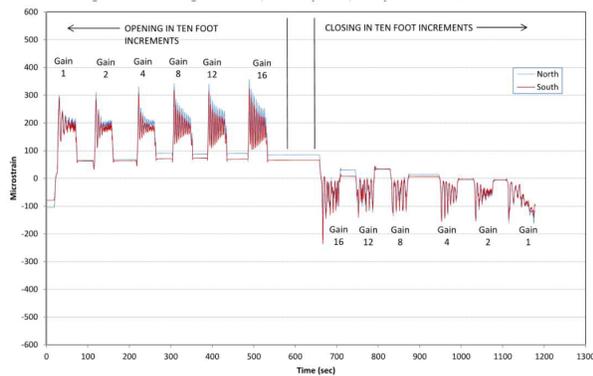
FIGURE 5: Lorain Lift Bridge. Strain Recordings of Proportional Gain Adjustments at the Drive.

Based on the testing shown in Figure 5, a proportional gain of 4.0 was selected as it provided for the short period of unstable operation with less pronounced oscillations. After selection of the proportional gain, an integral time constant was selected. The 2.0 second integral time constant was selected as it minimized the duration of oscillations. As a final adjustment, after the proportional gain and integral time constant were optimized, the accelerating ramp time was modified. The accelerating ramp time was short and a cause of excessive torque. The accelerating ramp time of the drives was increased to decrease the inertial loading and reduce the accelerating torque being applied to the bridge machinery. The final operating characteristics are shown in Figure 7.

The procedure included iterative adjustments to the acceleration time, the proportional gains, and the integral time constant associated with each drive. The effect of the gain and integral time constant adjustments were recorded with bridge operations in ten foot increments and included

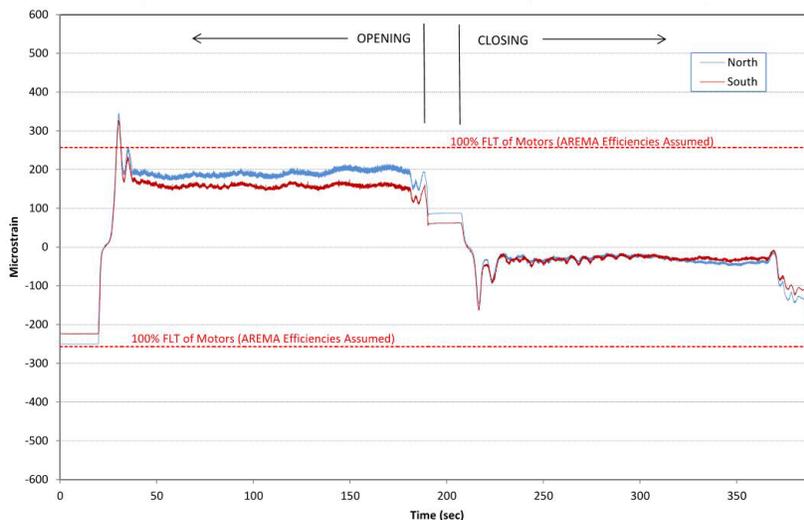
FIGURE 7: Lorain Lift Bridge. Strain Gage Recording Following Drive Adjustments.

The root cause of the operational issue was demonstrated to be improper drive tuning. After the tuning, span operation had minimal load peaks, negligible oscillations, and an elimination of the

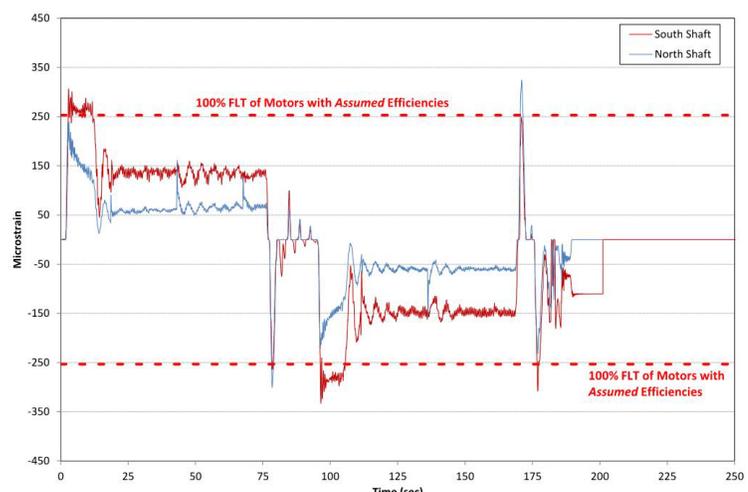
FIGURE 8: Hines Memorial Bridge. Rack Pinion Shaft Strain Gage Baseline Recordings.

The preliminary evaluation relied solely on mechanical strain gage load recordings. The baseline strain gage recording is shown in Figure 8. The recording confirmed poor load sharing between the two drivetrains. However, despite the relatively high loads noted with electrical recordings at the drives, the strain gage load recordings were lower relative to the expected full capacity of the motors. The expected electrical drive loads would be lower than measured if estimated reducer efficiencies from AASHTO (LRFD 5.8.4.2.1) were assumed. The investigation also included checks of the alignment of all of the components in the mechanical drivetrains. All components were found to be well-aligned.

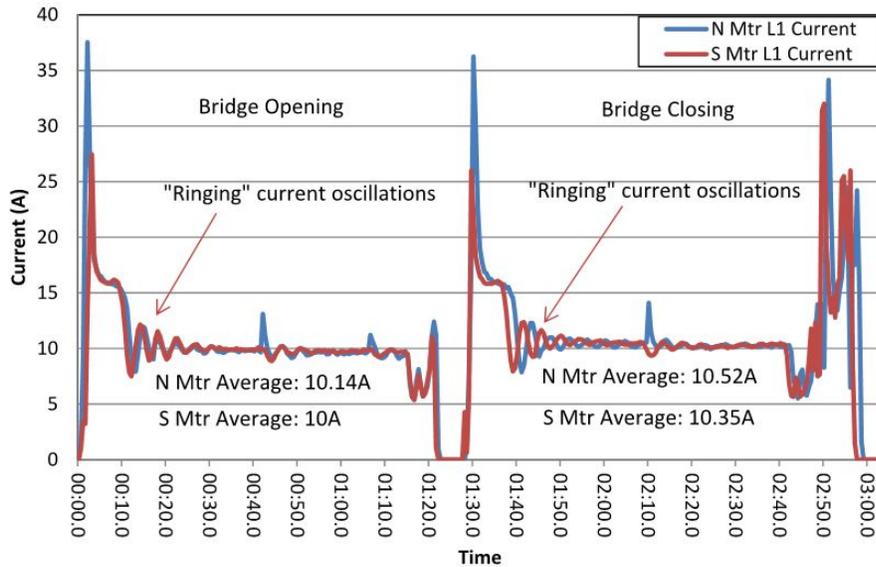
FIGURE 9: Hines Memorial Bridge. Motor Current Baseline.

The drive output current oscillations that were occurring were caused by the under-damped nature of the control loop that had been set up. These oscillations caused detrimental transient loads to be generated and applied to the mechanical system. This phenomenon is known as “Ringing”. Under-damping occurs when the control system integral and proportional gain constants are set too low based on the motor load characteristics. The elimination of this “Ringing” was achieved by an iterative process of increasing the integral and proportional gain constants in increments to obtain the desired critically damped response for the drive output currents.

Figure 9 and 10 show current recordings over a complete bridge operation prior to tuning (baseline) and following drive tuning. As can be seen by comparing the two recordings, the tuning and increasing of the integral and proportional current gain constant parameters of the drives eliminated the oscillations. The limiting of the unnecessary drive load oscillations thereby lowered the RMS (root mean square) loads during accelerating periods.

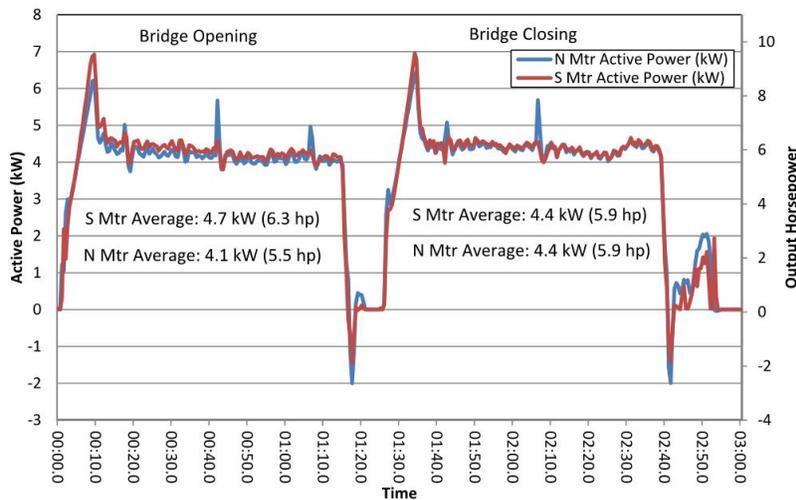
FIGURE 11: Hines Memorial Bridge. Final Electrical Power Measurements.

The adjustments had the desired effect. Optimization of the drive tuning and the load sharing provided significant improvements to the control of the bridge. The loading was reduced through the oil change and the speed reduction. These changes, combined with the modification of the drives' thermal overload protection, eliminated the nuisance tripping. The final electrical power recordings are shown in Figure 11.

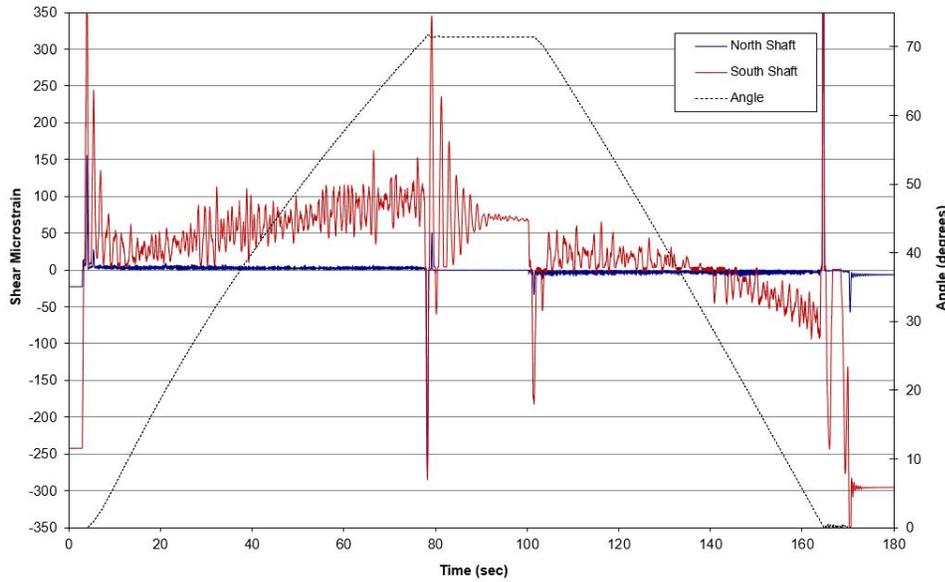
FIGURE 14: LaSalle Causeway Bascule Bridge. Baseline Strain Gage Recording.

The strain gage recordings showed poor load sharing between the two shafts at the output of the differential assembly. The baseline recording is shown in Figure 14.

The span drive machinery differential assembly is designed to mechanically equalize the loading at the two cross shafts and, ultimately, to each of the two rack pinions and operating struts. Figure 14 demonstrates that, with the exception of transient spikes in loads, the north shaft carried no load.

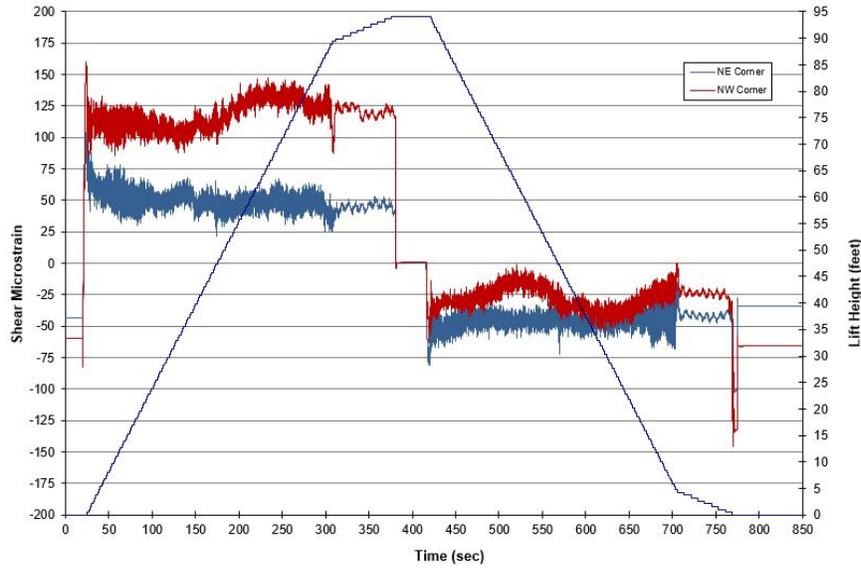
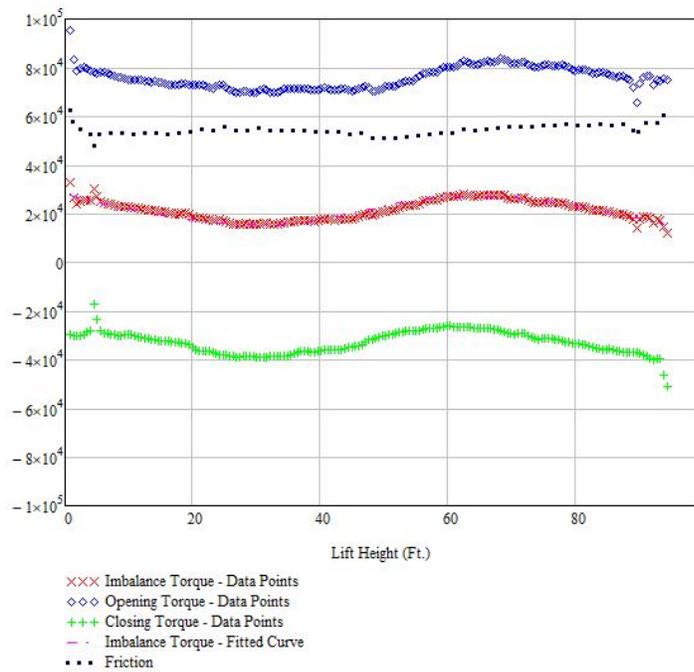
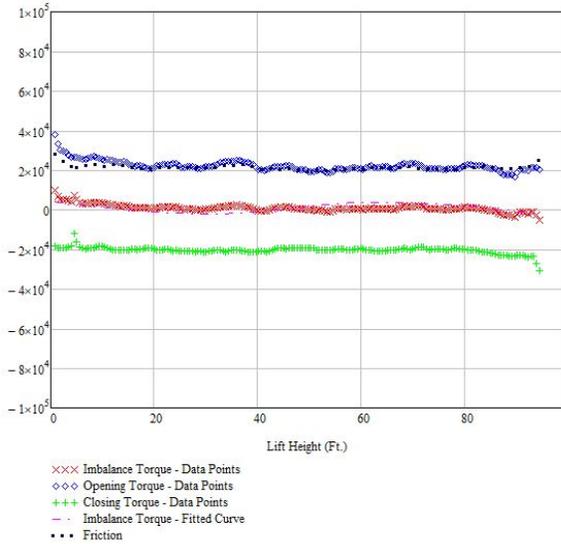
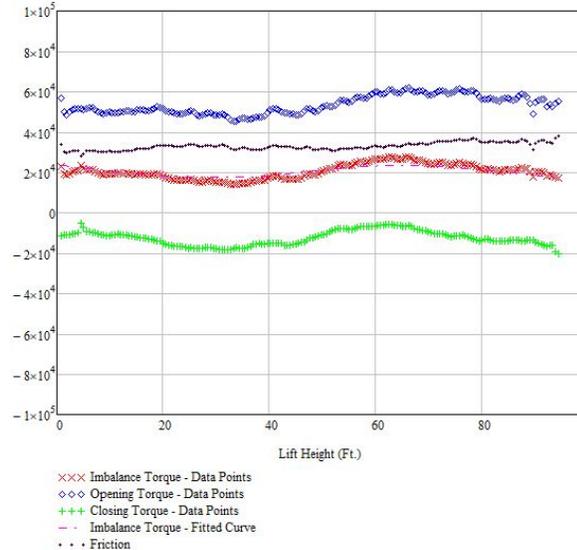
November 2018 testing results indicated a disparity in the corner loads and imbalance reactions for this tower drive vertical lift bridge. The behavior of the north tower machinery is described in Figures 16 through 19. Figure 16 shows the strain gage strip chart from the north tower. Figure 17 shows the imbalance curve fit from the two corners combined. Figure 18 and 19 show the imbalance curve fit data for each of the two corners, analyzed separately.

The theoretical imbalance behavior for this bridge, combining the effect of the counterweight ropes and the auxiliary counterweight system, is a sinusoidal curve. A sinusoidal curve was noted when evaluating the combined loading of the two corners. However, the evaluation of the individual corners yielded disparate trends. While the loading at the northwest corner was sinusoidal, the trend at the northeast corner was nearly a straight line. The observed loading suggests that one corner at the north tower was taking substantially more load, and the other corner was effectively “going along for the ride.”

The noted corner-to-corner imbalance deviation is significant when evaluating the transverse imbalance of the lift span. Where the acquired data conforms to the theoretical operating behavior, there is a high probability that the analysis would yield actual span imbalance. However, when the acquired data does not conform to the theoretical operating behavior, it is likely that the analysis would not.

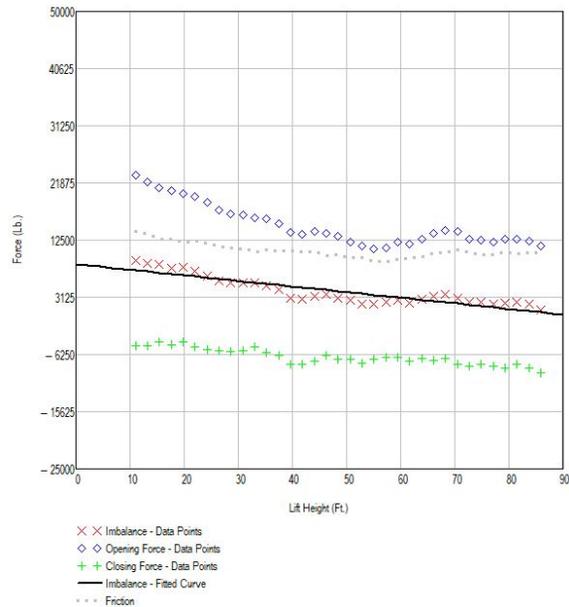
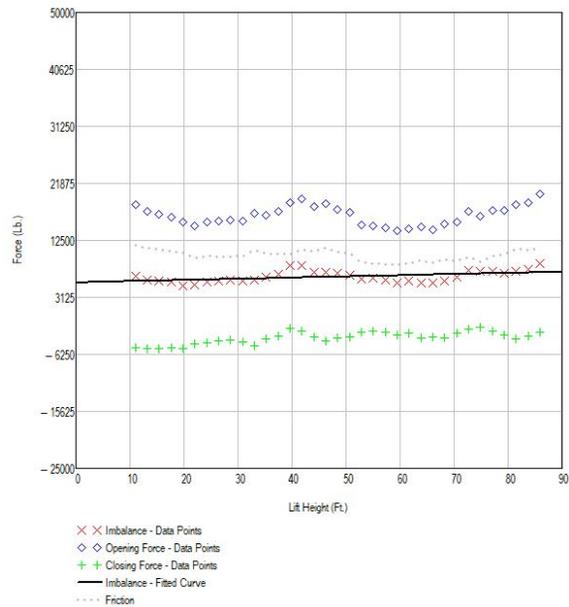
The theoretical imbalance behavior, combining the effect of the counterweight ropes and the auxiliary balance chains, results in a linear reduction in imbalance as the span is raised. The combined imbalance trend is shown in Figure 21. A linear trend was apparent in the analyses, but the trend differed at the corners. The imbalance at the northwest corner was reduced as the span

was raised, but the southwest corner increased slightly as the span was raised. See Figure 22 and 23.

The cause of the difference between the two corners' balance trends was not determined. Although the magnitude of the trend varied, the differences between the corners was apparent throughout the duration of the project, over multiple tests. The difference in the behavior of the corners could be a physical trend related to the ropes, balance chains, or other installation details. The difference may also have been related to load sharing behavior related to the machinery installation. In fact, load sharing and imbalance targets between corners was challenging to meet due to repeated counterweight rope slippage over the sheaves.

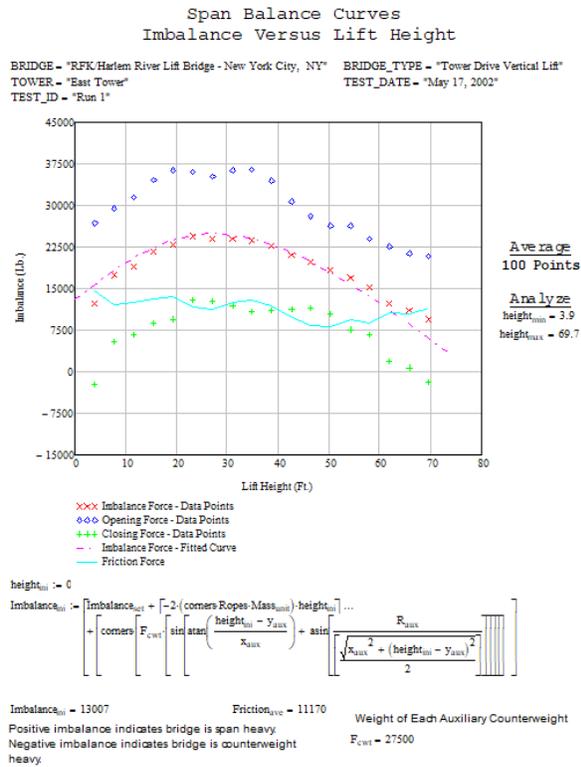
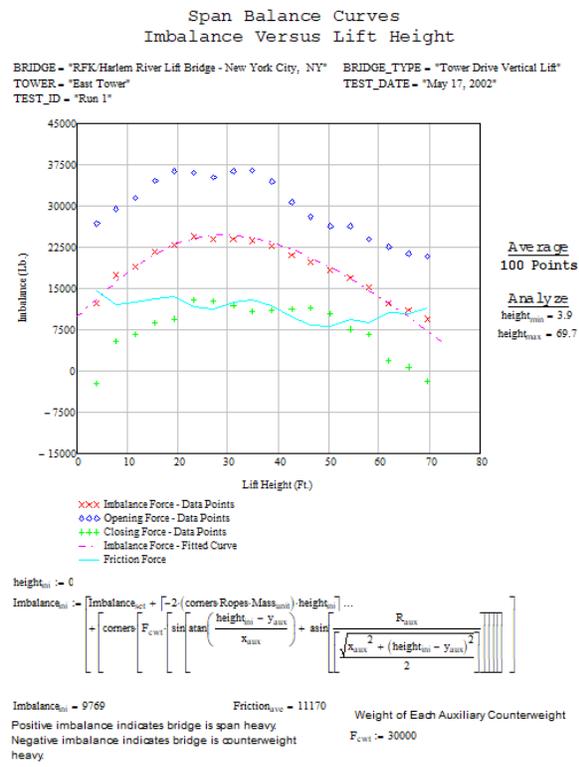
The analysis of strain gage recordings revealed that the theoretical imbalance curve deviated from the recorded data. The poor curve fit was noted at the start and the end of the data, near the full closed position and the full open position. See Figure 25. The force characteristics should match the curve defined by this equation. A deviation from the theoretical curve fit raises a question. Either the recorded strain does not solely result from imbalance and friction or one or more of the assumptions for the imbalance equation were incorrect.

It was determined that an improved correlation could be achieved by increasing the weight of the auxiliary counterweight in the theoretical equation that defines the curve. The improved imbalance curve fit using this change in the auxiliary counterweight is presented in Figure 26.
