**HEAVY MOVABLE STRUCTURES, INC.
NINETENTH BIENNIAL SYMPOSIUM**

**Norfolk Southern Bridge N 6.66 Rolling
Bascule Track Replacement**

Nicholas Bayer, P.E.
Norfolk Southern Corporation
Matthew Cassera, P.E.
HDR, Inc.
Andrew Cestaro
PCL Civil Constructors Inc

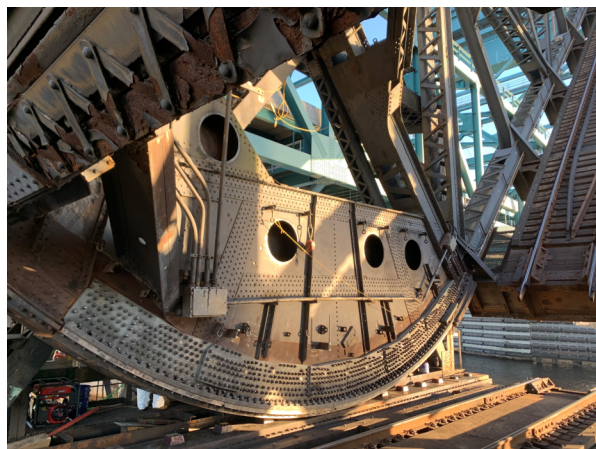
CAPTION: North rolling tread and track

After the rehabilitation, the cured zinc began to deform due to the bridge's immense rolling load, and the bearing load path transitioned into the flange angles which hold the curved tread in place. The new load path caused the welds on the rehabilitated curved treads to crack. Norfolk Southern performed various weld repairs throughout the years, but the welds continued to crack.

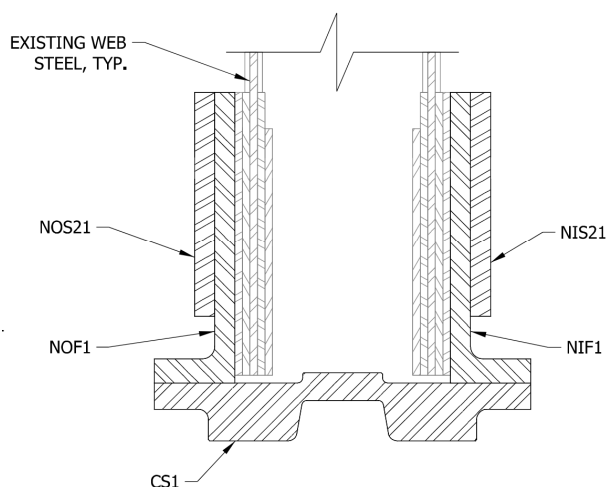
CAPTION: Cross-section of new flange angles and curved tread, existing web

The 2017 curved tread and connection angle design eliminates the problem by suspending the bridge through a slip-critical connection between the web girders and connection angles. The new connection angles are taller than the original to encompass a larger bolting area, which is needed to achieve the slip-critical joint requirements. The angles are also thicker to meet the stiffness and bearing requirements

created by the eccentric load from the weight of the bridge through the bolted connection. The bottoms of the flanges were shop machined to the radius required to set the curved treads back to the original roll radius of the bridge. Shims were added between the bottom of the curved web and the top of Curved Segment 1 to provide a direct load path between the two and to supplement the slip-critical connection under live load from rail traffic.

During analysis of the point cloud data, it was noted that the web spacing of each girder varied by up to 1" due to warping. Additional diaphragms were added between the webs of each girder using the existing internal radial stiffeners. The additional diaphragms help prevent further warping of the webs and resist the moment in the webs created by the eccentricity between the bridge load and the bearing location on the bottom of the connection angles.

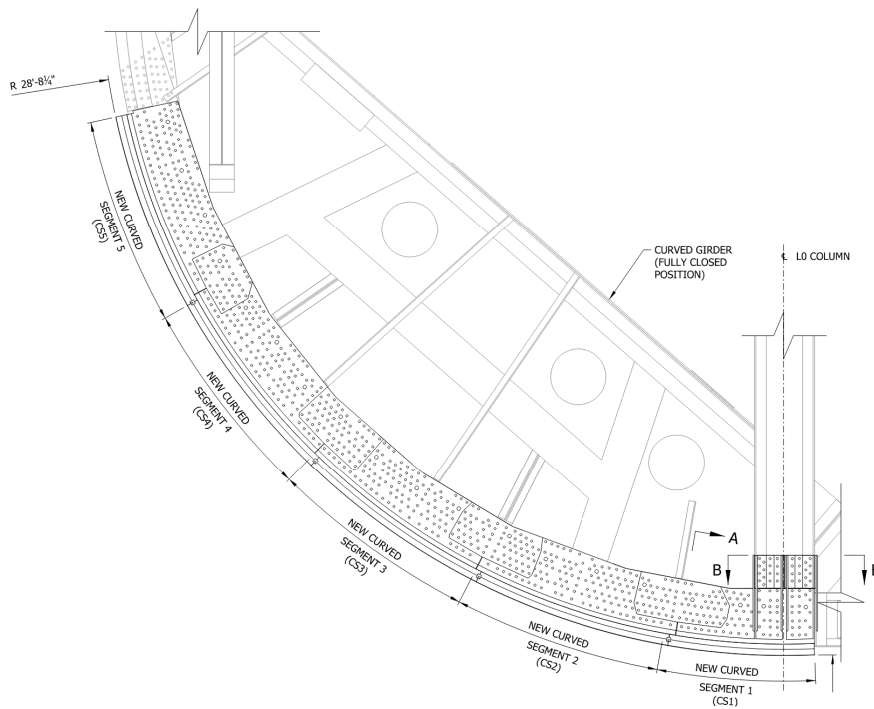
CAPTION: Profile View of New Curved Tread and Flange Angles

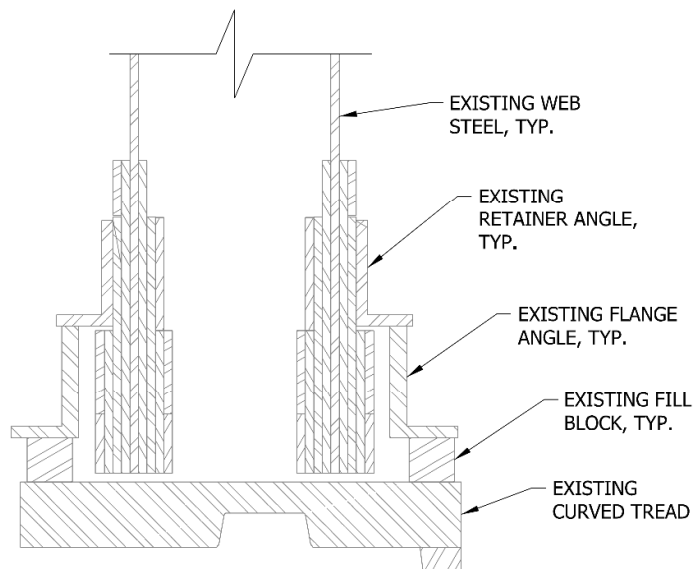
Historical data indicates, prior to the 2008 rehabilitation, the bottom of the built-up web girder was flame-cut. The inconsistency of the flame-cut edge created an uneven roll radius and uneven bearing surface on the bottom of the built-up web girder. After 2008, the bridge settled to a lesser roll radius due to the insufficient compressive strength of the zinc used to fill the gap between the bottom of the web girder and top of the curved tread. In a typical Scherzer design, the bottom of the web girder bears flush against the top of the curved treads, creating a smooth and even roll radius.

CAPTION: Cut-section of Existing Curved Tread

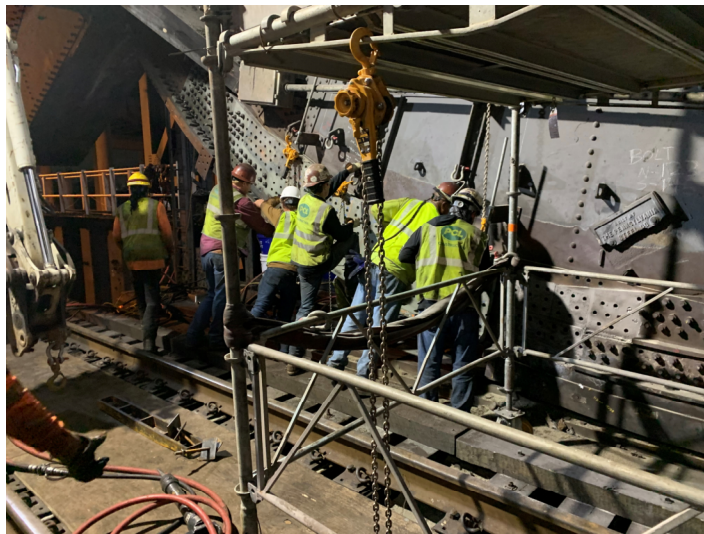
CAPTION: Drilling misaligned holes in flange angle

During the closure, preparations were made to ream holes if needed. In the first closure, 40-60% of the holes needed to be drilled or reamed throughout the segment, corresponding to about 250 holes of various alignment conditions between light reaming, to holes in the flange angle with no hole in the web girder at all.

The web girder was 7" thick, so even minor misalignment required a significant amount of reaming.

A significant number of holes were too misaligned to ream and needed to be drilled, requiring the web girder to be drilled 7" deep.

flange angles. When misalignment was encountered greater than minor reaming, the hole was drilled in the outer 2" ply with an annular cutter. The center of annular cutter was carefully lined up with the hole in the inner/existing plies of steel, elongating the hole. Once the hole was elongated, a plate washer was used to compensate for the elongated hole.

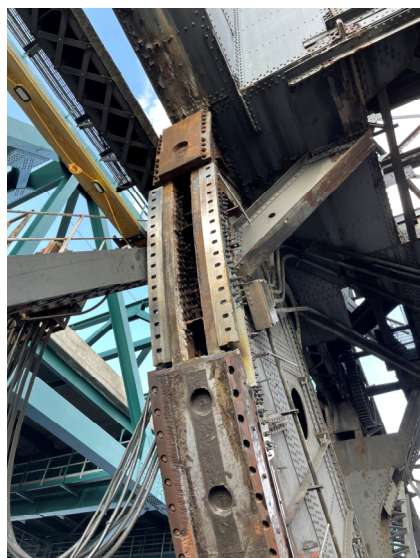
CAPTION: Segment 5 Flange Angles Exposed

The level of the zinc varied since it was poured as liquid, but in most cases, the top level of the zinc covered between two to four of the four vertical levels of bolts in the existing curved tread flange angles. This created challenges removing the bolts in the flange angles during the closure. Since the head of the bolt was on the inside, with the nut on the outside of the web, the nut could be turned from the outside. However, due to the softness of the zinc, the head would roll and the nut couldn't be removed. Even if the nut could be removed, the bolt would remain because of the zinc behind it.

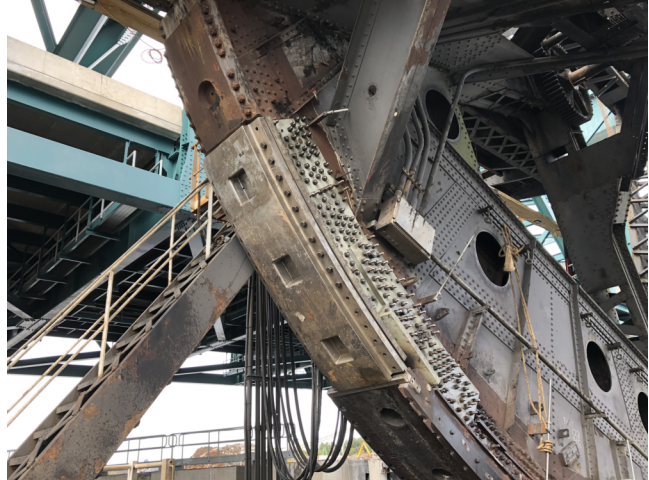
CAPTION: Segment 5 Installed

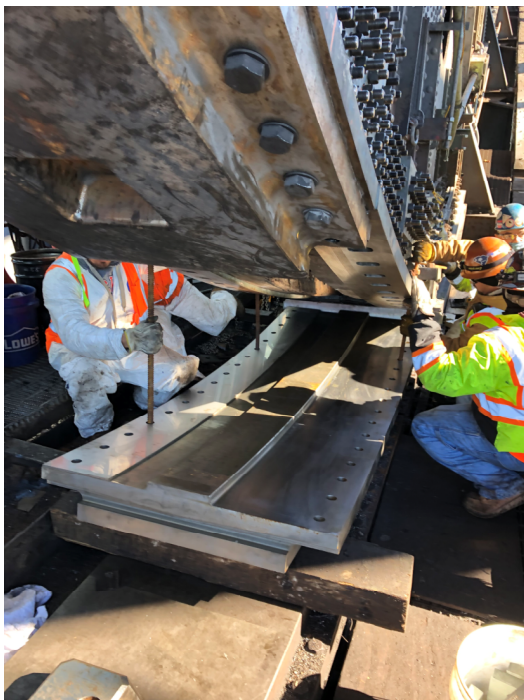
CAPTION: Installing curved segment

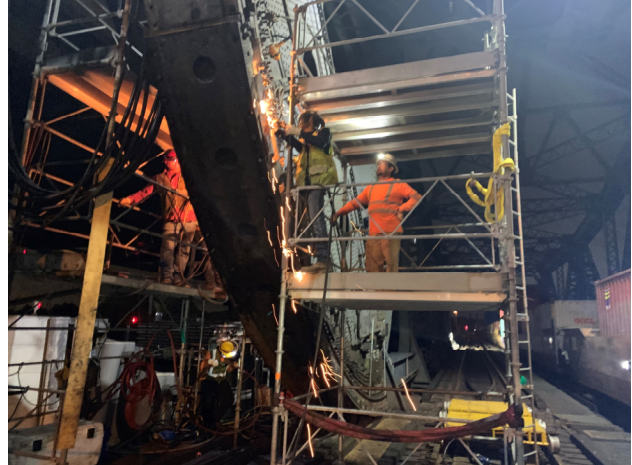
CAPTION: Inboard Scaffold

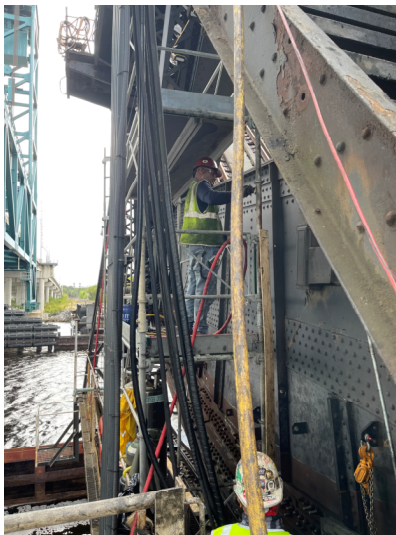
CAPTION: Outboard scaffold

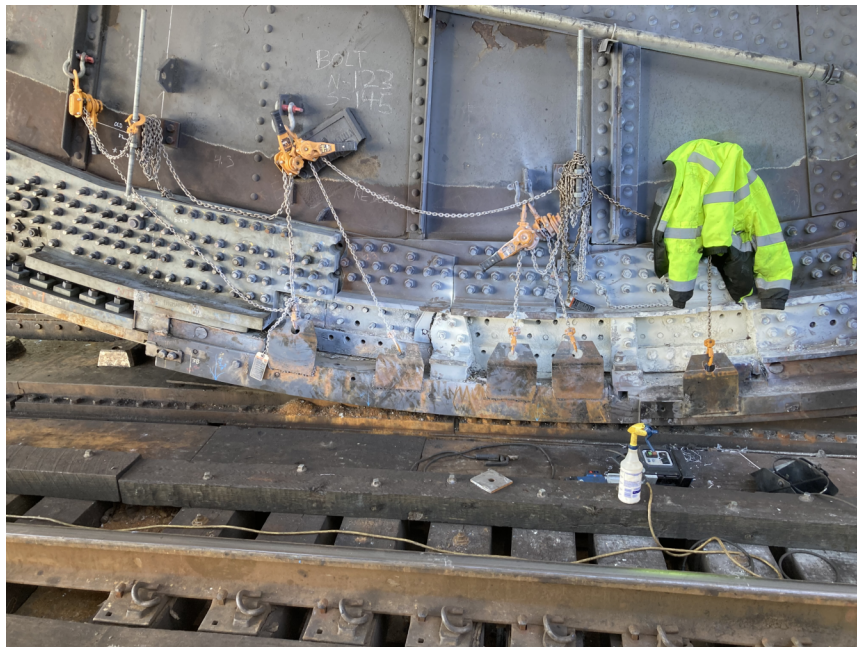
CAPTION: Pre-demo with come-alongs attached to existing tread

With the current state of the structure, it was no longer believed that the flange angles were providing any capacity to support the bearing load of the tread, and that the flange angles were only holding the tread in place and preventing it from falling.

The team developed a plan to sequentially remove the flange angle and fill block, while supporting the tread with come-alongs attached to hanger plates welded to the tread and supports above the flange angle. This allowed the rivets to be exposed and removed prior to the closure which significantly reduced the time required for demolition during the closure.

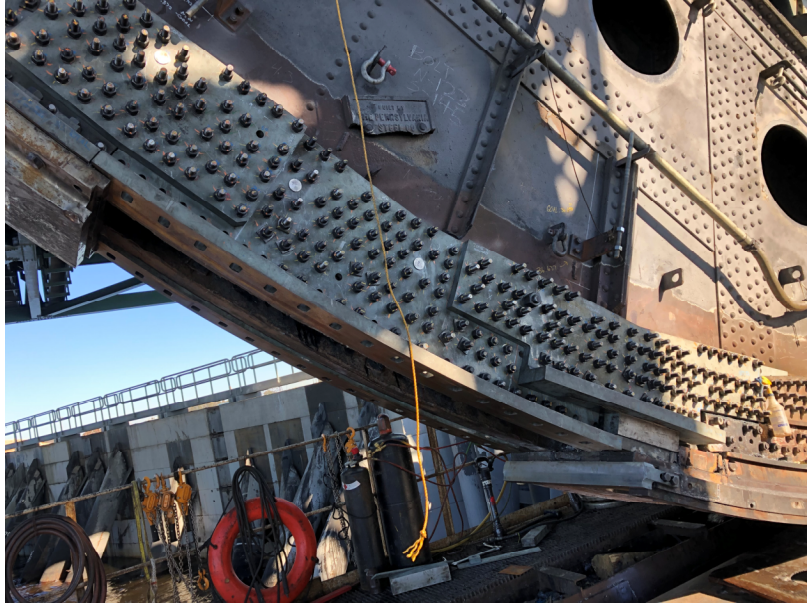
CAPTION: Bolt-up of Flange Angles
