**HEAVY MOVABLE STRUCTURES, INC.
NINETEENTH BIENNIAL SYMPOSIUM**

Reactivation of the Veterans Memorial
Bridge in Kaukauna, WI
Michael Delemont
AECOM

Abstract

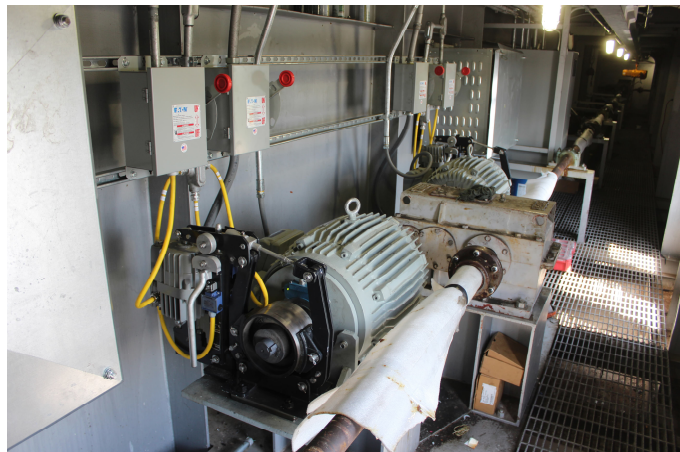
The main span motor drives and motors are key pieces of electrical equipment that make the bridge move. The span drives on this bridge had been obsolete for over 20 years. Obtaining parts and service for them would be impracticable. For this reason, it was recommended that they be replaced. The motors themselves were not obsolete, but would require reconditioning and replacement of their bearings. Considering this, it was recommended that new motors be installed that are an appropriate match for the new drives.

New Span Drive Motors

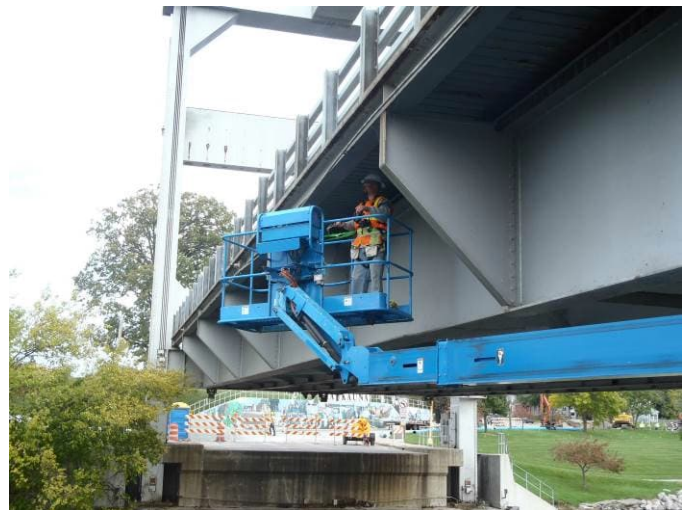
2016 Structural Inspection

Several of the wire ropes were very loose, damaged beyond acceptable use and needed to be replaced. Many more were marginally damaged. Given the amount of work it takes to prepare the bridge for cable replacement, it was decided to replace all of the cables.

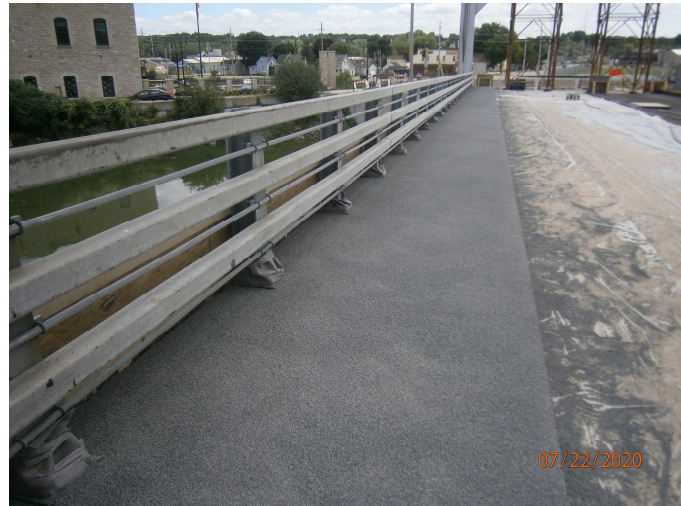
Existing railing modifications were determined to be required to reduce clear openings between rails.

Railing modifications and sidewalk overlay

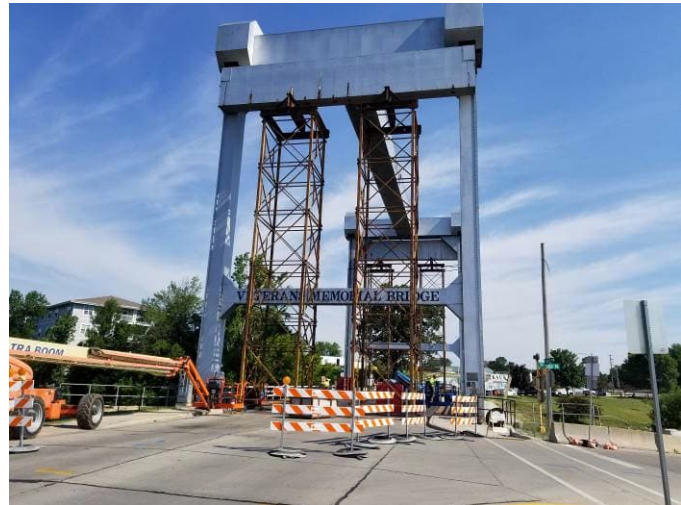
Counterweight shoring for wire rope replacement

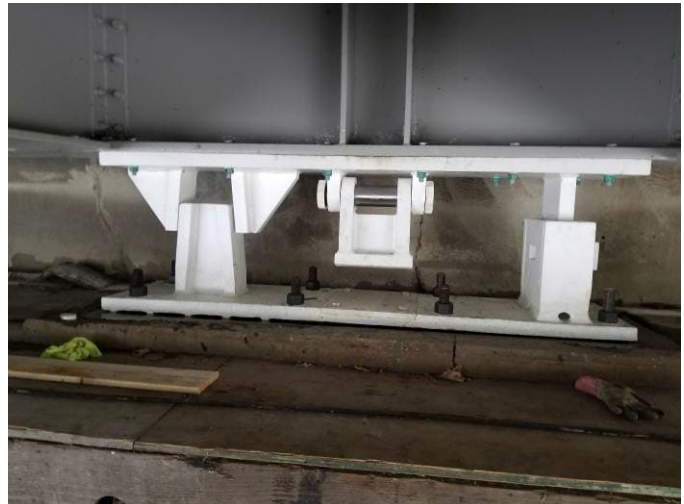
During scoping inspections, the condition of the anchor rods was difficult to determine without the nuts removed, but most of the visible portions of the rods appeared to be in good condition. During construction after removing the nuts and cleaning the anchor rods, it was determined that several of the anchor rods exhibited excessive section loss and required replacement. The upper portions of the rods were removed and replaced with new rods welded to the remaining portions of the rods. The rocker bearings had more wear than anticipated and required machining to clean up the shoe surface and additional bushings. A portion of the lift girder was discovered to have severe section loss with holes in the web just above the bottom flange.

Refurbished alignment guide, rocker bearing & span lock receiver

Repairs were made using bent plates bolted across these areas. Sometimes the condition of structural elements that are not visible cannot be known until things are removed during construction, but consideration should be given to performing more removal during design to better ascertain the need for repairs when obstructions are removed.

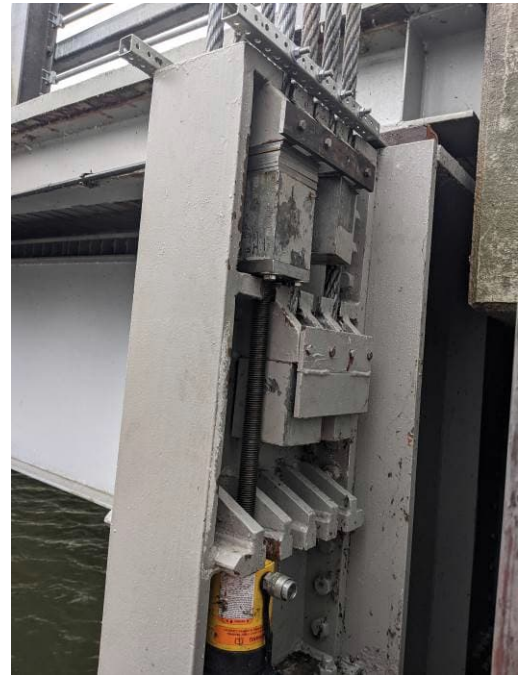
One wire rope at the southwest corner had significantly less tension than the other ropes in the same group. Shims were added and the rope still had less tension than the others. The rope tension could only be brought into tolerance after all the other ropes in that group were removed and rope tensioning equipment was modified to fit more shims to that rope. Had that effort been unsuccessful, a new rope likely would have been required. Wire rope fabrication, testing, installation, and shimming should all be observed closely for any signs of inconsistencies.

Jacking and shimming new wire rope
