HEAVY MOVABLE STRUCTURES, INC. NINETENTH BIENNIAL SYMPOSIUM

Rehabilitation to the trunnion and pinion supports at Monmouth County Bridge W-43 over the Shark River in the Boroughs of Belmar and Avon-by-the-Sea

Authors: Joseph R. Strafaci, PHD, PE, Michael A Ruggiero, PE

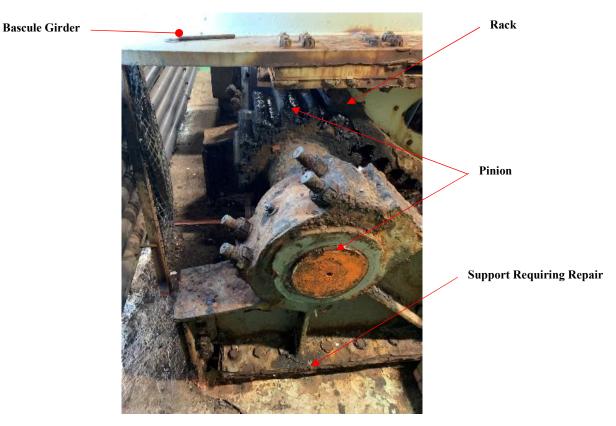
During the 2019 NBIS inspection, it was noted that the supports to the pinions required repair. (See Figure 3). These elements were deemed critical and flagged as a priority repair as they assist the direct operation of opening and closing the bascule span. The pinions allow for the rotation of the main gear shaft which in turn opens and closes the bridge. These supports were each configured around the mainthru girder of the bascule leaf. As the On-Call Engineer, HNTB and the County performed a follow up inspection, to identify the area of repair and develop a plan for implementation. During this inspection, it was discovered that the four outer trunnion supports were also in an advanced deteriorated state, exhibiting signs of corrosion and section loss. Shown in figures 5 and 6, the outer trunnion support provides one of eight main supports to the bascule span.

Figure 3 - W-43 Pinions (Northeast Corner)

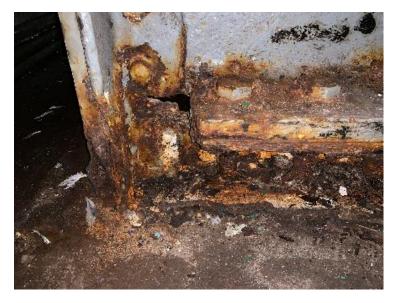
Figure 4 - Pinion Support Area Requiring Repair

As discussed above, the repair of the pinion supports was relatively straightforward. Based on HNTB's analysis it was determined that jacking was not required to underpin these supports. Therefore, these repairs could occur at any point during construction. The method of repair was identical to the trunnions in that, 1/2-inch steel plates were selected to reinforce the support. Following installation of the repair plates, rebar was installed, and Class A Concrete was poured to encase the supporting member. Similar to the trunnions a high-early admixture was also specified for this repair.

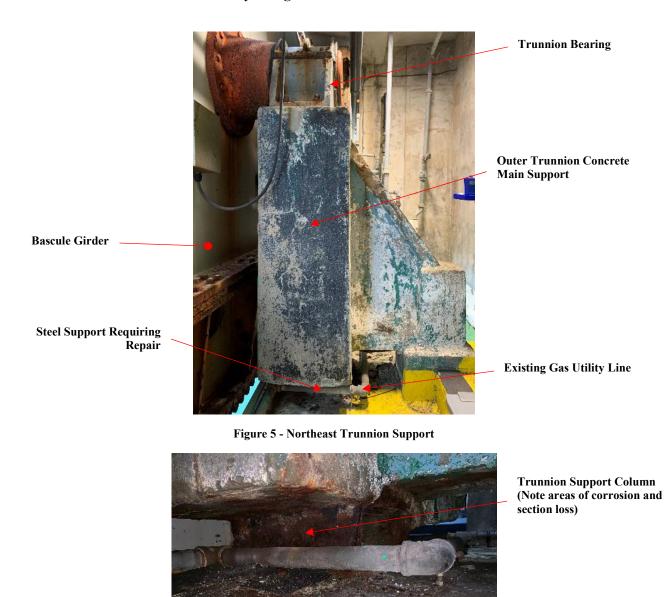
Figure 6 - Trunnion Steel Support Requiring Repair

Based on an evaluation of the existing as-builts and associated field inspection it was determined that the deterioration of these members is due to a combination of the corrosive environment in which Bridge W-43 is located, and the location of these supports. These supports also sit directly below the "Flower Box" (see Figure 7) an area of the deck that opens and closes due to the rotation of the bascule span. This "Flower Box" opening allows for infiltration of water and salt allowing it to pool underneath in the outer machine room, causing these supports to be highly susceptible to corrosive elements. This was further supported based on the fact to minimal deterioration was discovered to any of the supports located inside the inner machine room.

Following the evaluation, HNTB began to prepare contract documents for repairs to both the trunnion and pinion supports. It was determined that for both supports, the members needed to be reinforced with steel plates and encased in high-strength concrete to restore the lost section and prevent further deterioration of the supports.

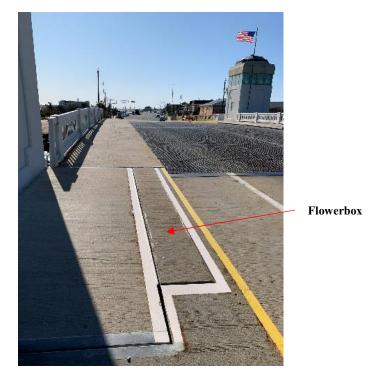
Figure 7 - Flowerbox Opening (Northeast Corner)

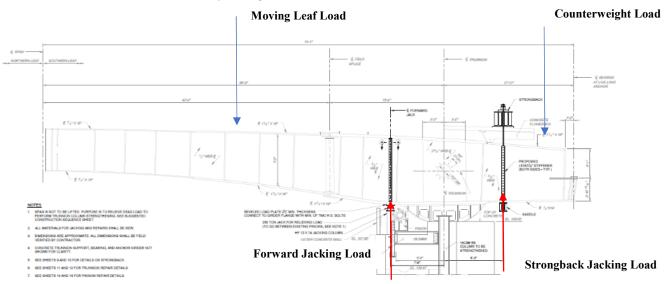
Based on this information a jacking scheme for the bascule span was developed using a combination of a forward jack paired with a strong back system. The forward jack was placed within the machine room directly underneath the lower flange of the bascule span. While a strongback system was positioned around the counterweight to act as a saddle. This illustrated in figures 8 and 9.

Figure 8 - Free Body Diagram for Bascule Span Jacking Scheme

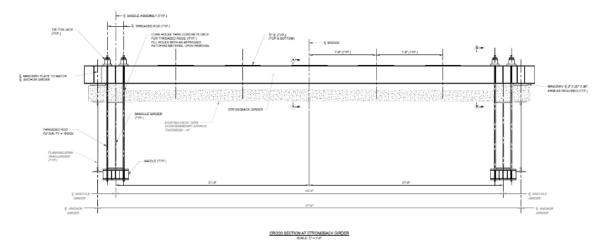
Figure 9 - Strong Back System Elevation View

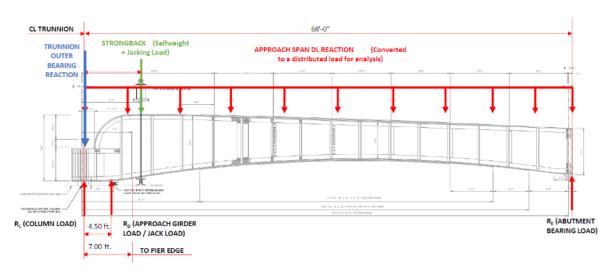
As you can see from the free body diagram (figure 10), this jack was placed directly in between the trunnion column and the strongback system. Placement of this jack was critical, as it allowed for the load to be almost completely transferred back into the flanking span. Based on an analysis, it was determined that some dead load was still acting within the trunnion column. However, based on HNTB's analysis it was deemed that the column when fully exposed and could safely operate under this load.

Figure 10 - Flanking Span Jacking Scheme

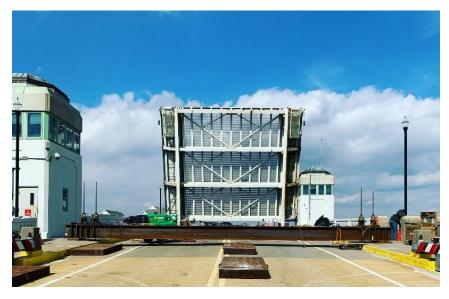
Figure 12 - Strongback Girder following Installation on Southern Span

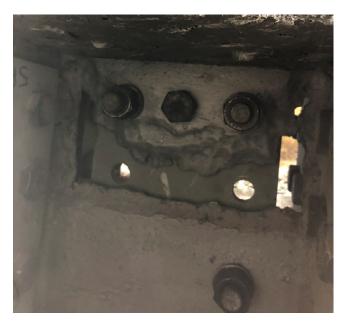
In addition to the above RFI's following removal of the concrete and cleaning the trunnion supports it was revealed during construction that deterioration to these supports was worse than expected, specifically the northwest corner. As shown below, the northwest corner support suffered 100% section loss to the web compromising the support further. Given the direct lines of communication the HNTB worked quickly to resolve the issue, providing modifications to the initial detail to further reinforce the member. This was issued to the contractor via a field order. Given the quick work of HNTB, no extra cost or schedule impacts were incurred by the contractor.

Figure 13 - Northwest Trunnion Support with 100% Section Loss
