**HEAVY MOVABLE STRUCTURES, INC.
TWENTIETH BIENNIAL SYMPOSIUM**

**Inspection of the Very Large Array Radio
Telescopes**

Dave Barrett and Reid Brooks
Modjeski and Masters

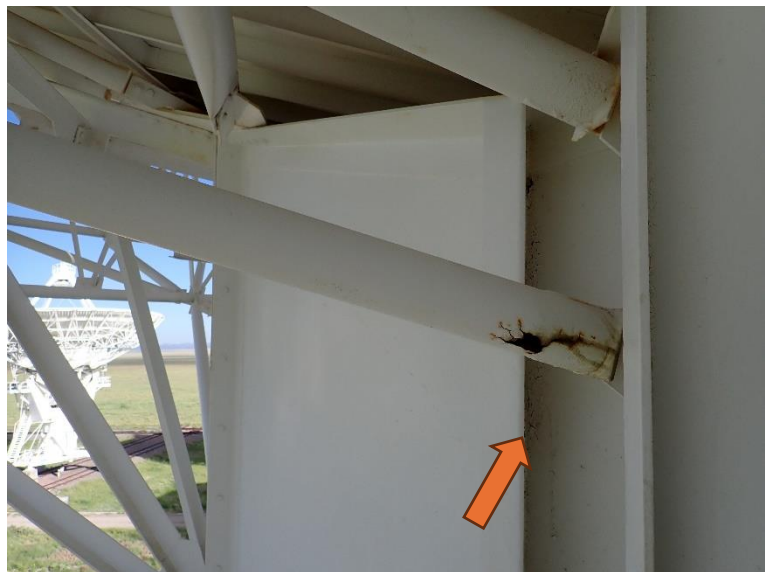
The reflector backup structure is made up of radial beams, ring beams, and supporting diagonal members. The members in the backup structure are connected by a combination of welds and bolts. As previously mentioned, many of these welds were performed in the field, and are of a lower quality than that typically seen for Heavy Movable Structures. The welds commonly have porosity and discontinuities which allow water to infiltrate the hollow tube members. Water was observed actively draining from multiple

Photo 9 Damage to the Reflector Backup Structure

tube members during the antenna movements. The presence of water inside the tube members has induced advanced corrosion in many places, resulting in holes, bulges and ruptures, cracking, and general section loss. Moisture intrusion, paint failure, and corrosion were found in several other locations, although were not as prevalent. The pedestals were also inspected and found to be cracked.

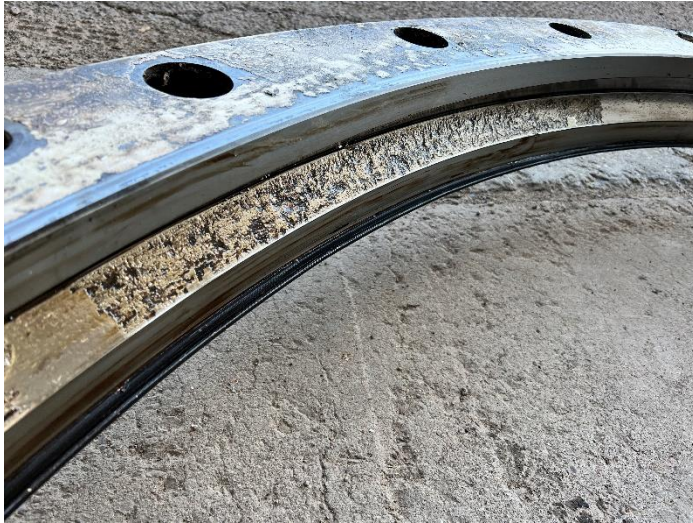
Photo 10 Damage to the Azimuth Bearing Race

The major mechanical finding was the damage in the azimuth bearing. This damage is typical of the telescopes, and the bearings are in the process of being replaced as part of a long-term maintenance program. One of the recently replaced bearings was disassembled and made available for inspection. It was noted that there is significant damage to the bearing, especially to the outer race. The bearing configuration is different than typical bearings for the heavy movable structures industry. The cross section of the bearing has the inner race concentric inside of the outer race. In-between the

The races, especially the outer races, had concentrated damage when inspected. The failure mechanism seems very similar to case crushing in hardened gears. Loose flakes of metal were found in the grease. These loose flakes break off and interact with the elements and races at other points in the bearing, causing stress concentration and additional damage. The damaged surfaces of the races incur stress concentration around the damaged edges and have a tendency to grow. This interaction damages the rolling elements as well, and depressions can be seen where they have rolled over damaged surfaces. The elevated levels of ferrous debris and elemental iron in the grease confirm the suspicion that the bearing is deteriorating and that the detached pieces are engaging in the mesh. Interestingly, the advanced wear of the bearing has not yet caused an issue with the operation of the telescopes. The positioning of the dishes is still quite accurate and has not disrupted the science being performed. The bearings have been in use since the telescopes were commissioned and have been in service for around 50 years. The failures seen in the bearings that we observed are typical according the VLA staff. Because of the typical nature of the failures, the bearings are being replaced in all of the telescopes as part of a long-term maintenance project.
