**HEAVY MOVABLE STRUCTURES, INC.  
TWENTIETH BIENNIAL SYMPOSIUM**

**James River Bridge – Main and Auxiliary  
Wire Rope Replacement**

Robert Powell and Stephen Grabowski, HDR, Inc.

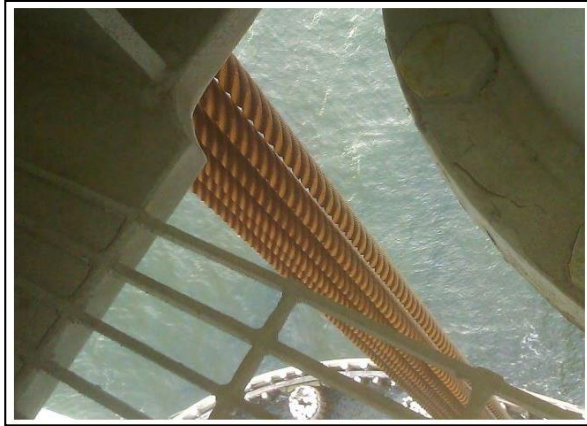
Criteria #4 and #7 were found to have been met. Most apparent was criteria #4. As shown in Figure 3, the ropes exhibited a layer of rust and lack of lubrication leading to rope deterioration. Criteria #7 was confirmed in conjunction with field measurements as shown in Figure 4 and the Roebling Wire Rope

Figure 3: Photo of the condition of the wire ropes from the 2013 investigation.

Given these findings, a recommendation for replacement of all 80 ropes was made. However, given that wire ropes for this application are not readily available, it was acknowledged that immediate replacement was not practical and recommended that the ropes be closely monitored while working towards replacement in the next 12-18 months.

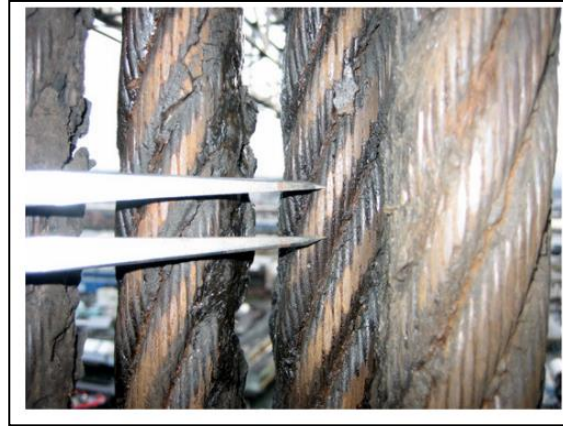
Handbook table. As shown in Figure 5, it was estimated that 78% of the outer wires remained. This corresponded to 90% of the rope area remaining intact which exceeds the six percent reduction due to wear of the baseline diameter in criteria #7.

Figure 4: Measurements taken on the outer wires during the 2013 investigation.

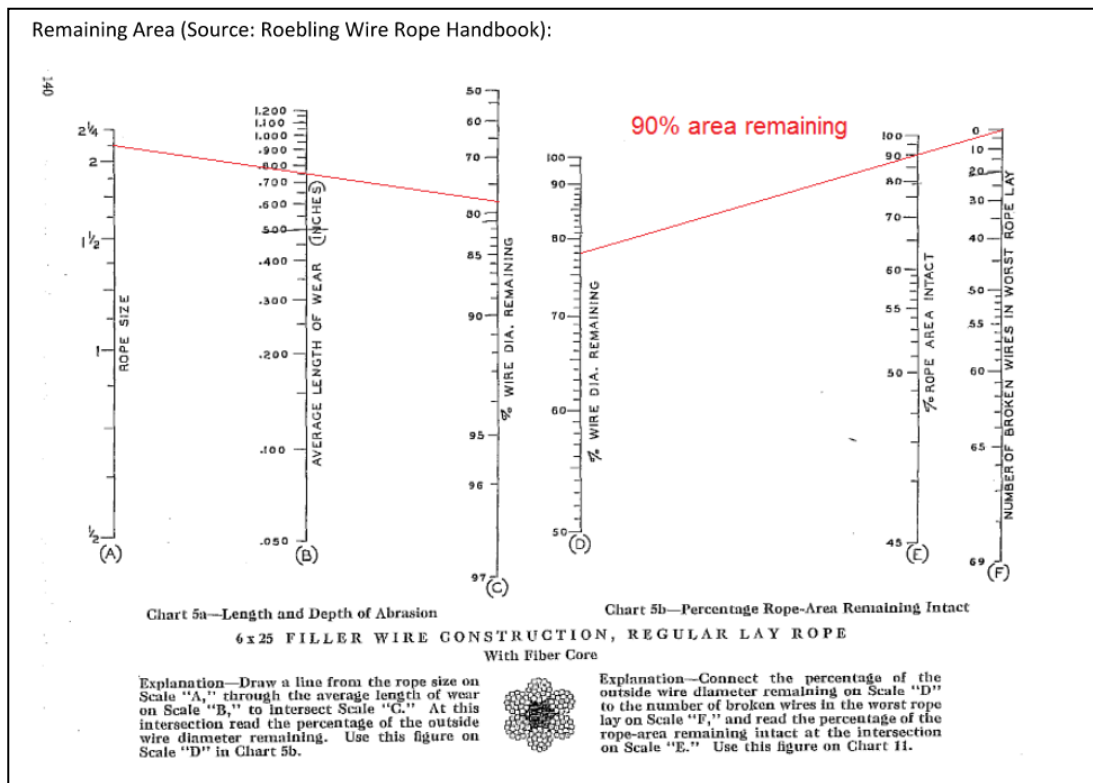
Figure 5: Analysis of the diameter reduction due to wear utilizing the Roebling Wire Rope Handbook

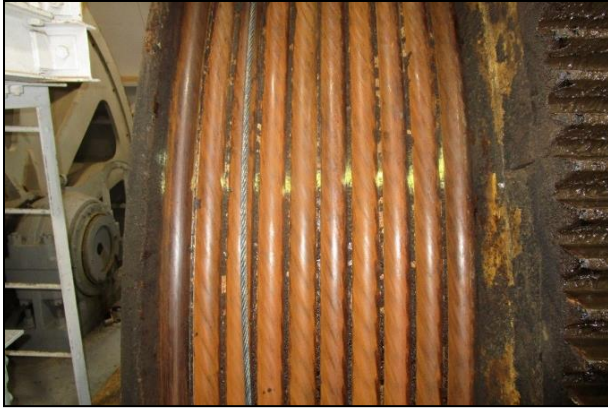
Figure 25: Condition of the wire rope sheaves prior to cleaning.

Upon completion of all rope removals, all the pin holes in the billet and the sheave grooves were then cleaned and lubricated and pins test fit to the billet to prepare for installation, refer to Figures 25 and 26. Also at this time, crews on the deck used a combination of the air winches and lifting equipment to remove the existing take-ups from the lifting girder, place them onto pallets for delivery off site to be refurbished. During the first outage the existing take-ups were saved for reuse on the opposite tower. During the second outage, the take-ups were cut out of the lifting girder adding to the efficiency of the work.

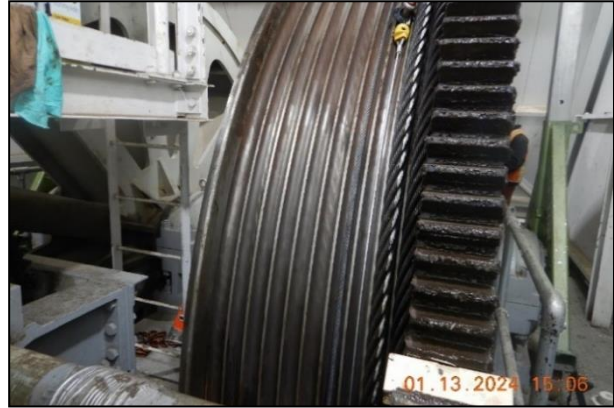
Figure 26: Condition of the wire rope sheaves following cleaning.

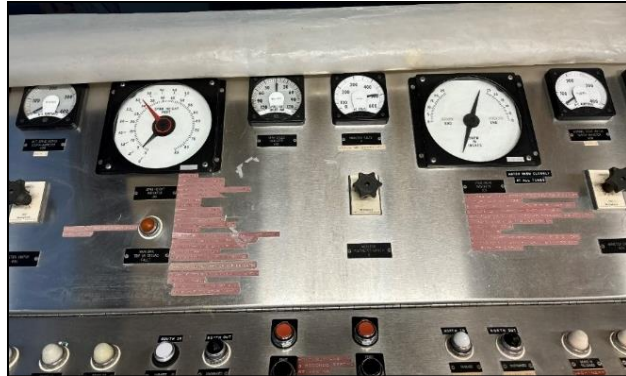
With the bridge ready for test lifts, the control desk was turned on to realize the skew and height were too far out to allow operation, refer to Figure 28. The team however was prepared for this, and VDOT bridge maintenance staff was requested to be on site and be prepared to adjust the electrical equipment. Adjustments were made until the skew and height were zeroed out. The bridge was successfully operated through full height lifts five times with no issues and no further adjustments to the electrical equipment were required.

Figure 28: Control desk indicating height and skew error.

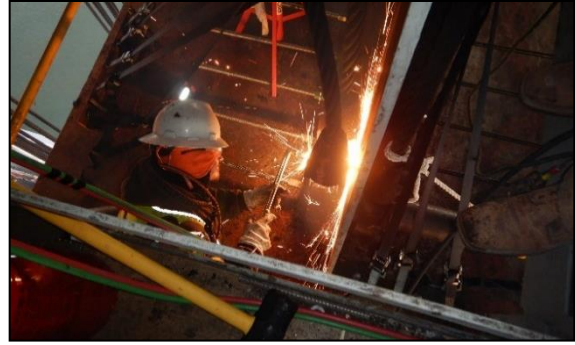
Even the best plans are not immune to challenges or obstacles. When challenges did occur, the best plan was a pre-approved backup plan. This meant all tools and equipment were already in place to allow crews to shift course and maintain schedule. When the first counterweight pin refused to move, the clevis ears

Figure 30: Flame cutting the first main counterweight pin.

were flame cut and freed from the pin allowing the pin to be removed without the hollow hydraulic ram, refer to Figure 30. The crew then returned to the original plan removing the remaining pins utilizing the hollow hydraulic rams and prybars.

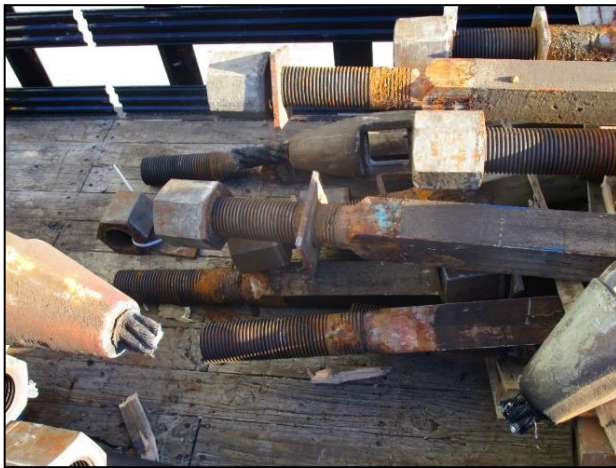
With the removal of the existing take-ups intended to be reused, it was realized that moisture retained within the take-up billet had corroded upper sections of the threads, refer to Figures 31 and 32. This raised a concern that the take-ups would not be viable for reinstallation and had the potential of delaying the project while new take-ups were fabricated. At the time of discovery, VDOT did have four spare take-ups, fabricated as a part of the procurement, at their disposal. The spares consisted of two long take-ups and two short take-ups. The contract documents required the take-ups to be cleaned and re-painted prior to installation. Therefore, to understand the full depth of the degradation, the take-ups were completely stripped of paint, mill scale and corrosion. With the take-ups fully cleaned, they were all thoroughly inspected, and four take-ups were rejected for installation. The remaining take-ups along with the four spares were approved for installation. Prior to inspection, calculations were performed to determine how much of the thread engagement would be required to develop the full safety factor of the ropes and prevent stripping. Calculations determined that the full height of the main take-up nut was not required to prevent stripping and meet the safety factor requirements of the ropes in direct tension. Inspection determined that in the worst cases degradation of the threads began with the nut set at 5.5 inches of thread protrusion from the nut, however in most cases it was much less. Based on the required engagement of the nut and the location of the deterioration, the recommendation was made to set all main take-up nuts in the second outage to a 5 inches nominal thread protrusion. This adjustment would allow the ropes to be set, tension adjustments to be made and still provide room for future adjustments.

Figure 31: Condition of the existing take-ups removed during the first outage.

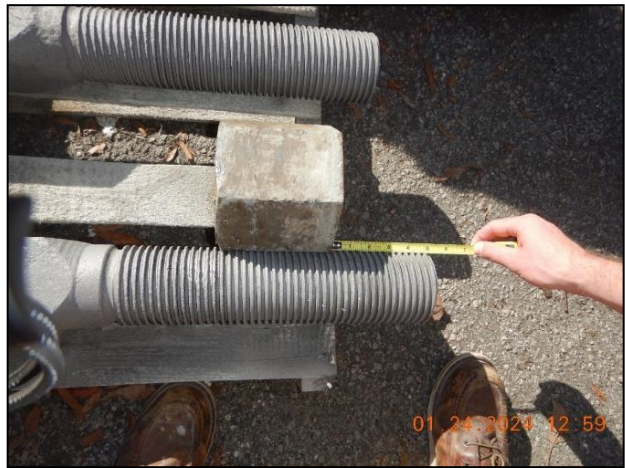
Figure 32: Condition of the existing take-ups following shop cleaning.

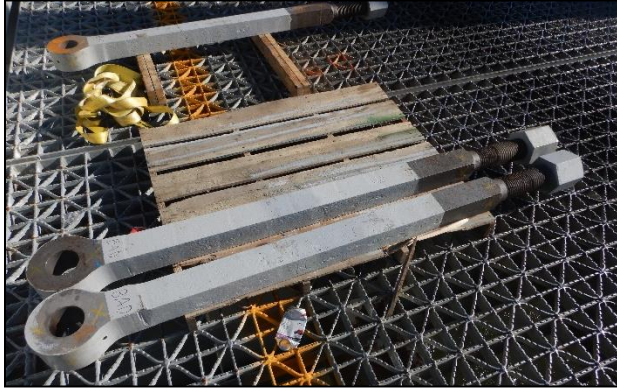
Just prior to the second outage an additional four long and three short take-ups were sourced from the procurement fabricator which had been machined as “test pieces” during equipment setup. These additional take-ups, while not necessary, were utilized to replace seven additional existing take-ups, refer to Figures 33 and 34. The additional replacements provided more buffer room for future adjustments as the take-ups with extending furthest down the threads were selected for replacement.

Figure 33: Rejected take-ups.

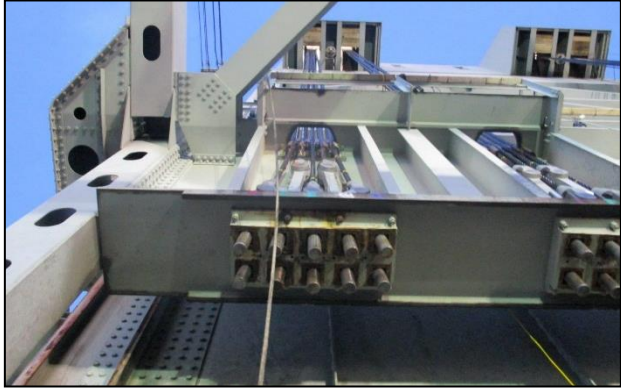
Figure 34: New take-ups installed in the lifting girder.
