**HEAVY MOVABLE STRUCTURES, INC.
TWENTIETH BIENNIAL SYMPOSIUM**

**Over Height Vehicle Collision Repairs to a
Rolling Lift Bridge**

Jonathan Eberle, PE, AECOM

Introduction

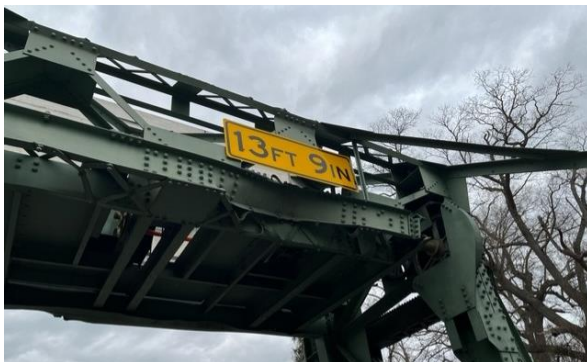
The structure was impacted by an excavator on a trailer travelling north on Rehoboth Blvd. The pivot point between the boom and arm of the excavator directly impacted the lower chord of the portal frame which provides stability to the posts and supports the machinery platform. The impact brought the travelling vehicle to a stop and caused significant damage to both the bridge and the excavator as shown in Figures 2 and 3.

Figure 2: Damage to portal frame from impact

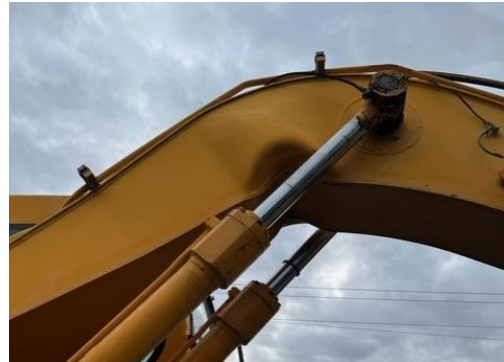
Figure 3: Damage to excavator from impact

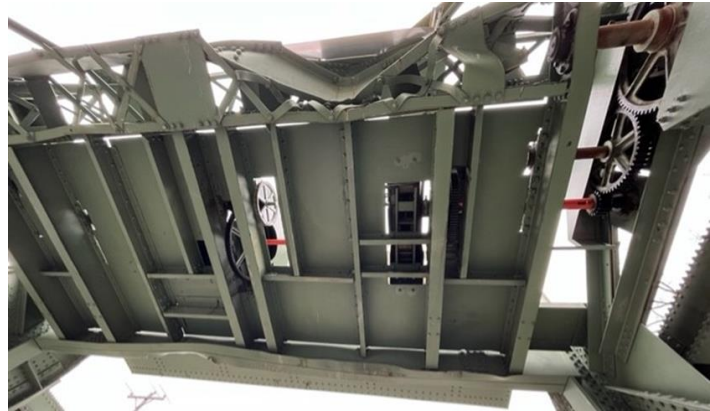
The portal frame lower chord channel where the excavator impacted was significantly deformed as shown in Figure 4. The channel deflected to the point that it came in contact with the rear channel member with the lacing connecting the two channels mangled. The remainder of the portal frame elements including the lower chord gusset plates, diagonal angle members, upper chord gusset plates and upper chord channel members also experienced damage which decreased in relation to the distance from the impact location. The lower chord gusset plates were deformed along with the front channel element. The diagonal angle elements immediately adjacent to the impact were deformed with the front angle at the east post severed completely (see Figure 5). The components at the top chord were deformed slightly but did not present any structural concerns (see Figure 6).

Figure 4: Damage to the machinery platform from below

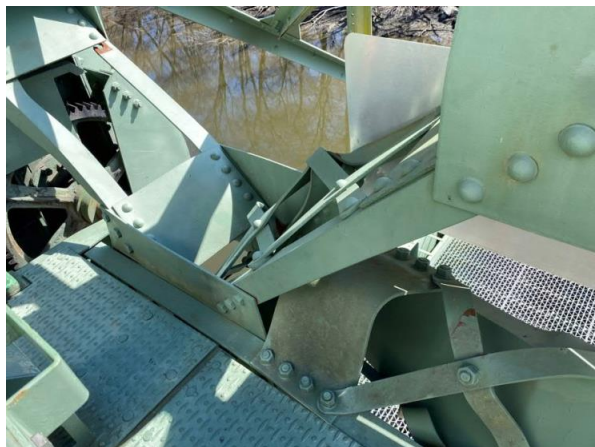
Figure 5: Damage to diagonals

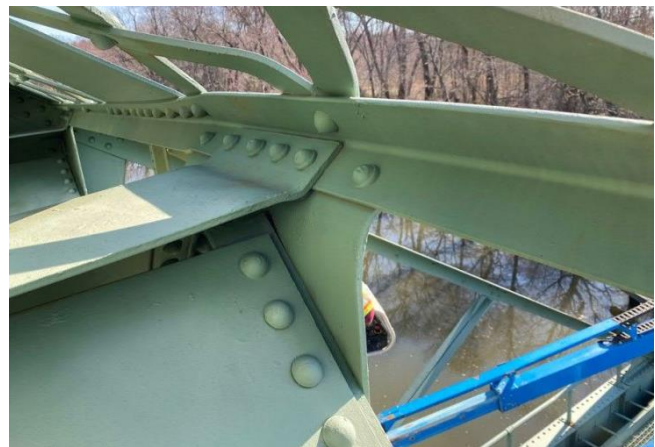
Figure 6: Deformation of upper chord and gussets

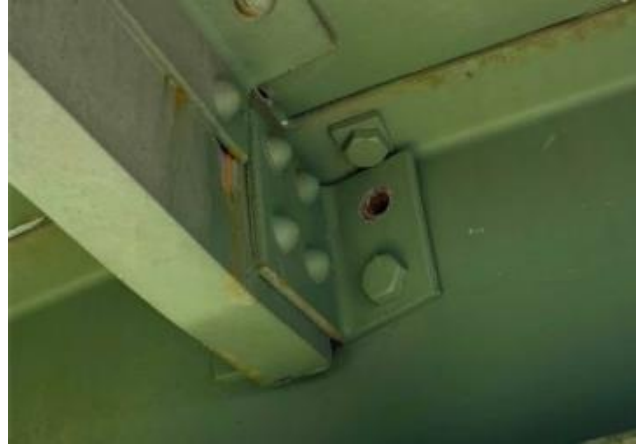
Figure 8: Damage to stringer in line with impact

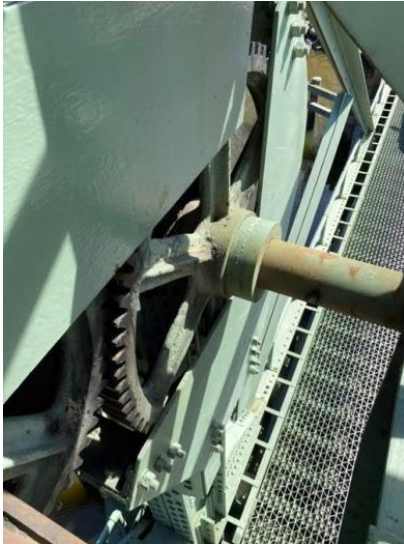
In addition to the structural damage sustained by the impact, there were also mechanical components that were affected by the impact. When the ends of the lower chord front channel pulled in, the final drive shafts, S1, were pulled towards the center of the bridge as well via the web bearing connected to the outboard stringers. The shaft on the east side translated inward and rotated in plan while the shaft on the west side appeared to have only translated inward. Gear G2 on the inside of the post was pulled into contact with the steel guard plate (see Figure 9) and evidence of the displacement was apparent at the pinion gear G1 where it was shifted in significantly from the normal position indicated by wear on the gear (see Figure 10).

Figure 9: G2 in contact with guard plate

As discussed in the findings section, displacement of the mechanical final drive shafts was noted during inspection but no physical damage was visually observed. To ensure that no bending of the shafts or cracking of either the shaft S1 or gears G1 or G2 had occurred, removal and shop testing of these components was detailed within the contract documents. Contingent items were included for shaft S1 and gear G2 replacement if either component were found to have defects from the shop evaluation and testing. Replacement of the bronze bearing liners for web bearings B1 and B2 were included in the contract given that these components had already been in service for over 90 years and with shaft S1 removed replacement of the liners had no significant cost implications.

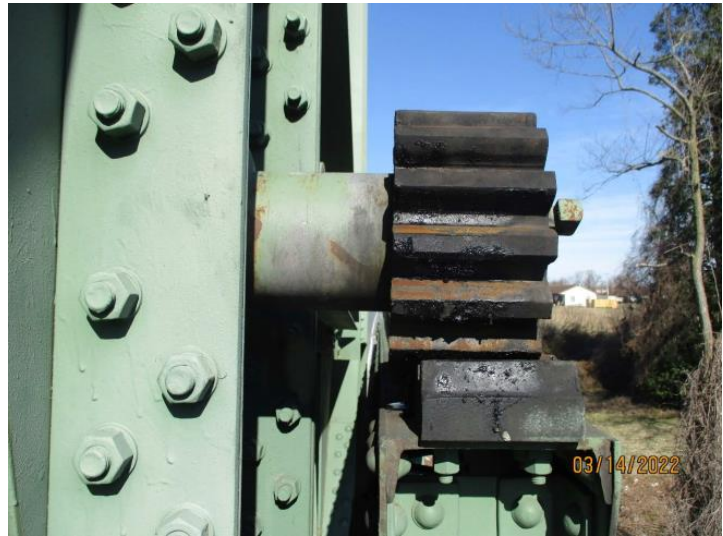
Figure 10: Pinion pulled towards middle of bridge

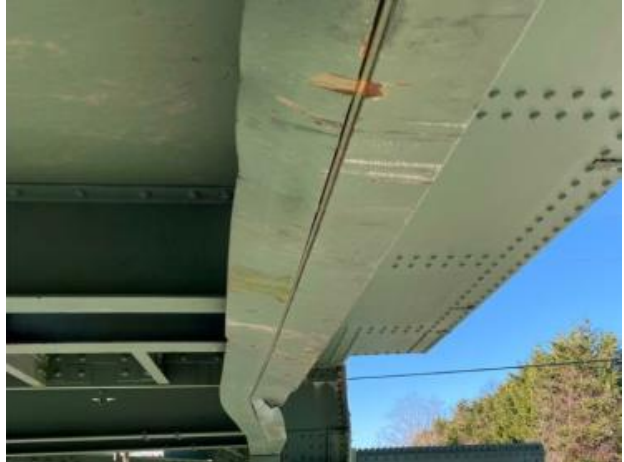
1. Damage to portal frame lower chord and counterweight girder from other impacts to the structure that occurred during the life of the structure. These impacts are most evident at the counterweight girder which sits a few inches lower than the portal frame and therefore has a higher potential for impact. As Figure 11 shows, there have been numerous lesser impacts to the structure since the bridge was last rehabilitated in 1996 when the counterweight girder was replaced. The lower flange exhibited significant deformation and in some locations the outstand leg was torn.

Figure 11: Counterweight girder bottom flange

In addition to the repairs for the damage sustained by the excavator impact, DelDOT also agreed to replace the damaged counterweight girder web and bottom flange. Since the machinery platform would already need to be temporarily supported and the roadway closed for repairs, this presented a good opportunity to perform this work. These elements in addition to the clip angles connecting to the stringers were detailed for replacement in kind similar to the portal frame elements.

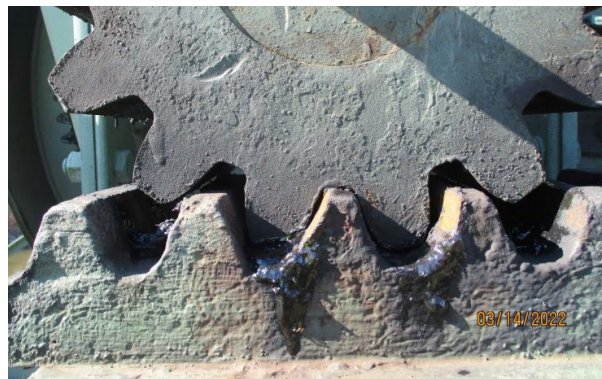
3. There was significant wear noted on the rack at the fully closed position as shown in Figure 12. This wear was likely related to the bouncing noted but this condition is also not uncommon in bridges of this age. The wear was primarily exhibited on the rack and concentrated on two teeth as the figure shows.

Figure 12: Wear on rack at closed position

The mechanical issues unrelated to the excavator impact were also included within the repair contract to be resolved while the bridge was closed for repairs. This included relocation of the rack sections from the fully closed position which were exhibiting wear to the rear of the rack where the rack section was outside of the normal operating range and showed no visible signs of wear. Review of the shop drawings confirmed that the rack segments were machined to the same dimensions and the sections could be exchanged with the holes reamed and new turned bolts installed to secure them.

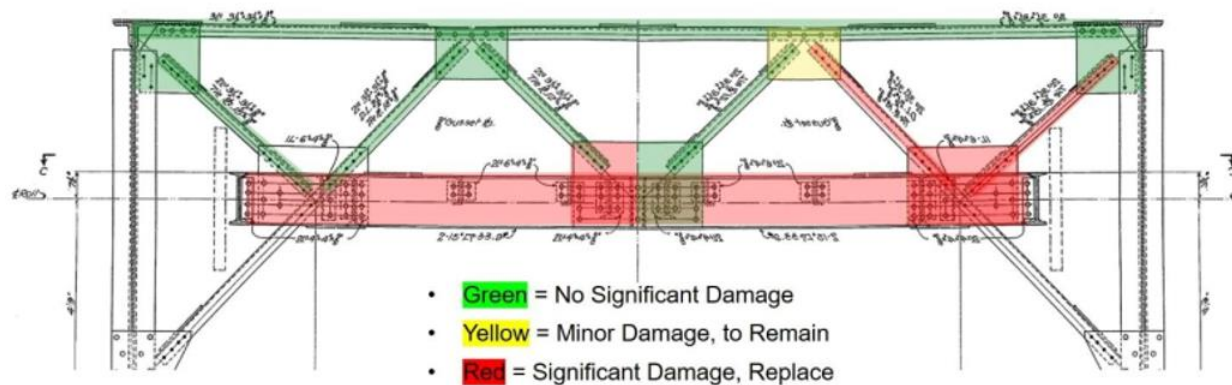
Figure 13: Identification of damage to portal frame elements and actions required

The repair scope for the bridge was established using the findings from the hands-on inspection. Structural components were grouped based upon their level of damage and identified for replacement, heat straightening or to be left as-is. Figure 13 summarizes the components of the portal frame and how they were grouped for repair designation. All elements to be replaced were detailed for replacement in kind with rivets replaced with high strength bolts and detailed using the available original construction and rehabilitation design drawings and shop drawings.

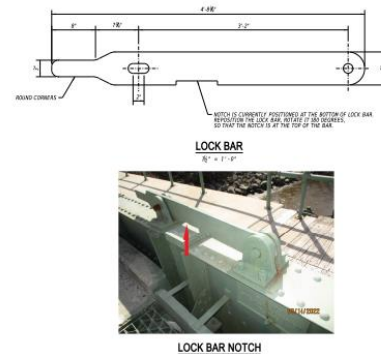
2. The inspection of the bridge was completed using a single lane closure of the roadway with two-way traffic maintained in both directions via flaggers. During the inspection it was noted that the bascule leaf was bouncing at the tip when vehicles crossed the structure. In addition to the bouncing, damage to the lower flange of the bascule girder on the east side was found which indicated that the bouncing was likely an ongoing problem caused by the leaf not being properly seated in the closed position. There were two potential causes identified for this including: the lock bar for the bridge having been modified and no longer maintaining the bridge in the fully closed position and the balance of the structure was modified at some point during the structures history with weight removed from the ends of the bascule girder but no records were available to confirm the existing balance. The lock bar had been modified by cutting the bar to provide additional clearance (approx. $\frac{3}{4}$ ") which was likely done in the past when the pin was unable to be driven.

Figure 14: Repair detail for lock bar

The noted bouncing of the leaf was addressed by two means. First, strain gage testing of the leaf was prescribed following completion of the repairs to the damaged mechanical and structural components. This testing and subsequent balancing would ensure that the leaf provided a positive reaction at the toe to prevent any tendency for the toe to lift and allow bouncing. Second, the lock bar which had been modified was detailed to be rotated such that the unmodified top of the bar would be the contact surface and the bar was to be re-shimmed for a tight fit. See Figure 14 for photo of modification of and prescribed repair detail.

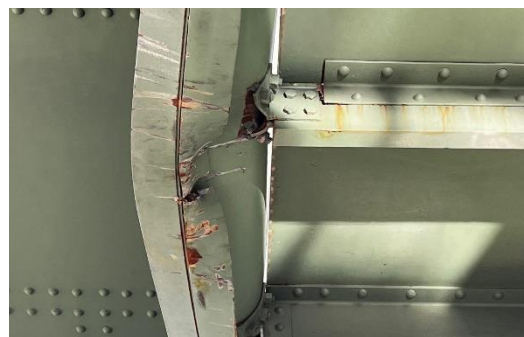
Figure 15: Damage to counterweight girder

to a stop. The damage from this second impact was assessed via another hands-on inspection. The additional damage to the portal frame did not affect any elements not already planned for replacement but the impact to the counterweight girder was significant as Figure 15 shows where the web was distorted several inches and connection plates badly damaged. Thankfully, these elements were already prescribed for replacement to address the other impacts to the structure and shop drawings had already been prepared and approved.

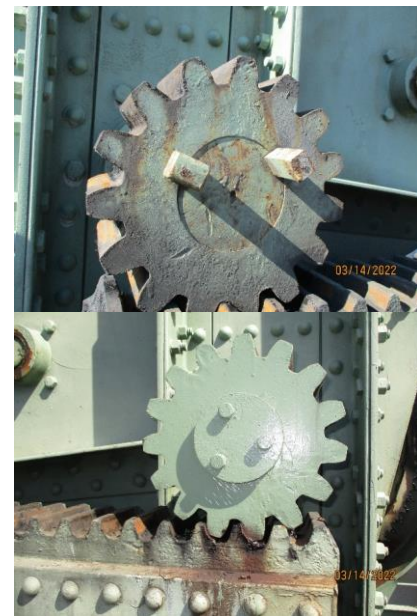
The final challenge presented during construction was that the gib keys for gear G1 on the west side had been cut off and a cap placed over the end of the shaft (see Figure 16). Removing the keys from the shaft on the east side of the bridge presented challenges for the contractor as one of the keys was missing the gib head. By fabricating a jig and welding onto the end of the key the contractor was able to extract both keys. With no exposed keys on the west side of the bridge it seemed very likely that removing the gear would prove nearly impossible without irreparably damaging the gear and/or shaft. Having removed shaft S1 on the east side of the bridge, confirming straightness and performing testing to confirm that no cracks were present within the shaft or gears it was clear that the shaft on the west side of the bridge which was minimally displaced was very unlikely to have any issues. With this in mind, the contractor was allowed to field verify straightness of the shaft to confirm there was no damage and leave the shaft in place.

Figure 16: Missing gib head, east (top); cut off keys with cap, west (bottom)

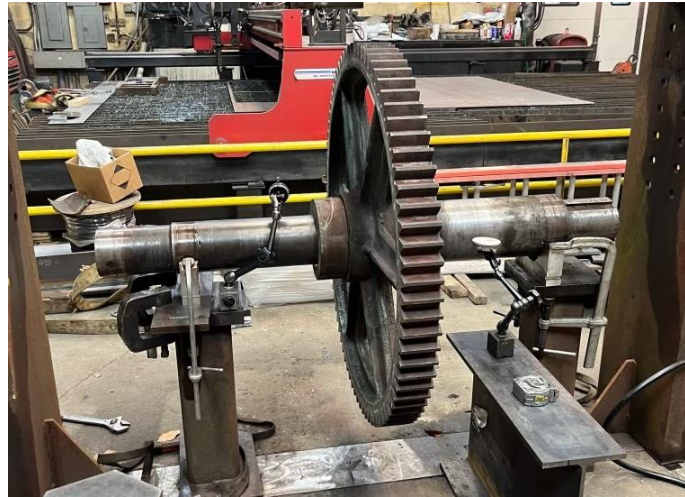
Figure 17: V block setup used in contractors' shop

To expedite the construction process and avoid the need for more extensive, costly and time-consuming repairs, unique construction methods were utilized. These methods were primarily related to the mechanical equipment realignment. When east shaft S3 was taken to the shop the out of straightness was measured and determined to be on the order of 3/8", well outside of the allowable runout tolerances. With the long lead time required to procure shaft material and machine a new shaft in addition to the risks of damaging the gear when removing it from the shaft, the contractor recommended straightening of the existing shaft. Using a setup on V blocks as shown in Figure 17 and a hydraulic press the contractor was

able to straighten the shaft and confirm that the runout was within the acceptable tolerances for a new shaft which saved significant time and costs for the project.
