**HEAVY MOVABLE STRUCTURES, INC.
TWENTIETH BIENNIAL SYMPOSIUM**

**Rehabilitation of LA 82: Vermillion River
Vertical Lift Bridge at Perry, Louisiana**

Dave Kanger, P.E.
Modjeski and Masters, Inc.

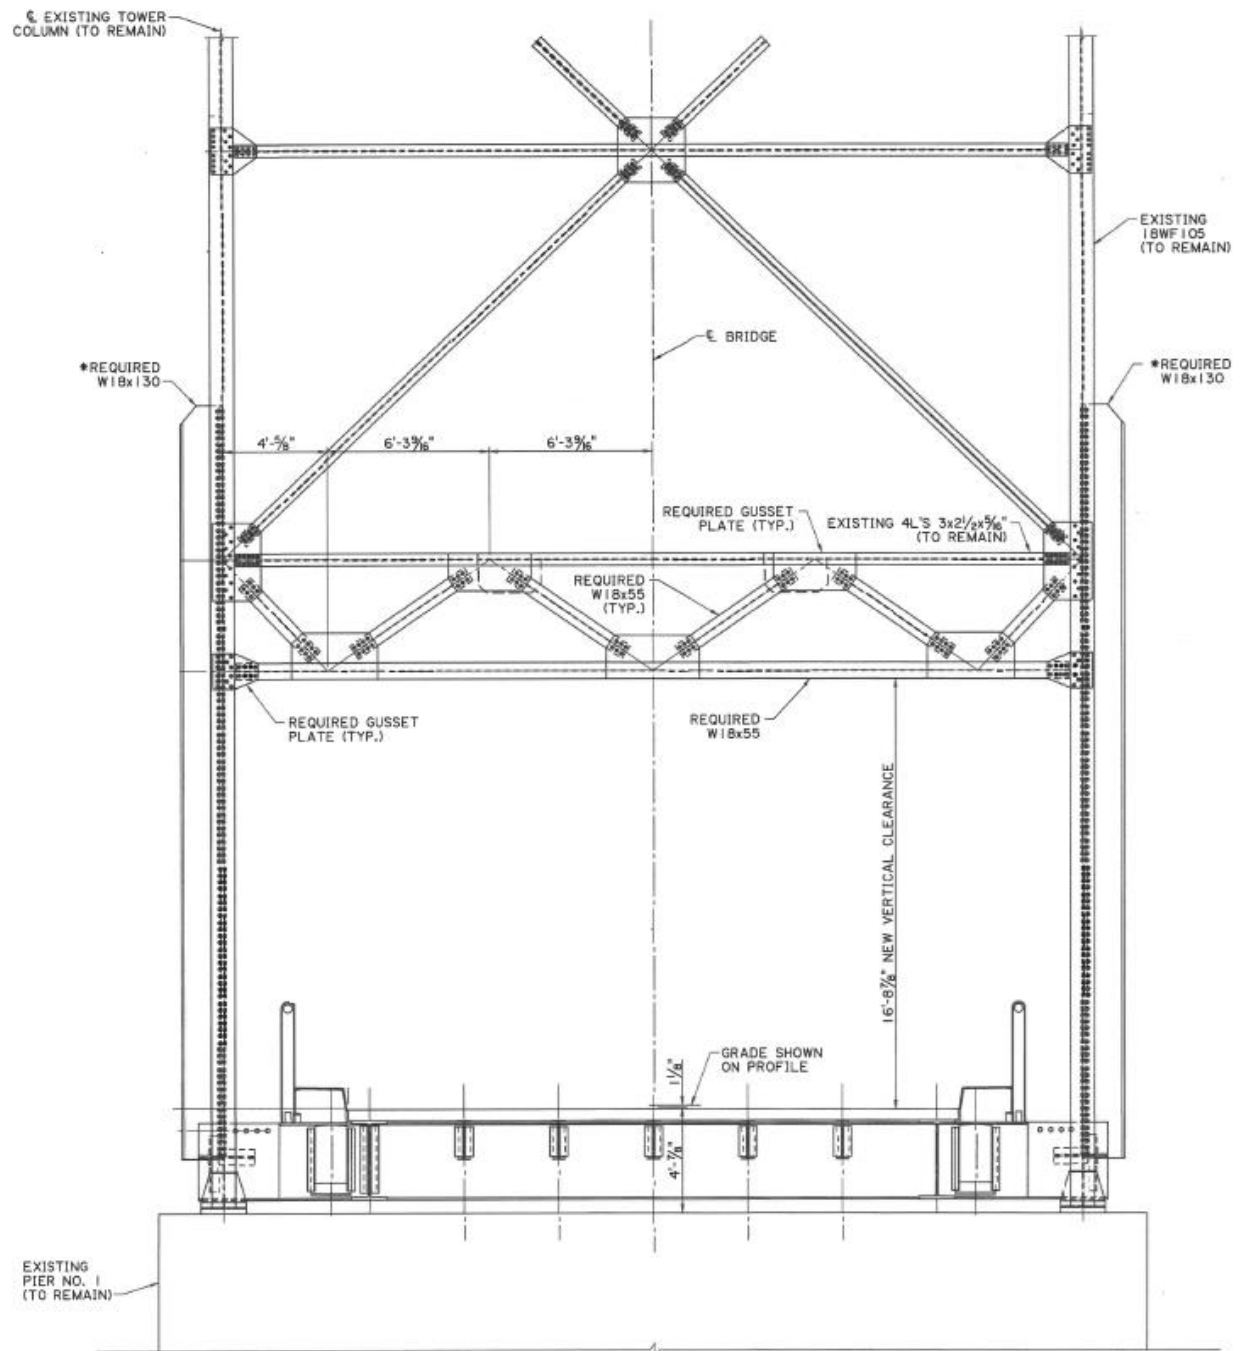
Figure 5 –Perry Bridge Tower Leg Rehabilitation

While tower leg metalwork was generally in good shape, several deficiencies with the tower and tower members were present that needed correcting. Both towers have been repeatedly struck by vehicles on against the low portal, necessitating replacement of portal members on multiple occasions. Additionally, some of these strikes have also deformed the tower legs out of vertical plumbness. Raising the portal above vehicular traffic, however, will increase the structural demand on the lower tower legs by increasing the unbraced length of the bottom panel.

The existing tower legs were also designed for circa 1950s wind load design criteria, and over the years, and under the current AASHTO LRFD Specification, the current wind design parameters have changed, increasing the demand on the tower legs and their anchorages.

While raising the tower would eliminate the low portal problem, it would not resolve by itself the need to increase tower capacity to resist current design wind loading.

For this reason, the rehabilitation alternative that was chosen was to raise the portal on the tower along with supplemental strengthening of the tower leg lower portion and its anchorage. The strengthening method was comprised of buttoning a new wide-flange section within the span-operating clearance zone of the tower leg that could strengthen the existing tower leg for both additional capacity to resist wind loading as well increase the capacity of the lower portion with a longer unbraced length due to the raise of the portal. (Figure 5)

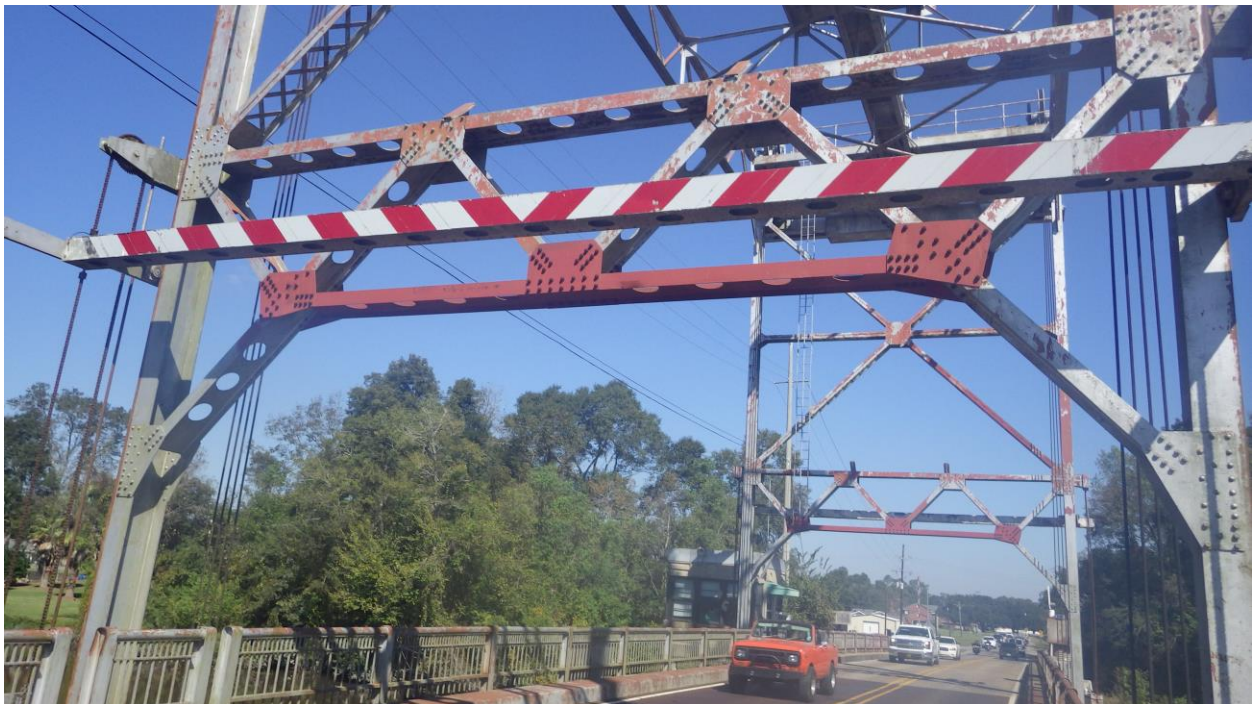
One of the main issues evident was the presence of low clearance tower portals which have been repeatedly hit by vehicular traffic, and as a likely result of these strikes, the district DOTD personnel suspected that the towers may also not be plumb. Tower portal struts exhibited permanent deformation of portal members, portal members were replaced several times, and most recently just prior to the final design phase for this rehab being presented.

Photo 2 – Tower Portal (replaced due to collision)

The lift span tower members needed strengthening to improve their capacity for modern design wind loading and to accommodate raising of the low portal members which frequently get hit, including straightening repairs, and replacement of the portal members.

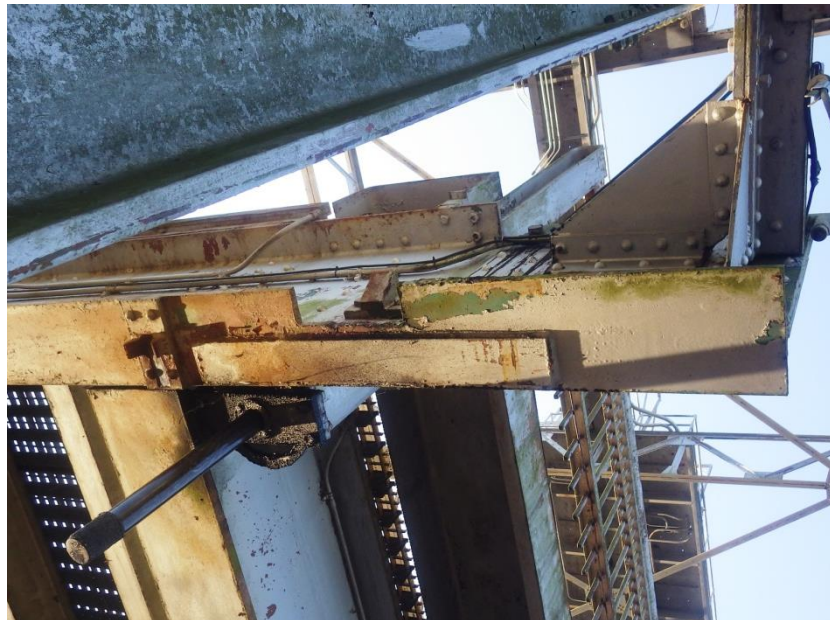
Photo 6 – End Floorbeams Were Torch Cut & 1" Thick Repair Plate Was Welded to NW & SW Sides for Span Locks

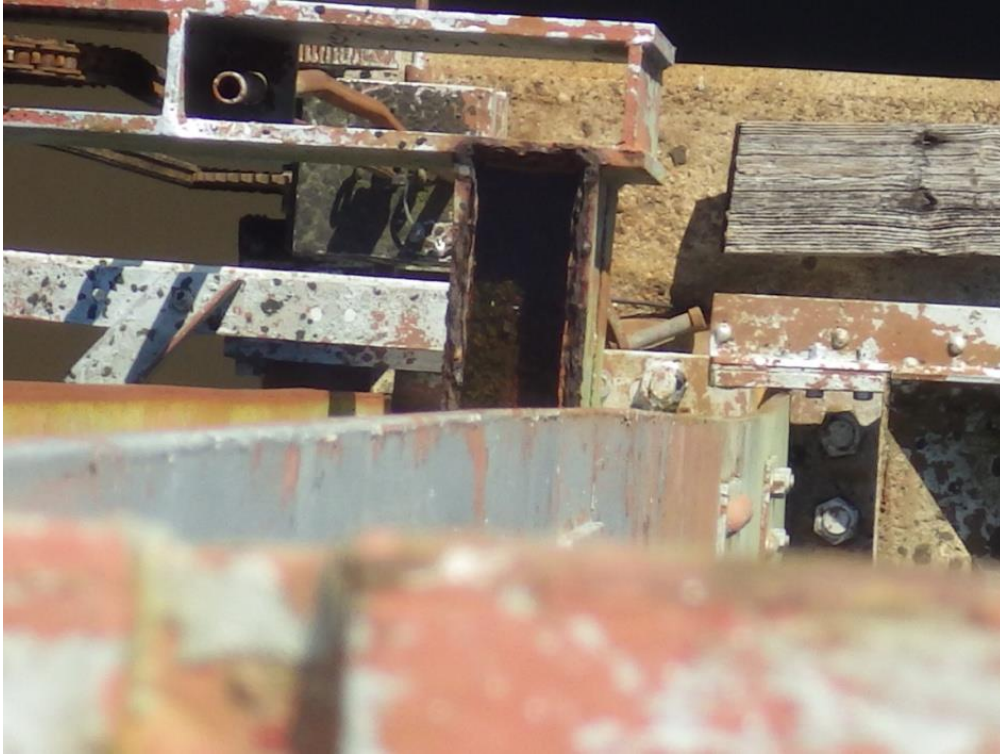
The towers are in generally good condition though there is evidence that at least one tower leg may not be plumb as a result of vehicle accidents with the tower portal bracing. A survey was performed to determine the disposition of the tower legs, and this survey did confirm minimal out-of-plumbness to be corrected. Additionally, the low clearance of the tower portal struts (14 feet) has resulted in numerous impacts which necessitated the replacement of the tower portal struts. The feasibility of raising the portals was studied, and as part of the tower strengthening, the portals will be raised.

Photo 9 – Northern Tower Legs Appeared to be Bowed Above Base

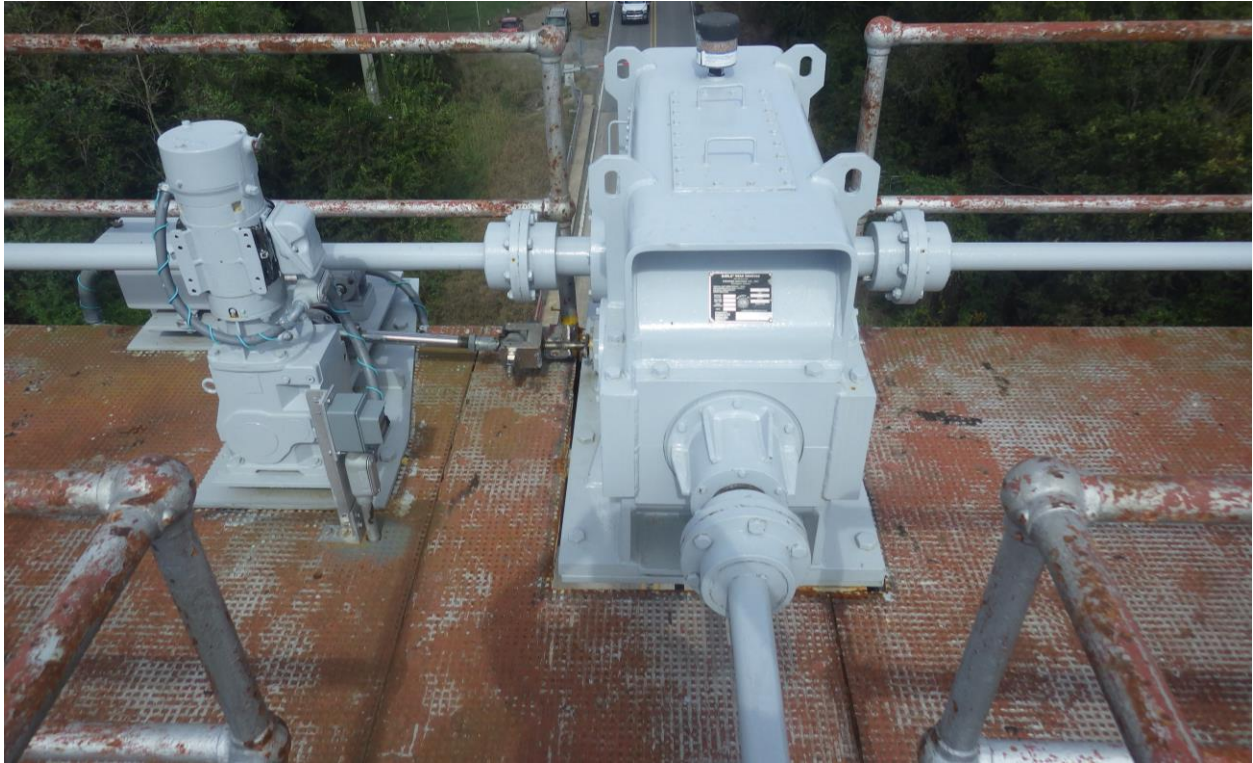
Photo 12 – Lift Span Secondary Reducer with Locking Clutch Assembly

on all reducers, rehabilitation of existing secondary gearboxes to eliminate oil leaks around the clutch, addition of new lubrication fittings to all shaft bearings, replacement of new bull gears, installation of new sealing gaskets and hardware kits at the primary reducer output couplings and secondary reducer input couplings and all primary line shaft couplings.
