**HEAVY MOVABLE STRUCTURES, INC.
TWENTIETH BIENNIAL SYMPOSIUM**

**Vertical Lift Bridge Seating Issues
Rt 1 & 9T Bridge over Hackensack River**

Hammad Mumtaz, Ph.D.
Robert Algazi, P.E.
WSP, USA

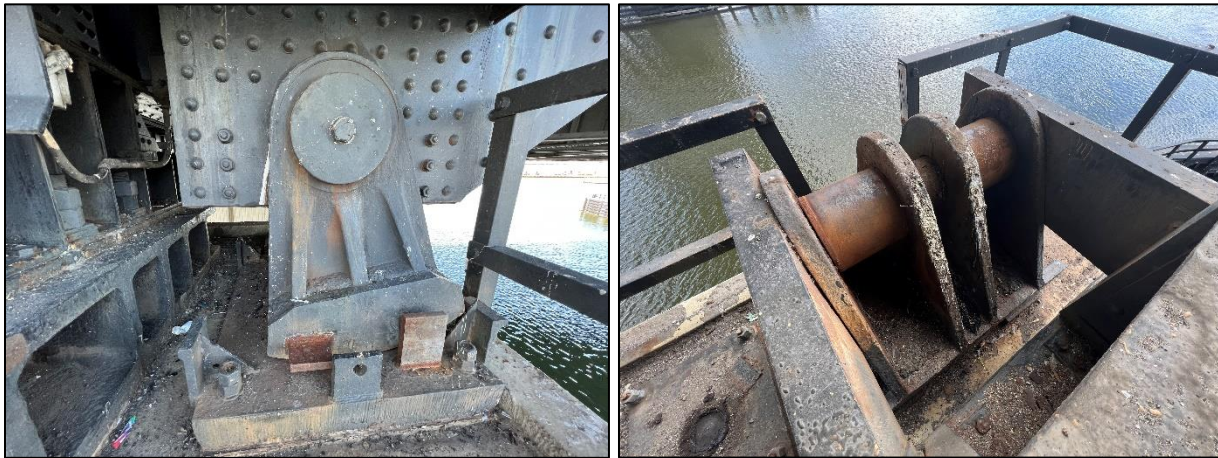
Historically, the Route 1&9T Bridge over the Hackensack River has experienced continuing seating issues at the live load shoes for several years. Periodically, one of the live load shoes (typically at the southwest corner) would not completely seat on the strike plate preventing the full seated limit switch from triggering. A significant gap between the southwest live load shoe and the strike plate has been noted and on occasion measuring upward of ½ inch. It is believed that due to the gap at the live load shoes, the ropes at this corner slip over time due to the high truck volume on this roadway that tends to use the right lane for the eastbound travel.

Photo 2: Left - Live Load Shoe; Right - Live Load Shoe Fixed Pin

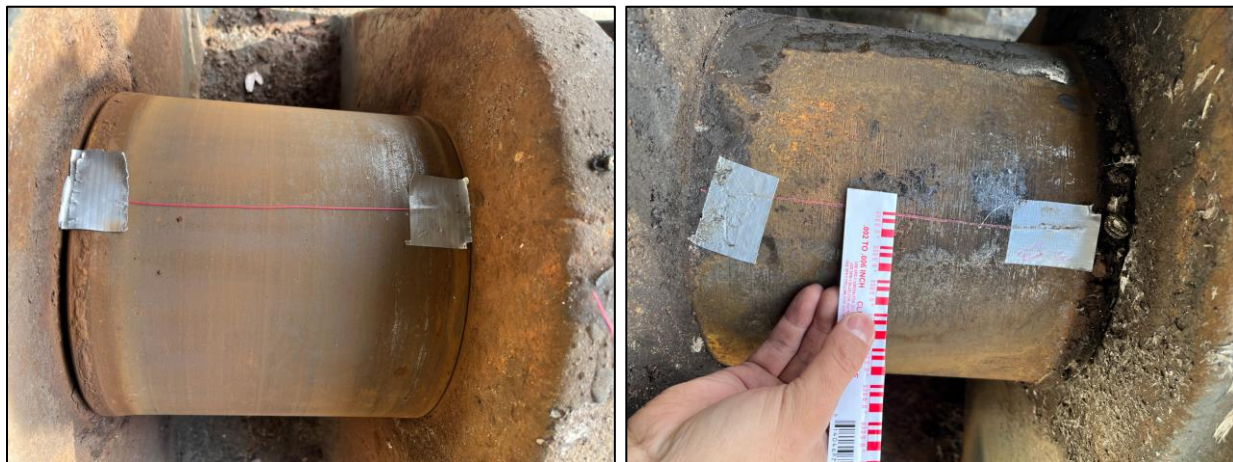
It is evident from the observations and measurements that the clearance at the southwest corner live load shoe has been increasing over time. There is a clear indication of the bridge being seated when there actually remains a gap at the shoe. The use of plastigages provided a method to directly assess the clearance and emphasize the importance for close monitoring of the bridge seating mechanism.

Photo 3: No contact on southwest live load shoe (left) & minor contact on the northwest live load shoe

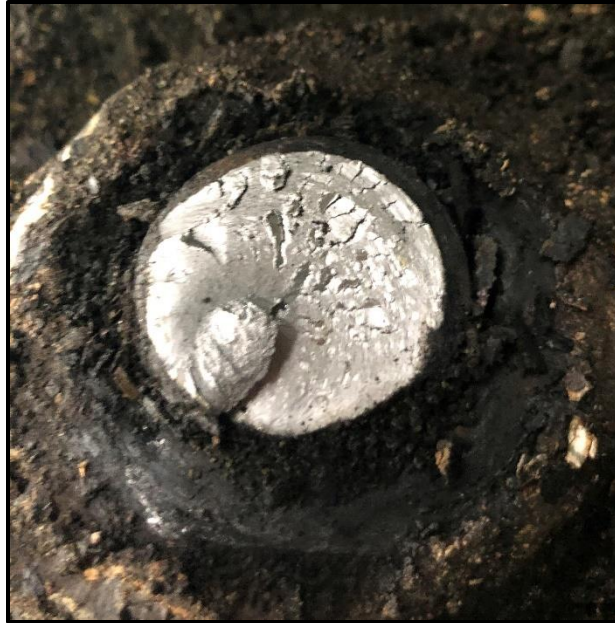
While loosening the live load shoe strike plate anchor bolts so it could be lifted to insert shims, one of the anchor bolts sheared, likely due to excessive torque applied by the work crew. The shearing occurred at the surface of the live load shoe base plate preventing the bolt to be reused; however, the bolt portion left in place at this location does provide some capacity for lateral loads.

Photo 5: Live Load Shoe Anchor Bolt Sheared

A live load shoe repair detail to supplement the broken anchor bolt additional anchorage was provided by the Contractor. The repair consists of a new channel mounted off a stiffener of the live load shoe strike plate that is anchored to the concrete with a new anchor bolt. The existing failed anchor remains and was caulked and painted to prevent corrosion.

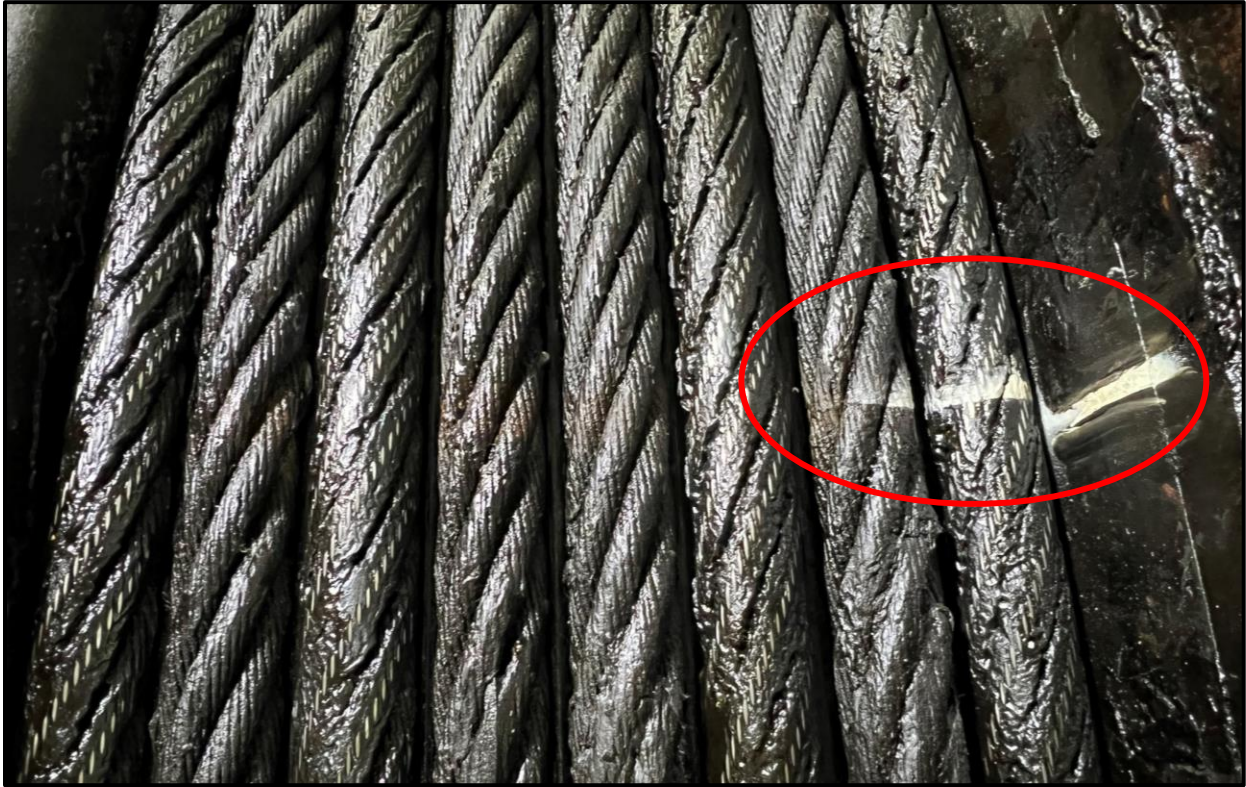
Observations during testing and inspection indicate that the span drive machinery indexing would tend to change over time. This would be most noticeable after any cross-indexing was corrected. The wire ropes would slip on the sheaves after the first bridge lift following indexing corrections. This was confirmed by observing alignment paint markings on the counterweight wire ropes and sheave before and after test lifts. The SW corner counterweight wire ropes would slip up, meaning that the SW live load shoe would also seat a higher similar amount. This would continue until the machinery was completely cross indexed again. Once cross indexed, the rope slippage would slow down but not completely disappear. It would continue

to slip until the bridge would no longer seat properly. Since the machinery would continue to become cross indexed over time, it is believed that the index is a symptom of the overall issue and not necessarily a cause; therefore, correcting the seating issue would also correct the indexing issue.

Photo 1: White Markings on the Wire Rope and Sheaves Indicating Rope Slippage

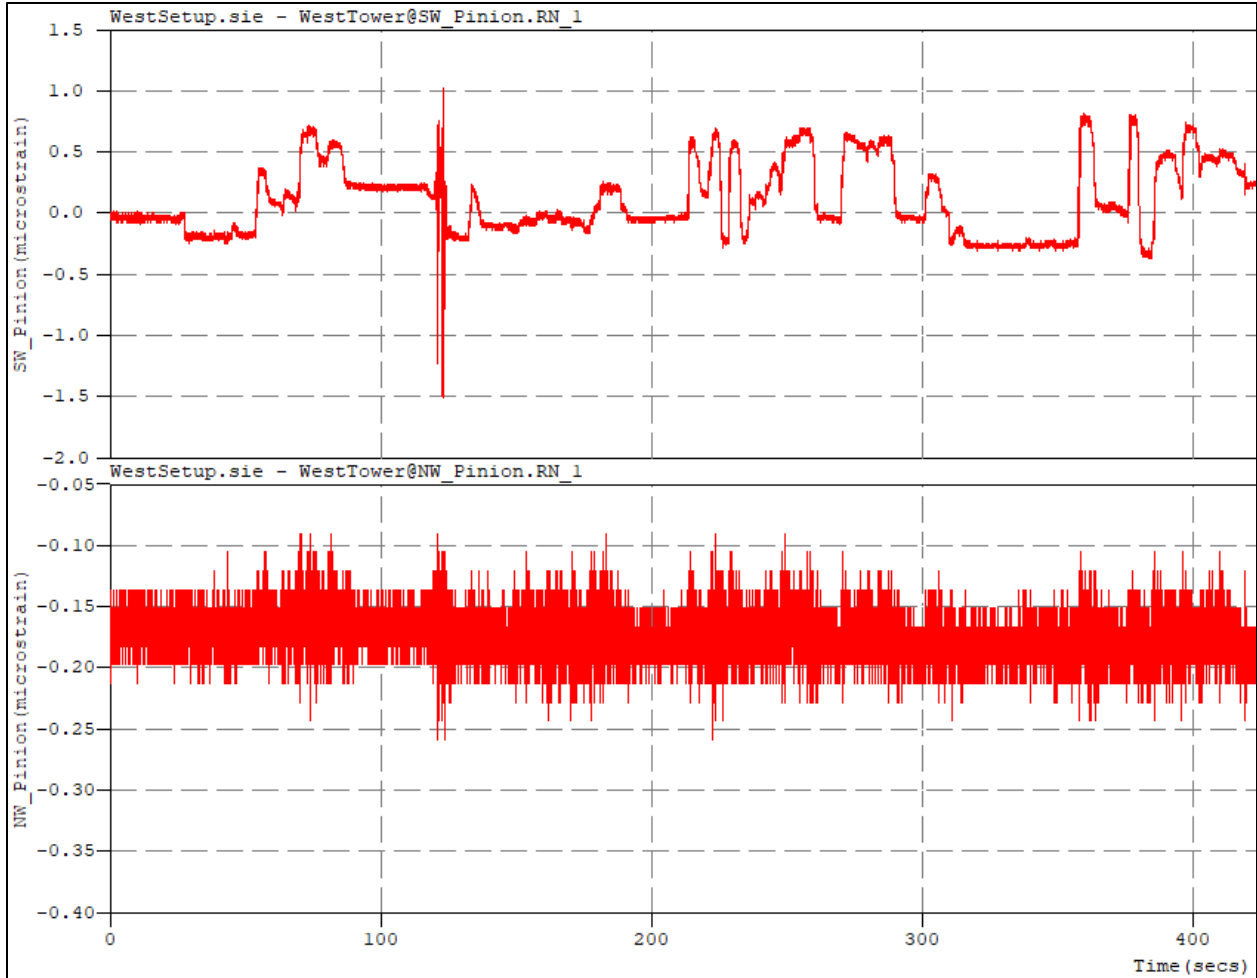
Table 6: Strain gage data under live load traffic

During the 2023 strain gage testing and after one complete test lift, the strain gage testing equipment was left on to record the torques in the west span drive machinery under live load traffic. While traffic was on the bridge, movement/torque was observed at the Southwest corner but not at the Northwest corner. This corresponds to the fact that the northwest corner was fully seated, and the wire ropes should not see the live load. This also confirms the southwest corner was not fully seated and the wire ropes will see the live load. Traffic on the southwest corner would increase the seating load seen on the machinery, as if the live load was pushing that corner down. Similarly, traffic on the northeast (opposite) corner would decrease the seating load seen on the machinery, as if the span was twisting resulting in uplift. Below are the raw recorded data for comparison.
