Aerial Bridge Emergency Counterweight Sheave Assembly Repairs

Paul Bandlow, P.E., Stafford Bandlow

AERIAL BRIDGE

EMERGENCY COUNTERWEIGHT SHEAVE ASSEMBLY REPAIRS

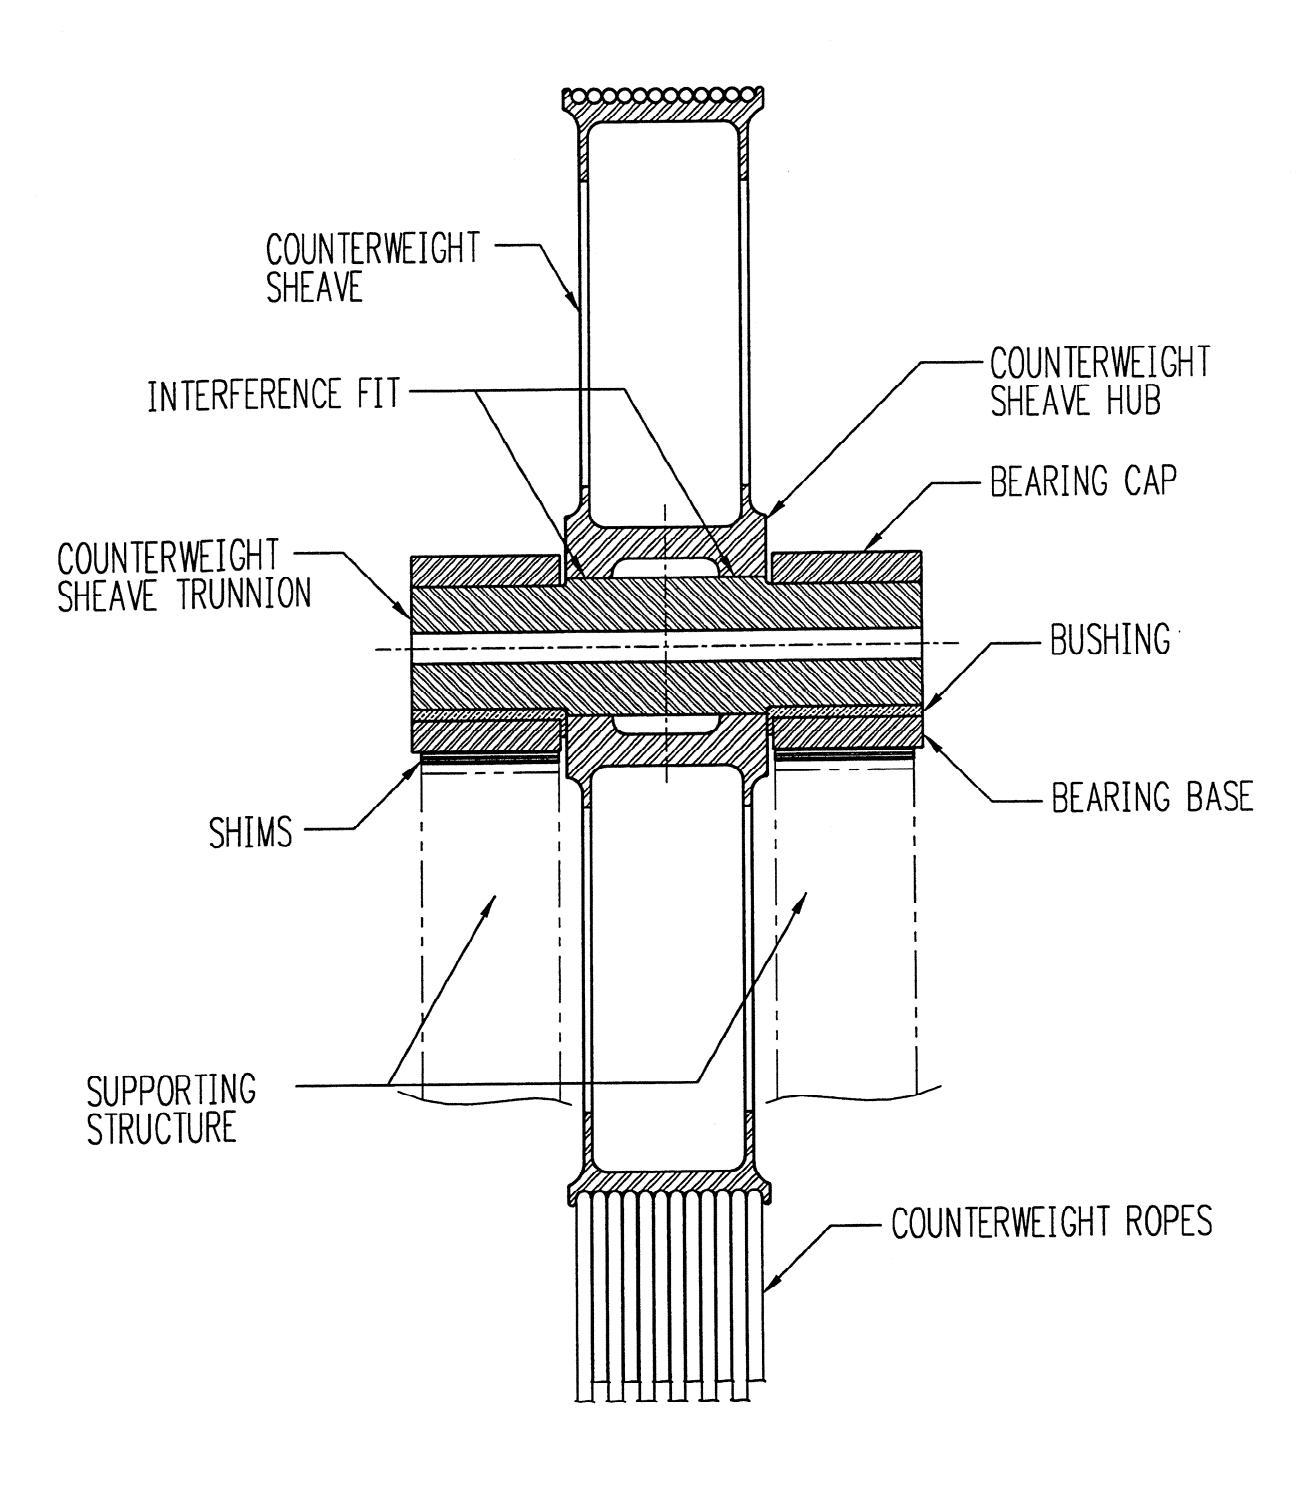
FIGURE 1 COUNTERWEIGHT SHEAVE ASSEMBLY resistance to both axial and rotational movement between the two components. Second, four square keys (two at each fit area) were provided to prevent rotational movement. Lastly, four axial threaded dowels (two at each end of the sheave hub) were installed at the interface of the sheave and shaft to primarily prevent axial movement although the dowels also provide resistance to rotational movement.

The trunnion had moved axially relative to sheave. At the time of the inspection the trunnion had moved in an easterly direction 7/16" relative to the sheave. The threads in the sheave and the trunnion that are used to secure the threaded dowels had sheared and the dowels had moved relative to the trunnion. The dowels were flush with the sheave on the east side and had apparently not moved relative to the sheave. On the west side the threads in both the sheave and the trunnion had sheared and the dowels had moved relative to both the sheave and the trunnion had

The fit between the trunnion and the hub of the sheave was loose at the east side of the sheave. A total radial clearance of 0.018" was measured between the hub and the trunnion on the east side. There was no clearance found between the hub and the trunnion on the west side of the sheave.

The shoulder on the trunnion was in hard contact with the bronze bushing on the east side. The hub of the sheave was in hard contact with the bronze bushing on the west side. The contact had resulted in plastic flow of the trunnion on the east side and plastic flow of the sheave on the west side. Also there was noticeable heat build up on both the trunnion and the sheave during operation as a result of the hard contact.

- 1. Remove the load from the sheave assembly.
- 2. Remove the existing dowels and jack the sheave back to its original position relative to the trunnion.
- 3. Secure the sheave to the trunnion to prevent axial movement.
- 4. Compensate for the gap created by the movement of the structure.
- 5. Align the trunnion with the bearings and verify proper alignment under full dead load.
