SEVENTH BIENNIAL SYMPOSIUM November 4 - 6, 1998

"Load Sharing of Vertical Lift Machinery" by

The Use of Load Sharing Devices for Tower Drive Vertical Lift Bridges

Jeffrey W. Newman, P.E. Modjeski and Masters, Inc. Harrisburg, Pennsylvania

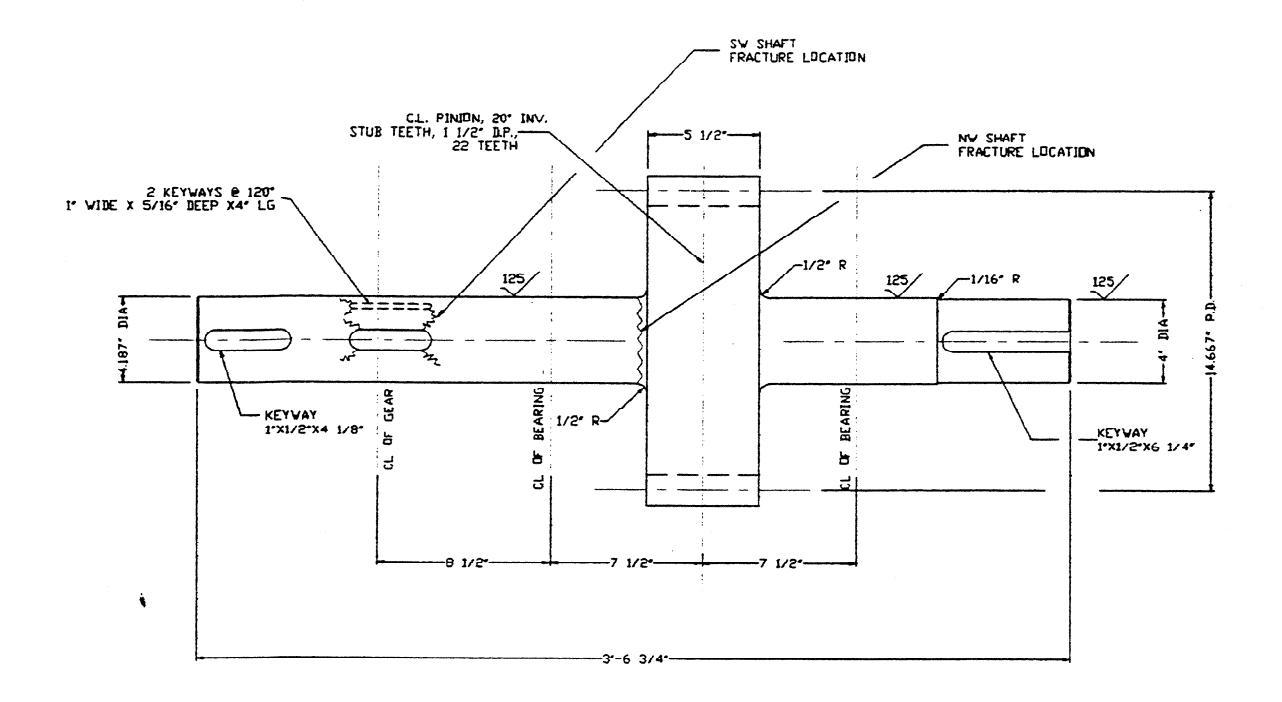
FIGURE 2: MAIN PINION SHAFT FRACTURE LOCATIONS

The movable span was put into operation in 1971 and did not experience any significant problems until 1992, at which time the northwest pinion shaft failed (See Photo 1 and Figure 2). After replacement of the northwest pinion shaft, the southwest pinon shaft was removed for examination (see Figure 2 and Photos 2 and 3). Photos 2 and 3 are of the southwest pinion shaft which displayed fractures emanating from two keyways and torsional distortion. A small gear (which showed no signs of distress) is mounted in this location which drives only electrical components such as; rotary cam limit switches, skew indicators, selsyn transmitters, and height indicators.

Detailed calculations were made in an attempt to determine the source of the fractures. First, the traditional design loading was checked to verify compliance with AREA. Then, analyses were performed to determine the loads required to produce keyslot distortion, fatigue cracks emanating from keyways, and fracture of the northwest pinion shaft at the pinion fillet radius. The results are summarized as follow:

2. <u>Keyslot Distortion of the Southwest Pinion Shaft</u> - The distortion was obviously due to torsional yielding of the shaft. Calculations showed that 23,000 lb-ft of torque was required to produce torsional yielding, (equal to 485% of rated motor torque if the pinions load shared).

3. <u>Fatigue Cracks at the Ends of Keyslots on the Southwest Pinion Shaft</u> - A fatigue analysis was performed that included the effects of stress concentration factors at the roots of the keyslots. As previously noted, the keyslots are for a small pinion that has little load and induced bending would be negligible. Therefore, the fatigue analysis concentrated on fluctuating torsional loading. The results showed that repeated torsional loads from zero to 10,420 lb-ft for one million cycles would be required to produce fatigue fracture (equal to 220% of rated motor torque if the pinions load shared).

4. <u>Fatigue Fracture of Northwest Pinon Shaft at Pinion Shaft Fillet</u> - This section of the shaft experienced bending stress reversal cycles (from separating forces between pinion and ring gear) and fluctuating torsional loading. Fatigue analysis indicated that cyclical torsional loading of zero to 11,800 lb-ft would be required for one million cycles to produce fatigue failure (equal to 250% of rated motor torque if the pinions load shared).

From the analysis performed, it appeared that consistently high overloads (at or above 250% of rated motor torque) would be required to produce the fatigue fractures and failures. While this seemed unlikely, it seemed nearly impossible to experience a motor overload of 485% to produce the yielding of the southwest pinion shaft. The best way to determine the actual torsional loads was to strain gage the pinion shafts.

Strain gaging was performed and revealed the torsional loads and distribution of loads to the northwest and southwest pinion shafts. The northwest shaft was assuming all of the positive torque (driving torque required to lift the span) and the southwest shaft was transmitting all of the negative torque (driving torque required to close the span). The pinions were not load sharing at all (see Figure 3). This resulted in all of the motor torque being transmitted to one of the pinion shafts at a time, which effectively doubled the normal design loads (see Figure 4). In addition to relatively high mean torsion during the opening cycle, excessive torsion was repeatedly experienced in the northwest pinion shaft during the start of opening and at the nearly closed slowdown. The southwest pinion shaft experienced relatively low mean torsion, but experienced high overloads during the nearly open slowdown, the start of closing, and during seating. The lack of load sharing resulted in stresses that exceeded the endurance limit stresses and resulted in fatigue fracture. Extremely high overloads were experienced by the southwest shaft during seating which were probably responsible for the torsional yielding.
