"Stone Harbor Bridge - Emergency Mechanical Repairs"

by David Nyarko, P.E. Parsons Brinckerhoff Quade & Douglas, Inc.

Eighth Biennial Movable Bridge Symposium Heavy Movable Structures Orlando, Florida November, 2000

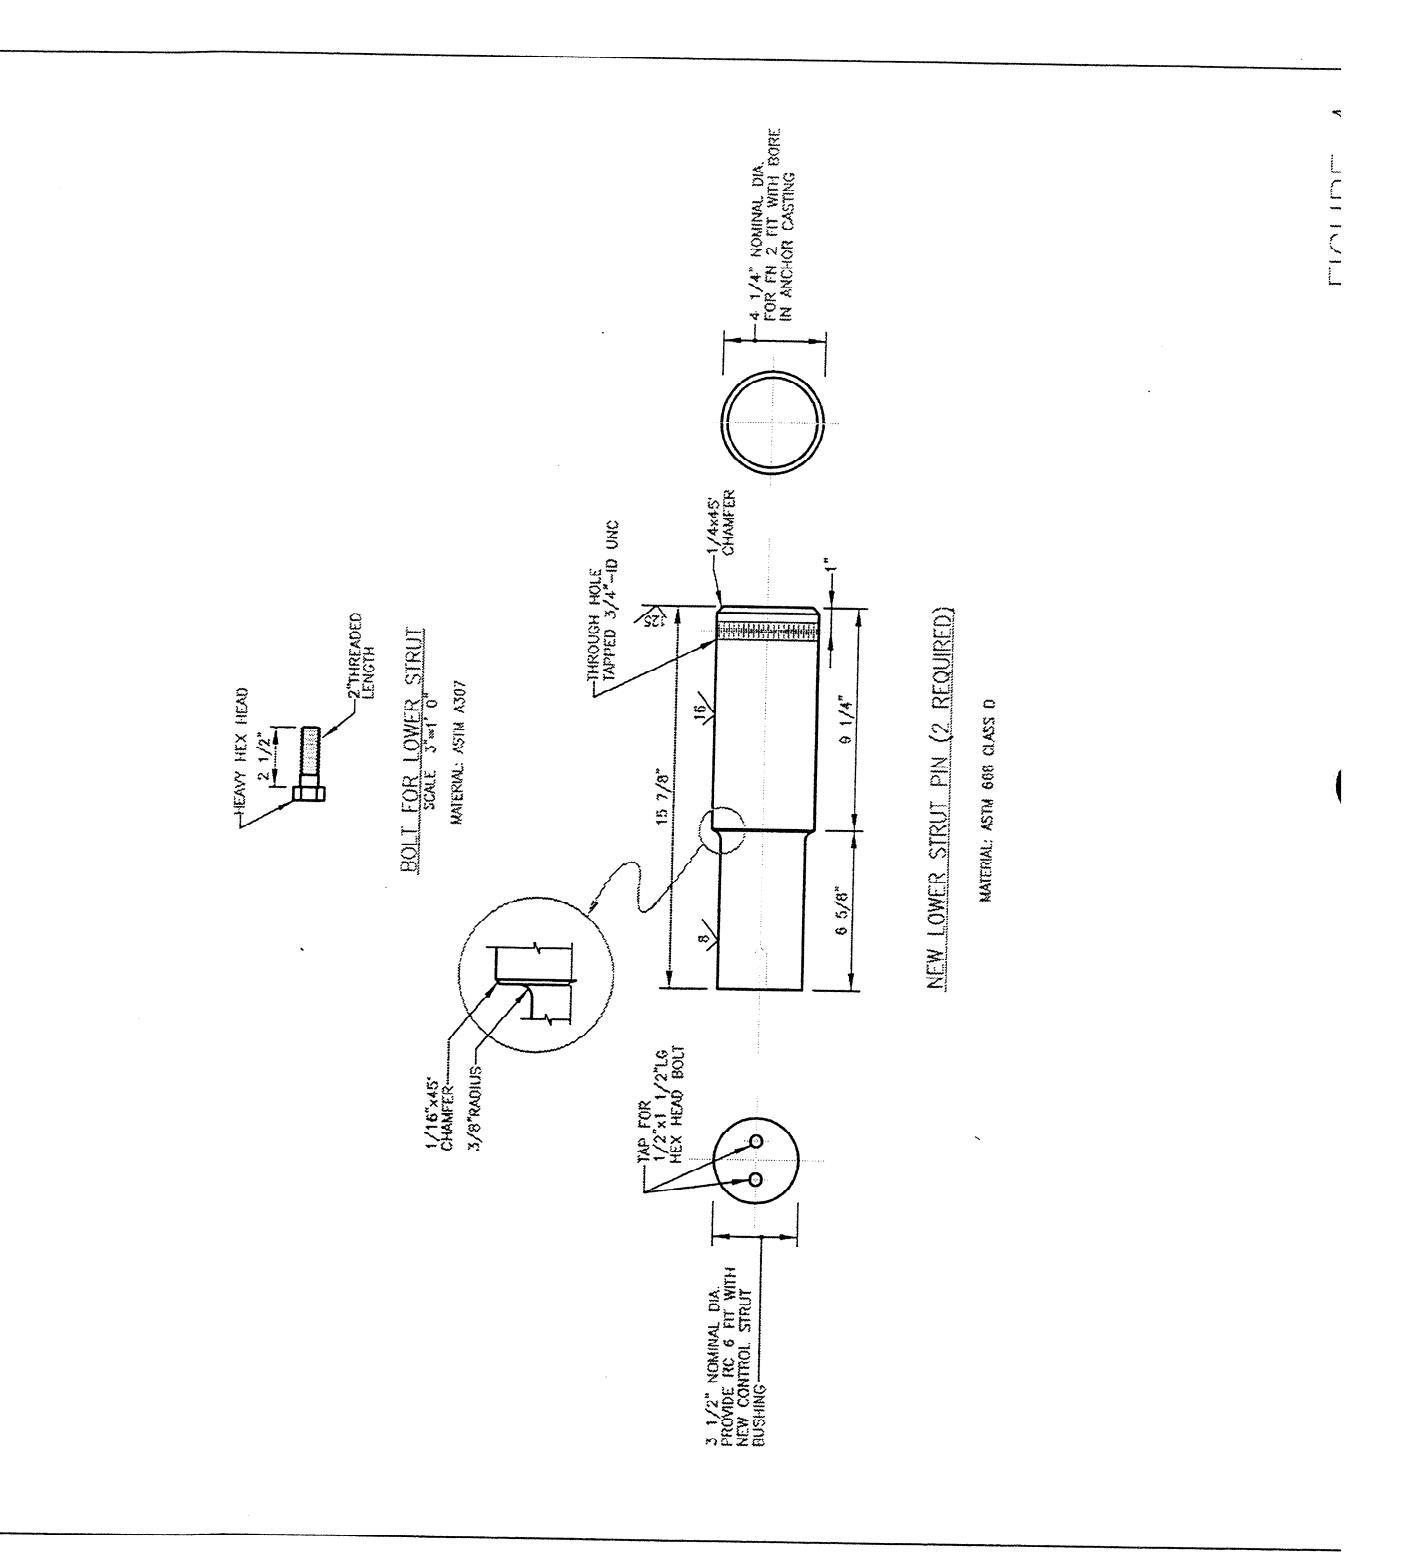
LICIDE 3

Control Strut: The southwest strut had broken several times and had been welded together. The welding of the strut had shortened the strut length, overstressing the strut and misaligned the entire leaf. A critical requirement of the Rall-type design is to maintain the exact geometry and relative position of the bascule leaf, control and operating struts as the bridge moves. The original center to center distance of the lower and upper pins was designed to be exactly 30 inches. The existing struts on the bascule span measured 33 and 32 inches. The struts have broken several times over and had been welded together. Also, the bushings in the upper strut were noisy and appeared to be seized inside the upper end of the strut sleeve. The set screws holding the strut sleeve to the bushings were missing. It was recommended that the struts be replaced. The following improvements to the original details were also made (Figure 3):

- 1. The new struts were 2 inches wider than the existing struts. The existing strut were fabricated out of 6-inch steel tubing and plates. The wall thickness of the tubing did not allow for a solid connection between the tubing and the bushings.
- 2. Struts were machined out of a single piece of forged steel instead of steel weldments. The existing struts had been repaired several times by field welding the broken pieces. The single forged steel minimized the high stress concentrated location on the struts.
- 3. The new bushings were flanged and bolted to the strut sleeves instead of being locked in place with set screws. The set screws connecting the bushings to the existing strut sleeves had failed. The flanged bushings provided a bolted connection between the strut sleeves and the bushings.

The wider struts provided enough surface area to directly bolt the flanged bushings to the struts.

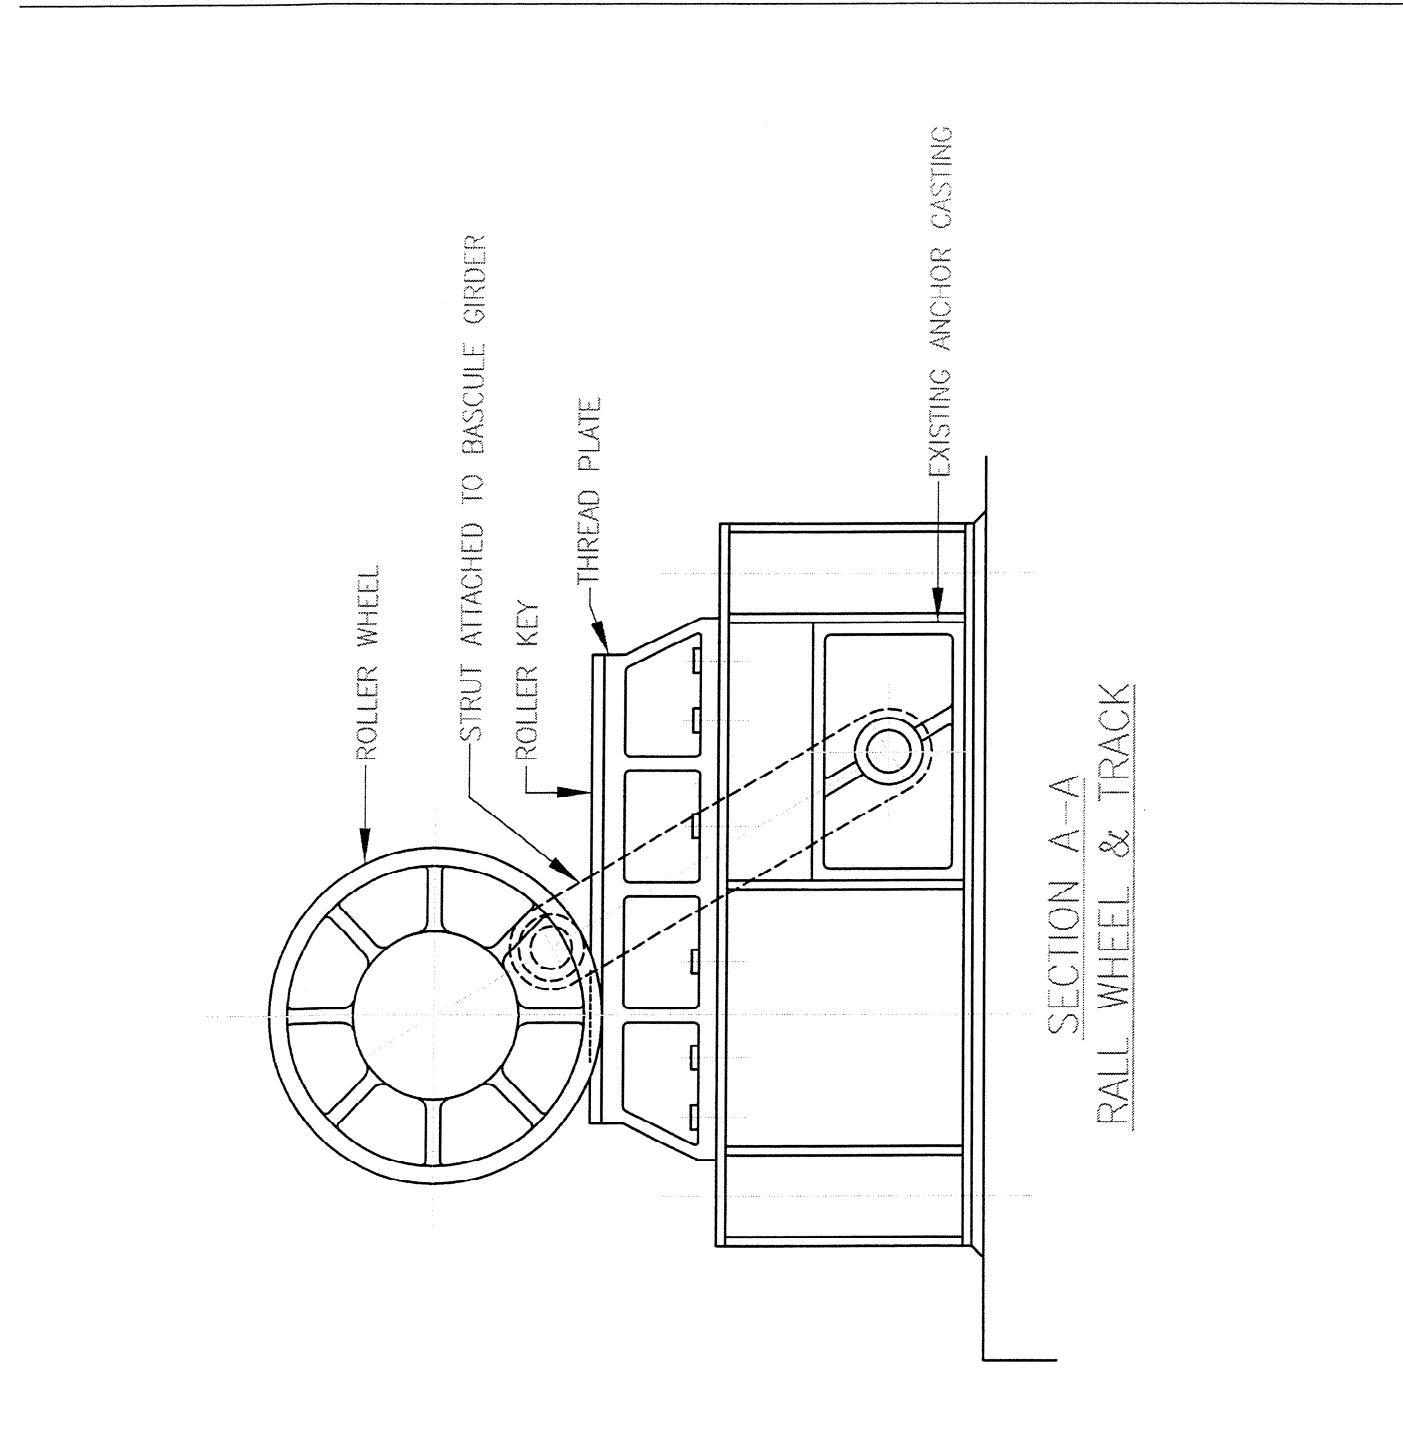
FIGURE 5

Months after the contract for the repair work was awarded, the lower pin that connects the control strut to the wheel support casting broke off during an opening. PB responded to this emergency and assisted the county and the repair contractor with a temporary replacement of the broken pin.

Examination of the broken piece led us to conclude that the pins were being subjected to live load and that failure is classic fatigue failure. After a site meeting with the county engineers and the contractor's crew, a decision was made to fabricate a new pin.

The broken pin was shrunk fit into the anchor casting (Figure 5). The initial challenge was to remove the broken half from the lower anchor casting without damaging the bore in the housing. After various discussions to find ways to shrink the broken piece or to expand the bore in the anchor casting, an iron-worker decided to burn off the broken half.

The pin dimensions on all existing drawings did not indicate the correct size of the pin, therefore, the new pin had to be re-machined and additional site work was postponed until the following morning. On Sunday, the new pin was fitted into the anchor casting bore.
