"The Effects of Balance, Friction and Control Sequencing on Span Skew and Seating During Lift Span Operation"

by Robert J. Tosolt, P.E. Stafford Bandlow Engineering, Inc.

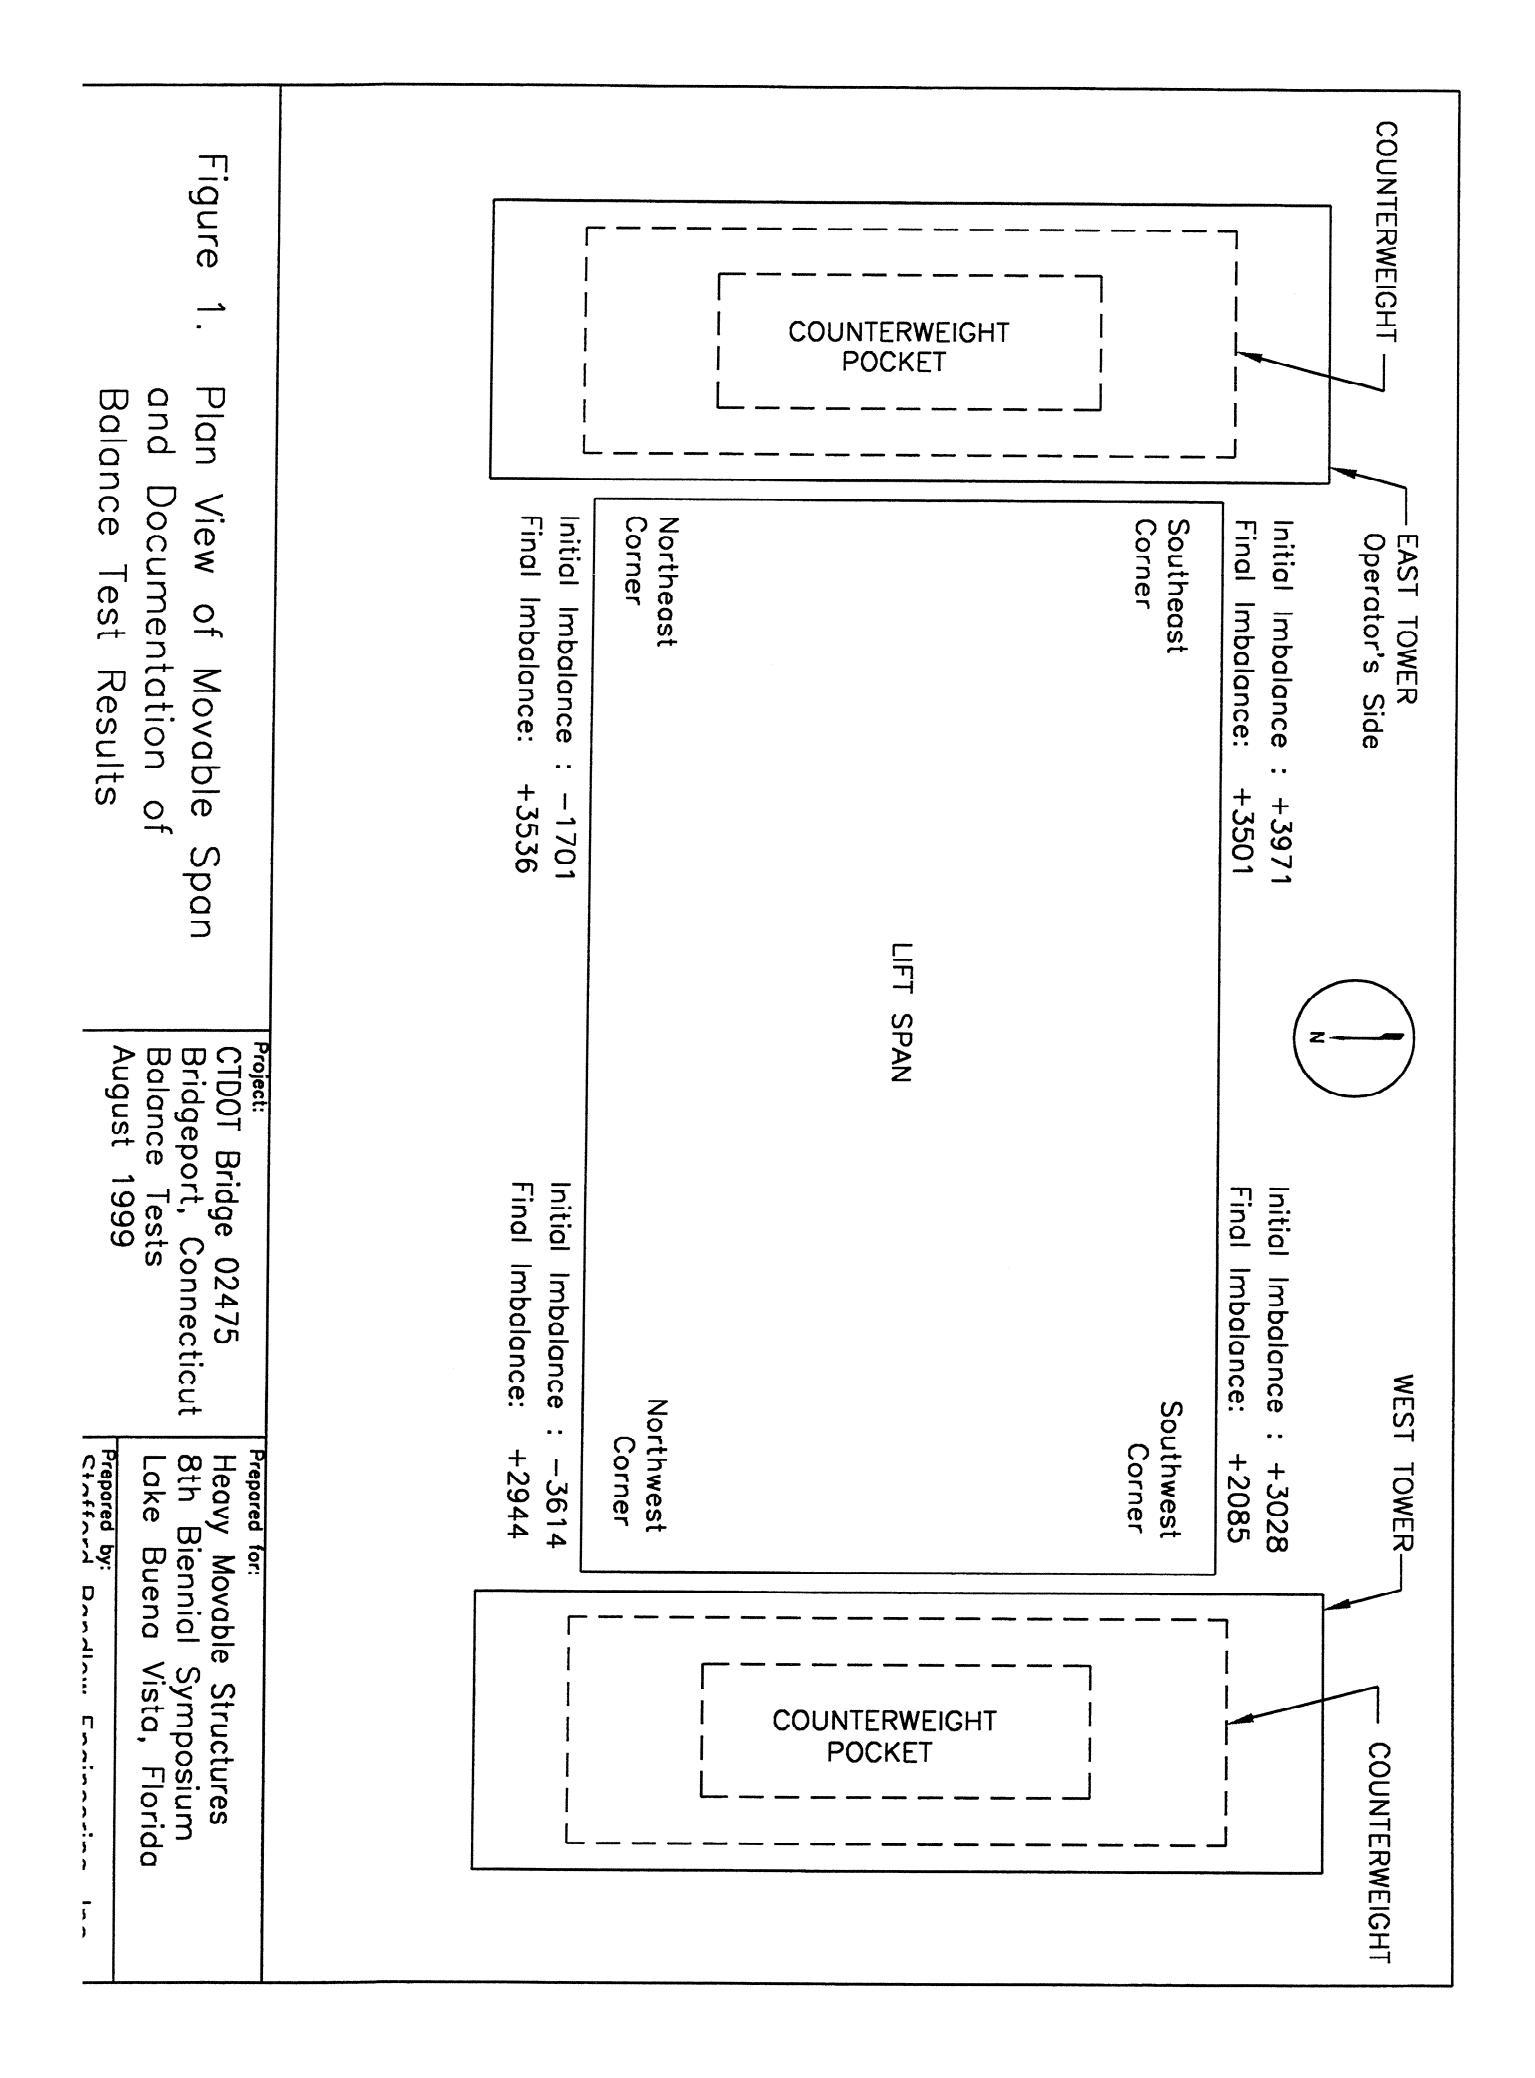
Results of the initial tests indicated that the bridge had a transverse imbalance problem. The South side of the bridge was reasonably well balanced, however, the North side of the bridge was considerably counterweight heavy. See Figure 1 at the end of this paper. The net effect of this balance condition was that the bridge was substantially counterweight heavy. An initial balance change was made in the counterweight pocket at the East end of the bridge. The subsequent test at that end of the bridge revealed that the weight shift did not achieve the desired result. Further weight changes were made followed by retesting. Once again, the physical changes did not produce the intended results. While each subsequent balance test indicated the total weight change that had been performed, the indicated changes did not occur at the expected corners. Likely sources for this phenomenon included a bottoming condition present at all rack and rack pinion locations that had an indeterminate effect on the loading in the transverse shafting, the severe transverse imbalance, and the location of the counterweight pocket at the center of the long narrow counterweight.

No action could be taken regarding the bottoming condition. However, the effects of the weight changes could be improved. Each counterweight was suspended by two groups of ropes, one at each corner. The addition or removal of weight at the center of the counterweight pocket produced an equal reaction in both groups of ropes. However, the severe transverse imbalance required that a substantial weight adjustment be performed at only one side of the counterweight. The centrally located pocket could not easily accommodate this need since any weight shift would produce a moment affecting both groups of ropes. The most effective means of changing the balance would be the placement of weight adjacent to the main counterweight rope terminations either at the counterweight or on the lift span to achieve a one to one relation. As the original design did not provide for weight adjustment at this location, a permanent means of securing the blocks would be required once the desired balance state was obtained.

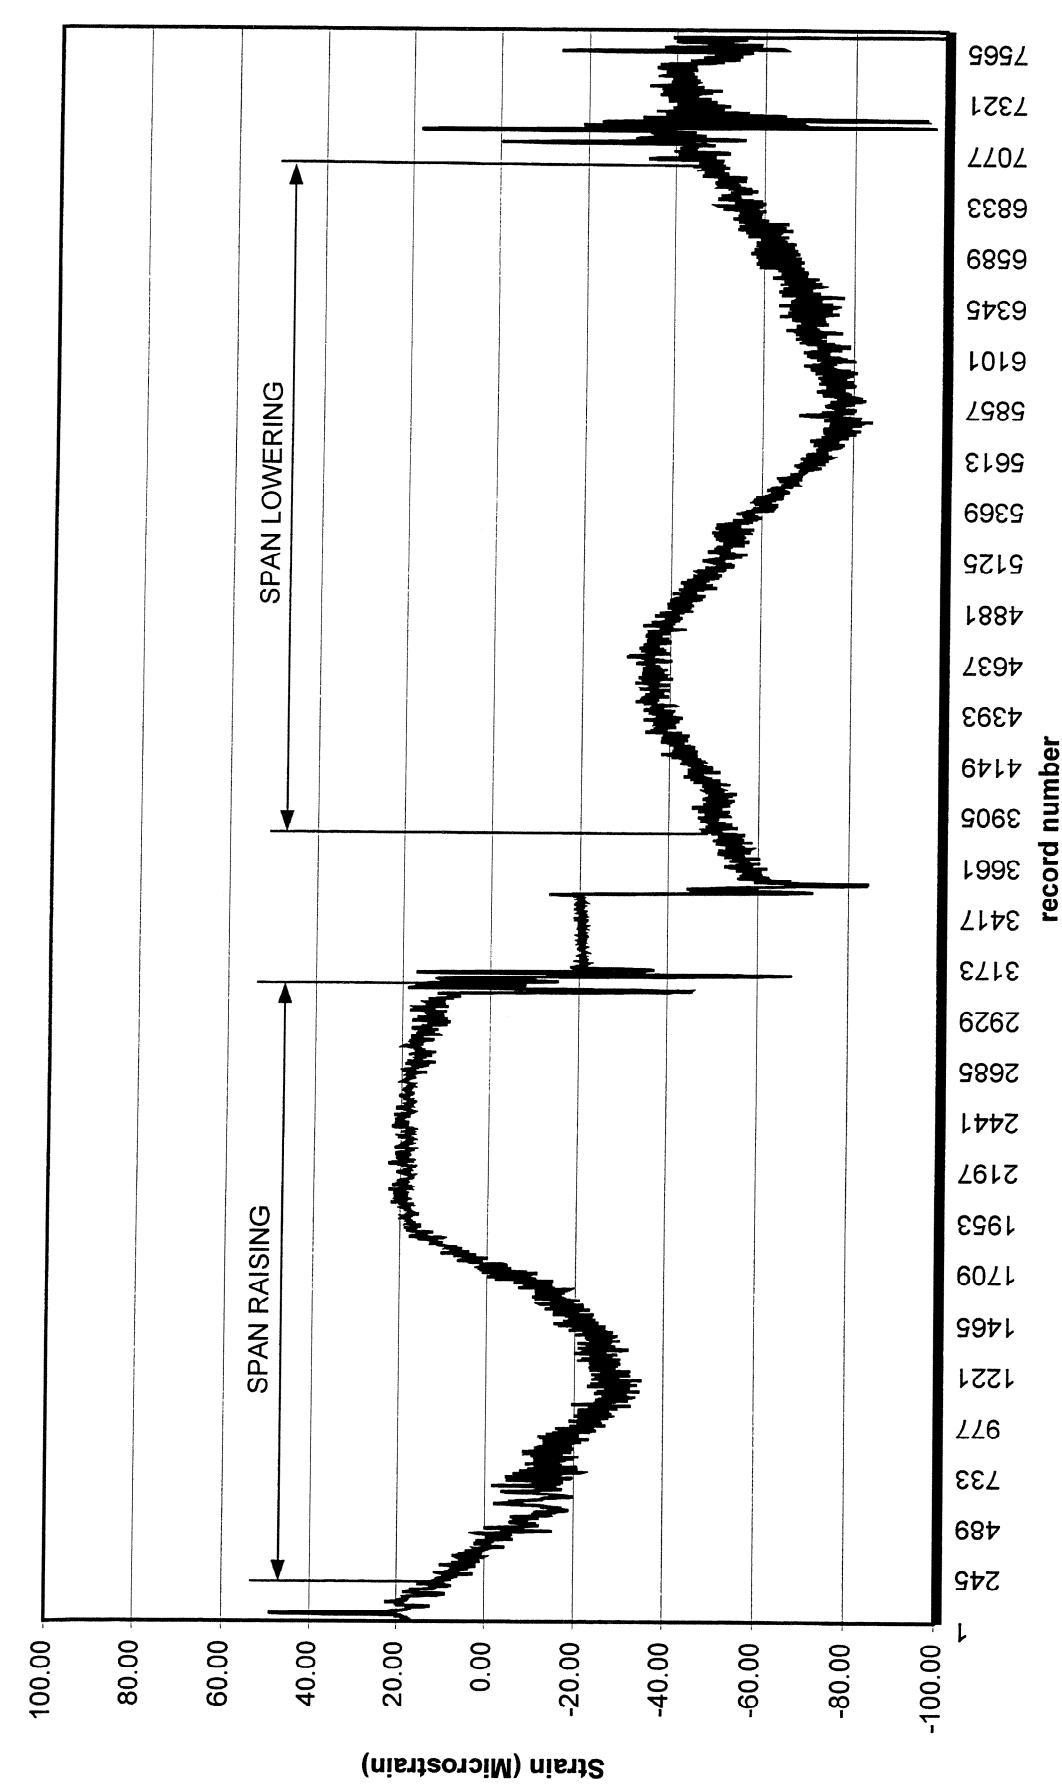
FIGURE 2 NS Bridge CD 182.30 over the Cuyahoga River Strip Chart Data - SW Corner, Run 2

The third and fourth items are apparent through comparison of the torque signature from the subject drive against a signature from a similar bridge. Figure 2 is the torque signature for NS Bridge CD182.30 discussed in Case 3. Figure 3 is the torque signature for the subject bridge. Figures 2 and 3 are located at the end of this paper. The actual balance curves are innately different for these bridges, as the curve for Figure 2 is a sinusoid and the curve for Figure 3 is linear. However, the startling difference in the amplitudes of the signatures is immediately apparent. The nominal amplitude of the signature in Figure 2 is roughly 5 microstrain. The nominal amplitude of the signature in Figure 3 varies from 5 to 80 microstrain. Discounting the effects of acceleration and deceleration, it is typical to have fluctuations in the signal due to periodic drive system events such as the meshing of gear teeth, however the nominal amplitude of the signature should be constant as seen in Figure 2. The random fluctuations in the signal apparent in Figure 3 that result in the non constant amplitude of the torque signature can only be attributed to friction.

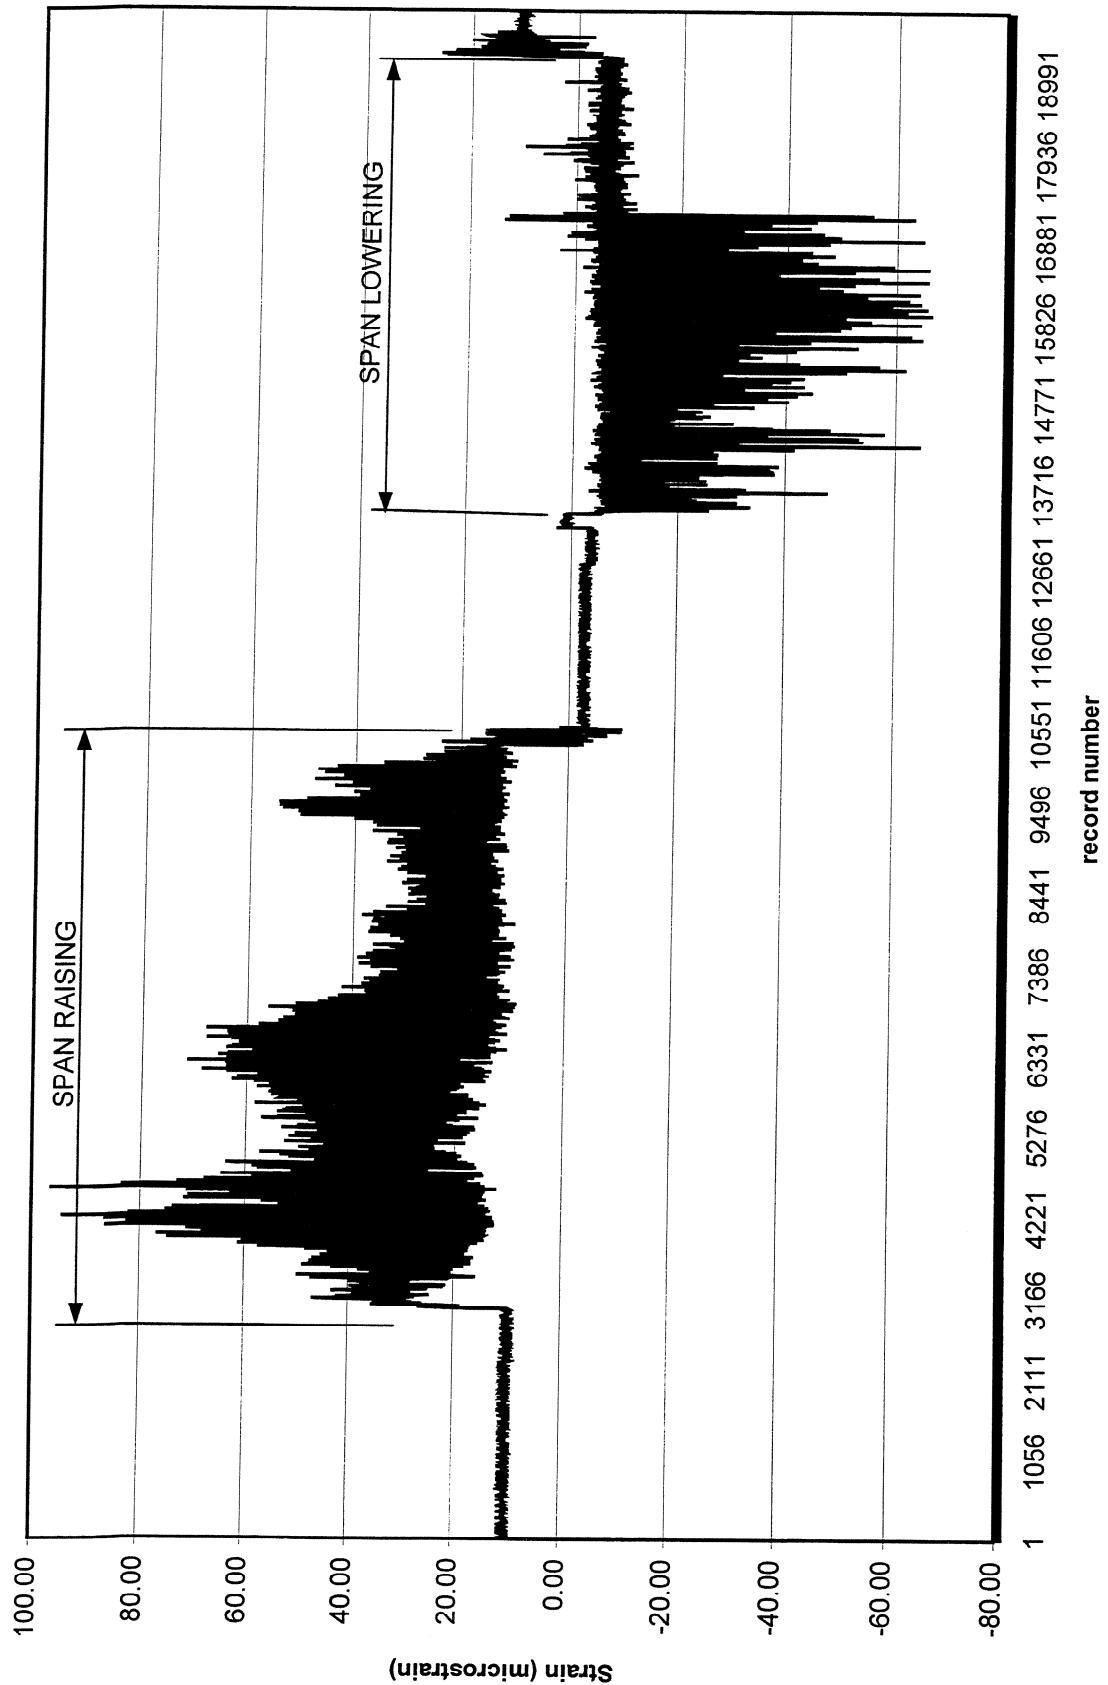
FIGURE 3 U.S. Route 1&9 Truck Bridge over the Passaic River Strip Chart Data - West Tower, North Corner

The excessive system friction was revealed through the recorded data in four ways.

- 1. Non repeatability of the magnitude of the torque signature.
- 2. Non repeatability of the general characteristic of the torque signature.
- 3. Amplitude of the torque signature.
- 4. Fluctuations in the signal.
