EIGHTH BIENNIAL SYMPOSIUM

"Replacement of the Counterweight Ropes and Sheaves on the Rio Guaiba Bridge, Porto Alegre, Brazil"

by Jeffrey D. Keyt, P.E. and John Schmid, P.E. Parsons Transportation Group and Raul Ozorio de Almeida ROCA Construction Brazil

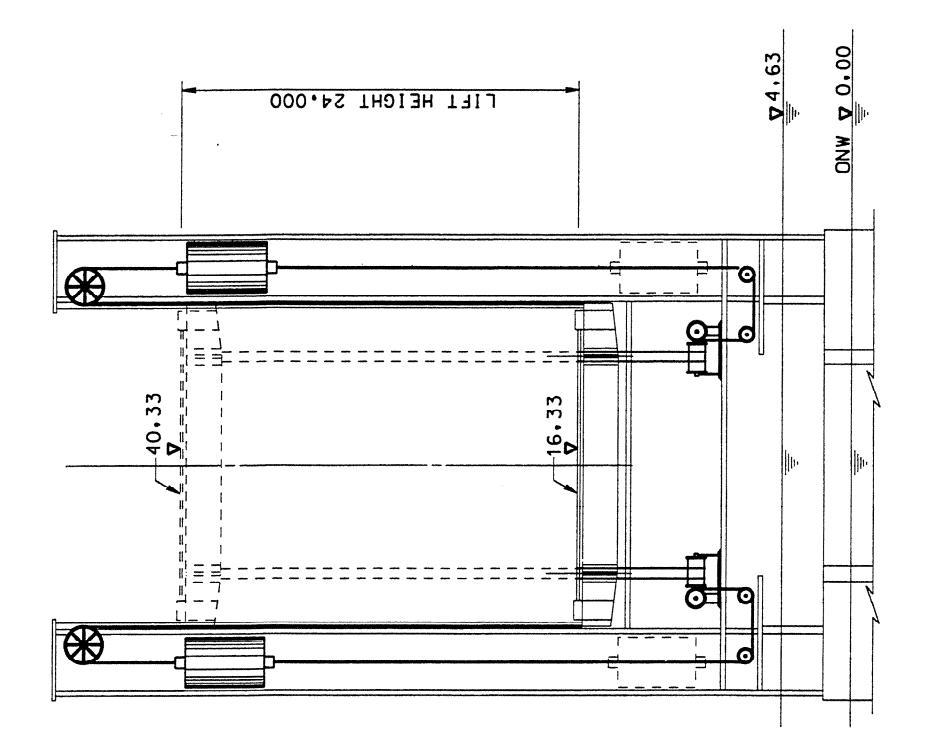
PLAN AND ELEVATION

RIO GUAIBA BRIDGE DETAILED INSPECTION OF COUNTENNEIGHT ROPES AND MECHANICAL COMPONENTS
