NINTH BIENNIAL SYMPOSIUM "Preserving Traditional Values with New Technologies"

EMERGENCY COUNTERWEIGHT SHEAVE TRUNNION REPLACEMENT AT NS BRIDGE CD182.30

Robert Tosolt, P.E. Stafford Bandlow Engineering, Inc.

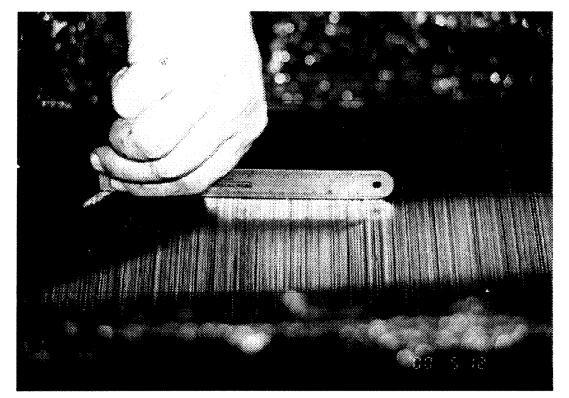
The surface finish of the journals ranged from 500 min. to 2000 min. as compared to the 8 min. finish required by AREMA for a new installation. Despite the severe abrasion of the journals, there was no readily apparent source for the wear. The lubricant appeared to be free of visible contaminants and an approximate check of bearing stress levels indicated that the bearings were designed in accordance with AREMA requirements. Given the lack of apparent sources, the following are proposed as potential sources for or contributors to the observed conditions:

Sheave Trunnion Journal: Severe abrasive wear of journal surface is evident by gaps between surface and straight edge.

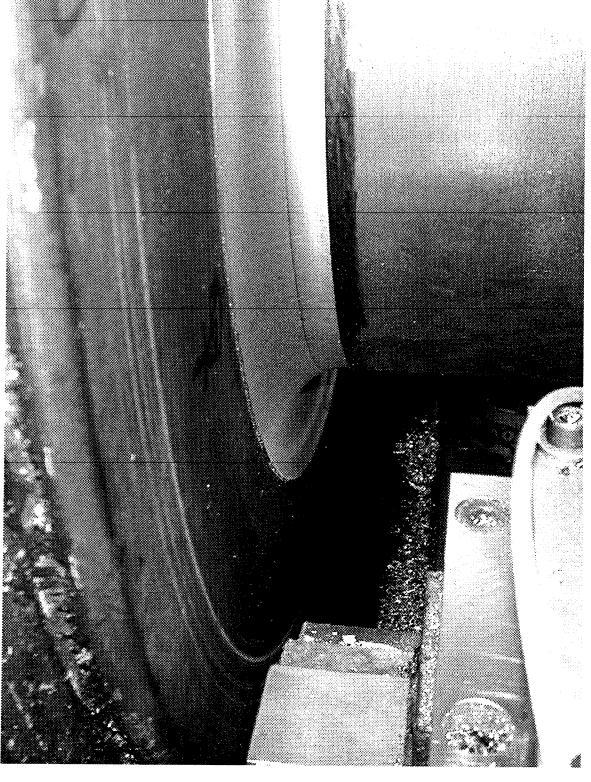
On the morning of February 07, 2002 at shift changeover, the rehabilitation of the NE sheave trunnion journals was near completion. The night shift had completed the machining operation to enlarge the fillet radius and were in the process of polishing the radius with a flapper wheel. A cursory inspection of the work to evaluate the surface finish revealed a distinct line near the toe of the fillet extending the full circumference of the outboard trunnion. The line was so uniform and distinct that two experienced machinists initially dismissed it as the interface between the sheave hub and trunnion shaft when questioned as to its origin. While aware that these fillets had tested negative for cracks during the scoping phase, little possibility existed that the visible lines were other than fatigue cracks. NDT personnel were immediately contacted to validate the visual assessment. Since a surface indication was clearly visible, the NDT technician opted to perform a Ultrasonic (UT) test using a 70 degree surface probe in order to determine the depth of propagation if the

indication was in fact a crack. The UT method verified that the observed indication was a crack as it had propagated to a depth of 5/8" to 3/4" below the surface of the journal, and that it extended the full 360 degrees about the circumference. Note that $\frac{1}{4}$ " material had been removed from the journal as part of the rehab work, therefore the observed crack had actually propagated 7/8" to $1 \frac{1}{8}$ " below the original journal surface. The fillet for the inboard journal was subsequently inspected and a crack was also confirmed at this location although less extensive than the outboard crack.
