HEAVY MOVABLE STRUCTURES, INC. FOURTEENTH BIENNIAL SYMPOSIUM

Machinery Rehabilitation at the East 11th Street Bridge over the Hylebos Creek Waterway Tacoma, Washington

Robert J. Tosolt, P.E. Stafford Bandlow Engineering, Inc.

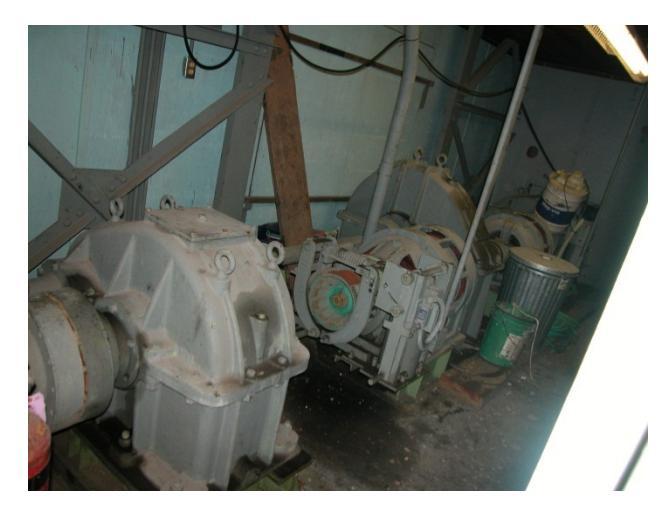
The overall condition of the existing span drive machinery was evaluated against prior inspection findings. The primary machinery is located inside an enclosed machinery room and was generally found in good condition on the West Leaf. The machinery for the East Leaf was subjected to damage from a fire which occurred following the bridge being taken out of service from the shaft failure. The fire, which was attributed to vandalism, resulted in widespread damage compromising the integrity of all components located inside the machinery enclosure.

Figure 4. Span Drive Machinery, West Leaf.

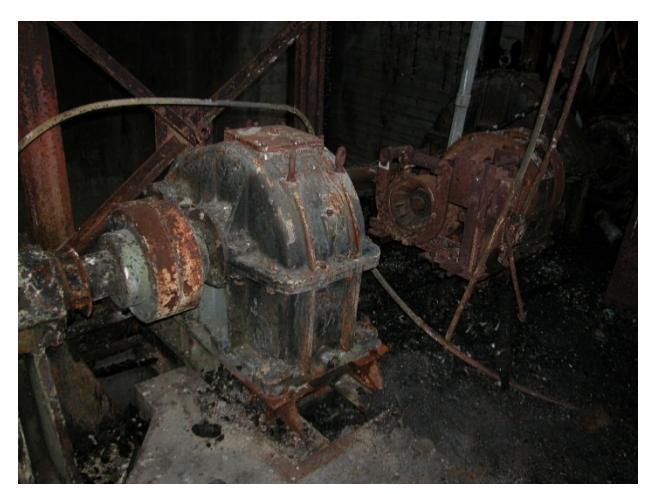
Figure 5. Span Drive Machinery, East Leaf.

As was evident in the photo for the East Leaf span drive machinery, the fire at the East Pier had consumed the machinery enclosure in its entirety so that only charred timbers remained. All steel in this vicinity, which included the trunnion bearings, showed evidence of heat exposure. A concern existed that the heat which the bearing housings were subjected to could have 'cooked' the grease and reduced it to a tacky consistency.

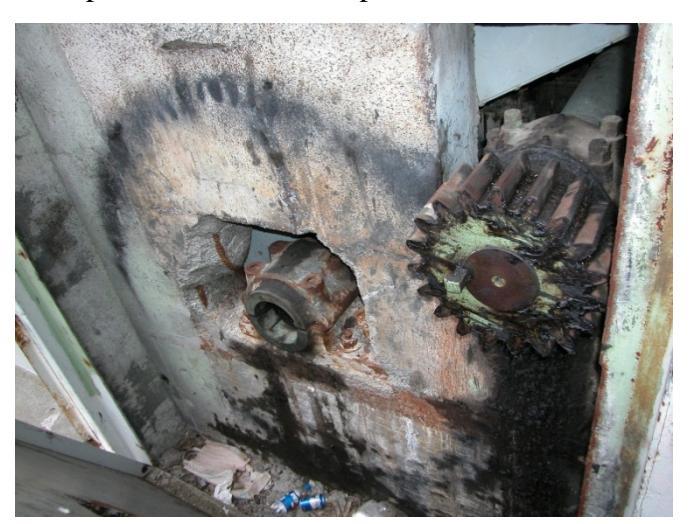
The low speed and final reduction components are located outboard of the machinery enclosure. Aside from the shaft failure at the NE rack pinion shaft, prior reports had also documented issues

Figure 6. Northeast Quadrant, Span Drive Machinery. View of missing gear where shaft failed.

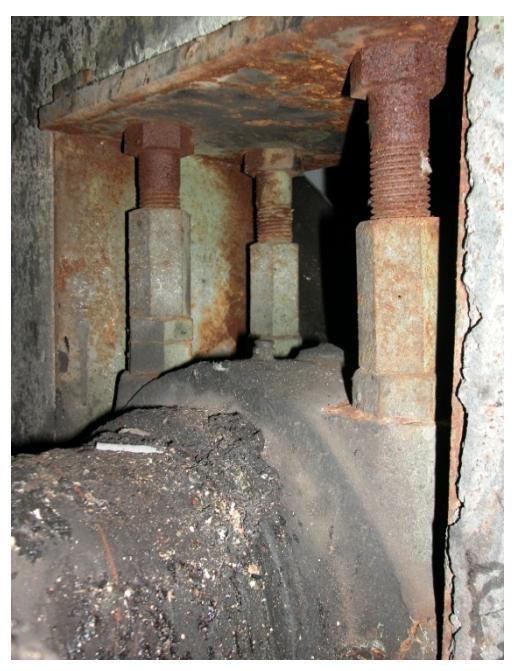
with inadequate support at the outboard rack pinion bearings, which were anchored in the pier wall. Field findings confirmed both issues. At the SE location, jack screws had been installed between the bearing cap and the top of the cutout in the pier wall to stabilize the cap.

Figure 7 Southeast Outboard Rack Pinion Bearing. Jack screws have been installed to stabilize cap.

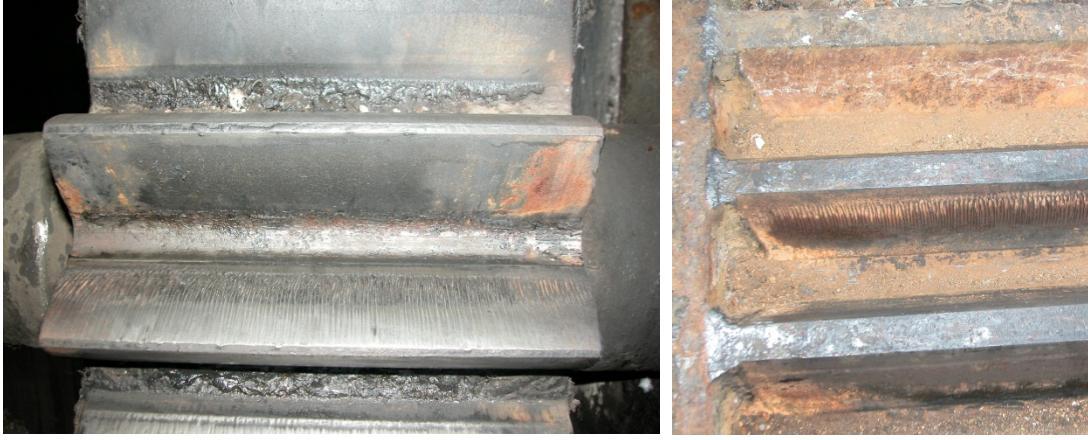
In addition to these findings, new deficiencies were noted at the main rack pinions and racks. The rack pinion teeth generally exhibited moderate plastic flow. However, several teeth on each rack pinion also exhibited severe abrasive scoring.

Due to the internal gear configuration with the span being left in the open position, all racks served as catch trays and were generally packed with water and debris. A limited number of rack teeth were cleaned to the extent necessary to verify that while the overall integrity was adequate, those teeth which mated with the severely abraded pinion teeth exhibited corresponding damage.

Figure 8. Representative Rack Pinion. Note severe abrasion evident across tooth width at bottom of photo.

Figure 9. Representative Rack. Note sever abrasive wear across tooth width at center of photo.

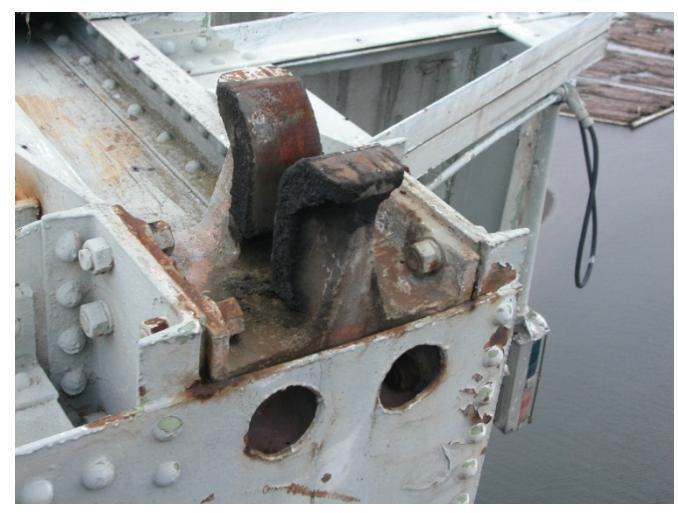
The actuating unit, at an age exceeding 30 years, had exceeded its serviceable life and was considered for replacement. While the guide and jaw castings appeared of stout construction, the original design, and the subsequent retrofit, did not provide for future adjustment of the components due to wear. Our inspection found that the retrofit wear plates exhibited deformation and that the weld repairs had failed at multiple locations. Salvage of these components was not possible.

Figure 10. Shear Lock Receiver. General View.

Based on the shortcoming of the original span lock design to incorporate wear shoes, combined with the scoping inspection finding of the failed efforts to address the wear shoe issue as part of a previous rehabilitation, re-use of the existing components was not an option. Having satisfactory experience with the shear lock design on other structures, the design team proposed to rehabilitate the shear locks to provide new guides and receivers utilizing a similar design but incorporating bronze wear shoes in both the guides and receivers with shims to facilitate initial and future adjustment. The rehabilitated system utilizes a new self-contained electro-mechanical

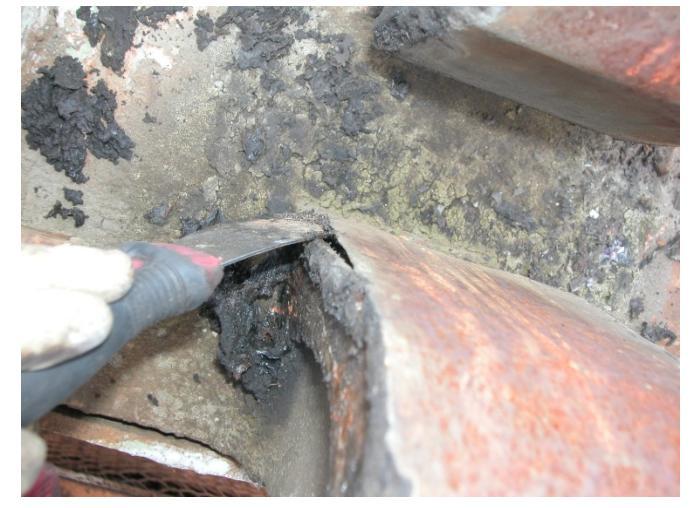
Figure 11. Shear Lock Receiver. Failed weld at wear shoe.

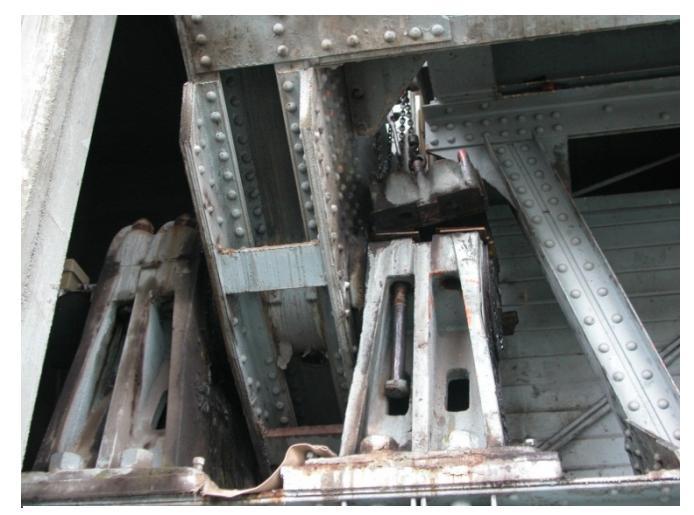
Figure 12. West Leaf. General view of trunnion bearings. Inboard (right) cap is raised for inspection.

Whereas the visual inspection of the bearings did not reveal any significant impact from the fire, the clearance measurements generated significant concern. As presented in the table, all measurements for the West Leaf (non fire damaged) bearings occurred at the top of the bearing as expected. In a heavily loaded bearing such as the trunnion bearings which support the entire dead weight of the movable leaf, the maximum clearance should exist at the top of the bearing if the bearings are well aligned to the trunnion journals.

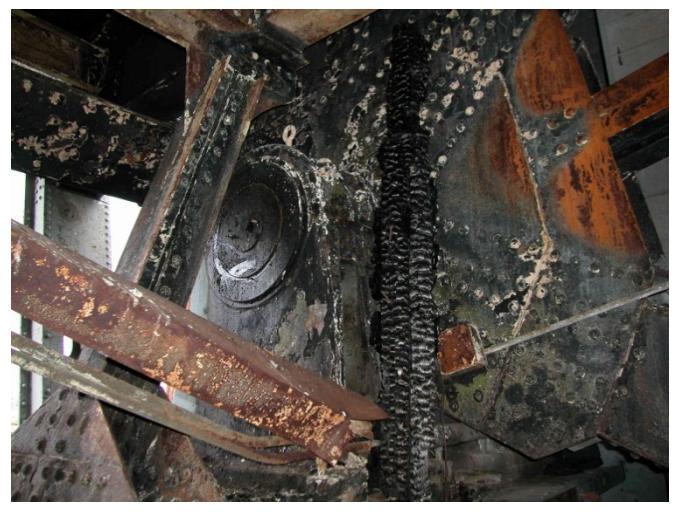
Figure 13. East Leaf. View of fire damage in vicinity of trunnion bearings.

All measurements for the East Leaf were substantially offset from the top of the bearing. In order for this condition to exist the bearing housings must be severely misaligned with the trunnion journals. The cause for this damage was attributed to structural deformation of the bearing supports from fire damage. A review of the bearing clearances suggest that the Strauss girder (trunnion support) had bowed so that the middle of the girder protruded toward the channel, which is consistent with the heat source (i.e. fire) being applied from the machinery room side of the girder. Further limited investigation provided direct evidence that the web of the support girder was bowed as indicated.

Based on the inspection findings, the trunnion bearings that support the west leaf were suitable for continued service, whereas the East Leaf trunnion bearings were not due to the fire damage.

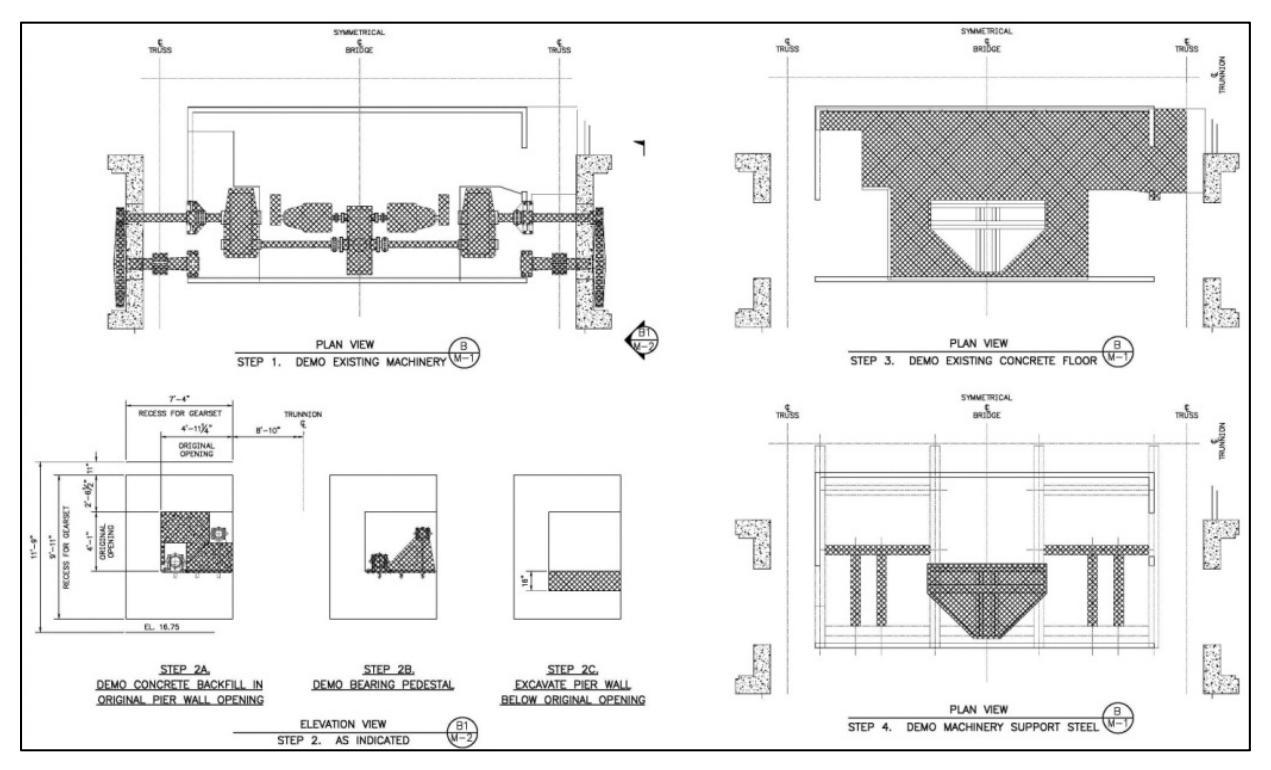
Figure 16. Removal of Existing Span Drive Machinery and Supports.

All rehabilitation concepts were based on removing all existing machinery, stripping the machinery enclosure to its primary support members (removing all paneling, demolishing the concrete flooring and secondary support members) and providing localized enlargement of the hole through the pier wall to facilitate removal of the existing bearing support shaft.

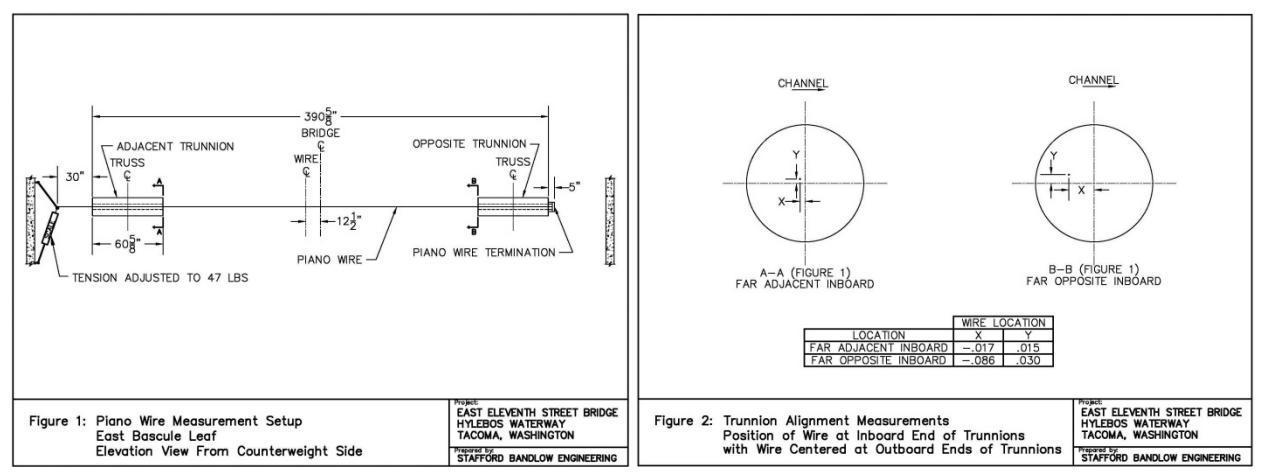
Figure 20. Piano Wire Alignment Measurement. Figure and Results

The measurements indicated that the inboard end of both trunnions were offset towards the channel in the horizontal plane and that both trunnions were offset down in the vertical plane. The measurements were consistent with the bearing clearances and observed girder deformation. While not significant from a structural perspective, the noted misalignment both with regard to magnitude and orientation is significant in terms of the function of the mechanical components. If left uncorrected the noted misalignment would contribute to localized loading of the bearings, higher contact stresses and an increase in system friction, all of which would shorten the service life of the components and would likely result in damage or failure over time. Therefore, the scope of the rehabilitation was expanded to include correction of the bearing alignment. Due to the magnitude of this task, which required the leaf to be jacked and independently supported so as to relieve load on the bearings, it was decided to replace the bearings outright to minimize any potential for scope creep and time loss should the existing bearing housings or bushings prove to have been damaged by the fire or misalignment.

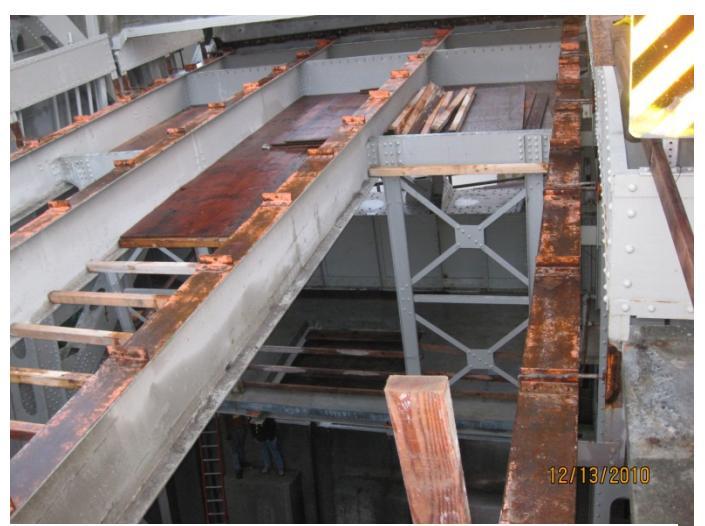
was noted, however, at the inboard pinion bearing. The problem at this bearing, which is mounted at the lower back corner of the machinery enclosure framing, is that the framing does not have sufficient rigidity to limit movement of the bearing under the design loading. The vertical support for the back end of the machinery enclosure is suspended off the overhead roadway stringers; it was determined that this framing arrangement could result in over one inch of movement of the bearing under the stringer and concentrated load imposed by the machinery design loading, an amount that is not problematic for vehicular traffic but that would be damaging to the machinery.

Figure 22. Span Drive Machinery Support Framing. View looking down on hanger for back end of machinery enclosure framing. The approach roadway has been removed from stringers during construction.

Since stabilizing the back end of the frame for the imposed load was not practical, the final span drive concept was explored.
