HEAVY MOVABLE STRUCTURES, INC. THIRTEENTH BIENNIAL SYMPOSIUM

Wilson Piggot Bridge Instrumentation and Load Testing Evaluation George C Patton, PE EC Driver & Associates, Inc.

CARIBE ROYALE RESORT ORLANDO, FLORIDA

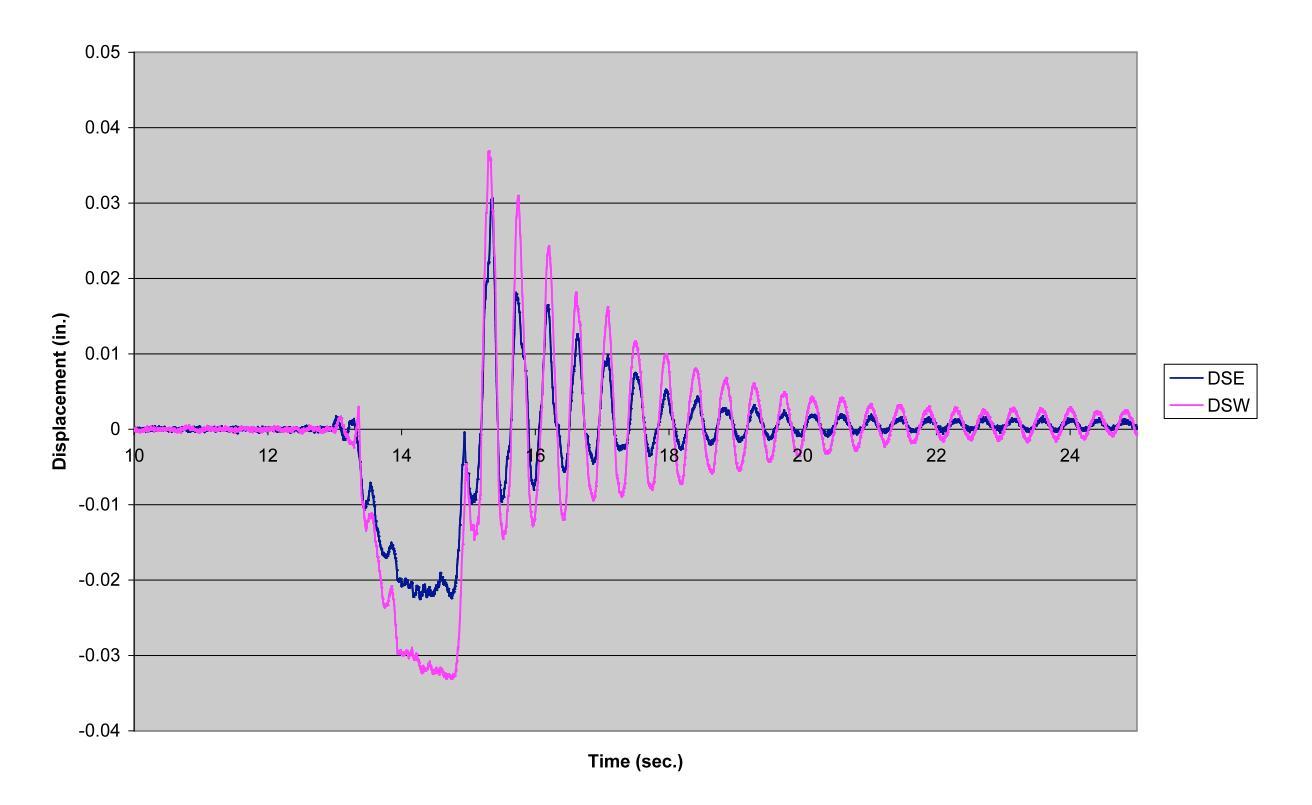
FIGURE 17: Vertical Deformation at South Leaf Bearing Stiffeners

The vertical displacements of the main girders at the live load shoes were generally found to be small (i.e. from 0.010" at NW, 0.015" at NE, 0.020" at SE and 0.030" at SW Live Load Shoes respectively.) The vertical displacement is a result of a combination of poorly adjusted live load shoes, compression of the

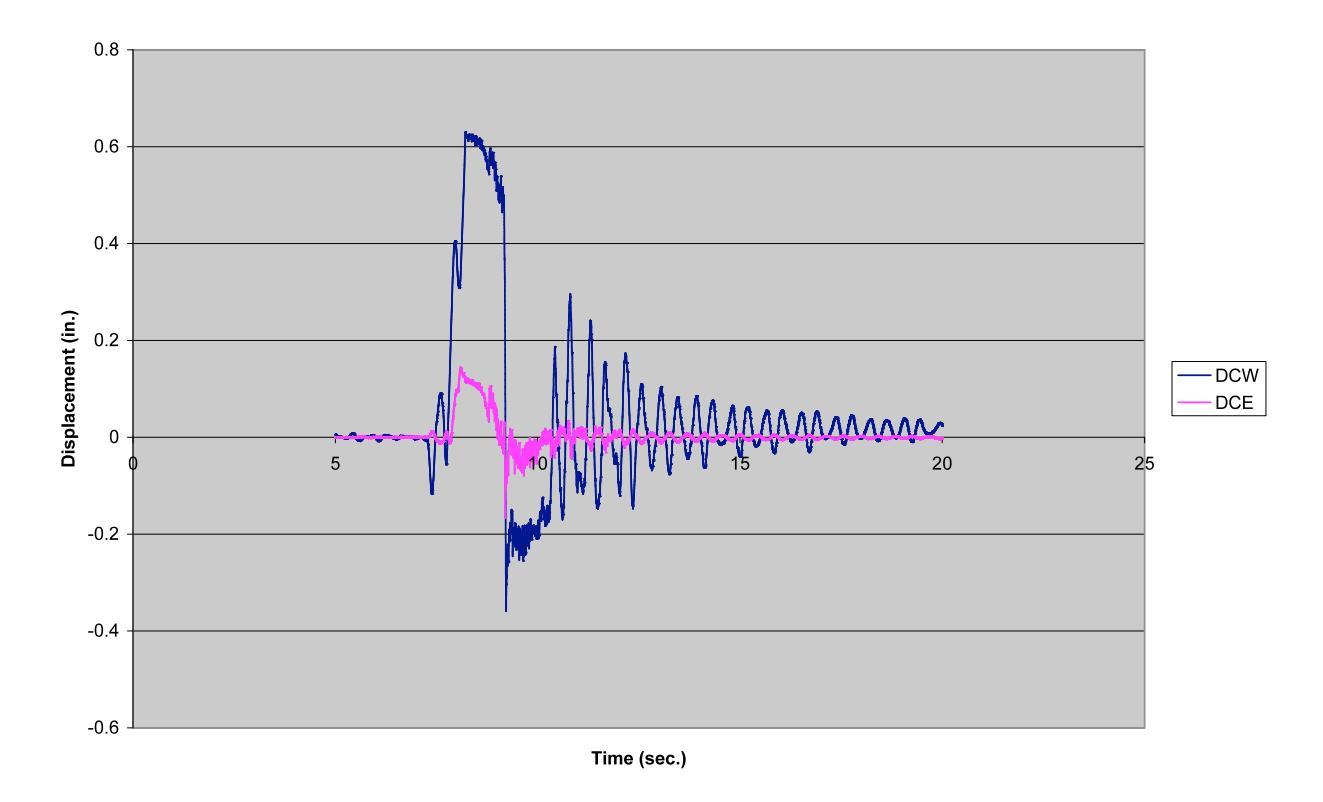
FIGURE 18: Differential Vertical Deformation at Joint between Bascule Leaves

The measured differential vertical displacements between the two leaves at the center of the bascule span were indicative of the worn and misadjusted span lock guide and receiver shoes. The west side span locks (southbound side) were found to be significantly more out of adjustment than the east side span locks. The southbound loading was observed to be generally greater than the northbound loading as the numerous heavy trucks leaving the borrow pit north of the bridge would cross the bridge fully loaded in the southbound direction and return empty in the northbound direction. The maximum differential deflection at the west side span lock was approximately 5/8" while the differential deflection at the east side span lock was approximately 1/8". The large difference in vertical displacements between the west and east sides of the leaf explains the consistently larger stress range in the west main girders than the east main girders.

The deflection of the lock bar under the load transfer reaction on the lock bar was computed and was found to be small (i.e. 0.01" which is an order of magnitude smaller than the measured displacements) and thus the differential deflection was found to be primarily the result of poorly adjusted span lock guides and receivers.

The difference in stress range between the east and west main girders due to the difference in differential deflection at the east and west span lock assemblies was found to be significant. Stress range at both the live load shoes and field splice were found to be 25% to 50% greater for the west main girders than the east main girders.

It was recommended that the span lock assemblies be replaced with new assemblies that include new preloaded, self-adjusting guides and receivers, such as the proprietary Cushionlok guide and receivers.

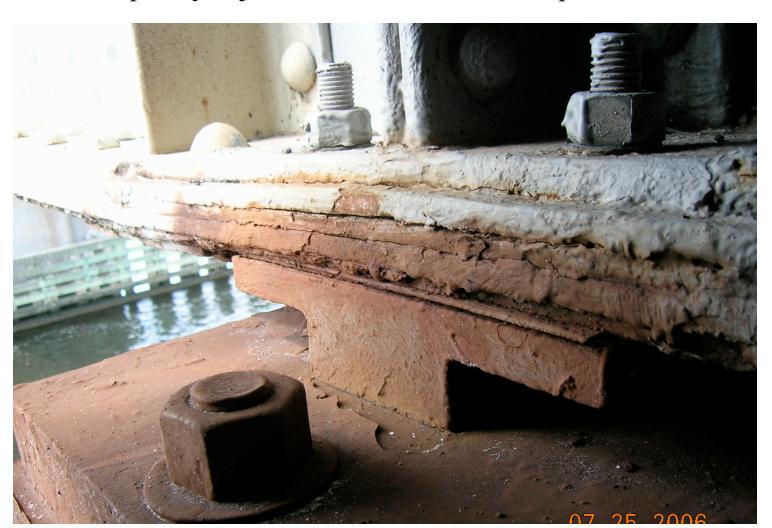
FIGURE 23: Live Load Shoe Typical Condition

slight gaps between the bottom flange cover plates, live load shoe and associated shims, and compression of the gap between the live load shoe bearing stiffener and the top of the bottom flange (see Fig. 23.) Slight closing of these gaps can be visually observed as traffic crosses the span. The gaps are a result of wear between these components following repeated heavy loading. The lack of proper pretension of the live load shoe mounting bolts was found to contribute

to the vibration and corresponding fretting corrosion between these components.

It was recommended that the worn bearing stiffeners be replaced with new heavier bearing stiffeners designed to resist current loads. Furthermore, to prevent future fretting corrosion, it was recommended that the base of the stiffeners include a tab plate bolted to the bottom flange. The significantly worn main girder bottom flange cover plates and live load shoe assembly also be replaced. Once the bottom flange rivets were replaced with high strength bolts, the pretension of the bolts prevent future fretting between the various components.
