# HEAVY MOVABLE STRUCTURES, INC. 13<sup>th</sup> BIENNIAL SYMPOSIUM

# Heavy Duty Riveted Bridge Deck AASHTO H20 Loading and Fatigue Testing

Kenneth P. Apperson, PE - Ohio Gratings Inc. Dr. Craig C. Menzemer, PhD, University of Akron

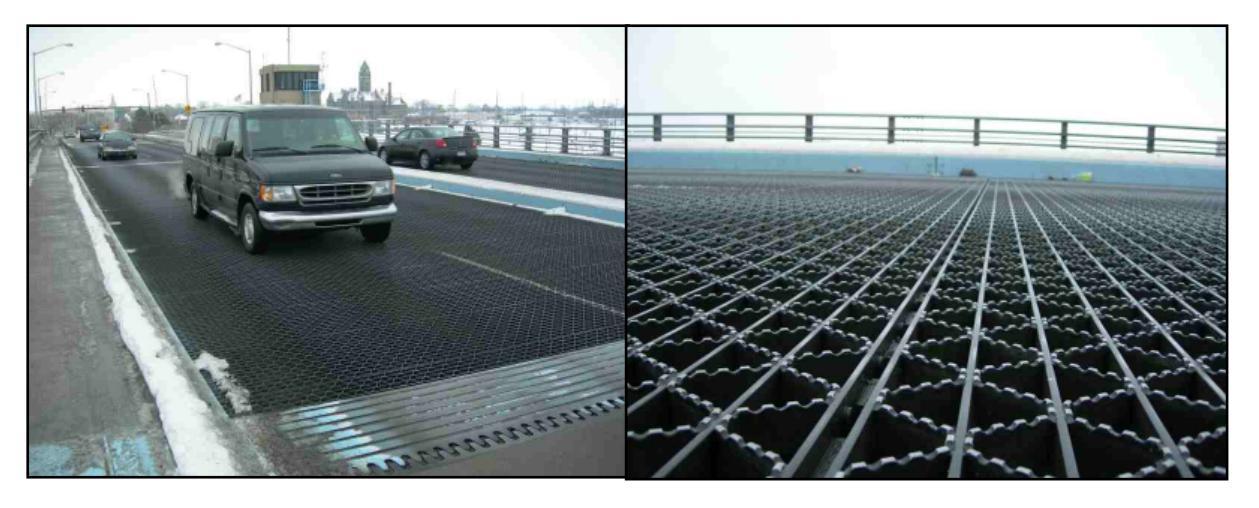
The Veterans Memorial Bridge in Bay City Michigan carries the four lane MI highway 25 over the Saginaw River. This Bascule Bridge was originally constructed in 1957. In 1994 a major renovation of the bridge included a new 5" Deep Heavy Duty Riveted Bridge Deck. The photos below were taken in February 2009. After over 15 years of service the deck is still in almost new condition.

Veteran's Memorial Bridge Bay City, Michigan Riveted Grating installed in 1994. Like new after over 15 years in service.

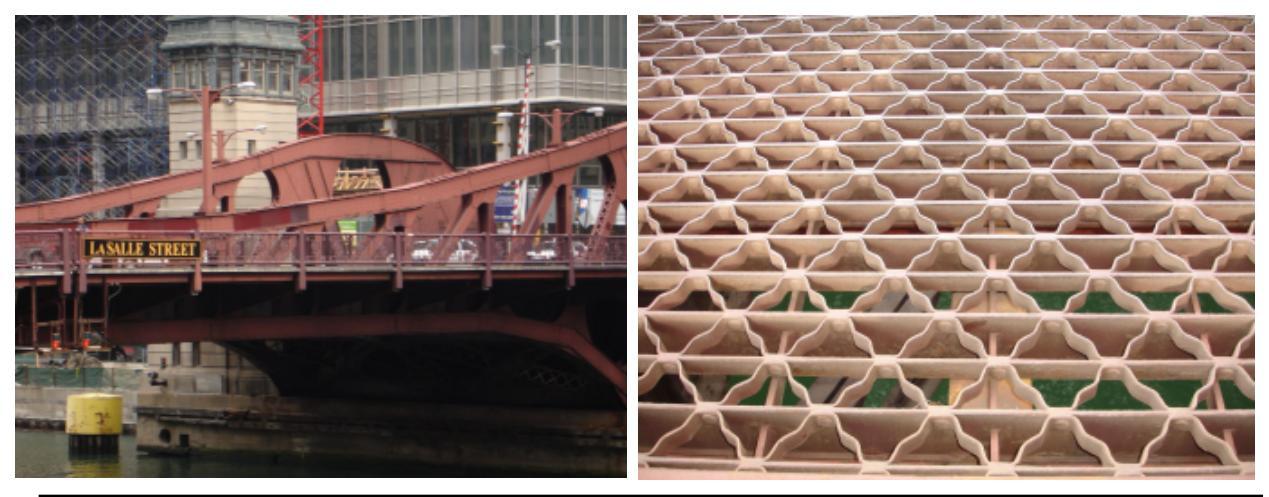
The historic LaSalle Street Bridge in the heart of Chicago was built in 1928, and a new riveted steel bridge deck was put in service during a 1971 renovation project. This busy bridge is exposed to annual average daily traffic of about 27,000 vehicles per day. An examination in June 2008, demonstrated that the riveted grating is still providing good service after over 37 years of heavy use.

The LaSalle St Bridge in Chicago, Illinois with Riveted Bridge Deck installed in 1971 is still in good condition after over 37 years in service.

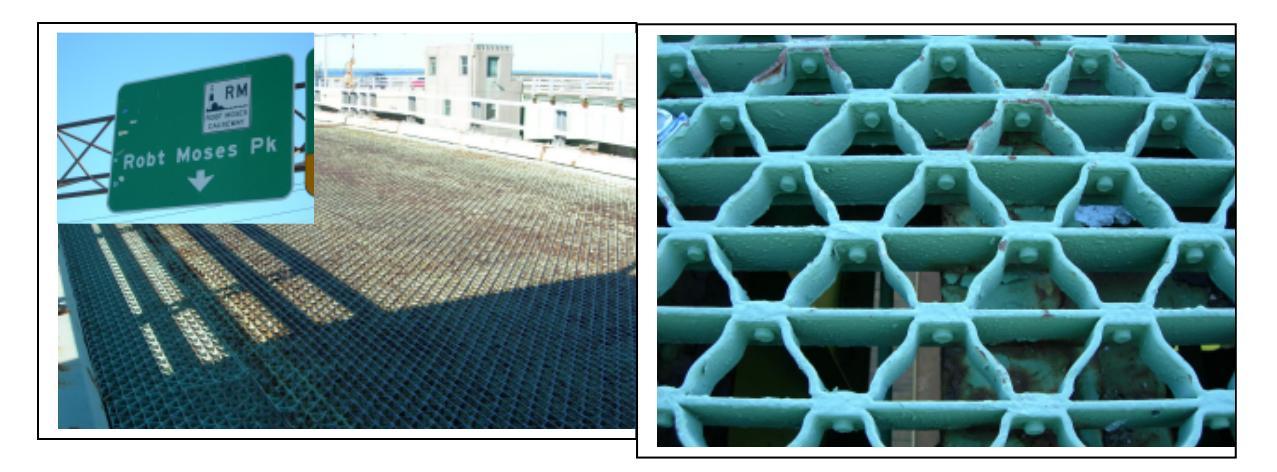
The Robert Moses Causeway Southbound Bridge at Captree State Park was built in 1951, and in 2007, when the photos below were taken; the original riveted bridge deck was still in service.

The Robert Moses Parkway Bridge in Long Island, New York with riveted steel deck installed in 1951 was still in service after 56 years.

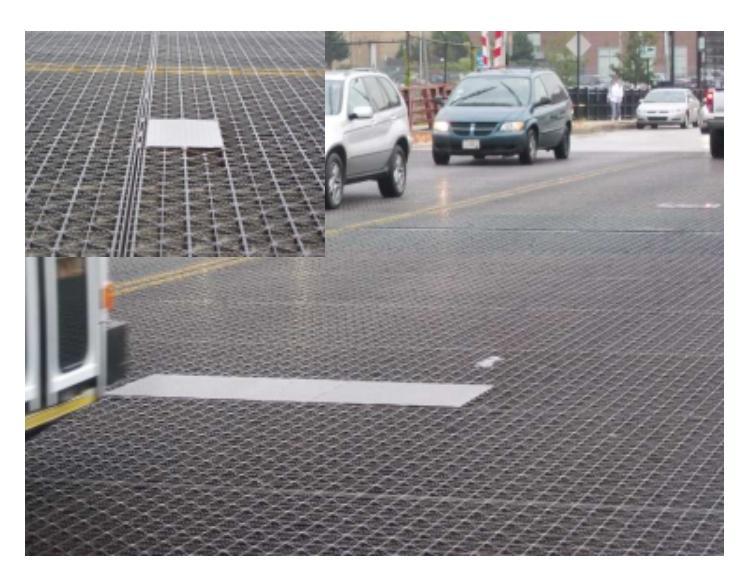
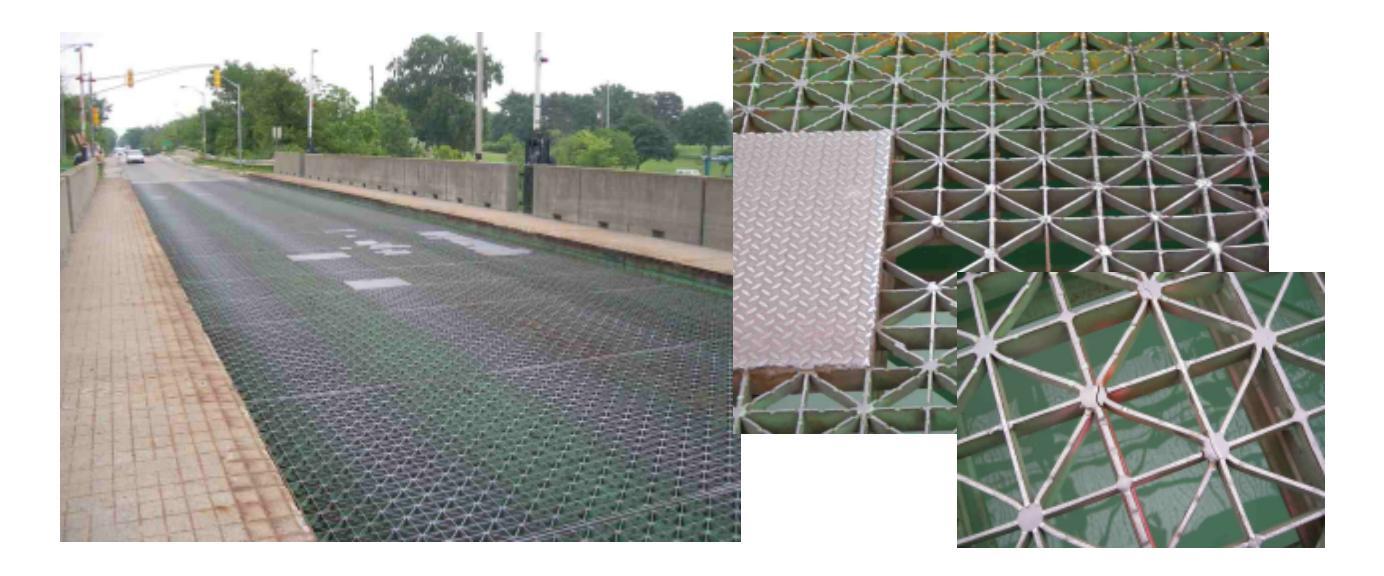
The welded type steel deck on the North Halsted Street Bridge in Chicago was installed in 1994. After less than 17 years, many of the transverse and diagonal bars have developed fatigue cracks and some bars have actually fallen out of the deck. Note the repair patch plates in several locations in the welded deck.

1930 with a concrete deck surface. In 1980 a welded steel deck was installed in order to lighten the dead load on the bridge to accommodate heavier trucks. By 2006 when the photos below were taken, many cracks had developed in the bars of the bridge deck. Some sections had so many missing bars that patch plates were required. In addition, the bridge deck was very noisy as the vehicles crossed. In 2007 the deck was replaced with a heavy duty riveted bridge deck.

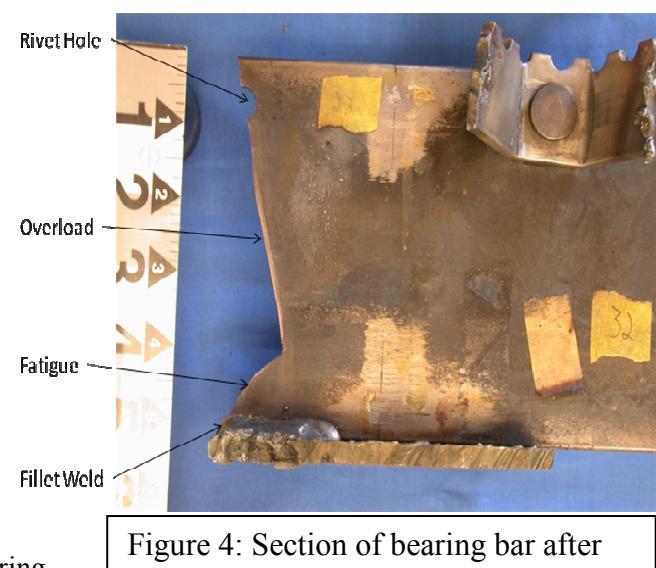
fatigue test of 37R5 Lite 5" x 1/4" steel deck.

Figure 4 shows one crack that developed during fatigue testing after 1,300,000 cycles in one of the bearing bars of the deck. The section of deck where this piece was removed was directly over the center support, or that area subjected to maximum negative bending. What is interesting to note is that the crack originated from the fillet weld used to attach the deck to the test fixture. In a number of instances, field installation would require fillet welding of the bearing bars to supporting steel. For the tests conducted in the laboratory, a plate was welded to the bottom of the

Located directly over a support, the fatigue crack that developed in Figure 4 would have experienced compression due to bending and shear. Tensile residual stress fields exist adjacent to a vast majority of weldments, due to the uneven heating and cooling that occurs during the joining process. Often these local residual stresses may be on the order of the yield point of the base metal. It is likely that the area close to the fillet weld experienced a net cyclic stress that was tensile. Inclination of the crack is most likely the result of the presence of shear as well.

Several options are available for modification of attachment system. One option is to raise the welded fastener plate closer to the neutral axis of the bearing bars as shown in figure 7. This will move the residual stress area around the welds into an area where they will be subjected to much lower levels of stress reversal during live loading. The fastener plates would then be attached to the stringers by bolted connections as shown. Another option is to use an attachment design that eliminates the need for welding

the fastener plate to the bearing bars. One way to accomplish this is to use a bearing bar angle rather than flat bar. This configuration is shown in figure 8. This method allows direct bolting of the bearing bars to the support stringers thus eliminating the welded fastener plate. The continuing research and testing program will include fatigue cycle testing with heavy duty riveted bridge deck using these alternate attachment systems.

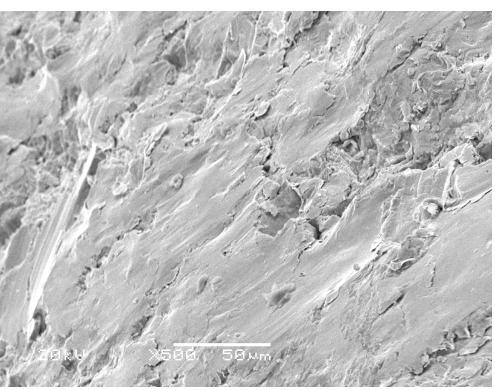
Figure 5 is a Scanning Electron Micrograph (SEM) image of the fracture surface in the area near the fillet weld. While there is a significant amount of mechanical damage from the surfaces coming into contact during negative bending, there are a series of what appear to be ridges or striations present, indicative of fatigue crack growth.

Figure 5: Area near the weld showing mechanical damage with some indication of striations.

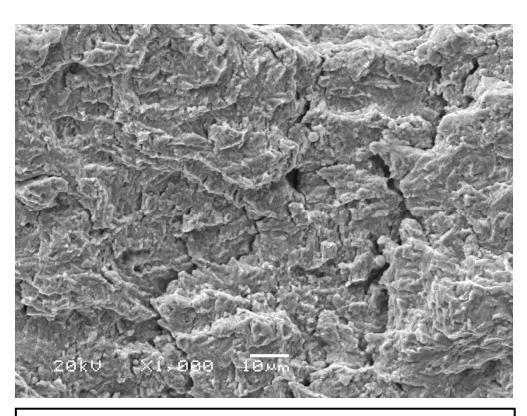
Figure 6 is an SEM micrograph taken in the overload region. The fracture surface has a rough macroscopic appearance. Upon closer examination, the matrix shows evidence of localized cracking and the formation of microvoids, indicative of tensile overload. Therefore, it is believed that the tensile fracture of this section up to the top of the grating resulted from the crack which started near the weld area. During the testing of this deck, no fatigue cracks were observed in the area of the rivet.

Figure 6: Overload region of fracture surface
