HEAVY MOVABLE STRUCTURES, INC. ELEVENTH BIENNIAL SYMPOSIUM

The Rehabilitation of a Water Control Structure – S310 Navigational Lock

Ryan Hamrick

PCL Civil Constructors, Inc.

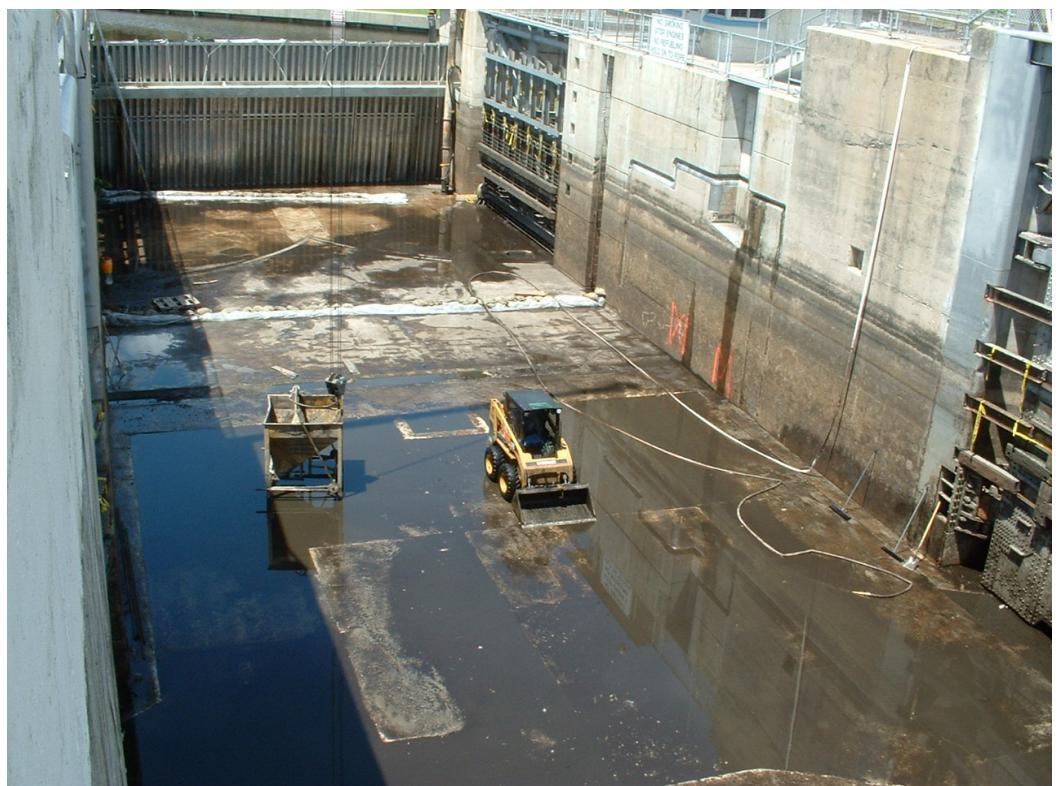
Figure 9: Dewatering and cleanup

After the water was removed, debris such as mud and fish needed to be removed. To do this, we lowered a small skid steer and concrete bucket into the lock chamber. We used a series of fire hose lines that were inside the lock to push the mud from behind the gates. We were than able to remove the debris from the main lock chamber with our equipment. It was critical that we remove this material as quickly as possible, as to allow the steel repairs to begin on the first set

The initial dewatering and debris removal process was approximately 8 days long. The dewatering maintenance process, however, continued throughout the project. Due to small leaks in the bulkheads and seepage through the lock chamber floor, water continuously collected within the lock chamber. All of the rainwater runoff from the area drained to the lock as well. This created a great deal of dewatering maintenance, especially when the coating system repairs began. It was key to have a clean, dry chamber floor with no standing water for equipment, such as jacks and rollers, as well as for a quality coating system application. To maintain the insurgent water, we placed a series of small electrical pumps within the lock chamber to move the water toward the larger four inch pumps. All of these pumps were operating the entire project, therefore maintenance of the pumps was necessary.

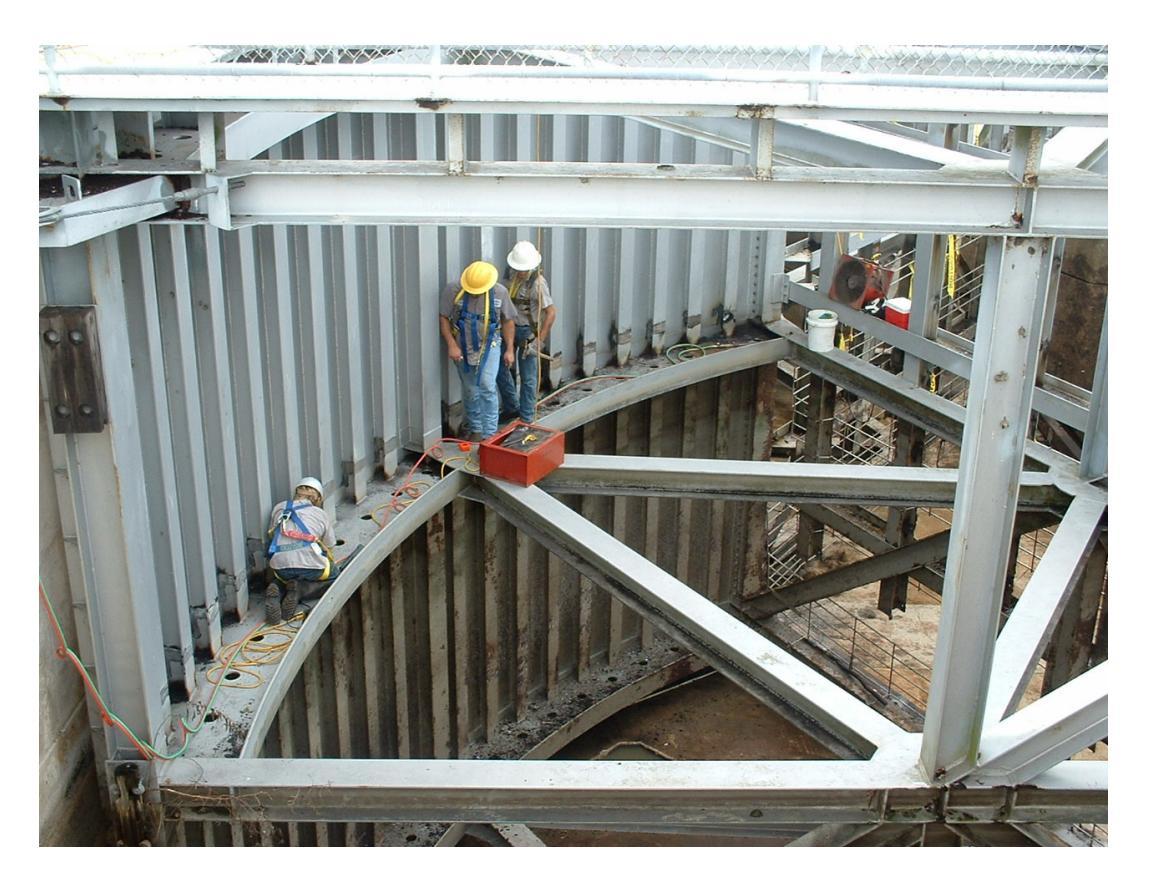
Figure 10: Gates 2 and 4 "T" Column repairs

The gate's structural steel repairs started on the two south gates, 2 and 4. The critical repairs here were scheduled to be complete in two weeks. The repairs consisted of 36 vertical "T" columns that were to be replaced at the water line (Figure 10). The bottom twelve inches of each column was removed and new pieces were welded on. The timing in which these repairs were done was very important, due to the fact that the coating system subcontractor was waiting to commence work.

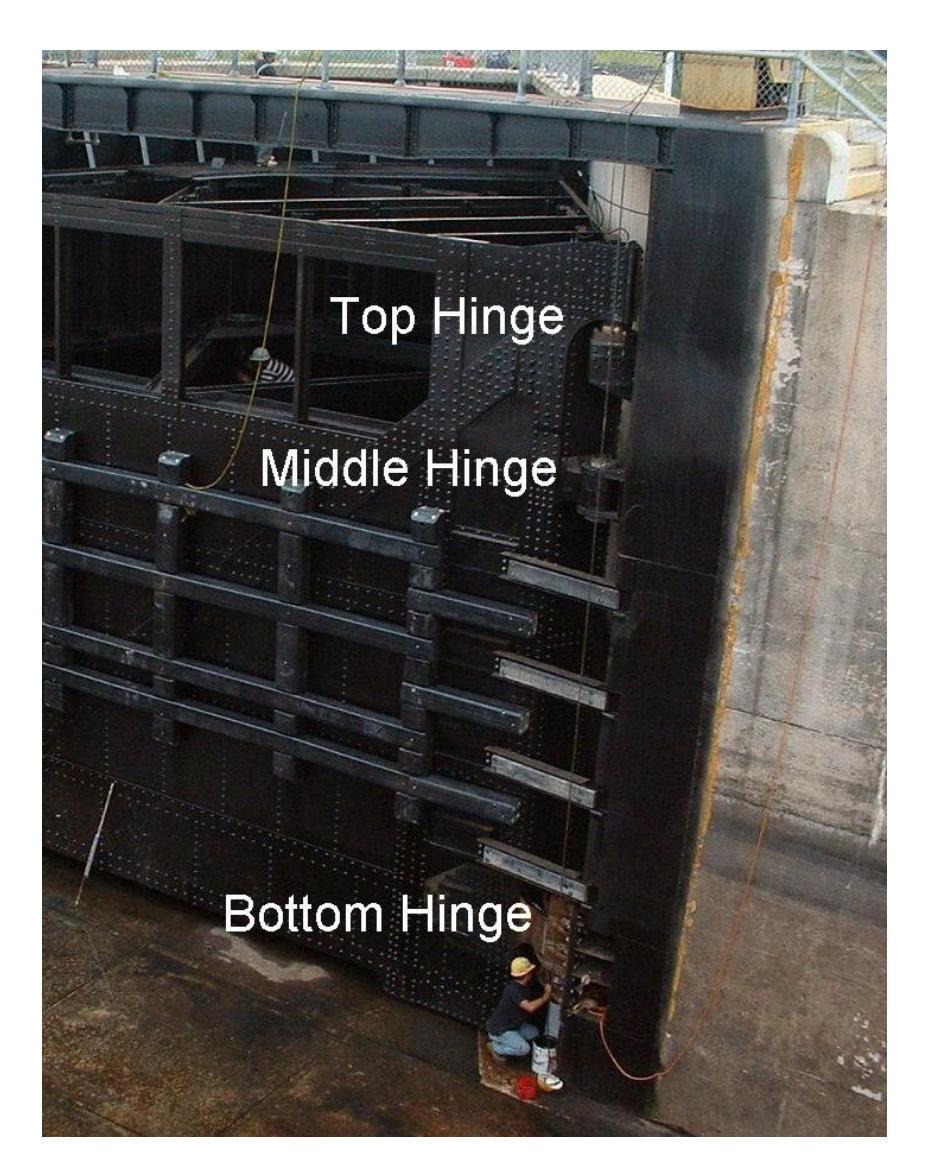
Figure 11: Hinge Layout

Each gate has three hinge locations (Figure 11), all of which were being replaced. Each hinge point is made up of a pin, casting and bushing. The bottom hinge location on each gate is the most critical and largest of the three. This hinge also carries a majority of the weight. This hinge has two separate bushings that were replaced, as well as a casting that was resurfaced and machined (Figures 12-15). The two top hinge locations received new bushings only. All three of these hinge points were critical to the project schedule because of the long lead time required for machine work.

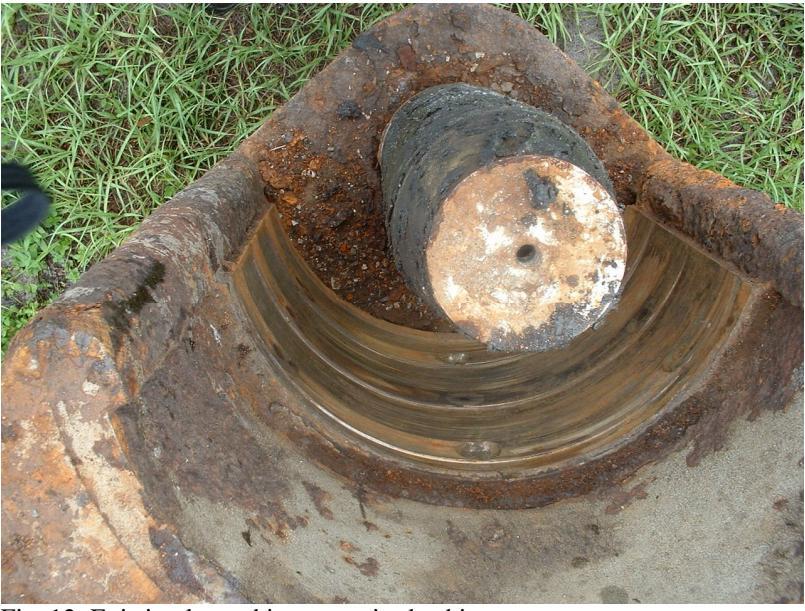
Fig. 12: Existing lower hinge exterior bushing

When the existing bushings were exposed, we found that the original design drawings did not match the current field conditions. The upper hinge bushing had an additional flange that was not indicated on the original drawings, while the lower hinge exterior bushing was half as short as indicated. Fortunately the fabricator was able to modify the molds and pour the new brass bushings without impacting the overall project schedule. The castings were machined, the brass bushings were poured and the hinges were reassembled. The reinstallation of the hinges was the final critical repair performed prior to reopening the lock structure.

The main contributing factor to why the hinges were in such bad condition was the failure of the three buoyancy tanks in each of the gates. These tanks were designed to act as a float for the gates and relieve much of the pressure from the hinges. Over time the buoyancy tanks began to leak causing them to fill with water. This added a great deal of weight to the gates, causing added strain to the hinges. In the project's original scope of work, the buoyancy tanks were to be repaired so they would hold air, therefore removing the extra strain in the hinges. Due to the severity of the buoyancy tanks and cost savings, the tanks were completely replaced rather than repaired.

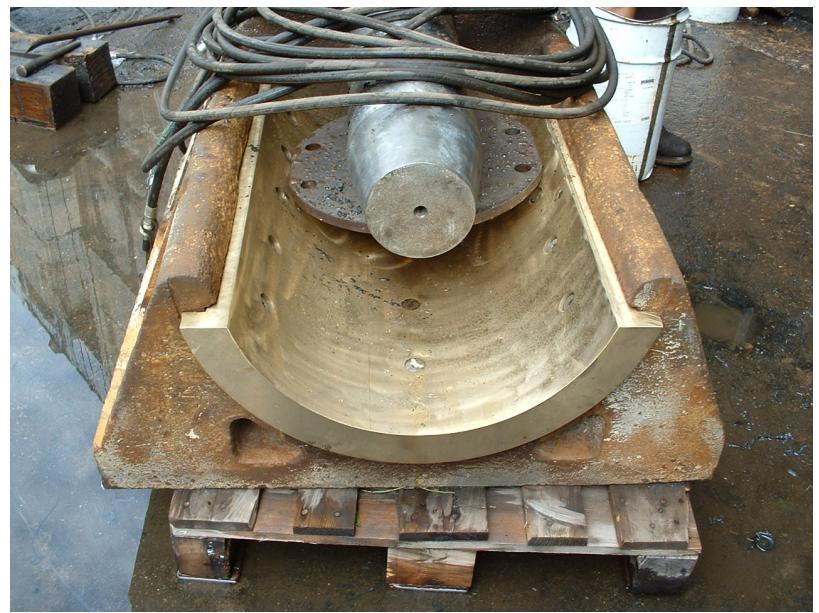
Fig. 13: New lower hinge exterior bushing

Each of the bushings required a special mold, that had to be made prior to the bushing itself. The casting for the bottom hinge had three large grooves that had developed over the years of wear and tear. These grooves had to be filled with stainless steel material and then machined to create a smooth wearing surface. This was a long lead item due to the machine work required. All of the material build up and machine work took approximately six weeks. To lessen the time delay of this, the molds for the bushings were made prior to construction. The dimensions for the molds were taken off of original design drawings. This created a significant amount of liability, due to the fact that the drawings were over 70 years old. The bushings, which were made of brass, were not poured until the existing bushing dimensions could be verified to ensure proper replacement.

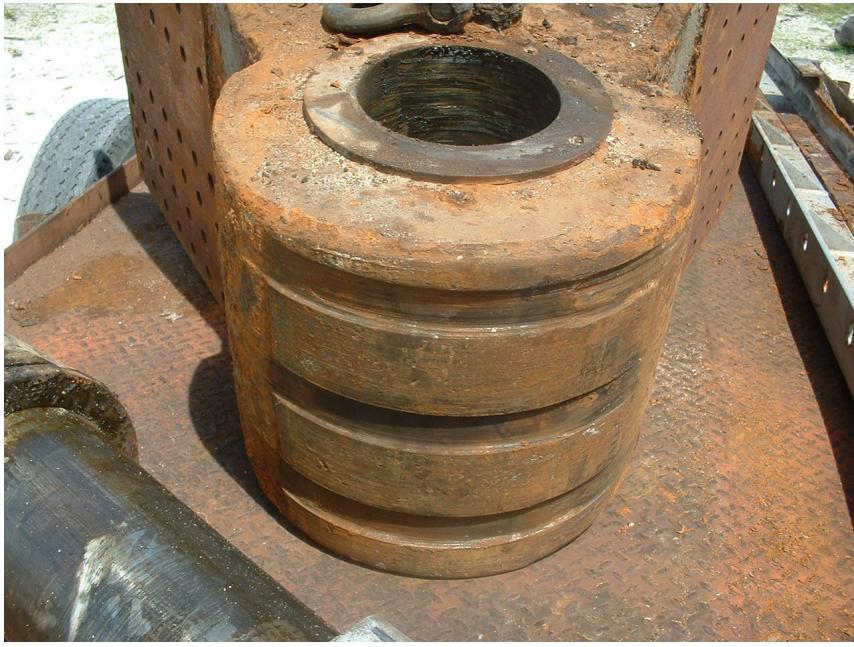
Fig. 14: Existing lower hinge casting & interior bushing

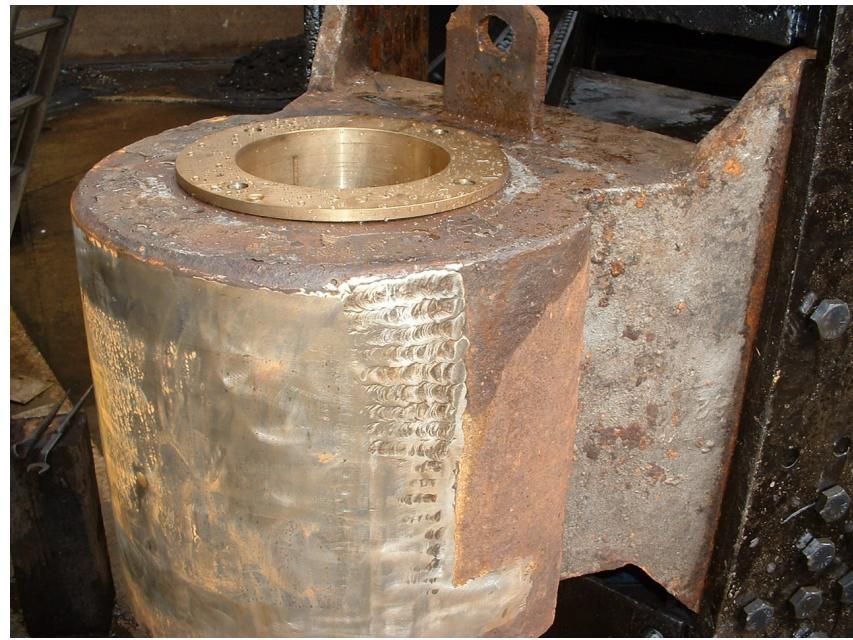
Fig. 15: New lower hinge casting & interior bushing

To ensure that the new hinges would be maintained for years to come, new lubrication systems were installed on all four gates. There had been a problem in the past where the lubrication system was no longer properly working and allowed the lubricant to leak. To alleviate the problem, a new stainless steel lubrication system was installed.

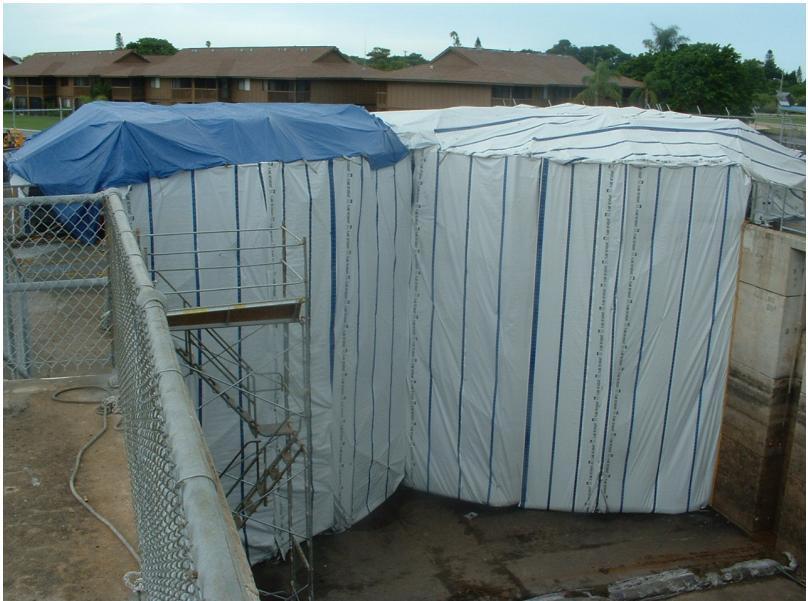
Figure 16: Gates 2 and 4 containment

The gates' coating system was extremely important due to the underwater nature of the structure. The coating process consisted of three major operations: containment, blasting and coating application. The actual coating application for this project had three levels: prime coat, intermediate coat and a final coat. The plan for the coating system was to start on gates 2 and 4, following the structural steel repairs on the gates. The containment was a combination of scaffolding and several layers of tarps, which were constructed to enclose both gates at the same time. The containment system was necessary due to the contract documents stating that lead paint was used on the existing structure. The containment was also used to prevent overspray and reduce the noise from the blasting and coating procedures. All coating procedures followed the Steel Structures Painting Council (SSPC) Guide 6-Class 2A. The coating subcontractor was QP-1 and QP-2 certified for coating and lead abatement.

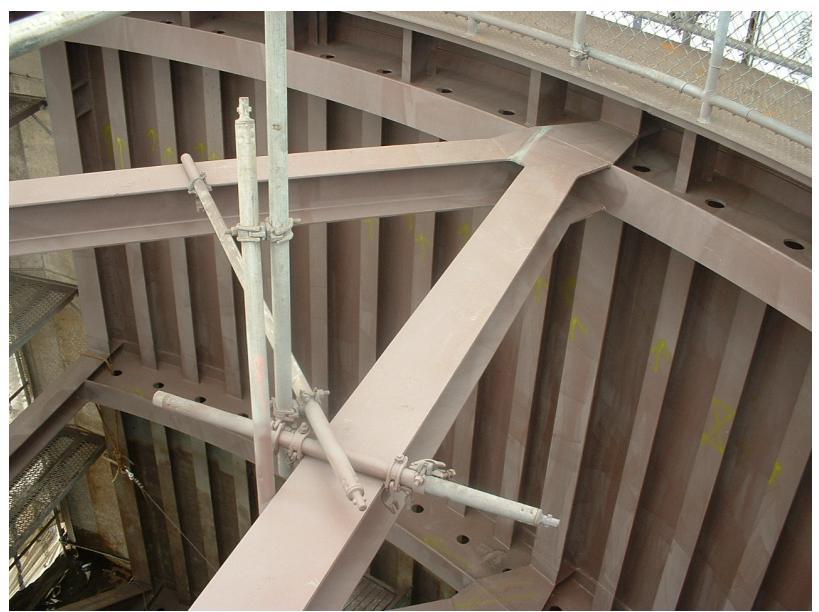
Figure 17: Prime coat application

Once the containment system was constructed, blasting procedures began. The blasting process removed all the existing paint from the structure and exposed the metal to a near white finish. Throughout the blasting process, and all coating procedures, a certified NACE inspector monitored and documented all activities. The inspector documented hundreds of measurements that recorded dry film thicknesses. There was a given tolerance that each coating application had to be within. Following the blasting was the application of the prime coat. In this particular system, the intermediate coat and the final were the same product and application. There had to be two separate coats because neither coat could be applied too thick. It was very important that the coats be applied within the given tolerances to create a good bond. The prime coat was applied, allowed the appropriate time to cure, and then the intermediate coat was applied. All of

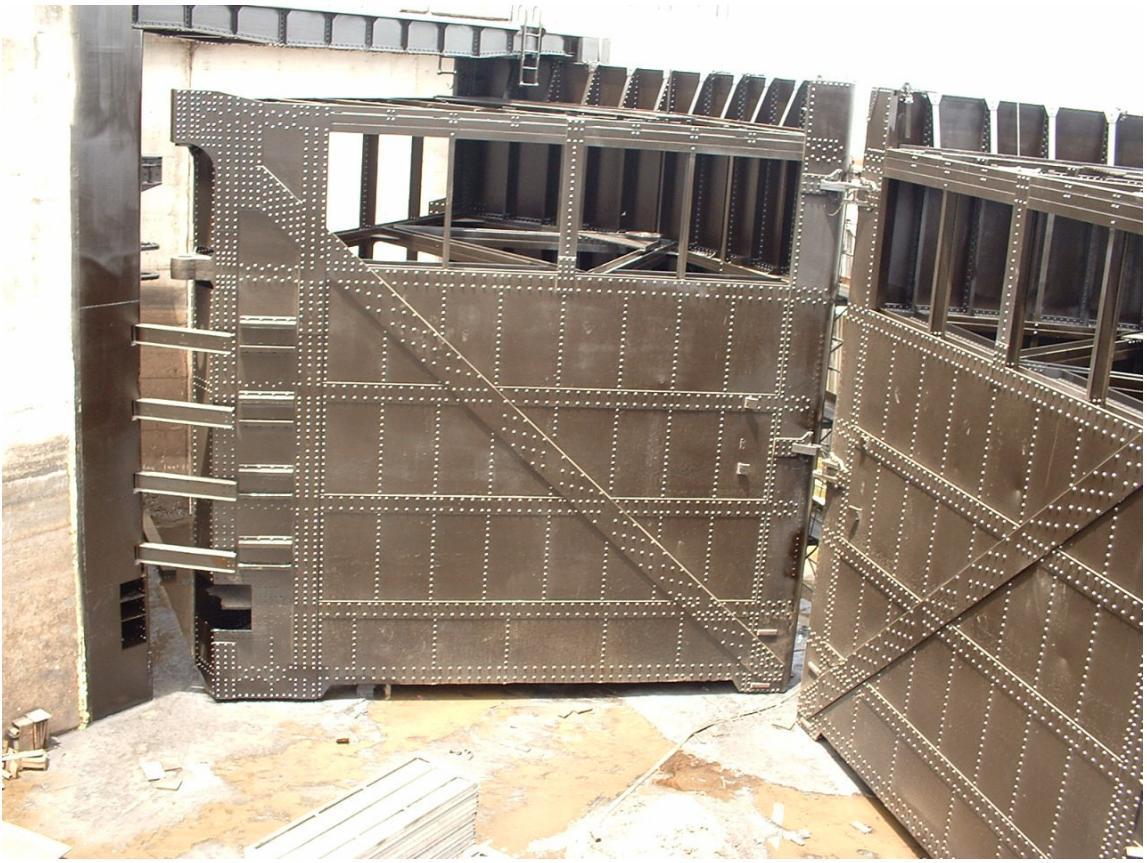
Figure 18: Gates 1 and 3 final coat

From the time of containment construction to coating system completion on gates 2 and 4, was approximately four weeks. During this time, the structural steel and mechanical repairs had progressed according to schedule, so the coating application could now begin on gates 1 and 3. The containment system was removed from the first two gates and installed over the two remaining gates. The coating system process was then repeated on the new gates, however new challenges were presented for this process. Large amounts of rainfall begin to occur on a daily basis, severely hampering the coating system progress. The coating subcontractor rushed to maintain the schedule, while being mindful of the quality of workmanship. Along with rainfall contributing to delays, was the threat of a major hurricane. Preparations for the oncoming hurricane were being made while the final coat for gates 1 and 3 was being applied. There was no time for final thickness readings to be taken, due to the containment system needing to be removed for safety reasons during the storm. Because of this, there were significantly more touch up areas on gates 1 and 3.
