# HEAVY MOVABLE STRUCTURES, INC. ELEVENTH BIENNIAL SYMPOSIUM

# CHALLENGES OF A DESIGN-BUILD BASCULE BRIDGE REHABILITATION

Caleb Linn PCL Civil Constructors, Inc.

The NE 14<sup>th</sup> Street Causeway (Figure 1) is a four lane, two span hydraulic bascule bridge carrying traffic over the Atlantic Intracoastal Waterway in Pompano Beach, Florida. In March of 2005, the Florida

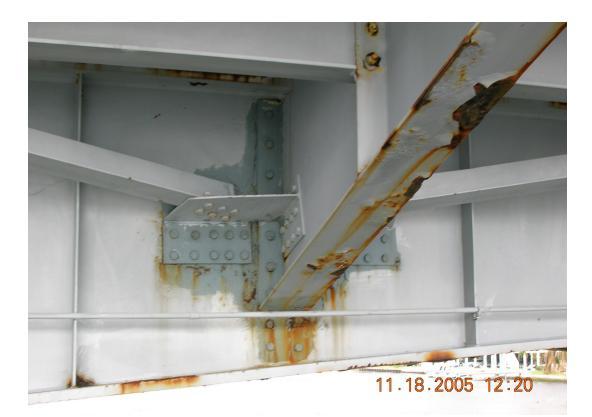
group conducted multiple visual inspections revealing flexing of the girder web and severe deterioration on the fracture critical weld connecting the floor beam to the main girder. As a result of the investigation, the bridge was immediately closed to vehicular traffic to ensure the safety of the public was not compromised.

Figure 14a. Existing connection plates conceal deterioration on the main girder.

After closing the roadway, H&H calculated a conservative connection capacity based on the estimated deterioration of the fracture critical weld, and the section loss in the girder web. The calculation revealed that the connection was marginally adequate to carry vehicles. The parties involved in the investigation held a meeting and decided it was prudent to ascertain the condition of each of the fracture critical floor beam connections prior to reopening the bridge.

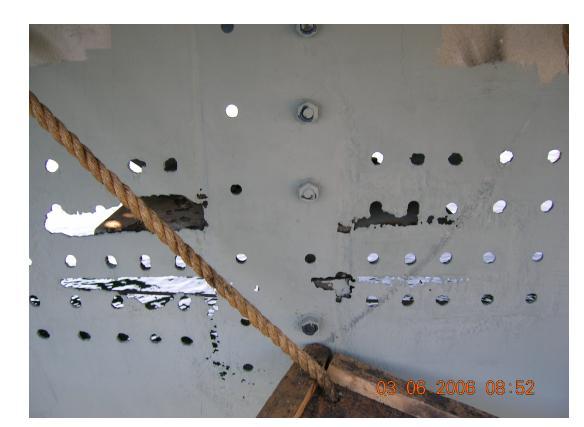
Figure 14b. Sidewalk bracket removed exposing main girder deterioration.

- 1. Remove existing sidewalk bracket.
- 2. Power tool clean main girder web to expose extent of steel deterioration/corrosion.
- 3. Engineer of Record inspect deteriorated/corroded main girder web to determine limits of 3/8" thick cover plate.
- 4. Drill 15/16" diameter holes in main girder web for cover plate connection.
- 5. Fill pitted areas of main girder web to be covered by plate with FDOT approved metal epoxy compound.
- 6. Apply zinc primer to area of main girder web to be covered by 3/8" thick plate.
- 7. Install 3/8" thick steel cover plate.
- 8. Install new sidewalk bracket.

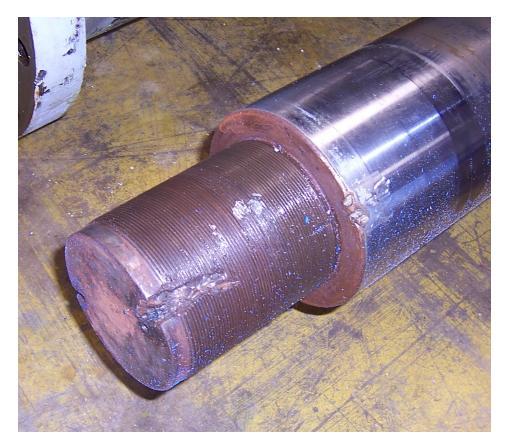
1) Two areas of damage caused by flame cutting were discovered on one of the cylinder rods (Figure 19).

Figure 19. Damage to cylinder rod.

To resolve the issues, the team met with the owner to discuss possible repair procedures. It was determined that the damage to the rod thread did not compromise the structural integrity of the cylinder rod and no further action was required. To repair the other damaged area of the rod, the team decided to feather the edges of the plating and damaged substrate such that there would be no sharp edges to exacerbate delaminating of the plating. The team also determined it would be necessary to machine two pistons to match the two pistons previously undercut to allow fluid to pass.

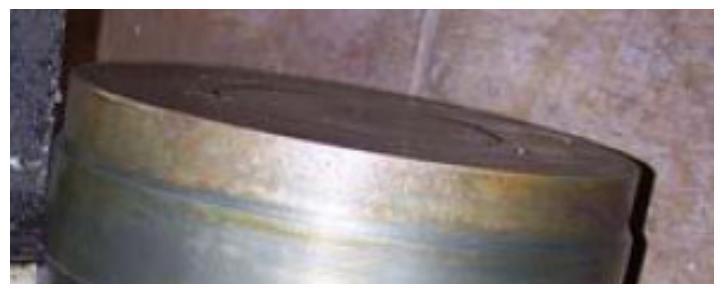
2) Two of the four cylinders had additional machining on the piston to allow oil on the cap end of the cylinder to vent out the cap port (Figure 20). The two cylinders without this machining completely covered and thus sealed the cap port. This trapped fluid at the bottom of the cylinder, preventing full retraction of the cylinder.

Figure 20. Machining on piston allowed fluid to cap port.

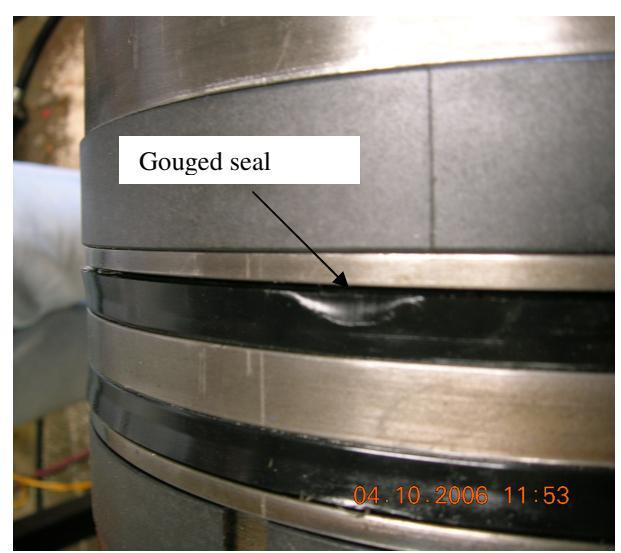
Figure 21. Refurbished seals display gouging after testing of the cylinders.

Once the four cylinders were refurbished, including the additional repairs necessary due to the unforeseen conditions of the cylinders, final testing was performed to ensure the cylinders were operating properly. During this testing, excessive leakage was witnessed in each of the four cylinders. Hydradyne Hydraulics again dissembled the cylinders to try to determine the cause for the leakage. Upon disassembly, gouging of the piston seals was revealed (Figure 21). Hydradyne determined that the damage to the piston seal was caused by sharp edges in the cylinder tube where the rod port and rod gauge port enter the tube. This was another unforeseen condition that had to be repaired by rounding the edges of each port hole in the tube and again replacing the piston seals. Once this work was completed, the cylinders were re-tested and approved for reinstallation.

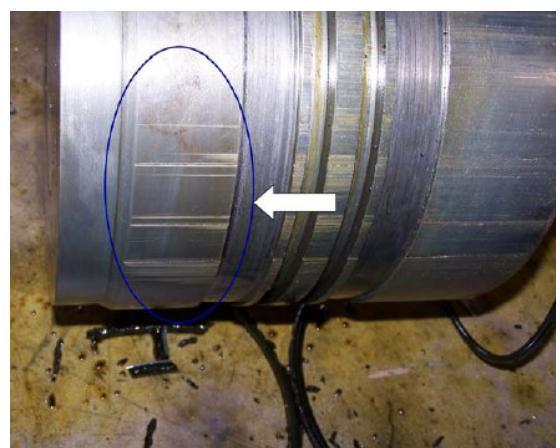
1) Heavy longitudinal scoring of the cylinder barrel and piston circumference was discovered on two of the cylinders (Figure 22).

Figure 22. Scoring of piston.

To resolve the final two issues with the cylinders, the team again held discussions with the owner to determine a repair. The group decided to hone the damaged cylinder barrels, which would increase the

barrel inside diameter by a minimum of 0.03 in. and thus require new oversized pistons and seals for the cylinders to operate properly. Of greater concern was that the cylinder rod with nickel-chrome damage would need to be re-plated. The nickel-chrome required for the re-plating has a minimum (30) week lead time, which would not allow the repair to be completed before the contract end date. The team is currently working with the owner to determine the extent to which this rod will be repaired.

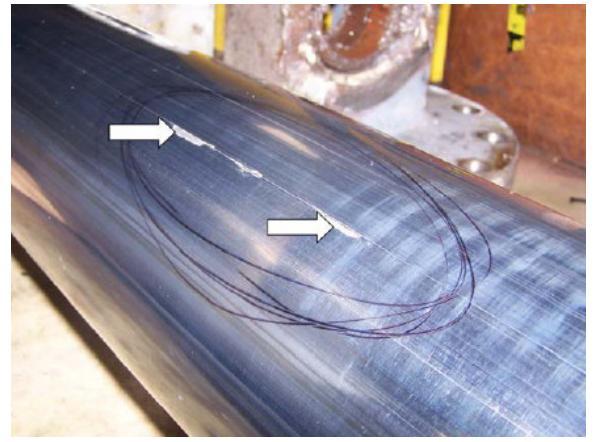
2) On one of the cylinders with longitudinal scoring, the nickel-chrome plating had failed in three locations on the cylinder rod, exposing the substrate beneath (Figure 23). In addition to the failure, several other areas displayed plating delaminated from the substrate resulting in a "bubble" in the plating.

Figure 23. Nickel-chrome plating damage.
