HEAVY MOVABLE STRUCTURES, INC. THIRTEENTH BIENNIAL SYMPOSIUM

Link Arm Repair and Counterweight Hanger Fatigue Strengthening for Long Island's South Shore Bascule Bridges

Ronald Kudla, P.E. NYSDOT Director of Bridge Maintenance for Region 10

> Dennis Biegel, P.E. STV Incorporated

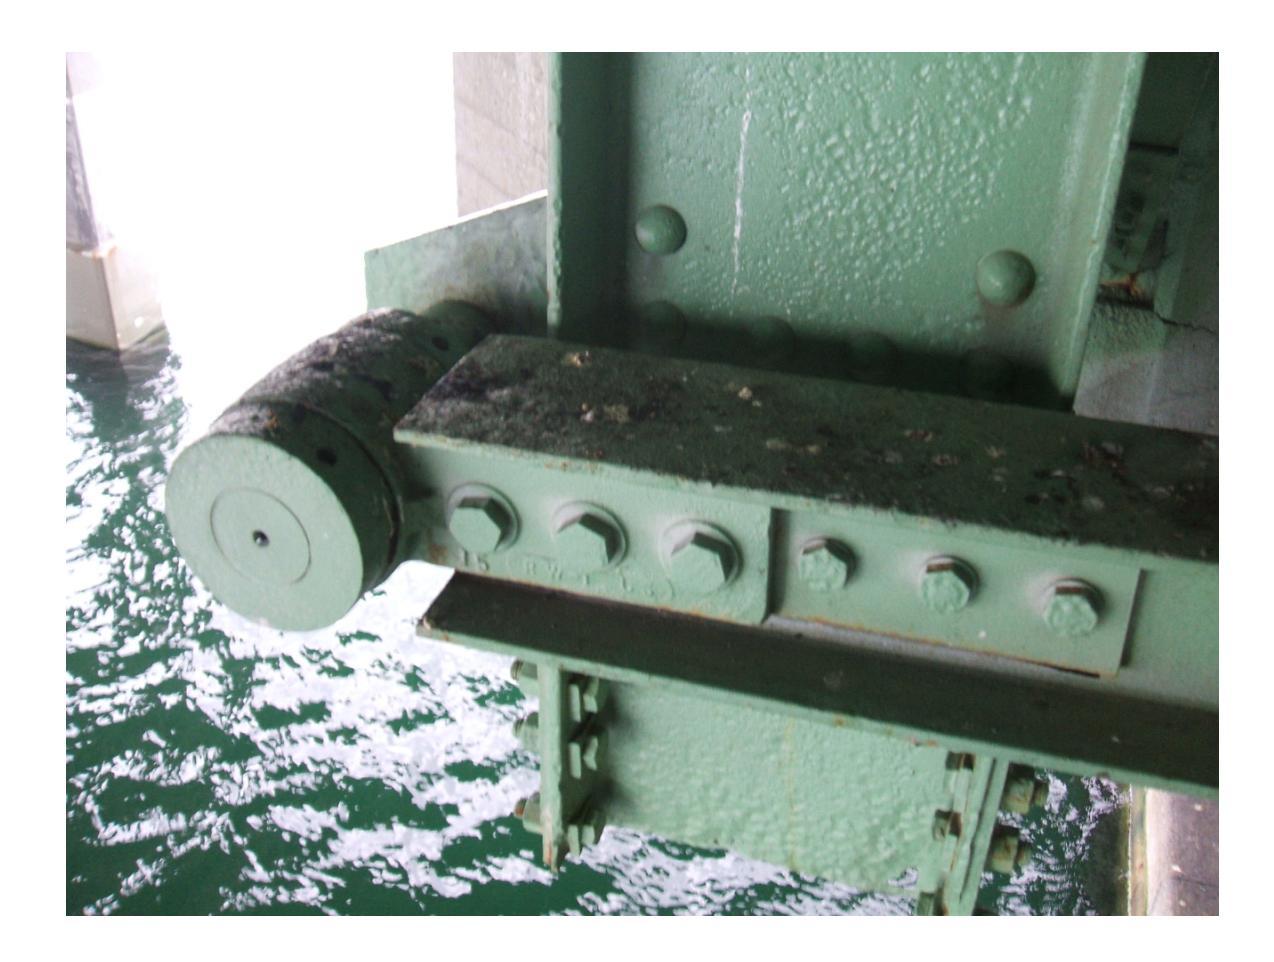
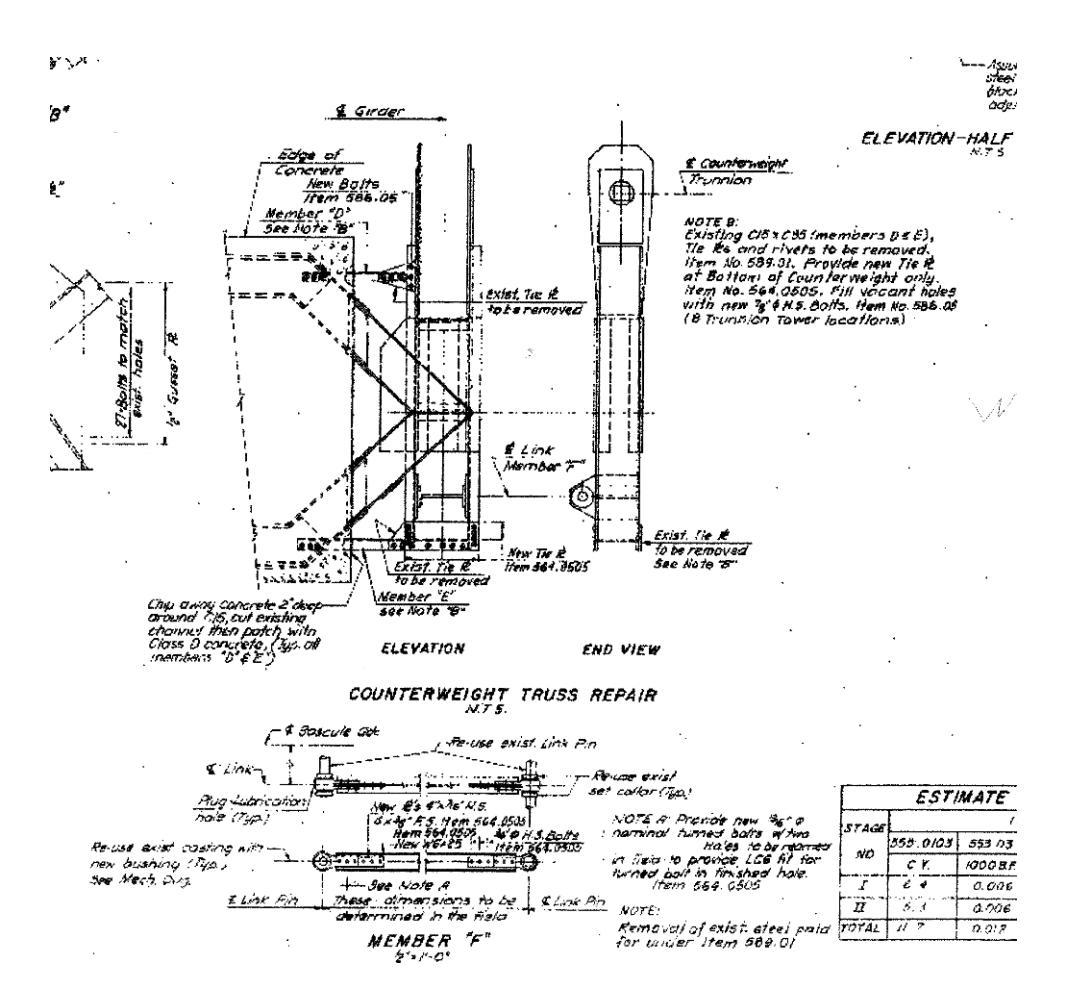
The link arm assemblies originally consisted of 6-inch, 22.5-pound H-pile sections with cast steel, bronze bushed bearing assemblies fastened with turned bolts to each end of the H-pile. In the early 1990's, the H-pile sections were replaced with W6x25 sections as part of a major rehabilitation of the bridge. The cast bearing housings were retained, but had new bronze bushings installed. New turned bolts were provided to fasten the old castings to the new W-section to the AASHTO-standard ANSI LC6 class fit. New shaft collars were provided to retain the link arm ends axially on their shafts. What is significant to note is that the contract drawings do not dictate a tolerance on the overall length of the link arms, rather a note is provided indicating that the end-to-end dimensions should "be determined in the field". In addition, a note is provided directing that the lubrication holes be plugged.

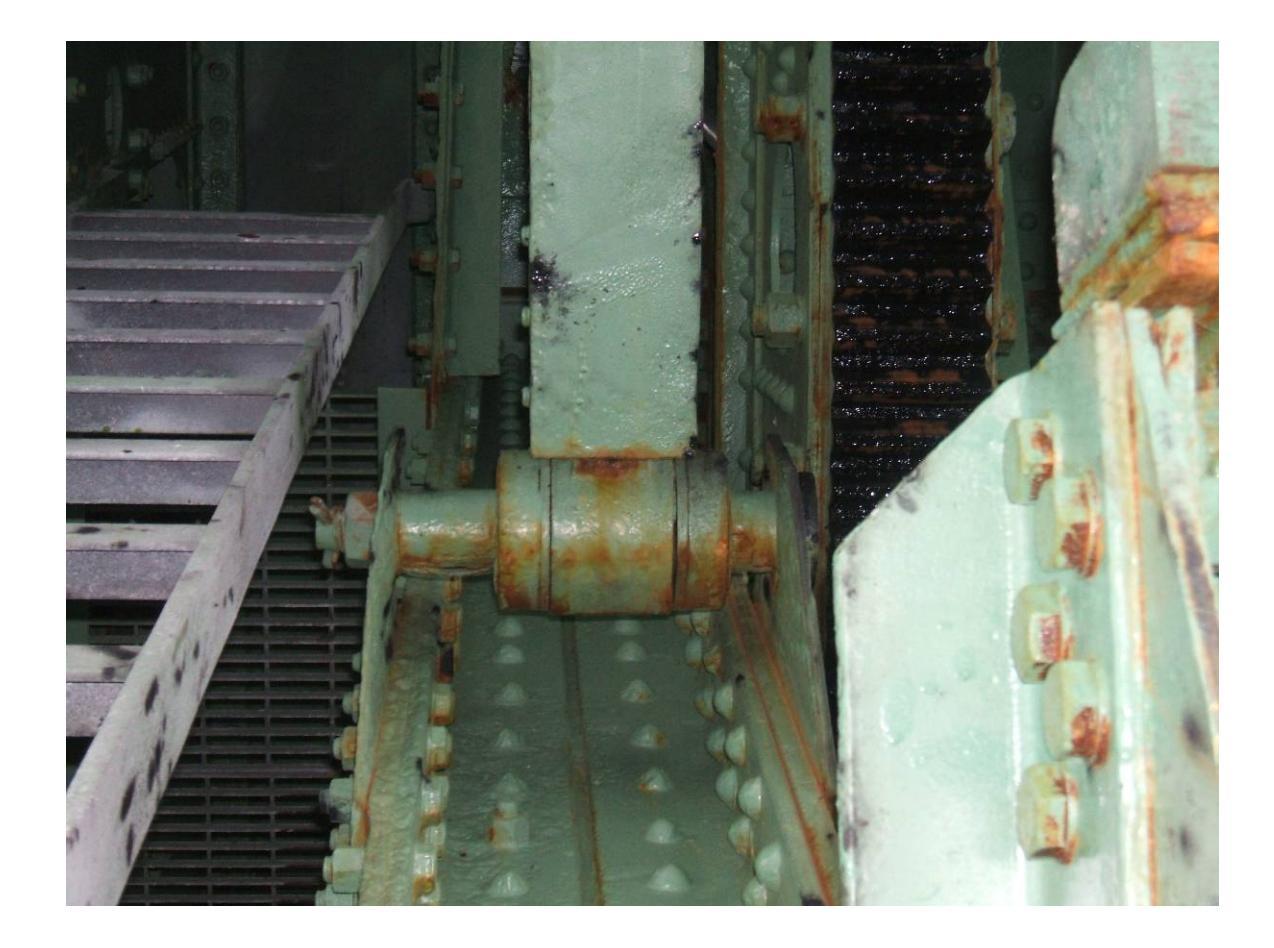
The link arm W-sections were in very good overall condition. The tower-end bearings and to a lesser extent, the counterweight-end bearings exhibited fretting corrosion and axial misalignment along their shafts. The link arm end shafts extend beyond the bearing bushings, passing through a pair of vertical plates. Each shaft has a smaller, square cross section near one end, which fits through one of the two vertical plates, and is intended to prevent rotation with respect to the trunnion towers and counterweight truss. Most of the vertical plates exhibited section loss with local plastic deformation around the square holes for the square ends of the link arm shafts.

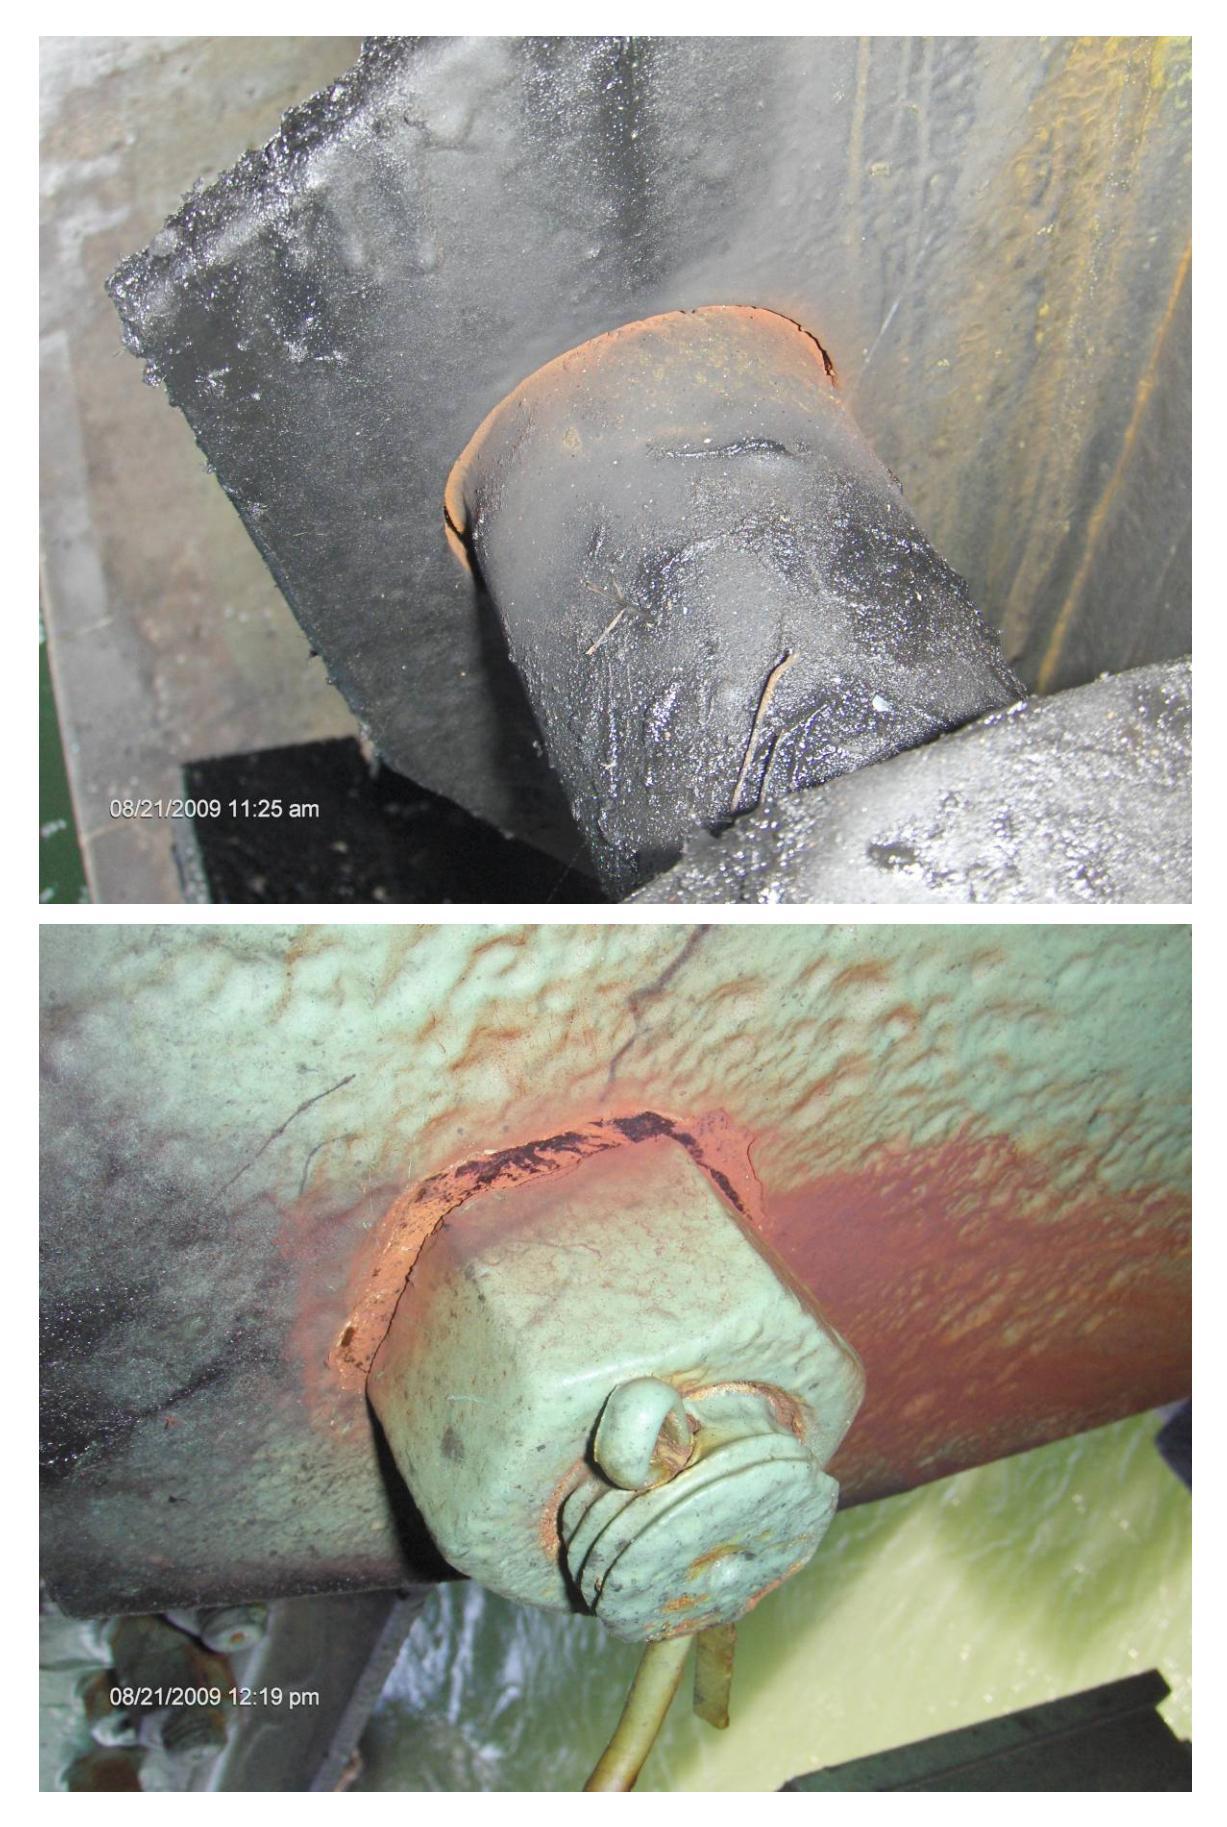
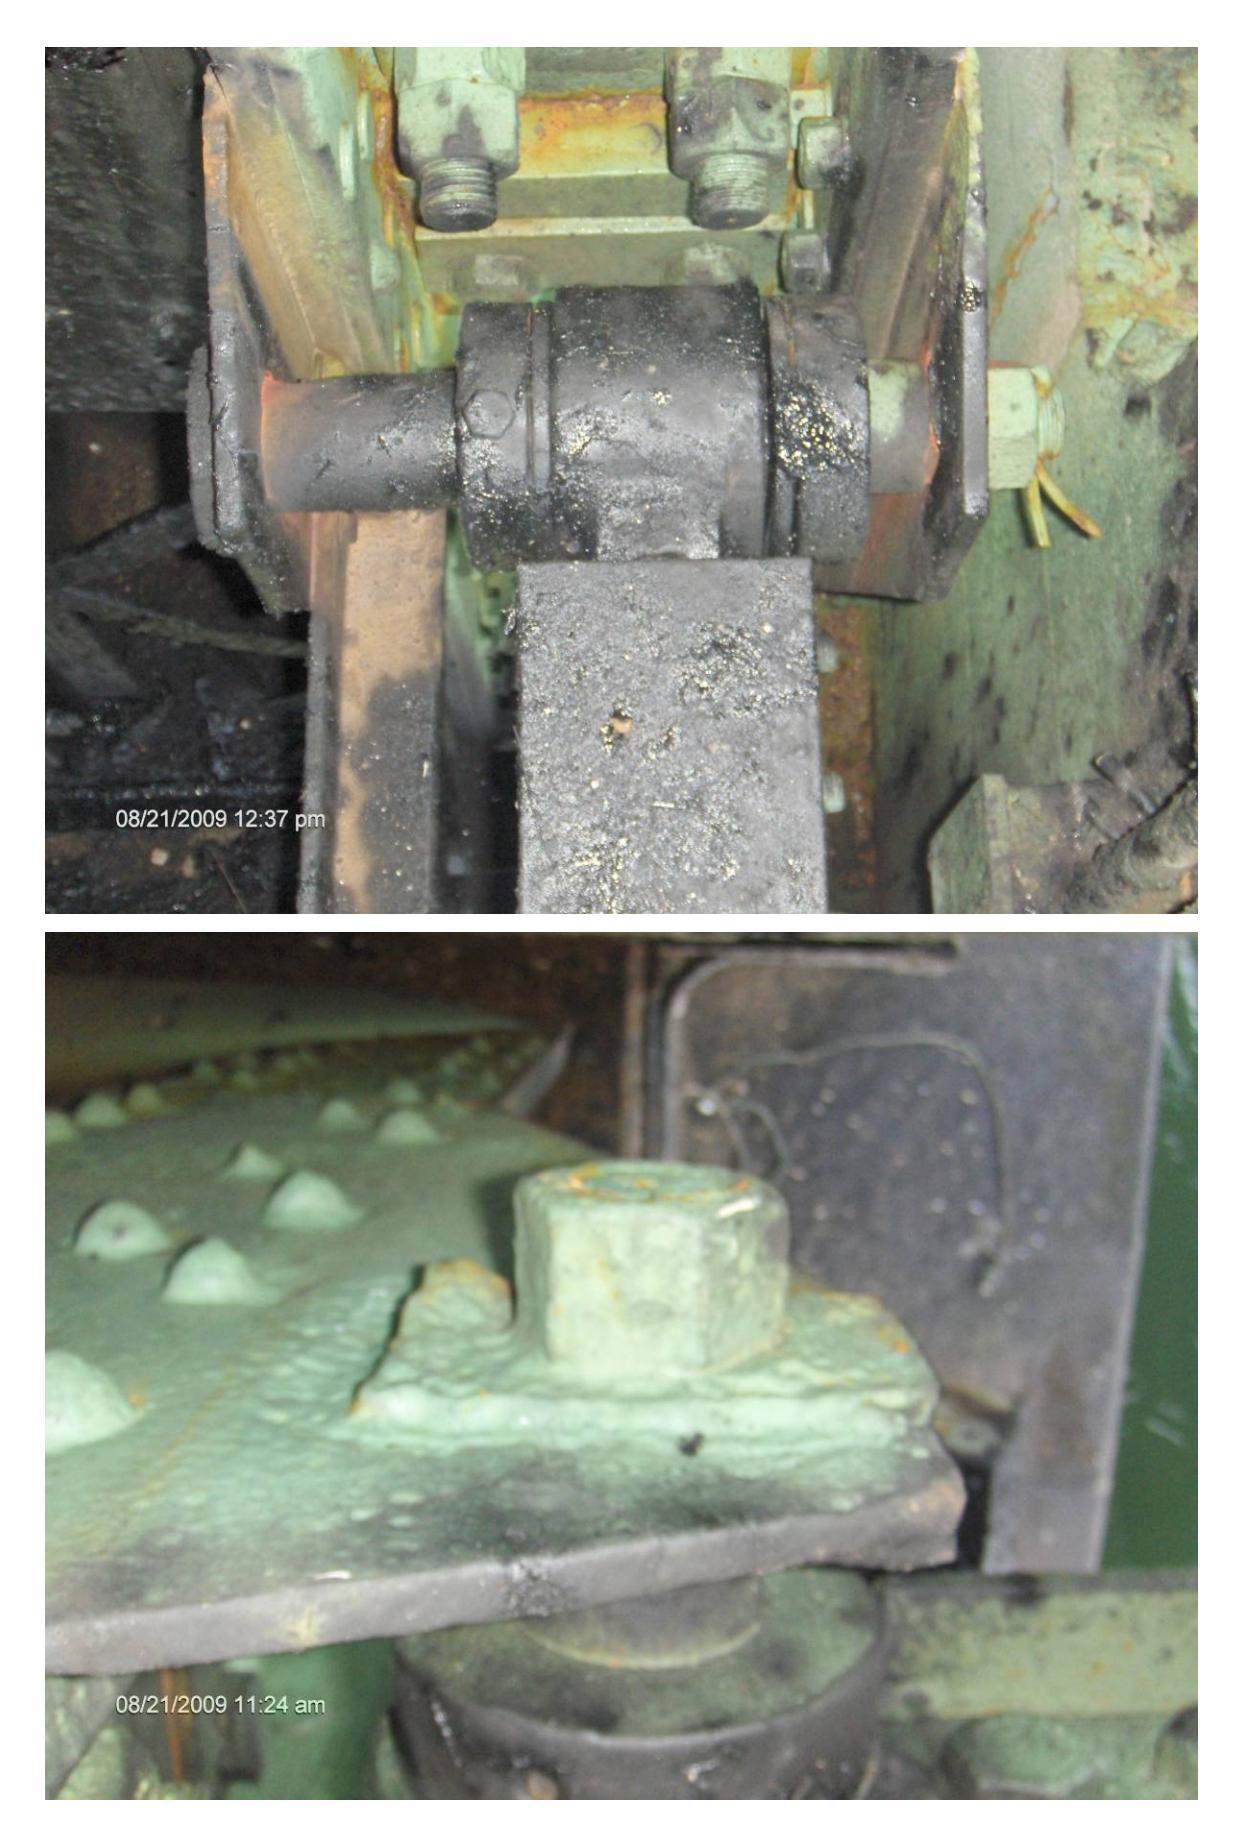
The inspected conditions of the link arms and their end attachments was notably worse than that observed at the Meadowbrook Parkway bascule. This is likely because the Loop Parkway structure is more exposed to coastal storms and weather than is the Meadowbrook Parkway structure and because the Loop Parkway bascule has a significantly greater demand for navigation openings. Many of the vertical connecting plates exhibited section loss and warping or yielding. The fit of the link arm shafts in these plates was compromised with fretting corrosion clearly evident. The link arm end bearings were not centered axially on their shafts and in some cases the fit of the retaining shaft collars on the link arm shafts had failed.

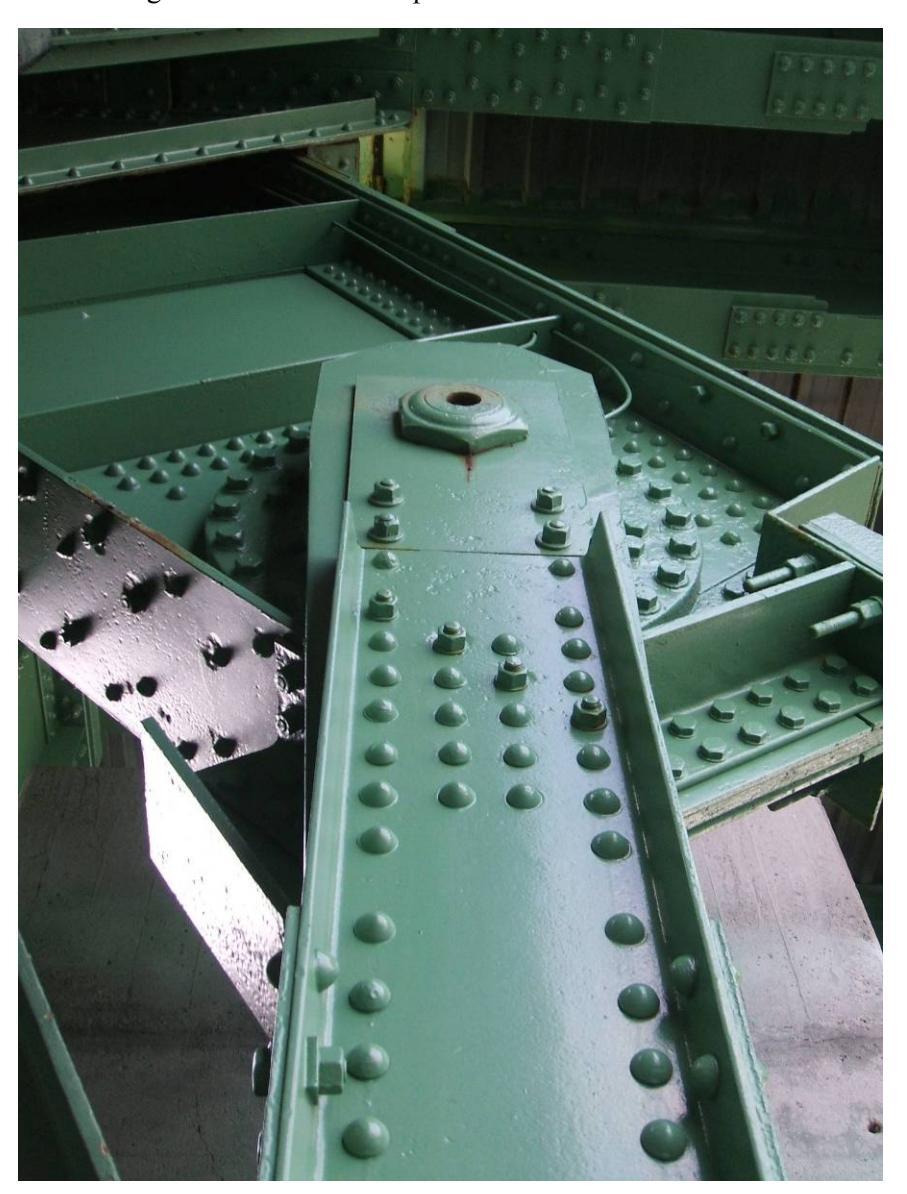
The Loop Parkway bascule also had the additional problem of bending stresses in the transverse plane developing in the counterweight link arms during opening and closing operations. The strain gage readings indicated the hanger plates were bending and twisting. The induced stresses were not momentary phenomena, but increased in magnitude as the bascule leafs opened. Upon closing, the stresses tended to switch from compression to tension, or vice versa, and reduce in magnitude as the leaves closed. The strain gage readings also indicated that bending in a longitudinal plane was occurring. Again, this was not a momentary phenomenon as one might expect from inertial forces. Rather the bending increased in magnitude as the leaves opened.

The strain gage results suggested that several things were happening to the bascule system as it was being operated. First was that the leaves also translated transversely as they opened and closed. Field surveys performed by a contractor hired by the Region to perform the STV team's recommended repair work suggested that at least the outboard faces of the main and counterweight trunnion shafts are misaligned by 0.12-inches for the west leaf and 0.11-inches for the east leaf. The inboard face of the trunnion shafts is not readily accessible for surveying purposes. Second, the link arms are of differing lengths with the centers of their end shafts not correctly located with respect to their theoretical locations. This again was confirmed later by surveys performed by the contractor. This condition caused high axial forces in the link arms and binding at the end bearings to develop during opening and closing operations. The high load condition was exacerbated by the lack of lubrication at the end bearings. High torques between the end bearing shafts and the vertical connecting plates were caused by steel-on-steel friction, which led to localized yielding of the plates. This may have actually relieved some of the binding in the short term, but the condition of the link arms remained a maintenance issue. The high forces developed through the link arms, combined with frictional resistance in the counterweight trunnion bearing assemblies are the cause of the longitudinal bending detected by the strain gages.
