## HEAVY MOVABLE STRUCTURES, INC. 16<sup>th</sup> BIENNIAL SYMPOSIUM

# Main Street Bridge Vessel Impact, Analysis and Repairs

Mario R. Palumbo, P.Eng, The St. Lawrence Seaway Management Corporation David Marcic, PE, Hardesty & Hanover, LLP

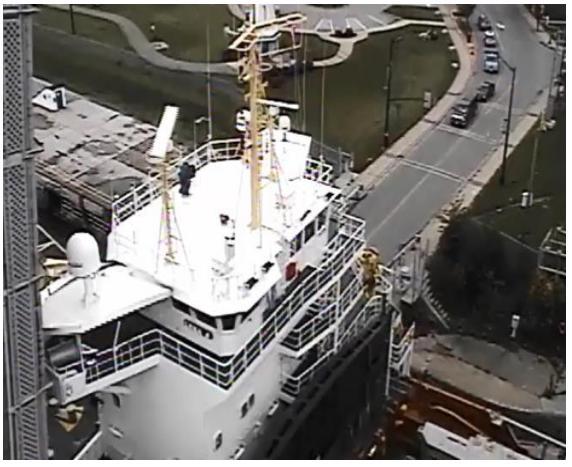
On September 30, 2015, a foreign vessel, the LenaJ, came into the lock, skewed and impacted the North girder of Bridge 19 while it was in the raised position.

Vessel Impact on North Girder Facing West

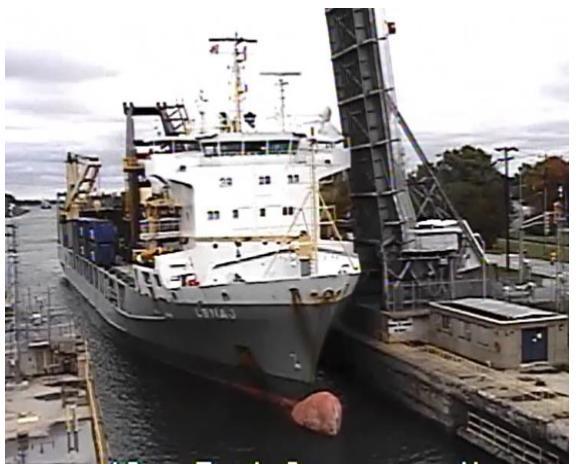
Vessel Impact on North Girder Facing North East

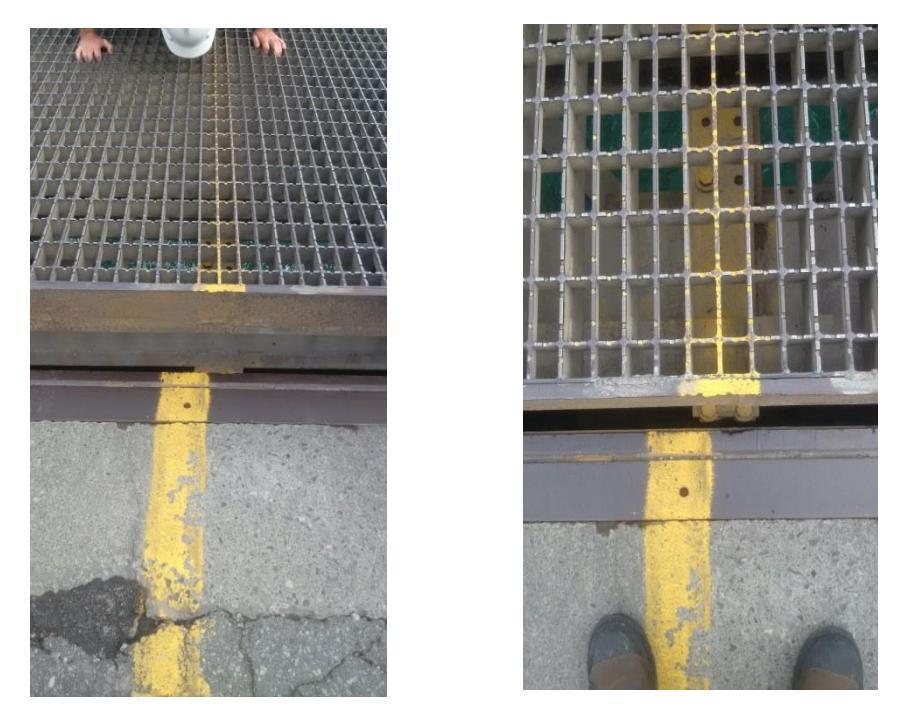
After an initial inspection of the critical elements, including drive machinery, rack and pinion, segmental girder and bridge structure, it was decided to operate the bridge in slow speed. The mechanical operation of the bridge appeared normal and no unusual noises were detected. The operation showed the bridge would not seat and the centering was interfering due to bridge misalignment. Two more bridge operations were done to observe if the bridge would find its center. However, the result was the same.

Bridge Deck misalignment After Impact

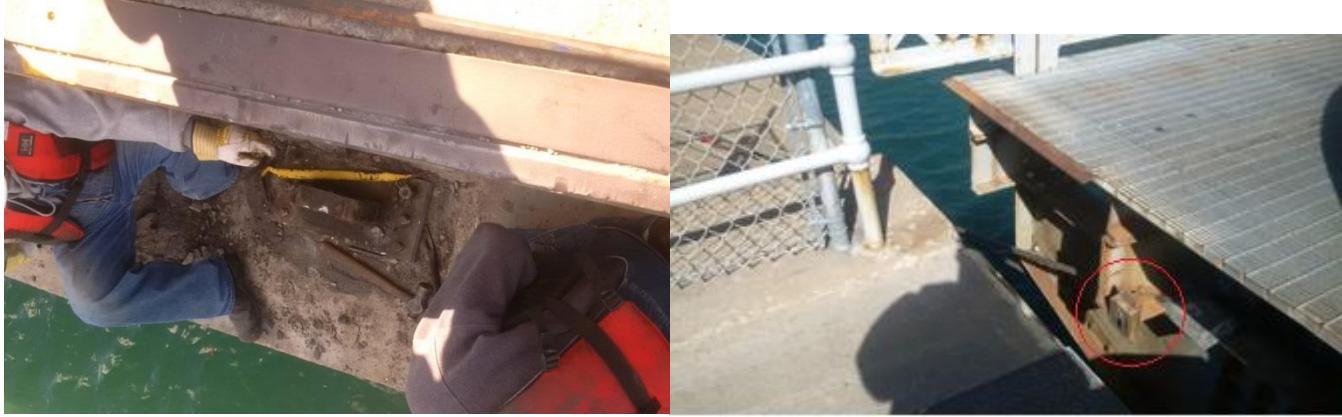
<u>Centering Pin Removal</u>

Limit Switch Flag Relocation

In order to have the bridge operational, the centering device was removed. It was also determined the limit switches for the bridge locks needed to be relocated so that the bridge would seat.

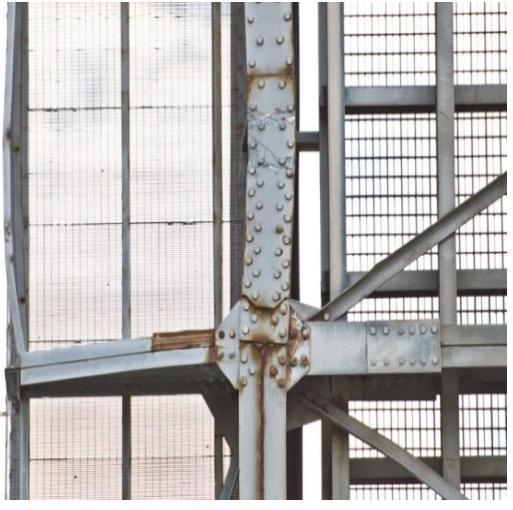
North Girder Impact Damage - Bottom of Girder

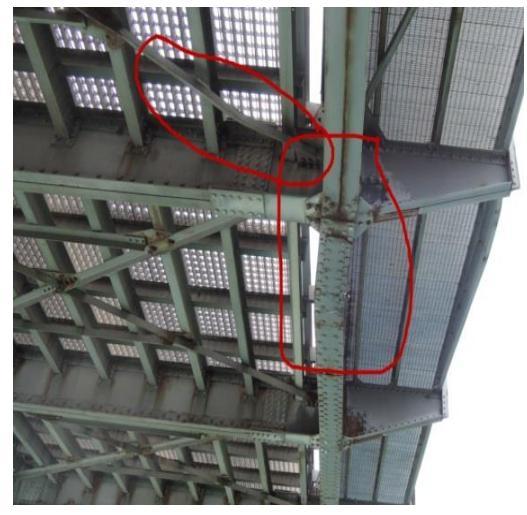
Cross Bracing Impact Damage

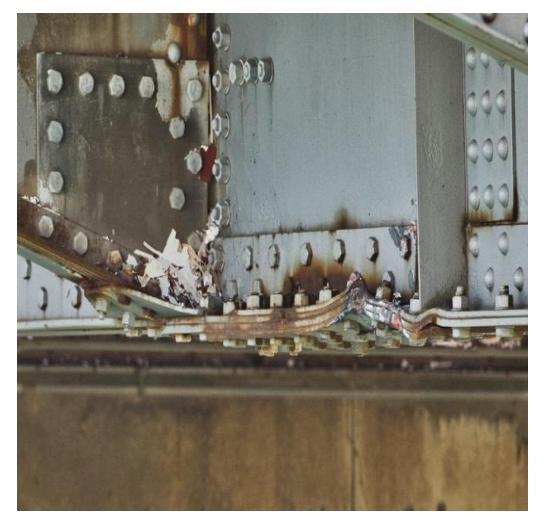
North Girder Impact Damage – Facing South

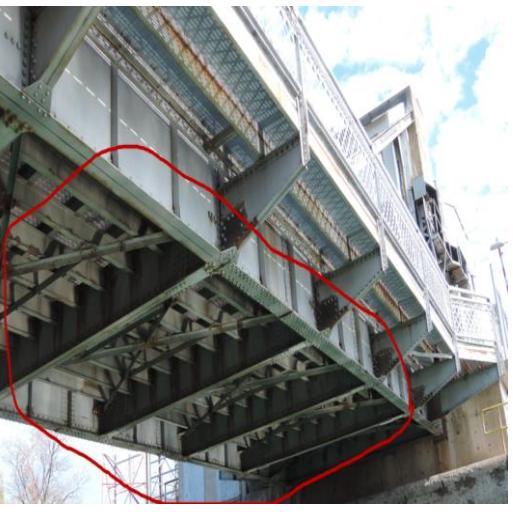
Global Deformation of Bay 1, 2 and 3

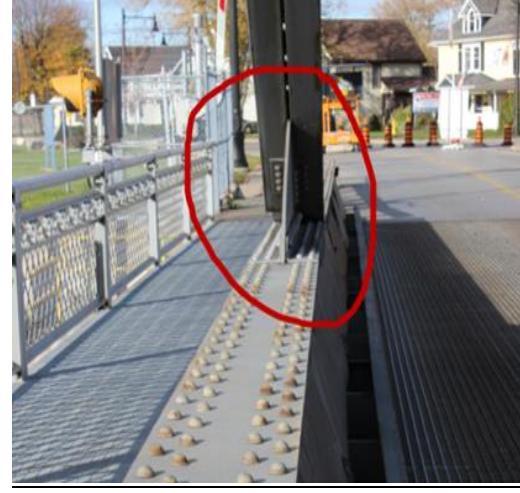
Deformation of South Girder Connection Plate

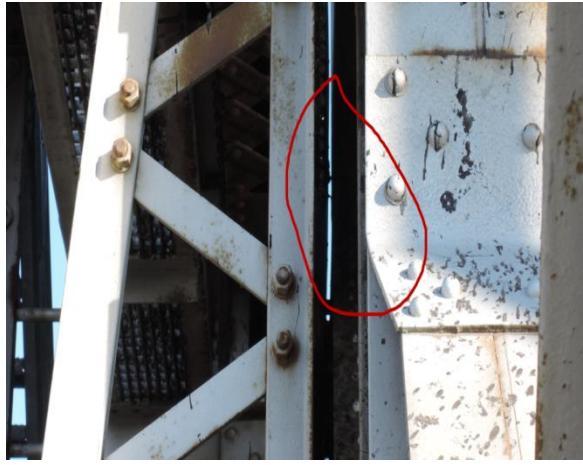
Gap Between Fixed and Movable Portion Reduced

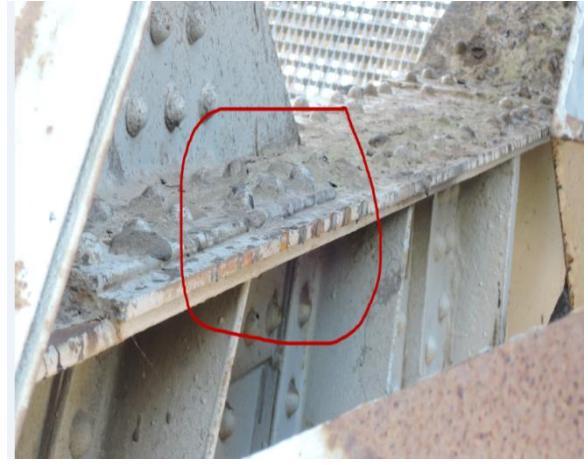
North Girder Rubbing on Rack Support

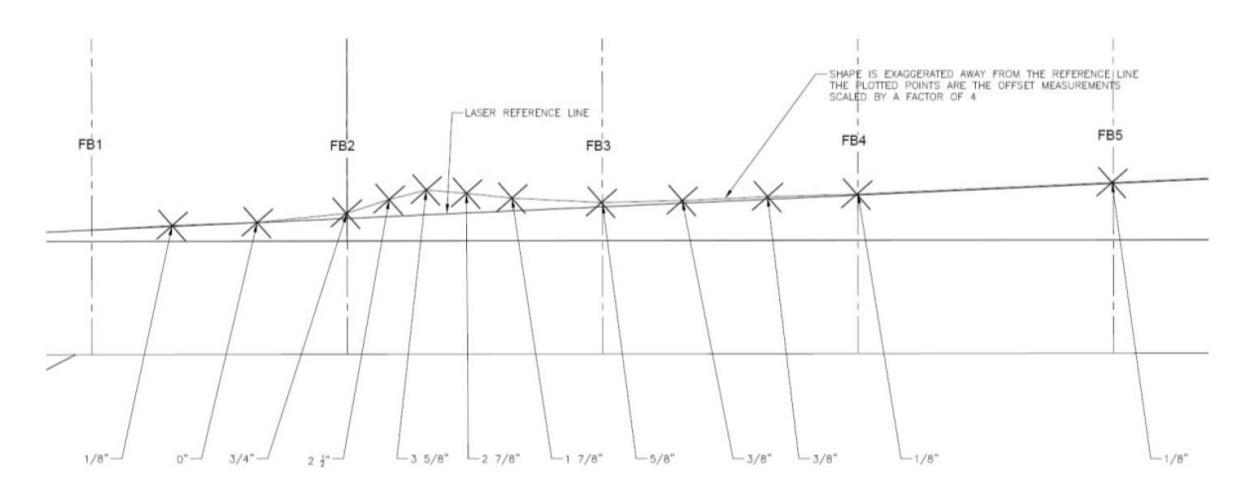
The ship impact was virtually re-created using several analytical software packages. This was done in order to understand the likely load path of the impact force, and determine if any members may have been damaged beyond those observed during the field inspection. The refined models show the girder that received the primary ship impact force. This location is between floor beam 2 and floor beam 3. At the worst point, 92 mm (3.625") deformation was measured.

Bascule Girder Measured Deformations

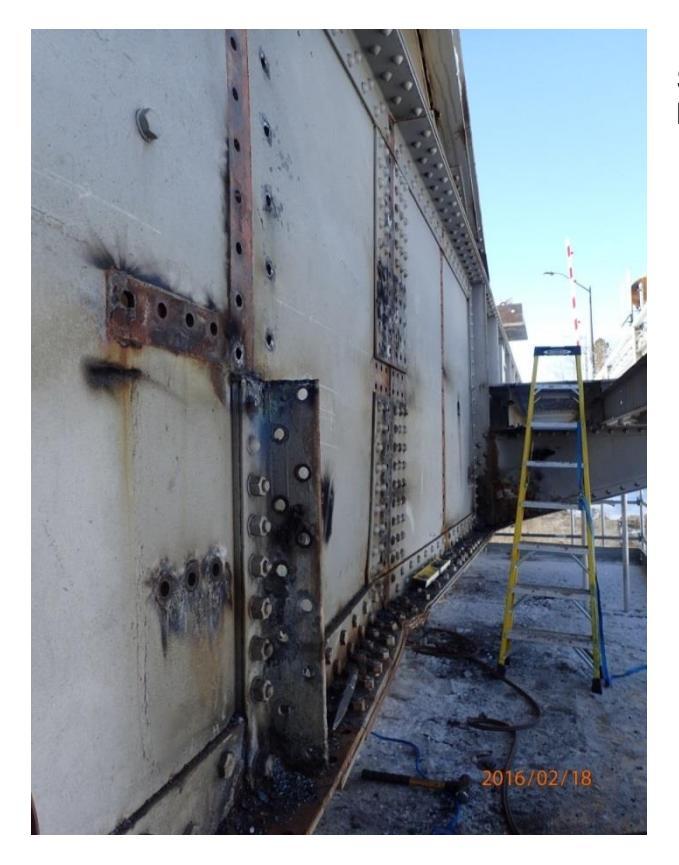
Section of North girder showing impact location and deformation.
