HEAVY MOVABLE STRUCTURES, INC. SIXTEENTH BIENNIAL SYMPOSIUM

Mechanical Rehabilitation of the Houghton-Hancock Vertical Lift Bridge

Andrew M. Brodsky, P. E. Reid C. Hoffman, P.E. Modjeski and Masters, Inc.

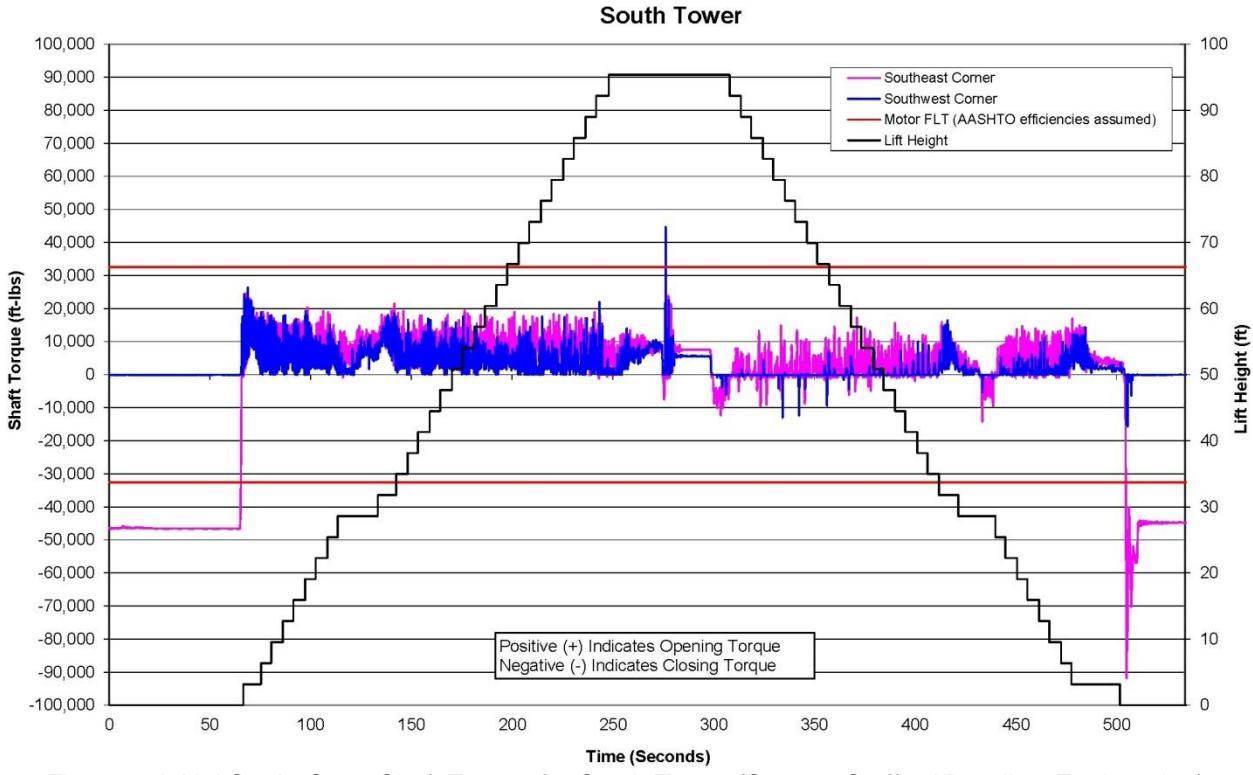
Figure 2: Initial Strain Gage Shaft Torque for South Tower (Source: Stafford Bandlow Engineering)

At the start of the project MDOT indicated that the bridge has historically had several issues including transverse and longitudinal skew during operation and poor seating characteristics that resulted in live load pumping under traffic. During the initial site visit, strain gage balance testing was conducted and revealed poor load sharing between corners in each tower. Backlash measurements that were taken during the initial inspection revealed considerable differences in total cumulative backlash through each gear reduction between the east and west corner in each tower. As a result of this cumulative backlash difference between corners, adjustment of the indexing between the east and west shafts would only allow the machinery to share load evenly during raising or lowering. For example, if the pinions were rotated to contact their raising face in the bridge fully seated position this adjustment of the indexing with the existing machinery would only allow for equal load sharing in one direction (raising) and the pinion with less backlash would be ahead of the opposite pinion in the other direction (closing).

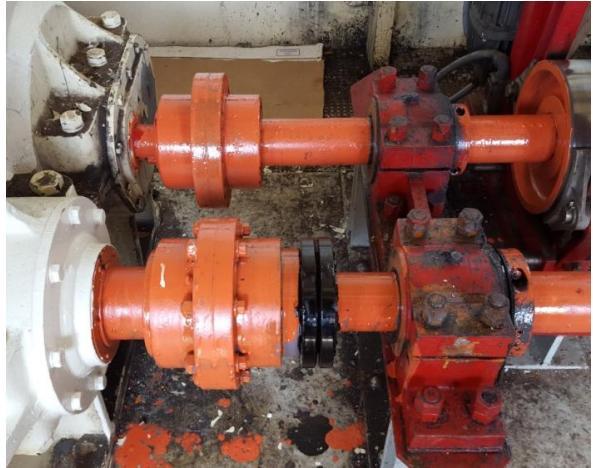
Photo 1: New Shaft Indexing Coupling Installed on Primary Reducer Output Shaft

In addition, the existing machinery design did not include means to adjust corner to corner indexing of the drive machinery in the event of rope slip at the sheaves. The gear couplings at the primary reducer output shaft only provided adjustment in 5.25° increments. This adjustment is equivalent to a change in backlash at the final pinions of 0.054". This change in backlash at the final pinions is not sufficient to provide precise indexing adjustment for load sharing. Implementation of a primary differential type reducer and

replacement of the subsequent open gearing was considered during the preliminary design, but the configuration of the existing motor and machinery brakes, along with the costs associated ruled out this option. The solution to allow indexing between corners utilizes a new indexing coupling on one primary reducer output shaft (per tower). This new indexing coupling was a custom double engagement gear coupling with a shrink disc on one side to allow for infinite adjustability of the corner to corner indexing of the machinery. A new shaft was also included in the design to use with the new shaft indexing coupling. The new indexing coupling was included as part of the advanced material procurement contract with pilot-bores in each coupling half. The general contractor for the main construction contract was responsible for measurement of the exiting components to provide final bore dimensions to the coupling manufacturer for final machining of the couplings.

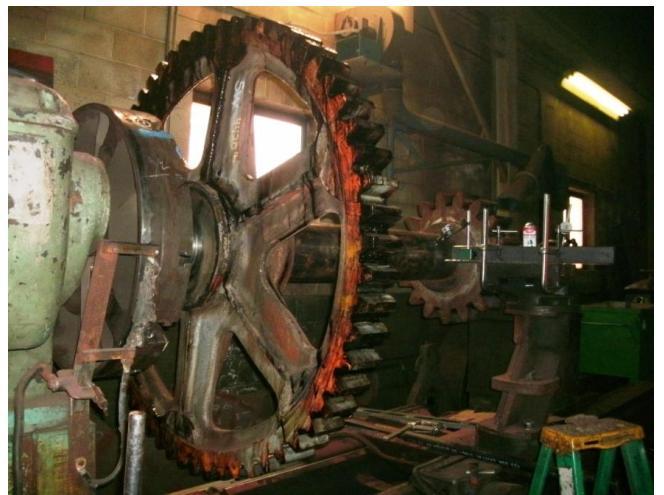
Photo 2: Southwest Pinion Shaft on Lathe for TIR Measurement

The Contract for this project included taking several backlash measurements at each open gearset to determine the cumulative backlash from the primary reducer output to the final pinion in each corner of each tower. At the start of construction in January 2015 Stafford Bandlow Engineering (SBE) obtained the required measurements for Zenith Tech, Inc. (ZTI) and reported significant run-out of the southwest pinion shaft and the southwest pinion top land. The run-out measurements prompted an in-depth investigation on the southwest

pinion shaft. This was not originally part of the project scope. The in-depth investigation required removal of the southwest pinion shaft from the tower top to take measurements of total shaft run-out in a machine shop. Prior to removing the southwest pinion shaft from the tower top, the remaining open gear measurements were recorded and showed measureable run-out at each final pinion. The shop measurements confirmed that the southwest pinion shaft was deformed.

The southwest pinion shaft was centered on a lathe at Calumet Machine in Hancock Michigan and measurements were taken at several locations along the pinion shaft after all paint had been removed. The total indicator reading (TIR) was recorded, and the highest documented reading for the southwest pinion shaft was 0.096" TIR. The measured TIR confirmed that the southwest pinion shaft was permanently deformed and was likely a result of an extreme event in the past. Upon confirmation that the southwest pinion shaft was deformed, the decision was made to replace all four pinion shafts during the 2015 winter bridge shutdown. The replacement of the four pinion shafts also included replacement of each final pinion, but re-used the existing gear mounted on the inboard end of each pinion shaft. The four new

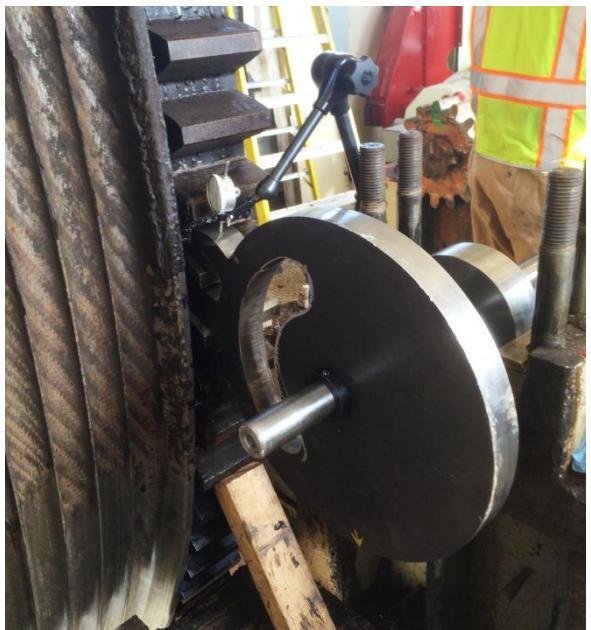
Photo 3: Dummy Gear Measurement Jig to Measure Backlash at Final Rack

All backlash measurements that were taken at the final pinion/rack with the deformed shafts could not be used to determine the necessary tooth thickness modification for each new pinion. New measurements were taken by Modjeski and Masters (M&M) with a custom measurement jig, which was fabricated by Calumet Machine. The fabricated measurement jig included a two inch thick dummy gear with 3 precisely machined gear teeth of known chordal tooth thickness. This dummy gear was mounted on a shaft

with round bearing inserts to rest in the existing pinion shaft bearing bases. Backlash measurements were directly measured along the tooth face using a dial indicator on the involute tooth profile of the dummy gear. Three measurements were taken along each tooth face with the dummy gear to directly measure for any tapered wear on the rack teeth. These measurements were repeated at several locations around the diameter of the rack for each sheave location. The new pinion/rack backlash measurements were used along with the original backlash measurements taken on the preceding gearsets by SBE to determine the required pinion tooth thickness at each location to compensate for the existing cumulative backlash differential.

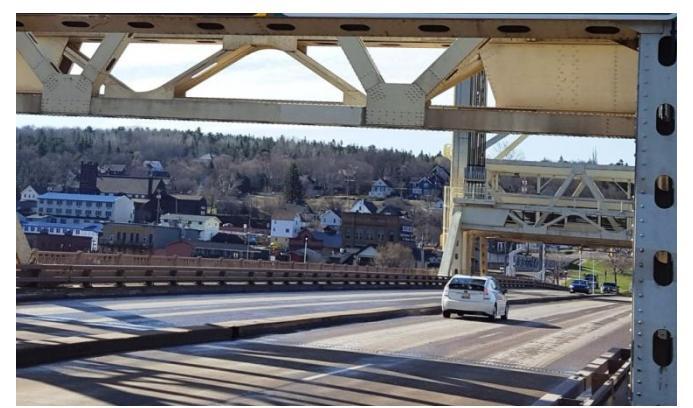
Photo 4: North End of Span Roadway Alignment

While shimming the southwest intermediate live load bearing there was an issue achieving proper roadway alignment. Even with all of the shims removed, the span was too high relative to the approach roadway elevation. In an effort to find out if this condition predated the construction contract, M&M discussed the issue with MDOT personnel. The bridge operators were able to confirm that there have been persistent problems for years when operating the southwest span locks with the bridge on the intermediate seats. This new information led to an investigation of the southwest span locks. Adjustments to the span lock elevation are made from inside the tower leg, and after inspecting the southwest span

lock it was clear that it had been adjusted up as high as possible and was still rubbing when actuated. All parties involved came to agreement on the solution to mill down the bottom of the southwest live load bearing ½ inch, which solved the issues relating to seating loads, roadway elevation, and span locks. Equalization of the seating loads through shimming of the live load supports virtually eliminated any seating problems that were evident in the past.

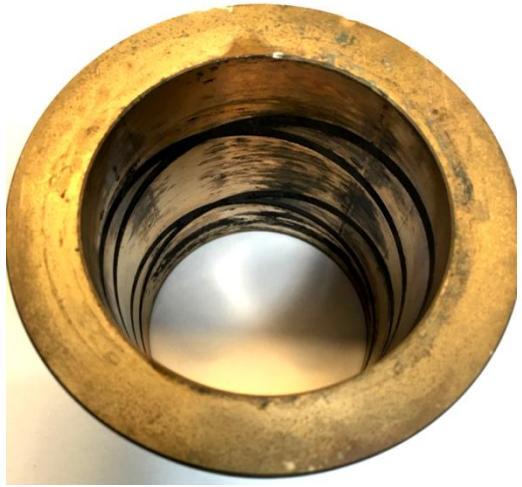
Photo 5: Balance Chain Bushing from 1996 Rehabilitation

The bushings manufactured for the 1996 rehab failed to meet the design intent. Although the cast bronze used has a high yield strength it has no self-lubricating properties. Bronze bushing manufacturers also do not recommend double loop style grooves for graphite filled lubrication, especially with limited shaft rotation like in this application. This style groove is much better suited for grease lubrication only. Over time the graphite had likely worn and was no longer providing the intended "self lubricating" properties to the bushing. Moisture and debris had likely also penetrated the voids in the harsh environment. In an attempt to combat debris build up and corrosion, the rehab designer included lubrication ports and passages on both sides of the link pins to provide fresh lubrication for the

bushings. However, the balance chains are nearly inaccessible for hands-on inspection and maintenance. Because of this, the passages were plugged at initial installation and fresh lubricant had never been added, thus further accelerating the propagation of contamination and link seizure.

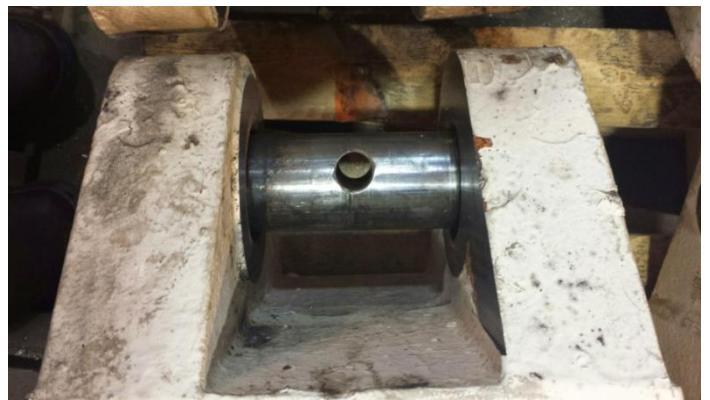
Photo 8: Balance Chain Link (Left Side: Boss not Removed, Right Side: Boss Removed

The removal of the balance chains required taking down each of the eight chain assemblies individually and shipping them by flat bed truck to Calumet Machine for disassembly and reassembly. During disassembly Calumet Machine discovered that the existing balance chain links did not match the details shown in the 1996 rehabilitation plans that were used to develop the current plans. A boss was present with a counterbore for the existing bushings on each link at the female end.

Upon disassembly this boss showed signs of significant corrosion on each link and was likely part of the cause for the seized links. Without modifications, the new balance chain bushings could not be installed in the existing balance chain links. The Contractor was directed to re-machine each balance chain link to accept the new balance chain bushing details as shown in the contract plans. A total of 264 balance chain links were machined to accept the new balance chain bushings.
