HEAVY MOVABLE STRUCTURES, INC. TWELFTH BIENNIAL SYMPOSIUM November, 2008

Reconstruction of the 7th Street Bridge over the Black River Port Huron, Michigan Pier Stabilization

John Brestin, P.E., S.E. HNTB Corporation

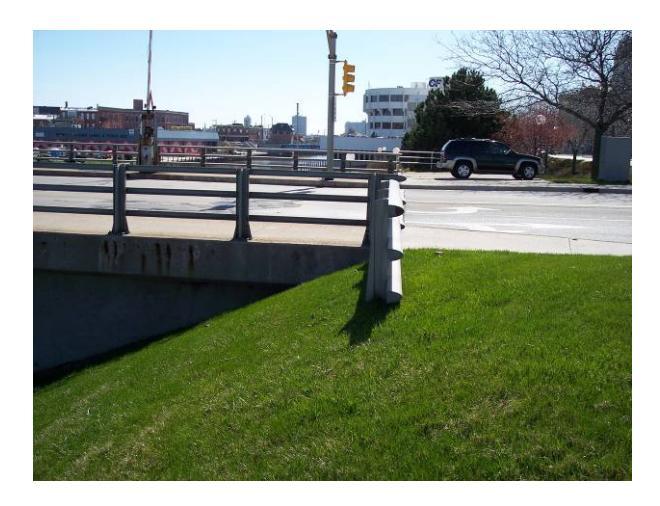
Figure 2: Railing at SW corner of bridge

In the spring of 2005, we began a geotechnical investigation and analysis of the bridge. During the investigation, we made the following observations. The offset in the aluminum railing shown in figure 2 offered antidotal evidence that the steep slope to the west of the south abutment is creeping toward the river relative to the bascule pier. At the southeast corner of the bridge, the slope paving shown in figure 3 is buckled and more dramatically shows that the south bank is not stable. But in both cases, it is clear that the banks have moved *more* than the bascule pier. Further, the bascule pier may actually be stable, since the intersection directly behind it has not suffered from any unusual distress. For instance, an old deep brick sewer manhole located at the north end of the intersection was in good condition when last observed by City officials.

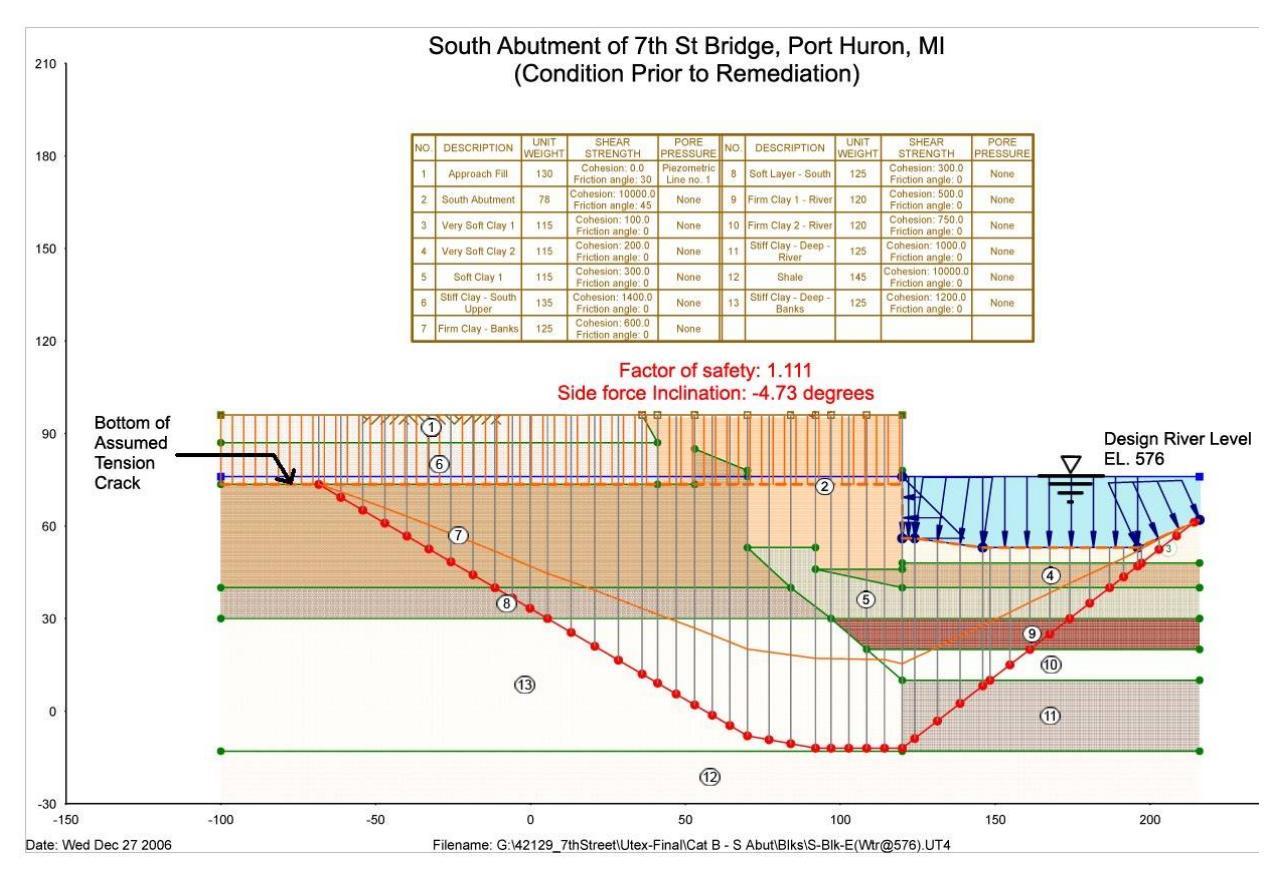
Figure 4: South Abutment - Most Critical Potential Failure Plane

In the undrained strength profile, the thick native clay deposit was assigned a friction angle of zero. The thick clay deposit was divided into several different zones to capture expected differences in undrained shear strength. The undrained strength profiles for the south and north banks are shown in Figures 4 and 5, respectively.

slides, which pass near the tips of existing piles, the weight of the abutments was included. Analysis of a Category B block slides appear in Figures 4 and 5.

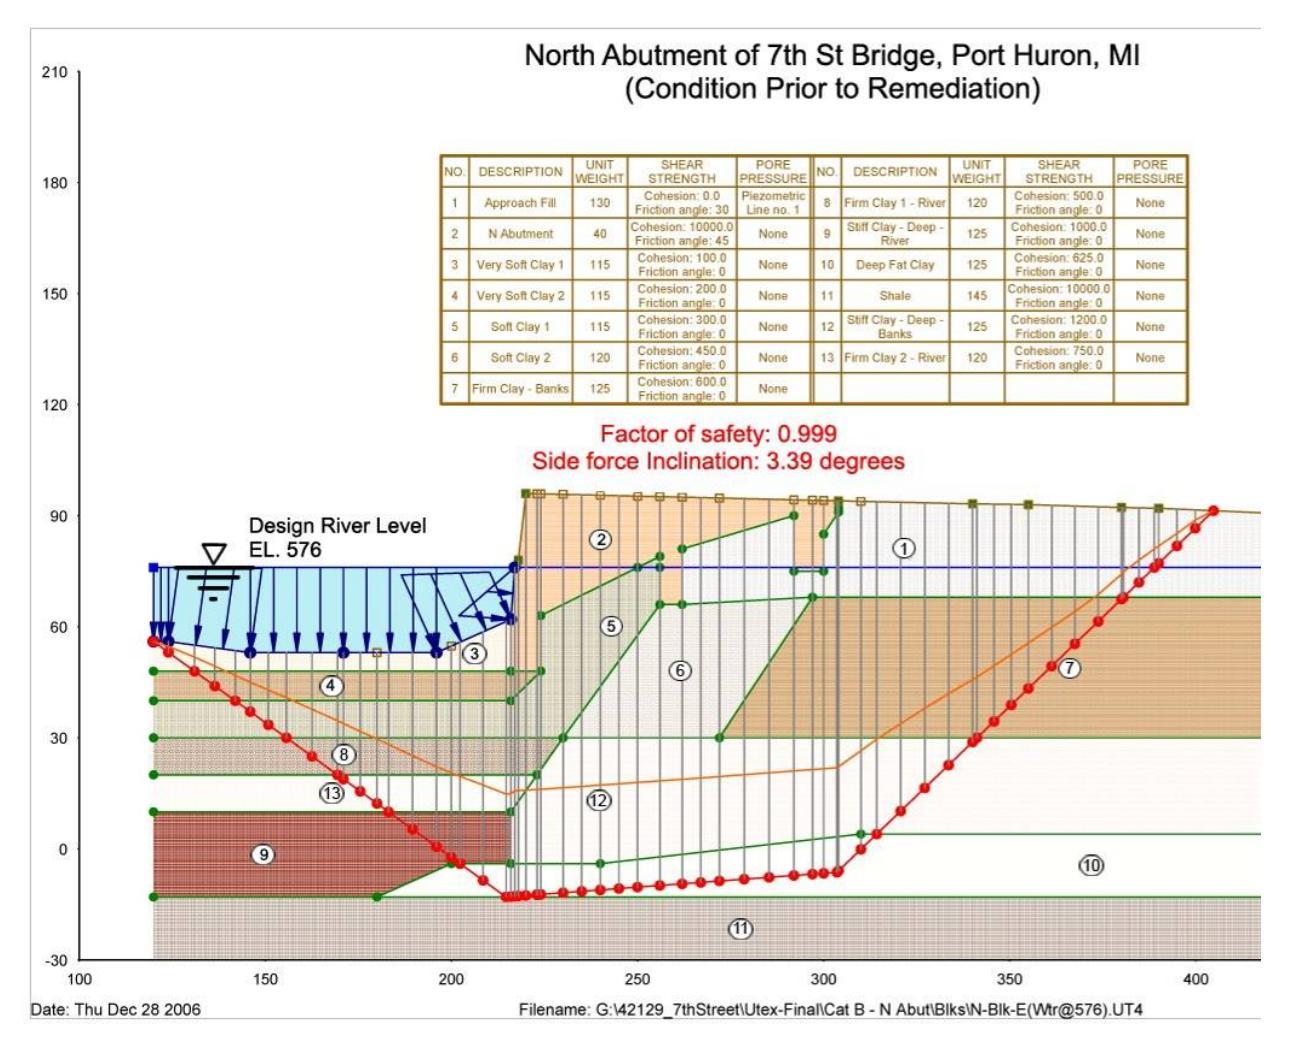
Figure 5: North Abutment - Most Critical Potential Failure Plane

Though our analysis was intentionally conservative and indicates that either pier could be the source of historic movement, the north (rest) pier appears to be the more likely to have moved. In addition to our analysis and site observations, we discovered by researching the history of Port Huron that the north side of the mouth of the Black River was created by importing fill (see figure 6). This information supports our conclusion that the north pier is the side that is experiencing movement. It was built on fill as opposed to the natural ground on the south side of the bridge.

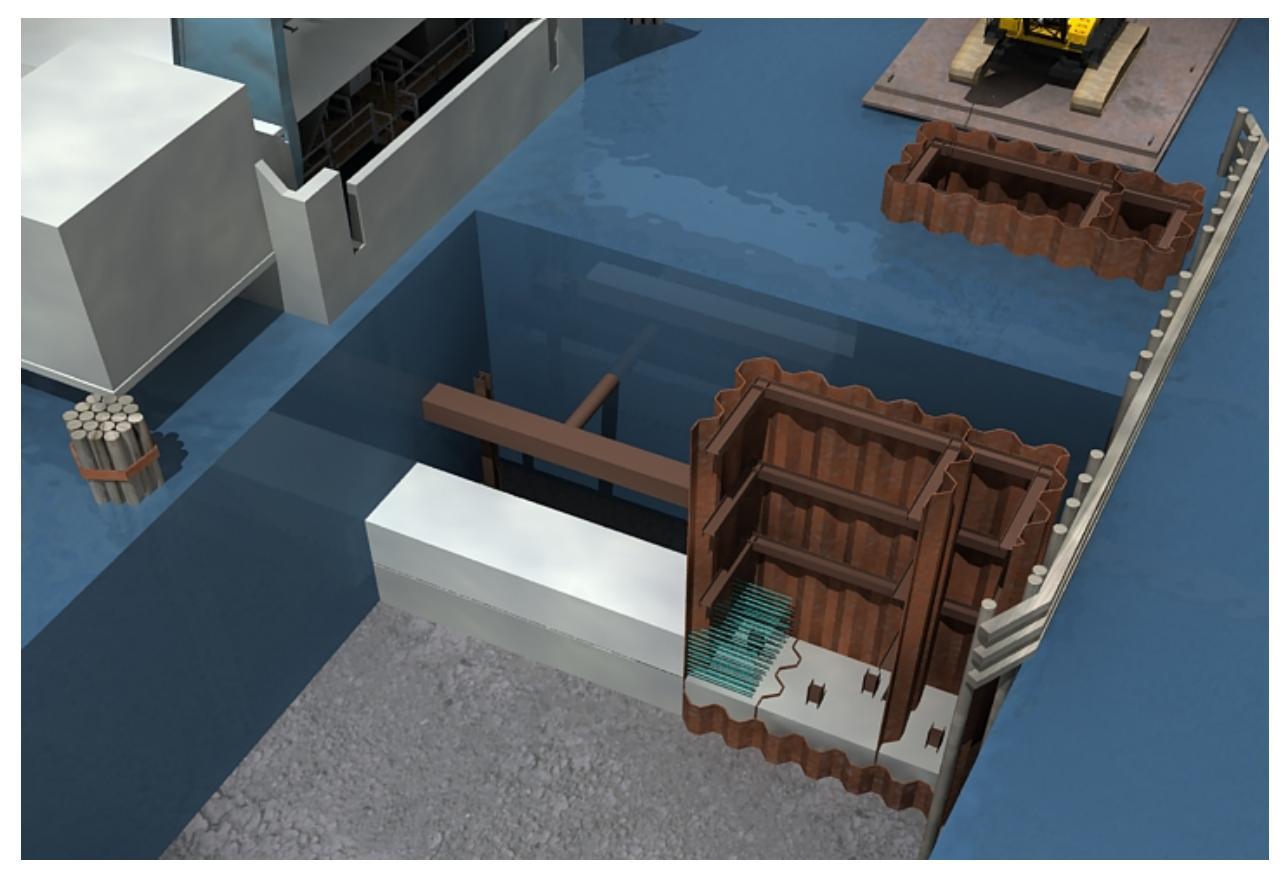
Figure 7: Rendering of Concrete Strut showing the staged construction

After the first section of the struts were built, the strut construction progressed across the river in thirds with a transition cell used to facilitate splicing the re-bar in the strut as shown in Figure 7 above. The sheeting at the interface of the transition did leak significantly between the first and second strut pours. Therefore, the contractor welded studs onto the transition sheets from the second to third strut pours to hold the sheets tight against the previous pour and prevent water from coming in through the interface at the re-bar locations.

Therefore the cage of steel next to the pier was tied up on a barge and the ends of the re-bar placed through a bulkhead that would be the forming surface for the reinforced tremie pour. The cage and form were lowered down to the proper elevation and braced against the cofferdam sheeting and weighted down so that the bulkhead would not float during the tremie pour. Horizontal ducts were used to block out locations that would be used after de-watering to drill through the reinforced tremie pour to drill and grout re-bar into the existing pier footing to connect the strut to the pier. This method worked extremely well to seal this area of the cofferdam and was employed for all four connections of the struts to the existing pier footings with success.
