Replacing the Counterweight Trunnion Bearings in a Strauss Bascule Bridge Burnside Bridge Reconstruction Project – Multnomah County, Oregon

Jon Henrichsen, P.E., Chuck Maggio, P.E., Ed Wortman, P.E., Tye Aldana, P.E.

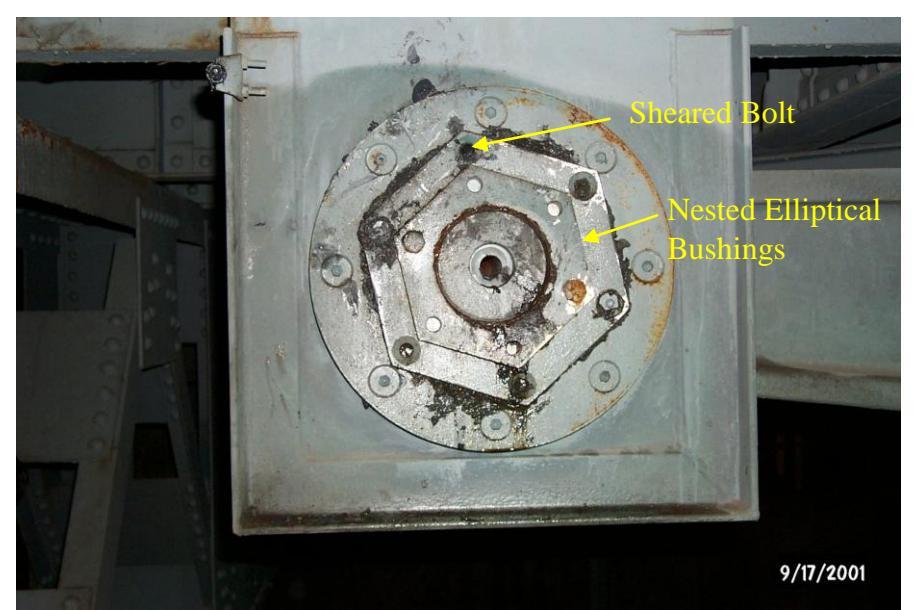
The inspection team also identified three sources of excessive system friction that they believed were the cause of the slow moving east leaf. The first was in the counterweight link arm bearings (Figure 2).

Figure 2: Counterweight Link Arm Bearing Assembly showing sheared bolts

Strain gauge measurements taken on the counterweight link arms during operation indicated that the loads in the two link arms for the east leaf counterweight were very different. Further investigation found that the link arms were slightly different lengths and as a result, they were unequally loaded. In addition, the design of the bearings (nested elliptical bearing inside an elliptical sleeve (Figure 2)) had led to point loading within the nest assembly, and as a result the bolts holding the bushing sleeve to the housing were shearing off. The second source of friction was uncovered by the three dimensional survey, which found that none of the main trunnion or counterweight trunnion bearings, nor any of the adjacent counterweight link arm bearings were in the same plan or were collinear.

- Replace historic 4³/₄" concrete deck
- Replace east counterweight trunnions & collars, and all four link arms
- Install transverse limiting struts (only seismic retrofit not eliminated)
- Install water quality catch basins
- Replace electric motors, brakes
- Overhaul live load shoes
- Overhaul span drive machinery equalizers
- Shim and repair bushings
- Spot paint high rust areas

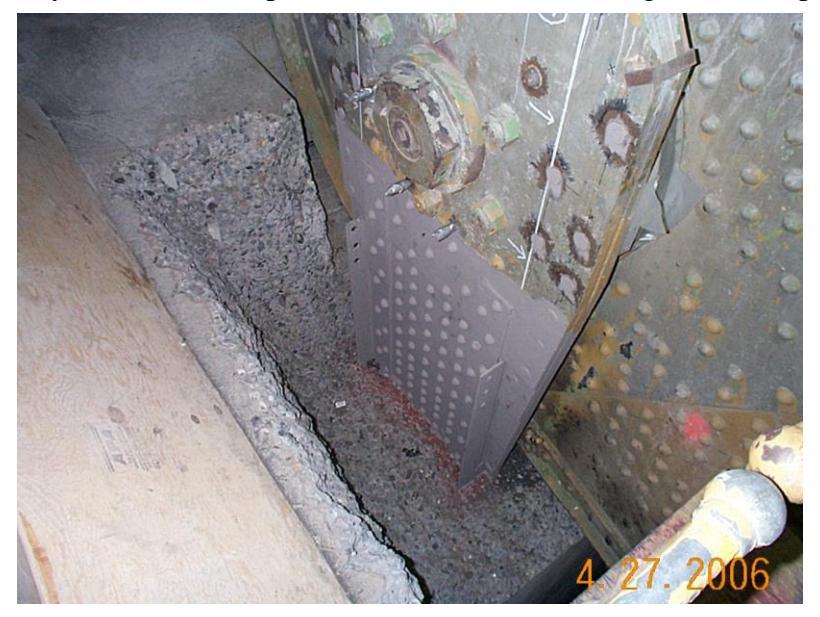
Figure 3: Counterweight Hanger – concrete removed

hangers with the concrete removed from the outboard side. Each hanger is composed of steel plates laminated together with rivets. The plates are widest at the interface trunnion and taper as they extend downward to the interface with the counterweight concrete. The outside of each hanger is supported from just below the counterweight trunnion by concrete. The inside of the hangers are

unsupported for about four feet before they enter the concrete. The concern became that a combination of high friction in the counterweight trunnion and link arms could result in bending at the inside interface of the hanger and concrete that the hangers were not designed to resist. To further complicate matters, the interface area received an inordinate amount of moisture when the bridge opened during wet weather, and the result was corrosion (which acted as a stress riser) all along the hanger-to-concrete interface. The condition of the counterweight hangers, trunnion and link arms led the team to the conclusion that without repair of all three elements, the hangers were in danger of developing a crack that could result in a catastrophic failure.

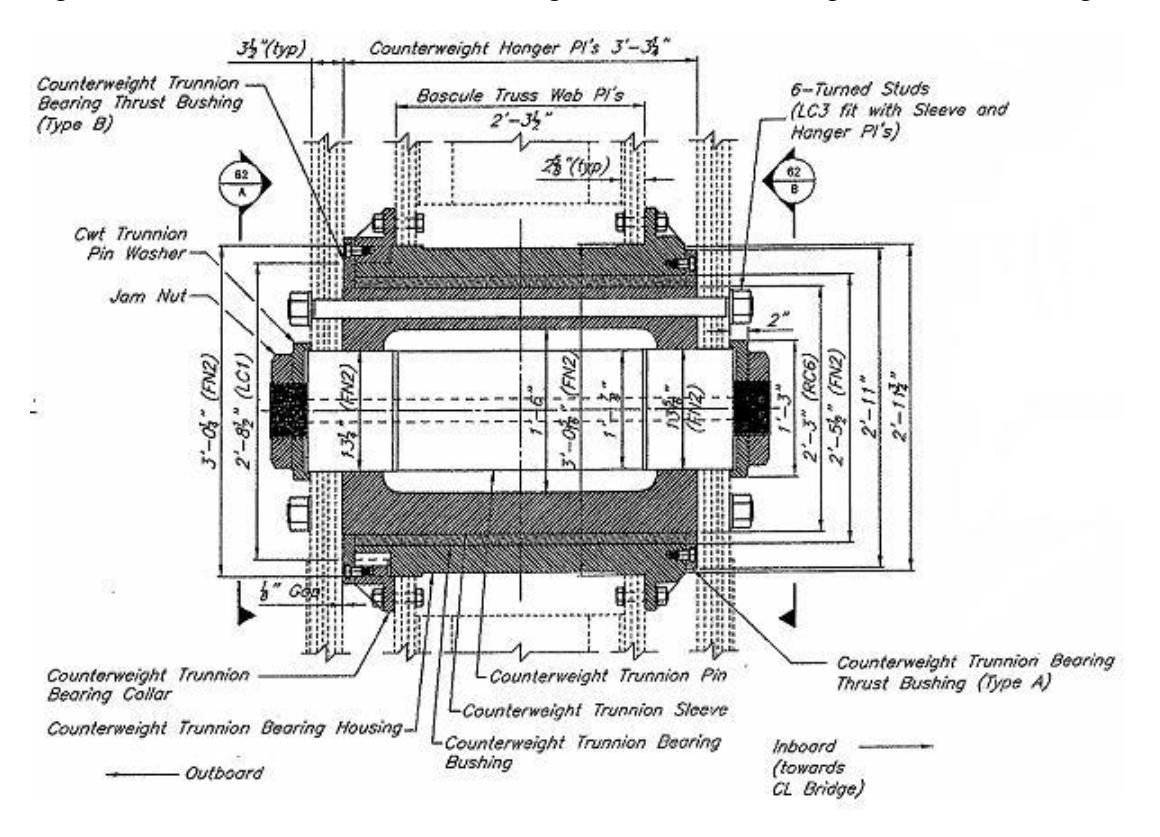
Figure 4: New Counterweight Trunnion

illustrates many of the challenges surrounding replacement of the counterweight trunnions. First and foremost was the configuration of the bearing surface that allowed the counterweight to rotate. The trunnion consisted of a flanged housing that was fit through and bolted to the heel end of the bascule truss. A bronze bushing was fit inside the housing from the flanged end, and held in place by a collar on the straight end of the housing. Into the bushing was fit a rotating sleeve with a center bore. The counterweight hangers sandwiched the rotating sleeve inside the bushing, and a pin was force fit through the counterweight hangers and the sleeve to hold them all together. Once the pin was in place, it transferred the weight of the counterweight to the bascule truss.

In order to replace the trunnion, the force fit pin needed to be removed, the counterweight had to be lowered approximately 4 1/2 feet, and rest of the assembly need to be pulled out. On the outboard side of the counterweight trunnion assembly, the assembly could come out towards the pit wall, where it was relatively easy to cut a hole through the wall to make space for the assembly and puller machinery. However, on the inboard side of the counterweight trunnion of the counterweight would need to be removed to make space for the assembly, a large portion of the counterweight would need to be removed to make space for the assembly and associated machinery to be removed. Unfortunately, the counterweight assembly was designed so it could only go in one

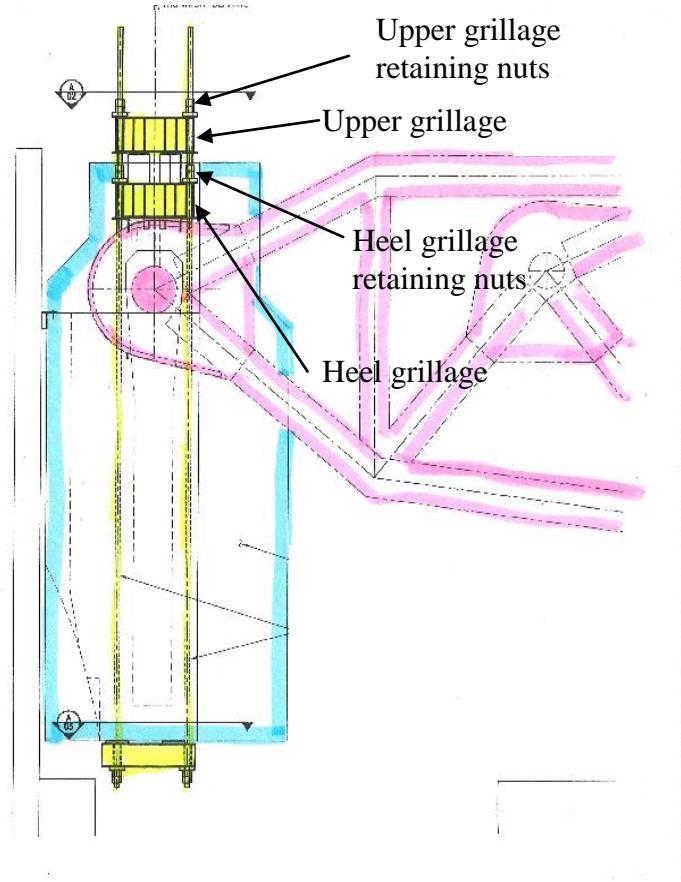
Figure 5: Counterweight Jacking System

the bottom of the counterweight, travel through the counterweight, through the heel grillage and attach to a third upper grillage, which was supported off the heel grillage by jacks. Figure 5 is a sketch of the system as was shown in the contract plans. The project specifications listed a number of requirements that the contractor's final design of the jacking system The system would must meet. require four jacks at each trunnion, acting on opposite diagonals. The jacks, rods, and grillages would be designed such that if one jack or rod failed, the equipment on the other diagonal would be able to the one half of carry the counterweight without being over stressed. The plan also required double acting jacks that could be actively raised and lowered and computer control that would allow for synchronous operation of all jacks within 0.040 inches of each

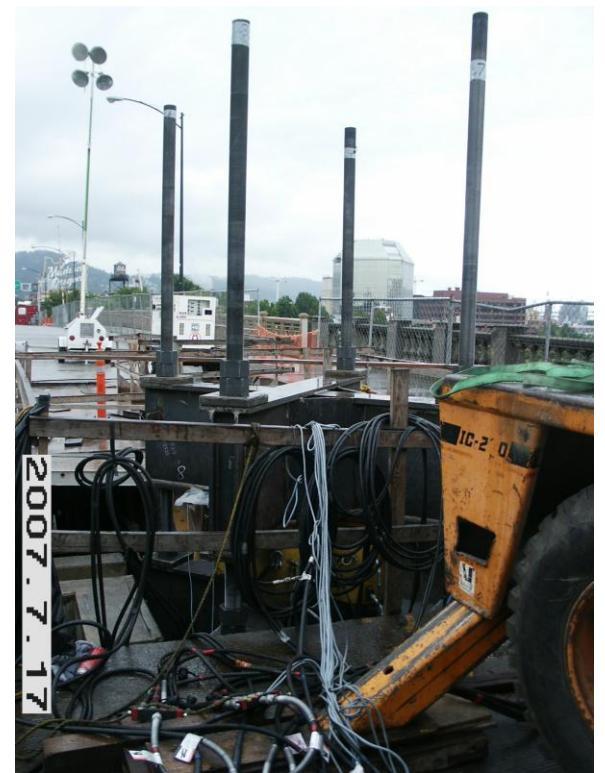
Figure 6: Counterweight Jacking Assembly

The roadway deck over the counterweight and main trunnions was removed to accommodate installation of the jacking system. Nine inch diameter holes were drilled through the counterweight to accommodate the jacking rods on the back side of the counterweight trunnion. The contractor had designed the grillage system such that the rods on the front side of the counterweight trunnions ran outside of the face of the counterweight, saving considerable drilling time. Figure 6 shows the partially installed jacking system.

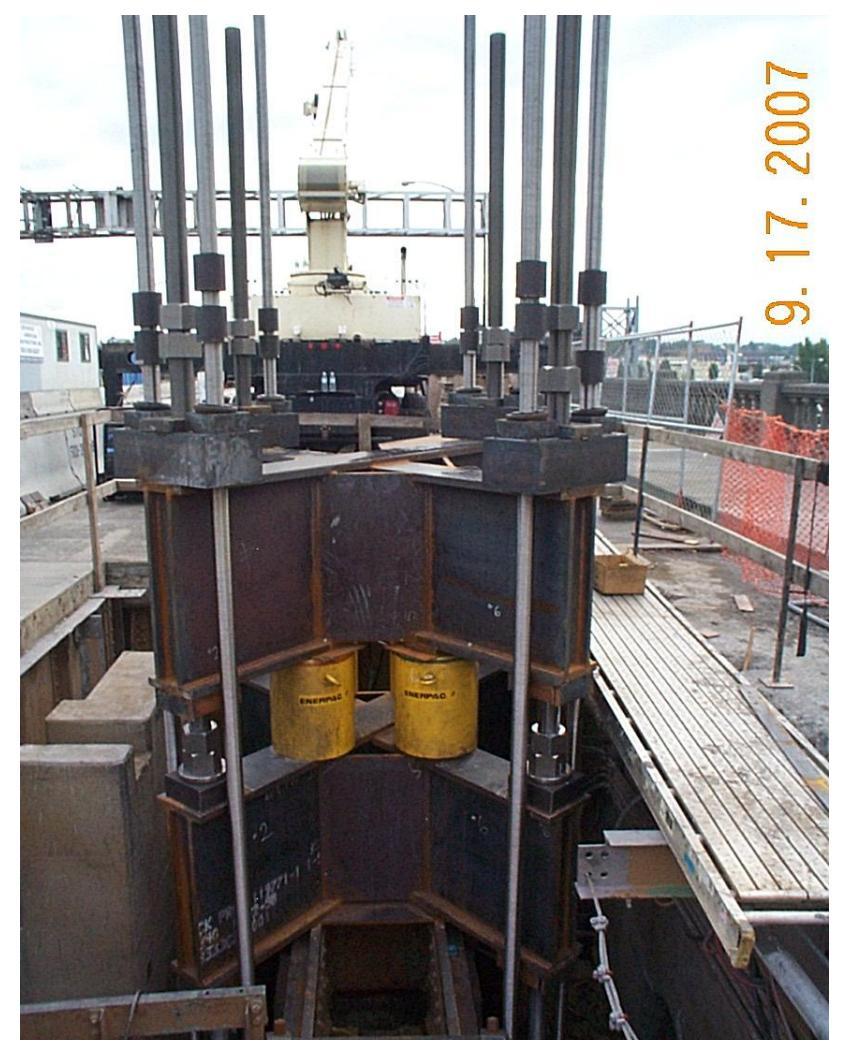
Figure 7: Redesigned jacking system

closed to traffic and the system was assembled and tested to 200%. During the test, deflection of the lifting rods and grillage caused the heel grillage rod retaining nuts to jam. A combination of the rod bending due to constraints on the rod from the grillage deflection, grillage hole size, and unevenly distributed nut/grillage bearing loads (lack of spherical washers) made it impossible to rotate the retaining nuts that kept the rods in place on the upper grillage. As a result the system had to be partially dismantled, the roadway reopened, and a modified design developed.

modified design about one month after the initial attempt to lower the counterweight. The revised design is shown assembled in Figure 7. The grillages and rods through the counterweight were left as in the original design. From the heel grillage to the upper grillage, the lifting rods were swapped out for rods with a larger thread, and extra three inch rods were installed on each side of the 4 inch rods. The three inch rods were then used for lifting the counterweight, which could then be locked off using the four inch rods in the center. That operation allowed the jacks to then lower the upper grillage for the next lifting stroke. Eliminating load on the four inch rods during the tightening of the heel grillage retaining nuts and ensuring the even distribution of load using spherical washers took care of the problems from the original system. AAC, who had initially

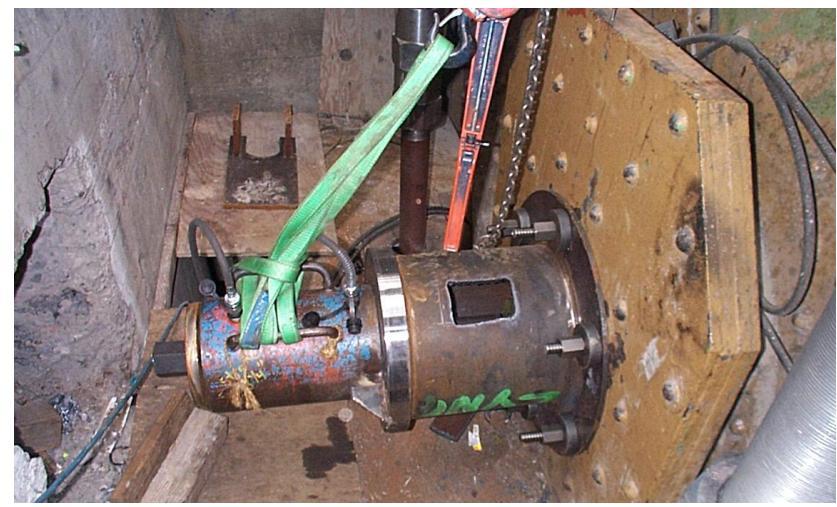
Figure 8: Trunnion Pin "pulling" Jack Assembly (pusher jack is on end of the pin).

were floating free. Next, AAC installed a jacking device to push/pull one of the trunnion pins out (show in Figure 8). At the insistence of the County team, AAC had developed the jacking system to put all of its force into the sleeve so that the hangers would not be damaged or bent. The maximum force used to try to remove the pins was 166 ton. At that force, neither of the counterweight pins would move. The County team did not want to use any additional force on the pins, so after discussions with AAC about their

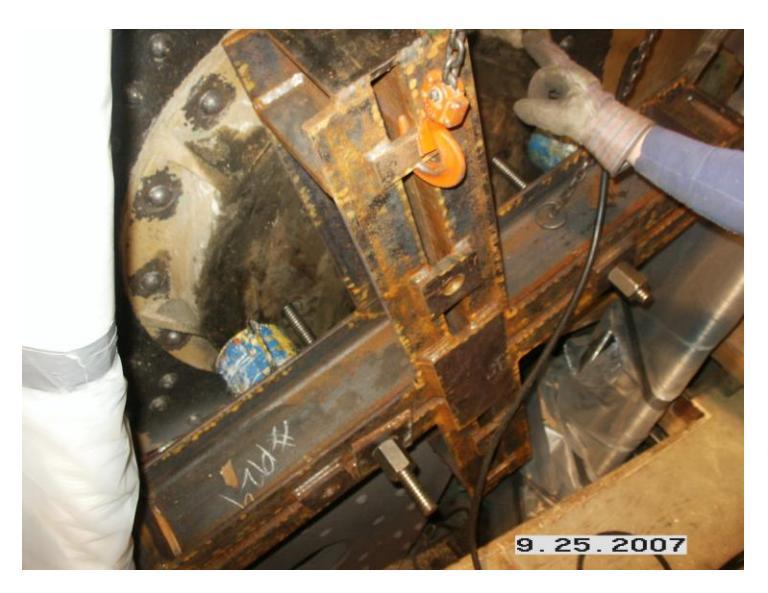
With the pins gone, the counterweight was lowered using the jacking system approximately 4½ feet, far enough that the hangers completely cleared the trunnion area of the bascule truss. Next, AAC used two 100 ton jacks (shown in Figure 10) to break the south trunnion sleeve free. With the trunnion sleeve free, they then switched to 20 ton long throw jacks to remove it the rest of the way. The north trunnion was harder to remove, but eventually was freed using the same jacking system and removed with the bushing still attached to it. This was not entirely unexpected since it was known from the initial borescope investigations that the NE trunnion was not rotating at the sleeve bushing interface. Once the sleeve was out, it was clear that the rotating surface was the

Figure 8: Removing a Trunnion Sleeve

outside of the bushing, and that all of the machine screws holding the bushing flange in place had sheared off to allow the movement.

Next AAC tried various methods to remove the south bushing, but eventually saw cut it and pushed it out with a rivet buster. Finally, the trunnion counterweight bearings were removed on both the north and south side using the same setup as was used on the sleeves to break the fit with the bascule truss. Once free, the south trunnion bearing had to be cut in half to

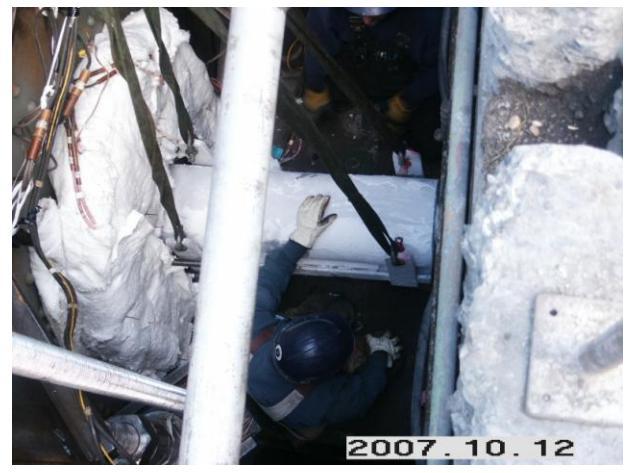
Figure 9: Trunnion Pin Installation

shrunk and then installed without further incident. Installation of the SE Trunnion pin is shown in Figure 11. The hanger plates and housing/bushing/sleeve assembly were heated with electric blankets.
