Paper No. 13

Spuyten Duyvil Emergency Response To Navigation Strikes

HEAVY MOVABLE STRUCTURES, INC.

TENTH BIENNIAL SYMPOSIUM

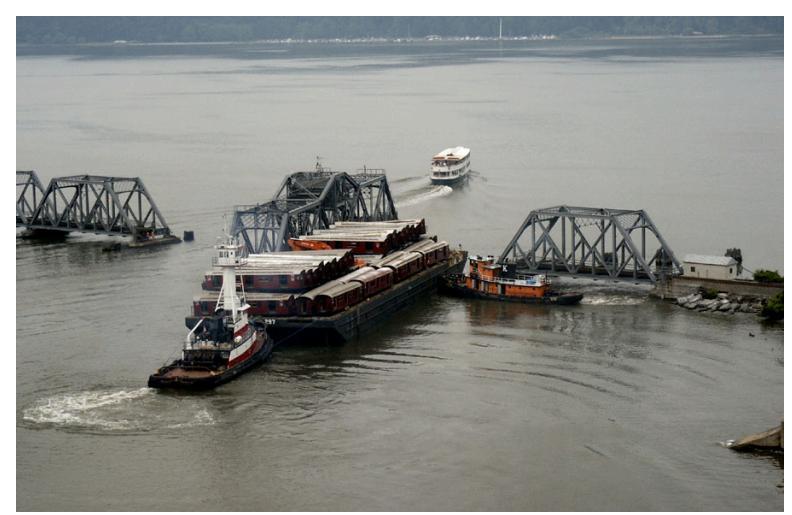
On Saturday, March 3, 2002, the Amtrak Spuyten Duyvil Bridge was struck by a barge loaded with old subway cars destined for an artificial reef site. After hours of railroad delays, Amtrak forces were able to close the bridge. Amtrak maintenance forces then noticed that not only was there obvious damage to the timber fender system and control house stairway, but the rim-bearing swing span had been pushed over 1.5 inches, thereby causing distress within the turntable structure and the electrical operating systems.

Figure 6. Barge with Subway Cars Passing through the Open Spuyten Duyvil Bridge

American Bridge and Cianbro, to the site on the following Monday to provide their evaluation and possible restoration plans. The team decided to lift-jack the 750-ton swing span in the middle, and to push-jack the span back, thus causing a reaction against the approach truss spans. Proper blocking was provided to brace the spans back to the abutments.

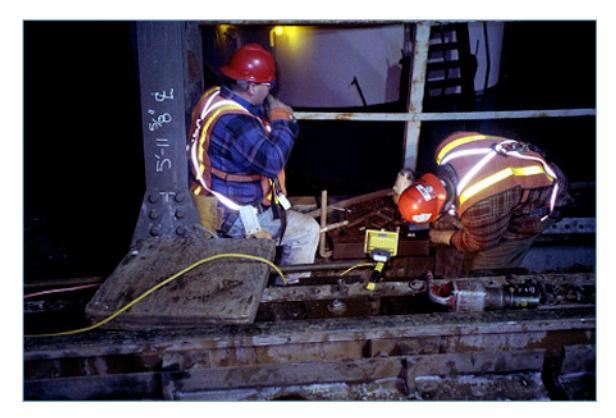
Figure 7. Emergency work through the night at Spuyten Duyvil.

Starting late at night on Friday, March 8, 2002, the team jacked (in stages) the bridge back into proper

position. We then removed the jacking to permit the span to swing. While performing test operations, the bridge partly recoiled toward the displaced position. The following Monday night, we repeated the "pushing and lifting," working the bridge to the point of successfully restoring the swing span to its proper, permanent position.

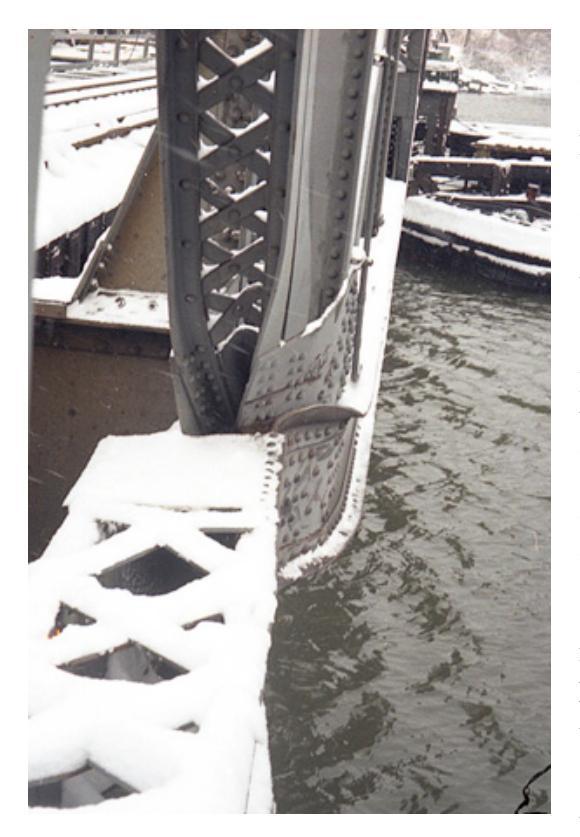
Less than one year after Hardesty & Hanover was requested to provide emergency services to Amtrak after the Spuyten Duyvil Bridge had been struck and damaged by a barge, the Designer firm again received an emergency call informing us of another navigational hit. Whereas the previous year's navigational hit merely dislocated the bridge from its center bearing, additionally, the latest strike caused severe damage to the structure, the mechanical drive system, and the electrical power supply.

Figure 8. Crushed Steel Truss Duyvil Bridge

Early Friday morning, February 7th, 2003, Alex Ostrovsky of Amtrak phoned Craig Rolwood (H&H) at home, and informed him that the open swing span of Spuyten Duyvil had been struck by a barge in the middle of the night, sending the span swinging in the wrong direction. It was conveyed that the damage comprised a deeply damaged fender system; crushed structural steel truss members at the point of impact; torn, flexible power feed cables ripped from their junction box connections; and sheared pinion shaft bearing block bolts cut from their base connections. By early morning, the span had been pulled shut using the tug that had caused the damage; however, train service over the span was suspended due to the damaged truss.

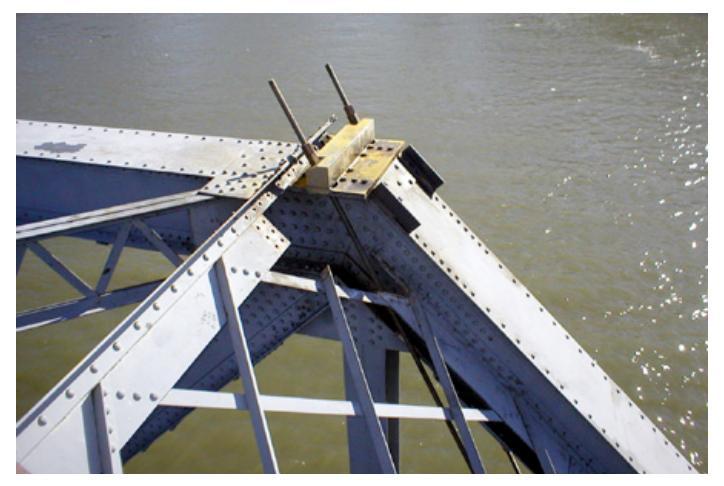
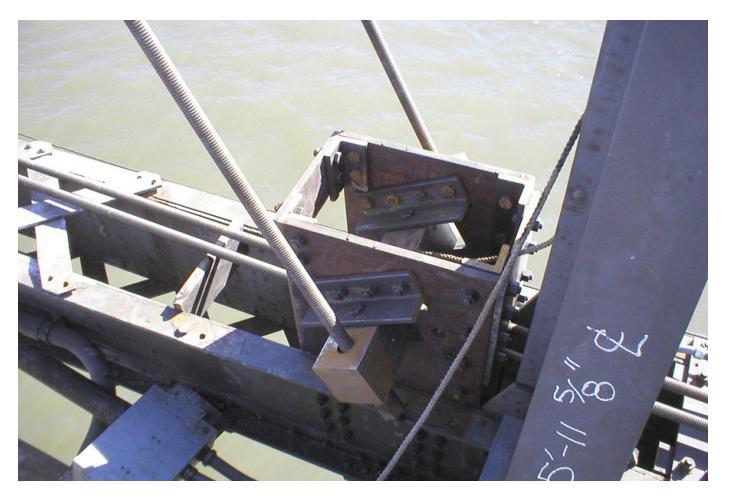
Figure 9. Temporary Steel Supports

Figure 10. Temporary Steel Supports

Over Saturday, Sunday, and into Monday, H&H worked closely with American Bridge and their fabricator to produce a temporary repair based upon available, high strength threaded rods, simple plate weldments, and field bolted connections. Designs were prepared "just-in-time," Friday evening, Saturday, and Sunday morning. The final bolt count and pattern design for one temporary piece was completed at 2:00 a.m. on Monday inside the control room of the Spuyten Duyvil Bridge. H&H supported the repair construction with field presence over the weekend. Temporary repairs were completed by Monday night.

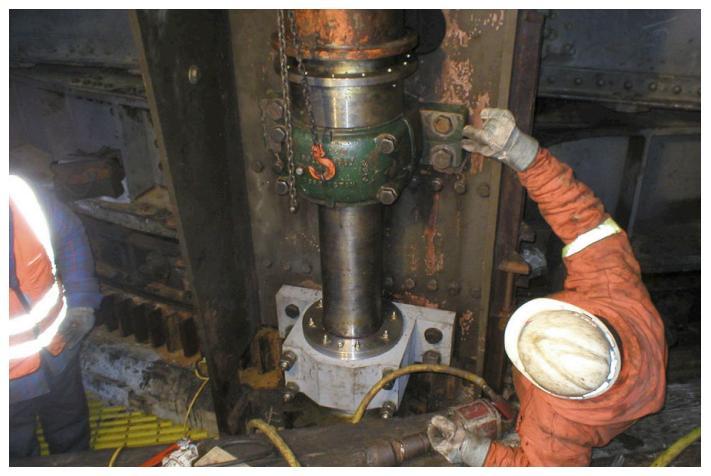
Figure 11. Mechanical Repairs of Pinion Shaft Bearings

While structural repairs were underway, the H&H electrical department assisted Amtrak in locating a source for a replacement, flexible cable. H&H's mechanical department provided assistance to Amtrak with the inspection work, the measurements taken during the jacking operation, and the reuse of the less damaged pinion, incorporating it to render the bridge mechanically operational.

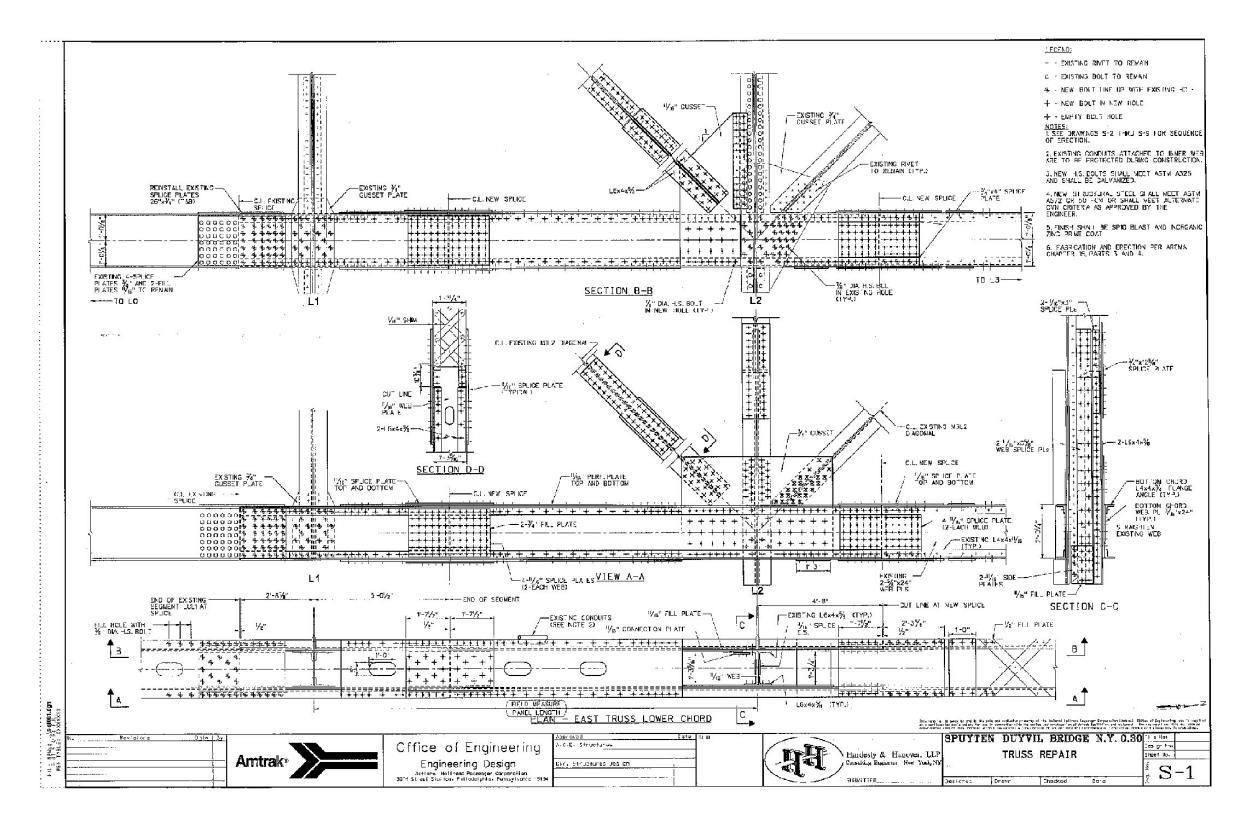
Figure 12. Permanent Steel Repairs

• One—during certain mornings in the summer, the southeast corner of the main span that had been struck and repaired, droops enough during some opening operations to just scrape across the top of the opposite wedge base ears during opening. Amtrak mitigated this condition by slightly grinding the wedge base ears to assure clearances. One plausible theory for this is that the temporary and permanent repairs performed have left a slight sag camber in the southeast corner.

Permanent structural repairs were then designed. Intensive coordination was required between Amtrak; Contractor, American Bridge; and Designer, Hardesty & Hanover to assure the constructibility of the design within tight, railroad operations windows. At this point mechanical replacement parts were ordered for installation.

Work to perform the permanent, structural steel repairs was coordinated with the repair work on the fender system, damaged from the first bridge strike incident in 2002, and the mechanical installation. The work occurred, first during the daytime, to complete that which could be accomplished during active rail operations, then secondly, at night—completing work that would foul the track.

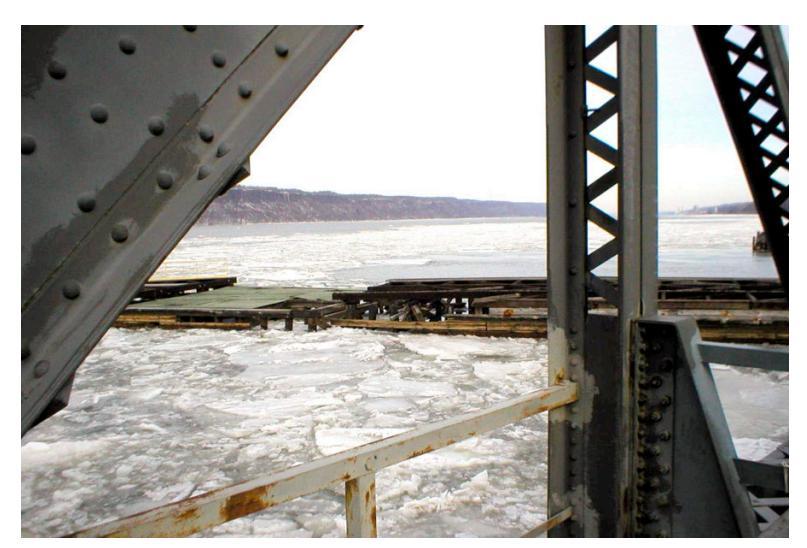
Figure 13. Heavy Ice Conditions, January 2004

ice. Some of these ice flows became lodged under the fender sheathing and among the timber pilings along the northwest corner of the fender system. The existing damage was compounded by deteriorated pile conditions, and resulted in large portions of the fender system breaking away due to the severe forces of ice flows against the timber fendering.
