# **Rehabilitation Of The Historic Bridge Of Lions**

Alan Klevens, P.E. Lichtenstein Consulting Engineers, Inc.

**TENTH BIENNIAL SYMPOSIUM**

**OCTOBER 25 - 28, 2004** The Omni Orlando Resort at ChampionsGate

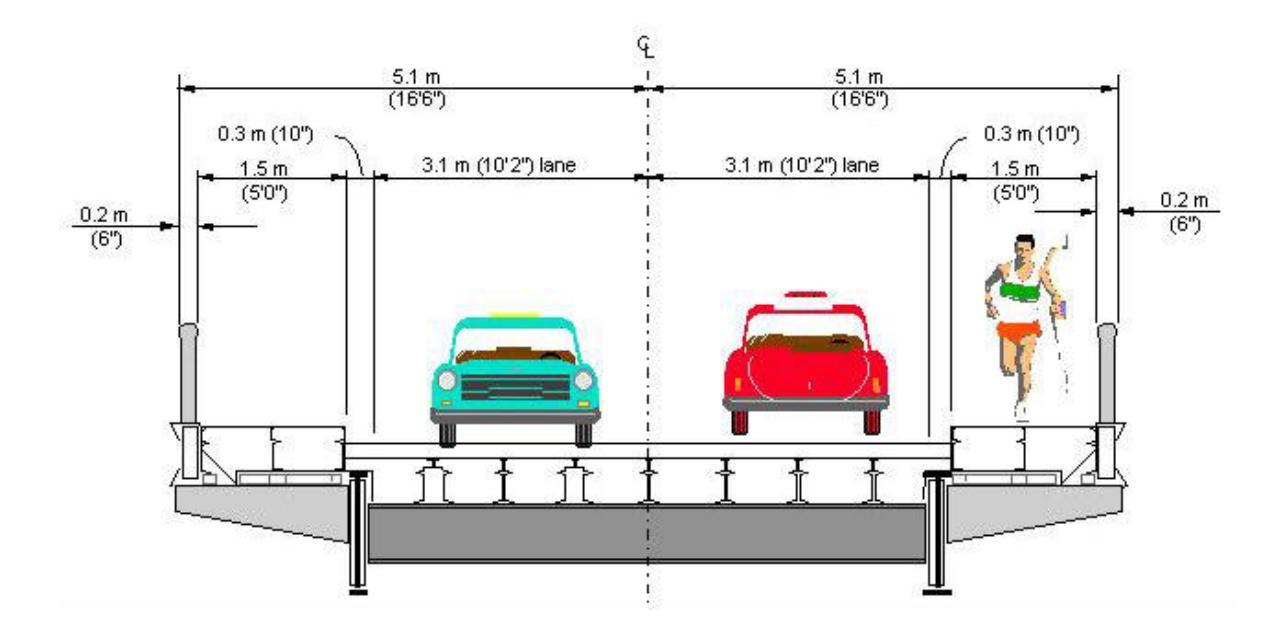
The existing bridge deck is 22'-0" from curb to curb. There are two 5'-0" sidewalks which run the full length of the bridge. The cross section is substandard because of the narrow lane widths and the lack of protection for pedestrians and bicyclists. See Figure 2. Additionally, the railing height and configuration do not meet the AASHTO requirements for pedestrian or bicycle railings.

Figure 2: Existing bascule span cross section.

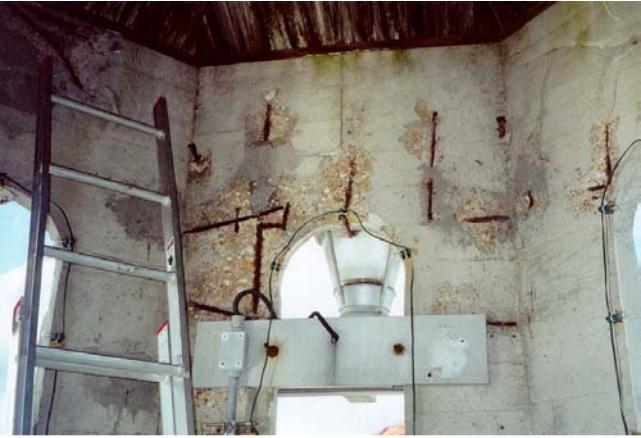
The towers require varying degrees of concrete repairs. Hollow areas, spalls, pop outs, cracks, and exposed reinforcing are present. The roofs have not been well maintained, so there is considerable damage to the cornices. See Figure 5.

Figure 5: Typical condition of interior of towers where windows have been left uncovered.,

isolated areas of deterioration, at the NW and SW towers. More extensive deterioration is evident at the NE and SE towers.

The deteriorated areas, identified and measured as part of the condition report for the bascule span, are to be repaired in accordance with generally accepted National Park Service conservation standards for concrete buildings. This includes carefully removing deteriorated areas to sound concrete, treating rusted steel, and placing new concrete to

match the existing. All work will be blended with surrounding sound concrete. Specifications include the requirement for this work to be preformed by skilled masons with demonstrated experience in concrete restoration. Approval of a test patch for the concrete finish coating is part of the project specifications.

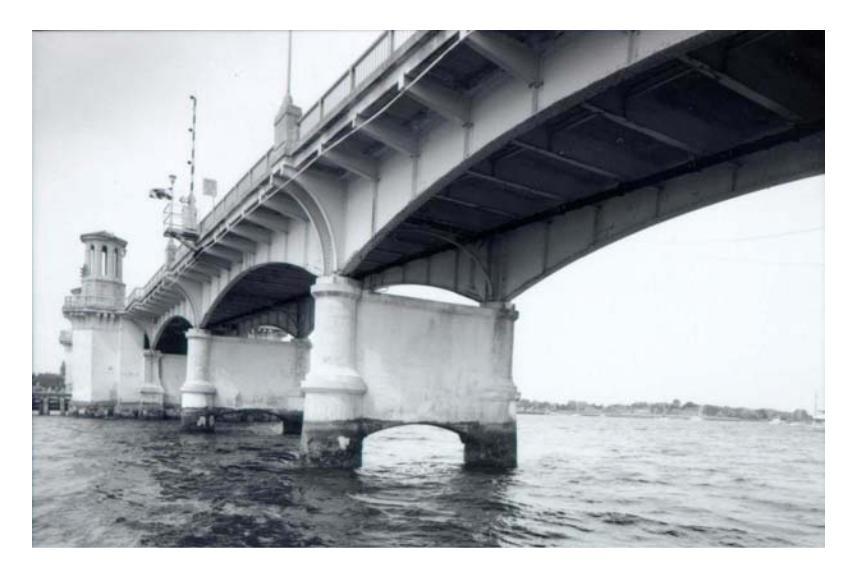
The in-depth inspection and testing program revealed that the approach span substructures were severely deteriorated and highly contaminated with chlorides. There has also been undermining and severe scour damage. As the bridge is being widened, the elephantine columns and partial web wall bents will be replicated and redesigned to accommodate the widening. The design of the existing open substructure, which is important to achieving the graceful arcaded rhythm of the bridge, lends itself well to the widening by repeating the column detail and making the plain web walls wider. See

Figure 7: Existing approach span underside and piers.

Figure 7. The in-kind replacement is in accordance with various Secretary of the Interior's standards and treatments and will compliment the reuse of the existing girders.

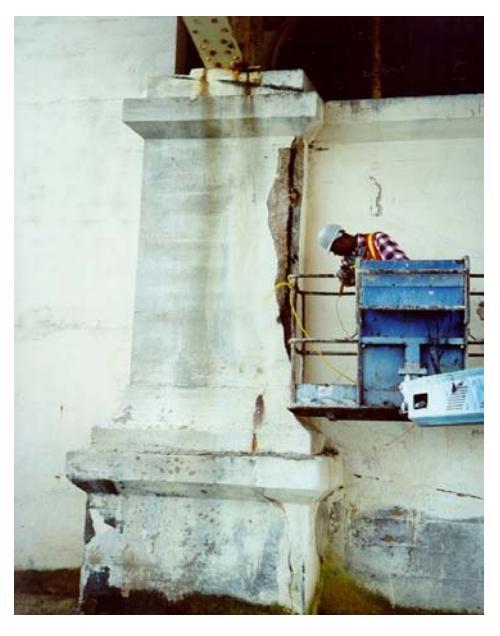
The piers typically had large spalled and hollow areas, zones of map cracking, and large open cracks due to corrosion of embedded steel. See Figure 9.

Spalls typically had exposed and corroded reinforcing steel. Tests performed on the concrete core samples were compressive strength testing, petrographic analysis, air content testing, and chloride-ion analysis.

Figure 9: Typical condition of bascule piers.

The results of the petrographic analysis indicate that the bascule pier concrete is poor to fair in quality, exhibiting non-uniform and high water/cement ratios, up to 0.65. Some air voids in the samples contained ettringite crystals, which are detrimental to the concrete due to its expansiveness over time, which may cause spalling and cracking.

Repair of concrete on the bascule piers will be done to the same matching procedures as the towers. Our inspection and testing program revealed large spalls, hollow areas, inadequate cover, chloride contamination to a depth of 6", and ettringite crystals, which in the presence of water, are detrimental to the concrete due to its expansiveness over time. Within 8' of the waterline, the chloride contaminated concrete is being removed to a depth of 6 inches. Additional thickness is being installed to allow for increased cover and the installation of an impressed current cathodic protection system. The band of extra thickness is continued around the entire pier with careful detailing at the plinth in the middle of the pier. Additionally, the openings in the counterweight pit are being sealed, and the exposed pier surfaces are being coating. These treatments should keep water from reacting with the ettringite crystals.
