# Inspection, Assessment and Repair of Movable Bridges for Local Authorities Using a System Approach

Steven Shaup, P.E. Lichtenstein Consulting Engineers, Inc.

**TENTH BIENNIAL SYMPOSIUM**

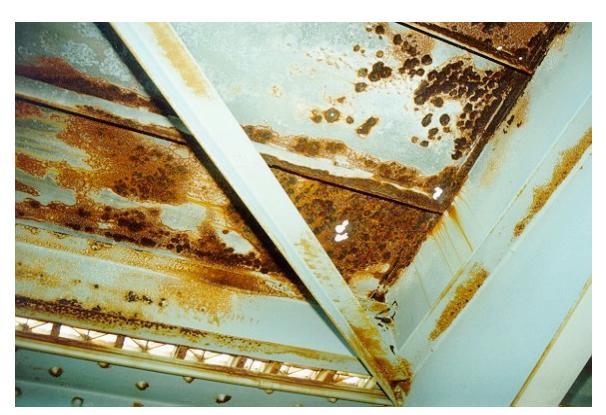
of the exterior flange plate between rivets, up to "in some locations. The steel components had areas of peeling paint throughout. Isolated welds connecting the open steel grid deck to the bascule girders and stringers had cracked. The sidewalk plates had widespread corrosion on the underside, with numerous areas of loss to the plates adjacent to their connections to the sidewalk brackets (see Figure 4). The top rail on the bascule spans had areas of 100% loss adjacent to the posts. Typical losses throughout the steel members ranged up to 1/8" deep. Where seat angles were present under stringers, bascule span floorbeams had losses in localized areas up to full web thickness, creating up to 1" diameter holes. Tie plates between the sidewalk brackets and main girder had up to 80% section loss.

Fig. 4 Holes in sidewalk plate, Main Street Bridge

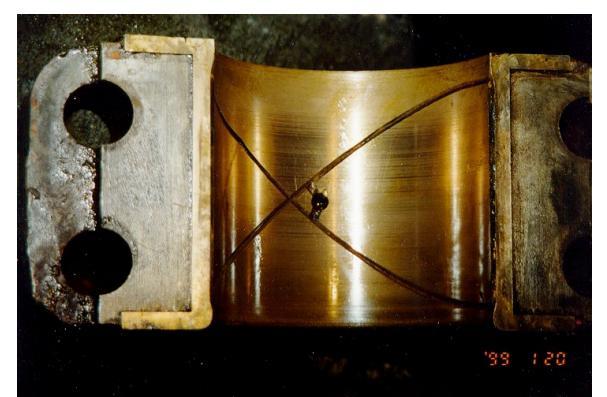
At High Bridge Road, the bearing cap grease grooves formed an 'X' pattern, but the lube ports only partially intersected one groove; at one location the lube port did not intersect either groove (see Figure 5).

Fig. 5 Misaligned lube port, High Bridge Road Bridge

Makeshift channels had been gouged into the bushing to connect the groove to the port. With the spans fully opened, the visible portions of the trunnion journals at High Bridge Road revealed significant scoring, with metallic particles visible in the grease at one location. The bronze bushings in the base of the housings did not have any grease grooves resulting in a lack of directly applied lubricant. Due to corrosion caused by moisture-trapping debris, the cap bolts at one trunnion bearing had to be replaced during the inspection.

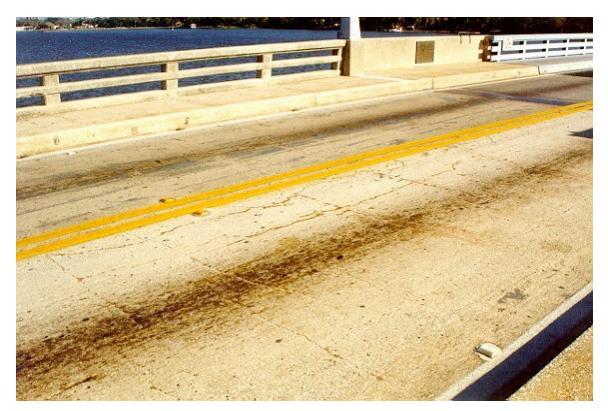
At Orange Avenue, the flanking span decks had significant cracking up to 1/8" wide throughout the deck top, and map cracking up to 1/16" wide on the deck underside (see Figure 6). The Hopkins Frame support for the machinery at this bridge had several cracked welds between the main vertical wide flange supports and a stiffening plate.

Fig. 6 Flanking span concrete deck, Orange Avenue Bridge

In 2001, plans were prepared for various rehabilitation items at Orange Avenue. Work included replacement of the concrete deck and railings on the flanking spans (item 7), cleaning and painting the flanking span steel beams and bearings, repairing the worst spalls on the deck, superstructure and substructure elements (item 25), replace bracket tie plate at one location (item 26), replace bascule span sidewalk plates (item 27), replace top portion of bascule span steel railings (item 29), provide bolts to supplement existing cracked welds at Hopkins frames (item 32) and hydrodemolishing the top 1" of

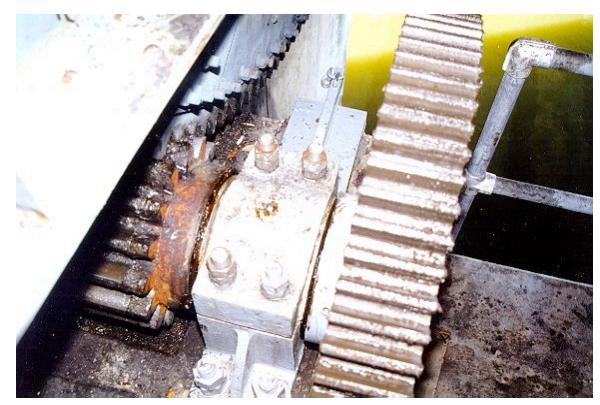
During prior repair work done at Main Street, problems were encountered during bearing installation. Epoxy used for anchor bolts had apparently failed and the anchor bolts pulled out of the pedestals under operating loads, allowing the bearings to move. The county had installed a restraint fastened to the back side of the concrete supports to limit movement (see Figure 7).

Fig. 7 Restraint at back of concrete support, Main Street Bridge

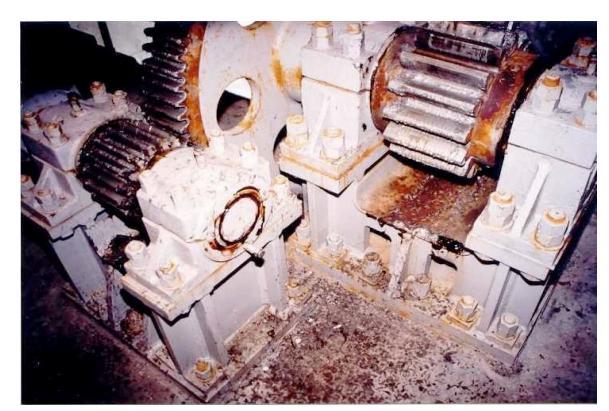
In 2000, plans were prepared for replacement of the concrete bearing pedestals at Main Street with steel weldments providing a common support for all four bearings at each corner of the span (item 4). As part of this work, an analysis of the existing machinery was also performed to determine the source of

problems with the span drive bearings, including movement of rack pinion shaft bearings, heat buildup, poor alignment and corrosion of the bearing journals. The analysis indicated that the span drive bearings were sufficiently sized; overheating of the bearings was most likely due to physical deficiencies with the bushings and housings, including small grease grooves, no chamfers at bushing split lines and poor alignment. The scope of the work involved in the repair project was increased to include re-setting the motor and machinery brake torque settings, modifying the bushing design for all bearings and specifying appropriate alignment tolerances and clearances for all rehabilitated bearings (items 11 and 24). Work was completed in 2001 (see Figure 9).

Fig. 9 New machinery supports, Main Street Bridge

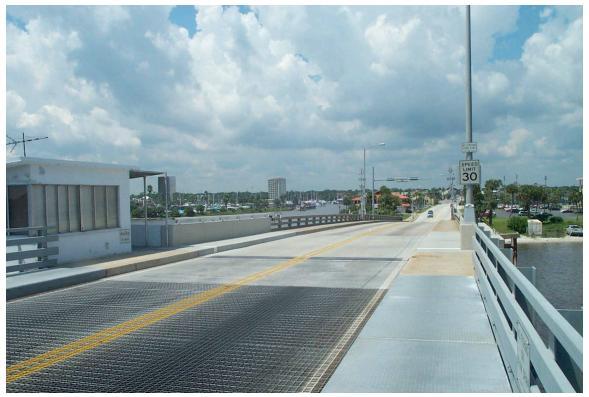
Fig. 10 Completed rehabilitation work at Orange Avenue Bridge

concrete in the filled steel grid deck and repouring it with latex modified concrete (item 84). Work was completed in 2003 (see Figure 10).
