## HEAVY MOVABLE STRUCTURES, INC. TWENTIETH BIENNIAL SYMPOSIUM

# Gear Couplings: Design, Maintenance, and Inspection Lessons Learned from Past Issues Adrian E. Soltys, PE. Wiss, Janney, Elstner Associates, Inc.

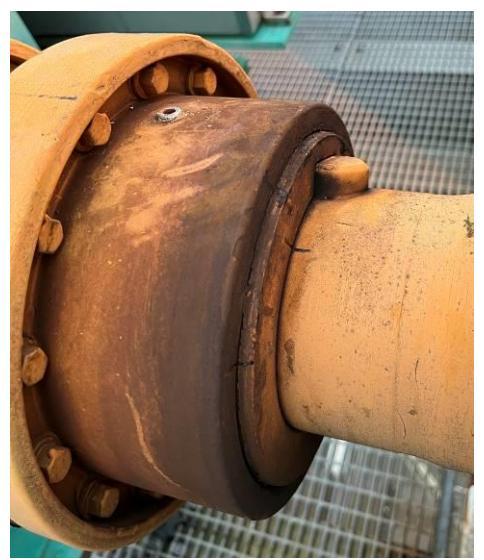
The initial challenge was twofold: identify what failed and take steps to safely lower the span to reopen to traffic, and then assess the extent of collateral damage and develop immediate repairs restore operation of the lift span. Mechanical engineering/inspection personnel responded on an emergency basis as part of a team with a bridge industry Contractor to assist in this initial effort. A remote visual inspection of the machinery via videoconference was performed. This inspection identified several line shaft couplings with external evidence of internal corrosion. See Figure 1. A coupling failure was immediately suspected.

Figure 1: Coupling immediately after failure. Note fretting on exterior of the coupling sleeve, indicating internal corrosion of the coupling.

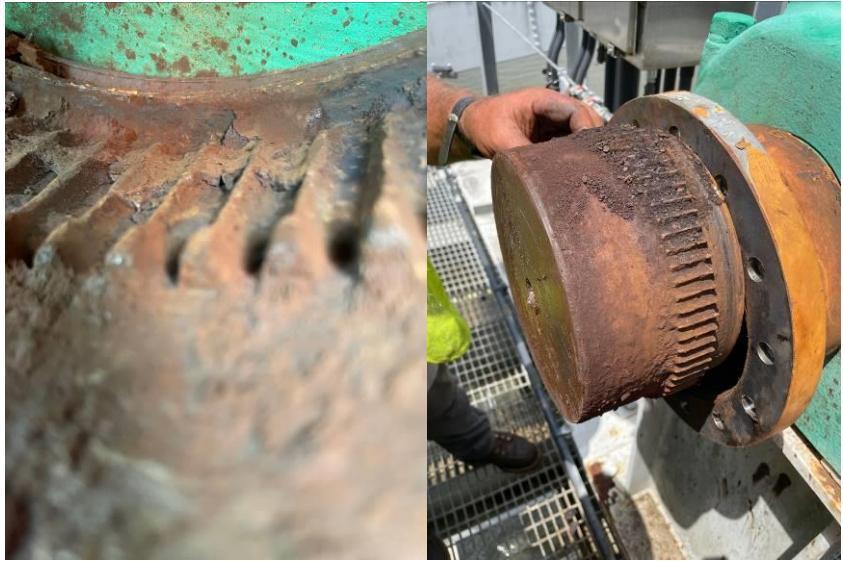
inspection was performed to determine the cause of the failure. It was found that the coupling gear teeth were severely deteriorated due to wear and corrosion. No grease was present within the coupling. See Figures 2 and 3.

Figure 2 (Left, Sleeve) and 3 (Right, Hub): Inspection of the failed coupling. Note lack of grease, excessive corrosion and wear present.

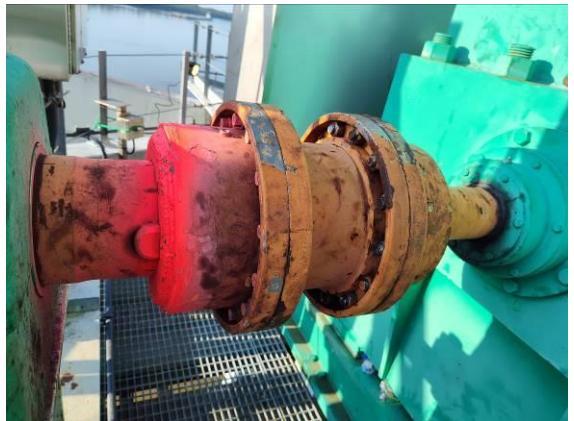
Figure 4: Weld was placed at the hub-sleeve interface of the failed coupling, marked in pink.

In order to return the bridge to service, a temporary fix was proposed to allow time for procurement of a new coupling for a permanent repair: weld the coupling sleeve to the coupling hub around the circumference of the sleeve-hub interface. This would effectively transform the flex-flex coupling into a flexrigid coupling. Prior to proceeding with this course of action, the alignment of the coupling was measured and it was determined that the coupling was very well aligned. It was decided by the Owner that welding was an acceptable temporary repair and the work

was executed by the Contractor, photographed in Figure 4. The lift span was authorized to be operated at a reduced speed and a reduced frequency of operation to limit the number of cycles on the weld and remaining line shafts/couplings.

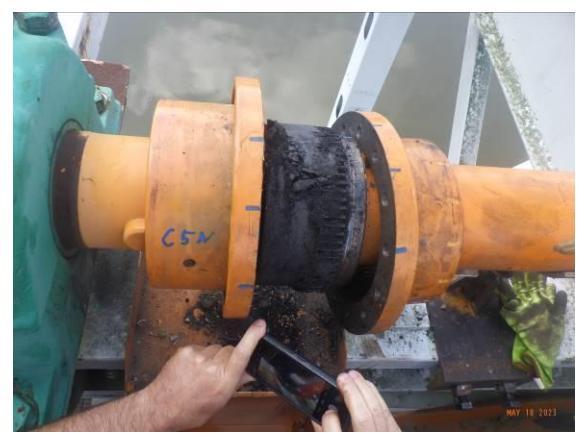
Figure 5: Coupling immediately after disassembly. Note hardened grease covering gear teeth.

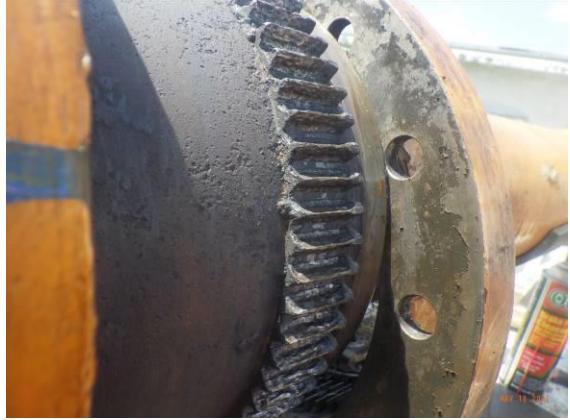
Figure 6: Coupling shown in Figure 5, after grease debris was removed. Note heavily worn and degraded gear teeth.

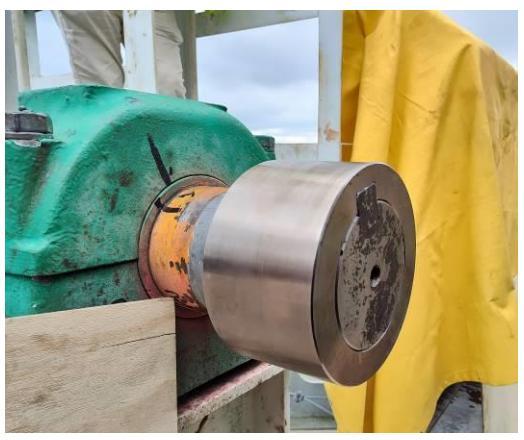
Figure 7: Custom coupling sleeve slid over the shaft, indicating the new coupling hub may be installed.

- 7. The shafts were cleaned and checked with the custom sleeve. It was discovered that each shaft and keys needed to be dressed up with sand-paper and flat stones before the sleeves were able to be installed with ease. See Figure 7 for a photo of the custom sleeve hub shown placed over the dressed-up shaft.

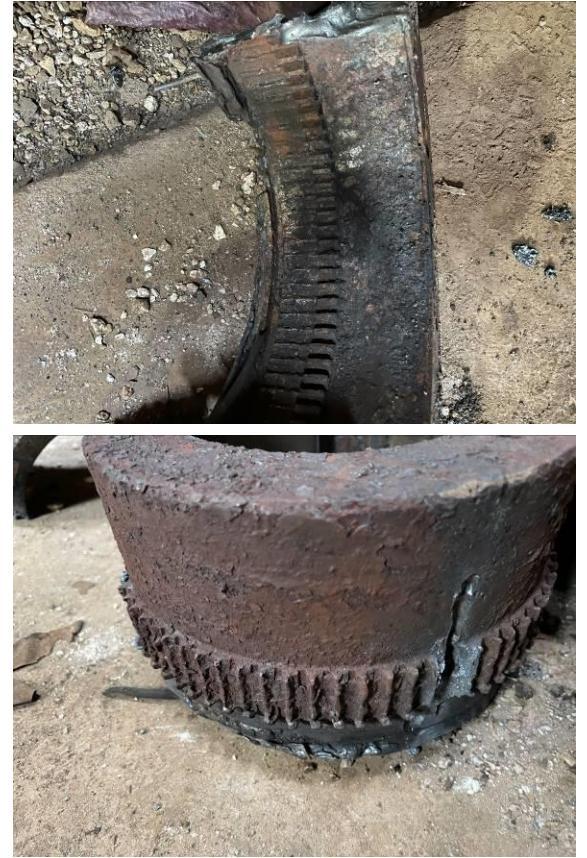
Figures 8 & 9: Photos showing the internal condition of the failed coupling. Note excessive wear and corrosion on gear teeth, with similarity to couplings shown in Case I. Also shown burn marks were inflicted during coupling disassembly from shaft.

coupling was the unit that experienced the failure. The failed coupling showed wear and corrosive damage to the gear teeth, which were no longer able to mesh and transfer torque. Figures 8 and 9 show photos of the internal condition of the failed coupling.

Procurement for a replacement coupling hub proceeded immediately after the coupling failure. It was found that a stock replacement coupling hub that was finished bored and keyed was immediately available from a warehouse. A review of the tolerances for this coupling found that while the fits for the bore and key were not 'per Code', they would meet the requirements of the coupling manufacturer. The ability of using the stock bore size of the coupling greatly reduced the total duration of the outage of the machinery. The new stock coupling was installed and operation of the leaf was restored within 48 hours

of the failure. Subsequent to the emergency repair a new floating shaft was procured as a permanent repair.

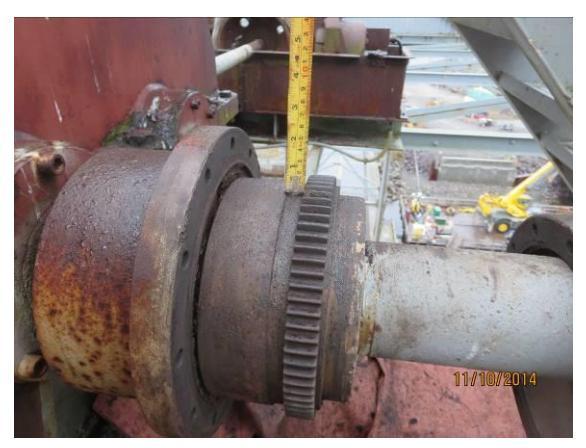
Inspection of the remaining couplings was undertaken immediately after the failure. The couplings were disassembled and were found in various stages of deterioration. Most couplings had issues of corrosion and excessive wear due to lack of lubrication and moisture intrusion. The couplings that only had light corrosion, and whose teeth appeared to be in good condition, were left in service. Otherwise, couplings that exhibited corrosive pitting, a battered appearance, any damage on the coupling gear teeth, were replaced (Figure 11).

Figure 11: Photograph showing coupling with corrosive damage to be replaced.

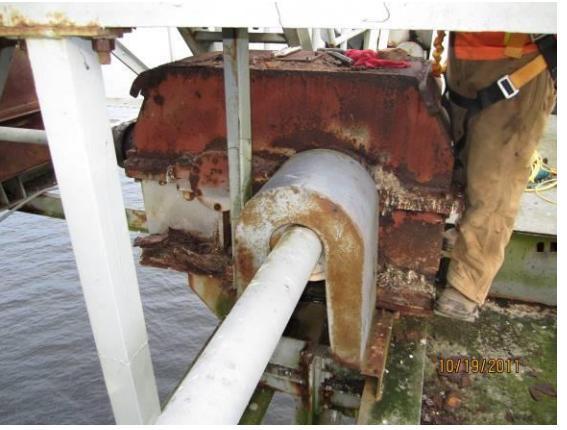
The installation date of the couplings was not available; however, the couplings could have been in service for as long as 55 years prior to experiencing catastrophic failure in 1 of 16 couplings. Similar to the previous two cases, the coupling failed in such a way that neither rotational movement nor torque were transferred from the coupling hub to the coupling sleeve. As the machinery system was operating, the coupling hub appeared to be rotating within the stationary sleeve as the internal coupling gear teeth were unable to mesh. It was noted during the inspection efforts that the metal covers over the shafts and couplings were difficult to remove, and the couplings were difficult to access for maintenance purposes, shown in Figure 10.

Figure 10 (above): Photograph showing coupling obscured by its protective cover.

- 4. Access for inspection and maintenance is important. For two of three cases, the couplings were covered. While covers may offer some benefits in terms of safety, they interfere with visual observation of the covered components. Consideration should be given to using alternatives to covers, such as guard rails, for protection of personnel from rotating machinery.
