## HEAVY MOVABLE STRUCTURES, INC. TWENTIETH BIENNIAL SYMPOSIUM

# Rehabilitation of the FEC MP260.93 Single Track Railroad Bridge St. Lucie River Stuart, FL

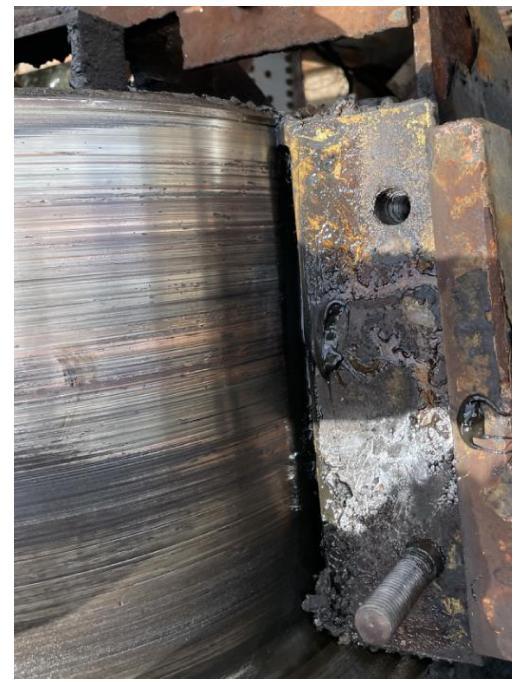
As Found Trunnion Journal

The trunnion journals had been damaged due to a lack of lubrication over the years and needed to be machined back to the AREMA specification of 8  $\mu$ in Ra surface finish for trunnion journals. The predicted amount of stock removal needed to reach 100% cleanup was less than 0.15" per side. To be safe, new bearings were manufactured to be 3/16" per side smaller than the original Ø20" nominal trunnion size.

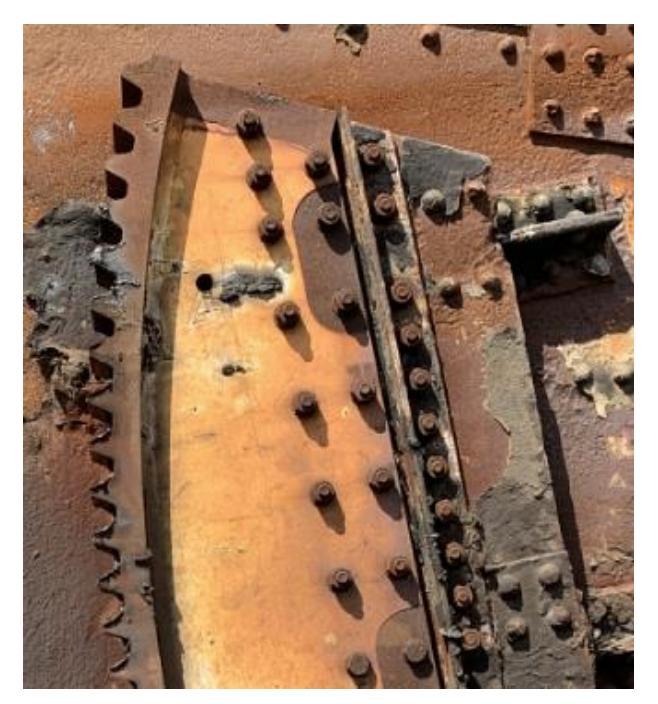
As Found Rack Teeth

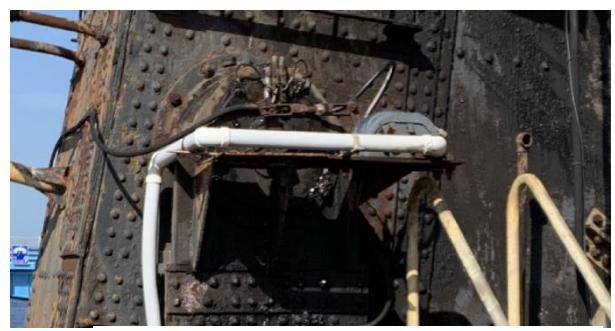
Unfortunately, this was not going to be possible. The location of the existing limit switch used to signal the system of the leaf's location, was in the direct line of site. And because of its age and the risk of damage, moving the switch was not possible.

Line of Site Obstructions

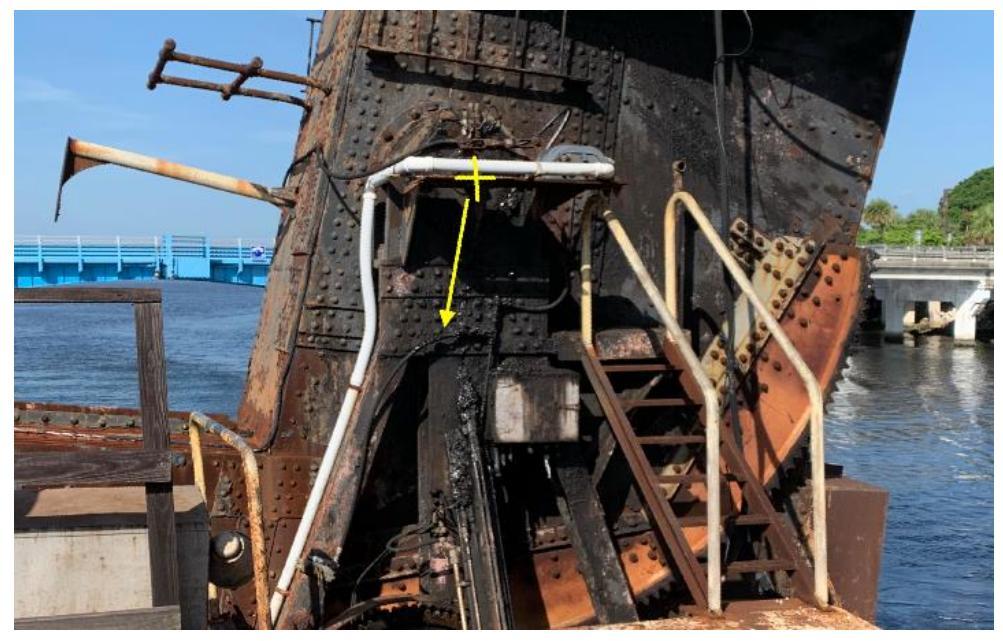
A significant amount of data was obtained during this first survey and the analysis of the data revealed the centerlines of the East and West trunnion shafts did not point at each other. They were each pointing downward and a bit south. Over the 100-year life span it was obvious that the two inboard journals had settled more than the outboard journals and were leaning toward the shore at an angle approximately 180° from the fully open position of the span.

As Found Tilt of COR

Unfortunately, the angles of the East and West CORs created by the independent trunnion shafts were not square to the span. This was a concerning issue as the parallelism between the two interior girder webs were significantly out of parallel. Tying the mesh of two sets of rack & pinion gears together in a straight line through the machinery was going to be an issue. The decision to leave these (2) independent CORs in the "as found" condition or to try to correct this issue would require more data.

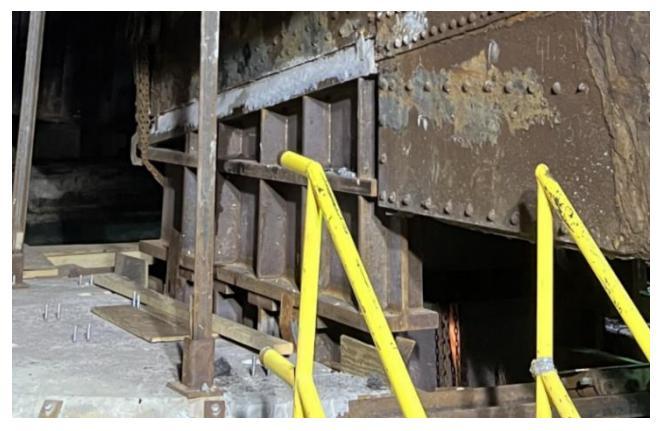
improved by approximately 50% toward being level but the toe end of the span started to move. The descision to stop was made and the load was fully transferred over to the False Work.

Span Alignment Through Cribbing.

With the span in this slightly modified location, a new set of dimensions were taken and a new 3D model was created and analyzed. *The results were good.* The approximate 0.6° of misalignment had fallen to under 0.3°. This level of missalignment was now within the allowable range listed in the specifications for the pinion shaft couplings.

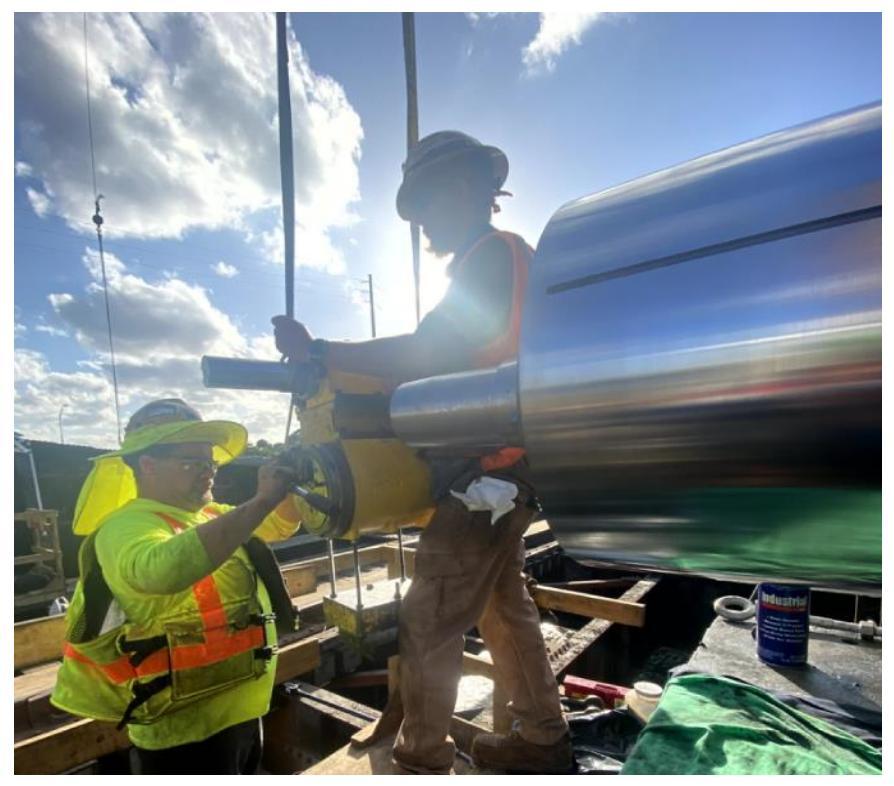
Inboard East Trunnion - Completed

It was now time to machine all (4) trunnions to the Ø19.625" RC6 fit specified. Train Traffic was to remain uninterrupted throughout the machining.

With (4) machines running simultaneously we successfully achieved the fit and finish required and within the budgeted time frame.

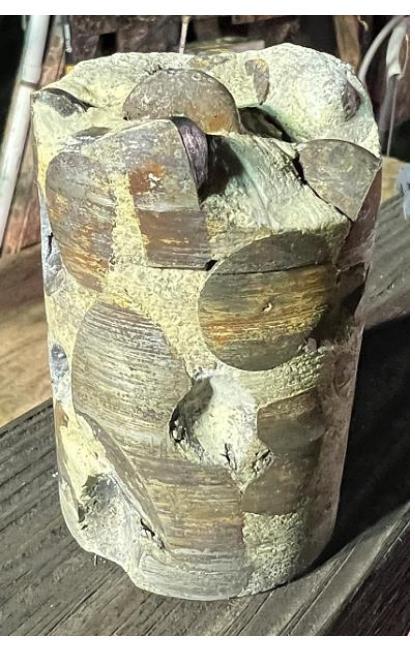
- 1. Total outage time was to be limited to 21 days.
- 2. The existing rack was in the way.
- 3. The girder webs were not parallel.
- 4. The weather damage was significant.
- 5. Half of the landing zone was hollow, and the other half was filled with a slurry of concrete and steel punchings.

Sample of concrete and steel slurry

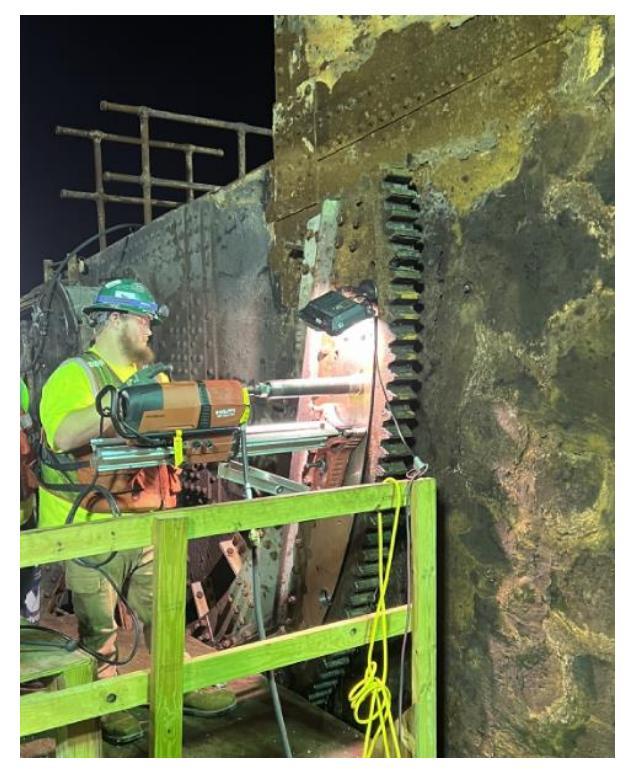
Core drilling Hole #1 - East Girder.

After mounting the plates, machining of the clearance holes through the girder web averaged a little less than (1) hole per night.

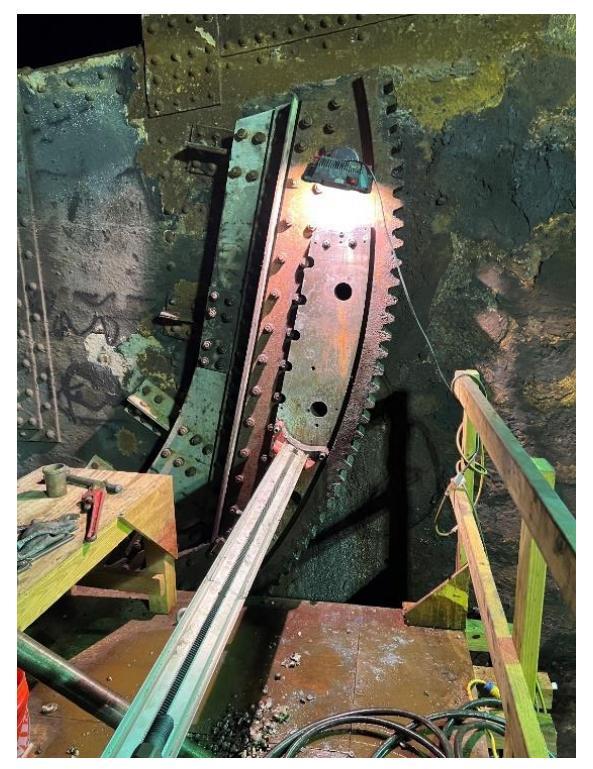
Holes #1 and #2 Completed – East Girder

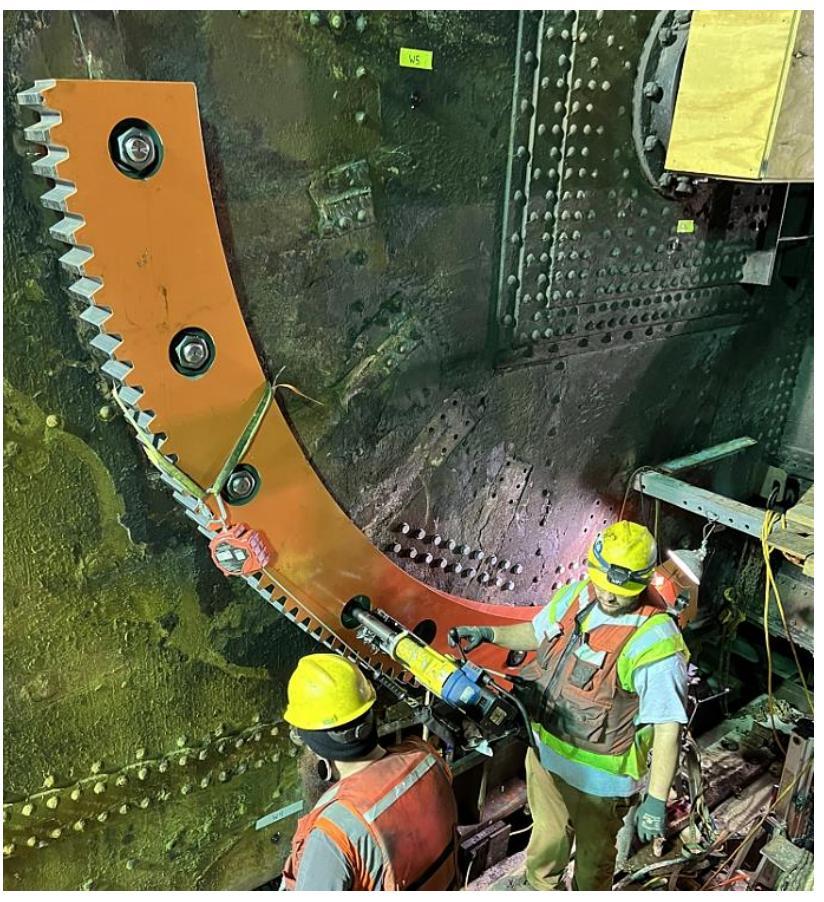
Machining RC5 Fit on Hole #4

From there, we removed one temporary fastener at a time, finished the subdrilled holes to the RC5 fit, and installed the final hardware.
