HEAVY MOVABLE STRUCTURES, INC. TWENTIETH BIENNIAL SYMPOSIUM

FDOT Sheridan Street over ICWW Bascule Bridge Rehabilitation Project Jordan N. Robbins, P.E. & G. Alan Klevens, P.E. PCL Construction, Inc. & TranSystems Corporation

Background/Introduction

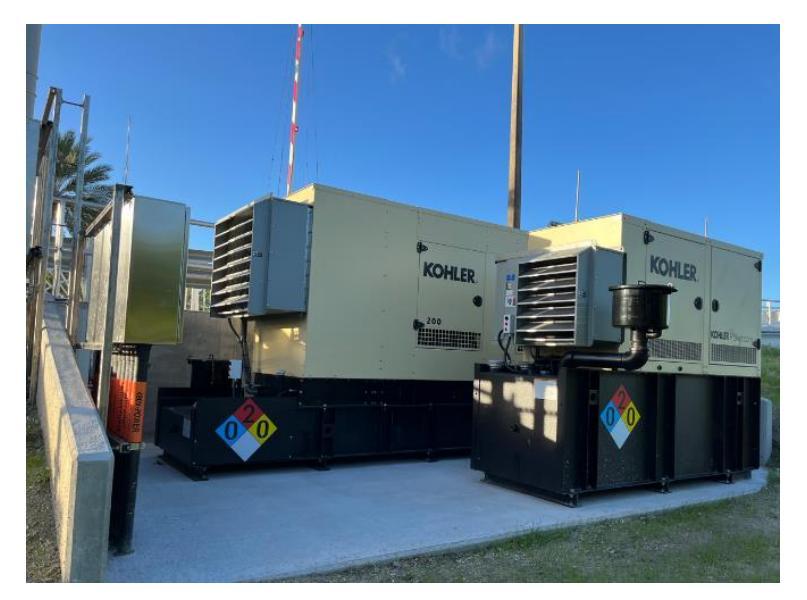
FIGURE 6: Standby Backup Generators

Due to the supply chain issues from the COVID-19 pandemic, the lead time for the 60 kW and 200 kW standby generators was identified as a schedule impact as soon as the project was awarded to the Contractor. The issue was that the generators would be arriving after the scheduled 90-day bridge closure,

The Consultant performed generator load calculations to confirm the existing bridge generator could support the new control house loads. A decision was made to relocate the existing generator from the control house to the new concrete generator pad, provide a temporary 200 kW main generator (furnished by an equipment rental company), and integrate both temporary generator sets into the new control system as back-up power until the new generators arrive.

This collaborative solution allowed the 60-day functional acceptance testing period to commence after completion of the structural, mechanical, and control system upgrades. After receipt of the permanent generators to the project, the Contractor removed the temporary generators, installed the permanent generators, and performed testing to confirm the new generators were functional with the new control system.

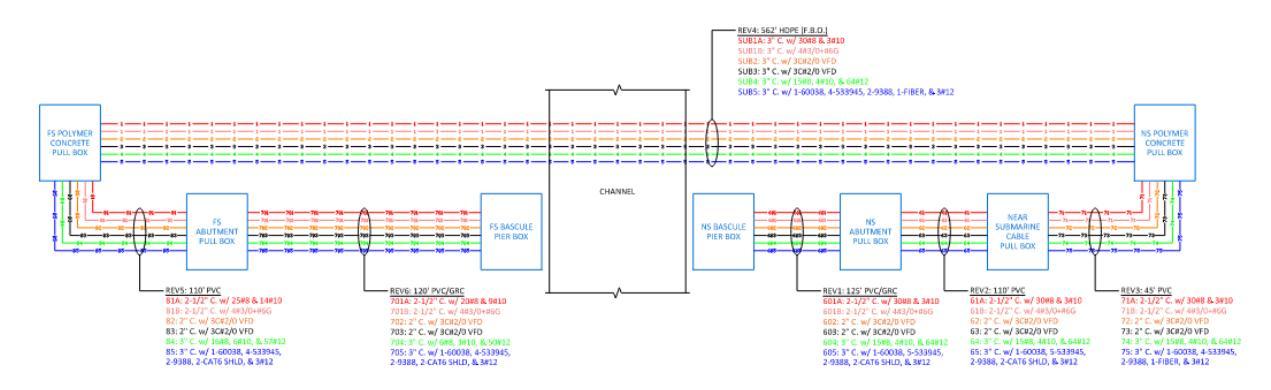
FIGURE 9: Revised Submarine Conductors and Conduits

The original design for the submarine conduit path was developed using the shortest path achievable based on the minimum bend radius for the HDPE conduit, which could be achieved by digging directional bore termination pits within the Intracoastal waterway. This resulted in a submarine conduit run of roughly 400 feet, which is approximately the width of the waterway from seawall to seawall. Due to the potential damage to the seawall that could have been introduced by these construction methods and the additional permit efforts to get these excavation methods approved by permitting agencies, the team was tasked with coming up with an alternate approach that would avoid extending the overall project duration.

The Contractor challenged its directional bore subcontractor to come up with the possible bore profiles that would mitigate cost impacts to the Department. Based on survey of the existing conditions and the capabilities of the directional bore machine drill rods, the directional bore contractor proposed a 577-ft long bore that achieved the minimum-required depth below mudline using the allowable permitted construction methods. The 577-foot option also offset the directional bore exit and entry pit locations to minimize interference with the seawall, fender piling, and new concrete generator pad. In anticipation of the increased length of the submarine conduit, and roughly 400-foot overall increase to the circuit, voltage drop calculations were rechecked for the original conductor sizes. It was determined that the additional length for the main power feed resulted in a need to upsize both the conductor ampacity and the size of the conduit, as well as the addition of sinewave output filters for the far side variable frequency drives. Due to the issue being identified prior to construction, the electrical contractor was able to accurately re-arrange the layout of the electrical cabinets, devices, and raceways, and order the appropriate materials without affecting the critical path of the project.

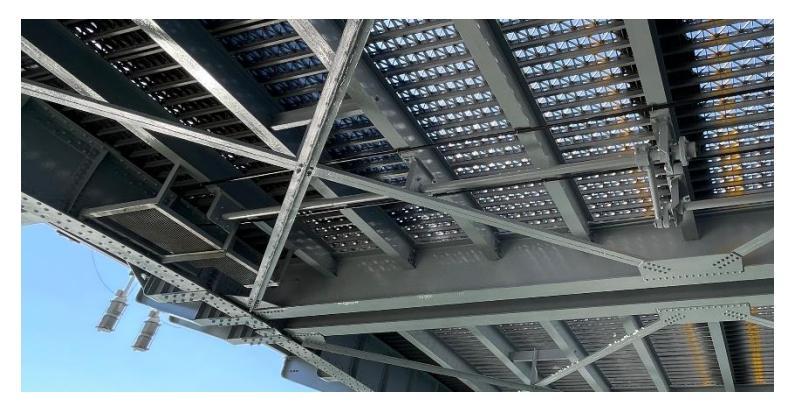
FIGURE 10: Abandoned Span Lock Shafting

After the live load shoes were replaced and the load was equalized, the Contractor discovered an undocumented as-built condition in the existing bascule span structural steel. The bascule span leaves were found to be "twisted" in opposite directions with respect to each other, and deflect significantly under live load, producing vibration at the tip of each leaf. The vibration was perceived by the Department to be excessive and was exacerbated by the impact loading received at the tip of each leaf due to the difference in elevation. The twist was such that the east leaf was higher than the west leaf at the south curb line and the west leaf was higher than the east leaf at the north curb line. This twist meant that vehicles traveling in both eastbound and westbound directions impacted the leaf tips as they crossed the centerline floor break. In order to reduce the impact of wheel loads at the leaf tips and reduce the perceived vibration, the Owner and Consultant team determined the twisting could be reduced and the elevation differences between east and west leaves could be minimized. In coordination with all contracted parties, the following procedures were completed:

- Measurements were taken at the tips of the leaves under a zero live load condition
- Abandoned span lock shafts • and access platform was removed from the east leaf to reduce dead load deflection and overall weight
- Counterweight plates were added near the west leaf tip, inside of the north span lock enclosure to induce deflection at the corners (opposite to the existing twisting).

- East leaf live load shoes were shimmed to be tight and achieve live load sharing. •
- The west leaf live load shoes were shimmed to raise the tip of the west leaf while achieving load • sharing and minimizing the difference in tip elevations between the east and west leaves. Final tip differences between east and west leaves of less than +/-5/16" were achieved and deemed acceptable. This iterative process can be found in Appendix A.
- The leaf twisting and final shimming resulted in elevation differences between sidewalk plates in both north and south sidewalks. Custom aluminum ramps with non-slip surfaces were added to equalize the elevations.

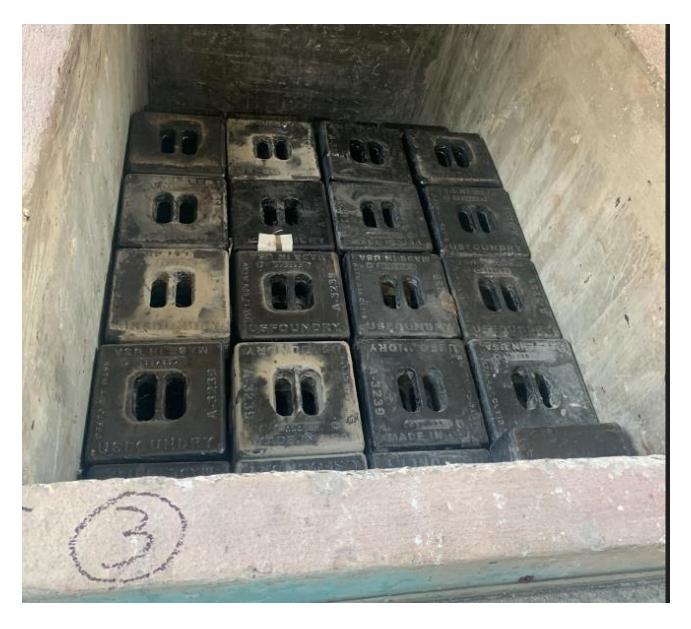
FIGURE 13: Painted Cast Iron Balance Blocks

The bridge twist issue also resulted in impacts to the bridge balance. The contract documents called to replace the existing concrete blocks in the counterweight pockets with a maximum of 1400 cast iron balance blocks. After all cast iron blocks were installed to offset the effects of the added weight on the spans, including the final toe counterweight to offset the bridge twist, the Contractor was unable to return the bridge to its initial balance state of a roughly 2000-pound toe reaction.

Since the lead time to procure more cast iron balance blocks would have resulted in a delay to the overall project, the Contractor worked with the local bridge maintenance company to procure additional balance blocks. The Contractor installed these blocks during regularly scheduled bridge openings to avoid impacts to traffic. Using the balance spreadsheet, the Contractor installed additional blocks until it calculated a seated reaction that was nearest to the original condition. After concurrence with the calculations, the project's balance engineering consultant performed final pressure transducer balance measurements. Minor modifications to the number of balance blocks in the pockets were made, and with concurrence by the Consultant the team was able to achieve a final balance condition for each leaf of roughly

3000 pounds (toe reaction) and acceptable angle of imbalance.

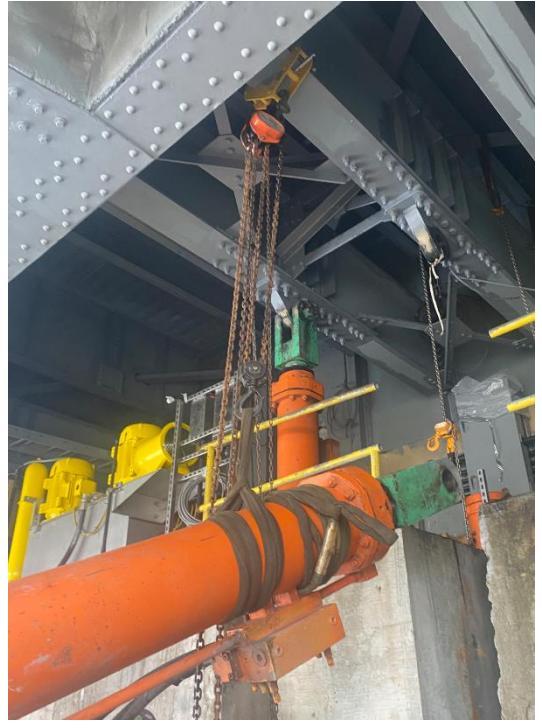
FIGURE 15: Removal of Hydraulic Cylinders

Prior to the bridge closure, the Contractor's hydraulic subcontractor was able to unpin the clevis from the bridge and unthread it from one of the hydraulic cylinder pistons. This allowed the existing bushings and seals to be removed from the top. The hydraulic subcontractor was then able to take precise measurements to create the shop drawings and ultimately fabricate the replacement components (rod seal, rod wiper, barrel O-rings, bronze bushings, and felt seal washer). Based upon the parts removed from the first cylinder, the team found little to no wear or deterioration of the rod gland bushings or the seals and there was no evidence that there was any side loading on the rod or rod bushing. This existing cylinder was left out of service while the leaf operated on the remaining three cylinders. During the bridge closure, after the replacement cylinder components were fabricated, the hydraulic subcontractor attempted to remove the clevis for the remaining seven cylinders as it had done previously, but now was unable to break the friction at the upper clevis threaded interface. Various methods were attempted, including heating the clevis, injecting anti-seize lubricants, and drilling and tapping a

hole into the side of the clevis to assist the wrench. None of these methods proved successful.

Through coordination and approval by the Department, the Contractor was directed to remove each cylinder one at a time from the bridge and deliver to a local hydraulic repair shop to perform the following:

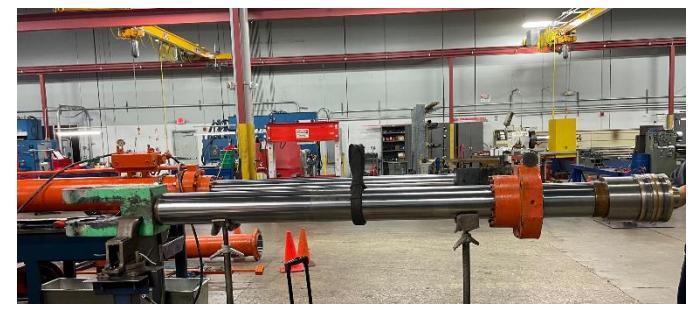
FIGURE 16: Shop Repair of Hydraulic Cylinders

The lesson learned for the project team was seeing firsthand the difficulty of getting components apart that have not been moved in nearly 20 years. Additionally, it was determined that even though upper and lower clevis pin connections were being greased on a monthly basis, the exposure of the cylinder to ambient conditions and humidity warrants a more though maintenance routine. Many of the threaded connections showed signs of rust, which proved that oxidation had penetrated into the threaded connection for the piston rod and rod end clevis. This issue should provide a good example of the benefits of incorporating the removal of rod eye clevises into yearly equipment maintenance schedules.

- Remove Hydraulic Oil from Cylinder
- Remove Piston from the cylinder bore
- Install Contractor-supplied Rod End seals and bearings,
- Furnish and Install New Piston Seals
- Polish Cylinder Rod
- Clean Cylinder
- Bench Test Cylinder

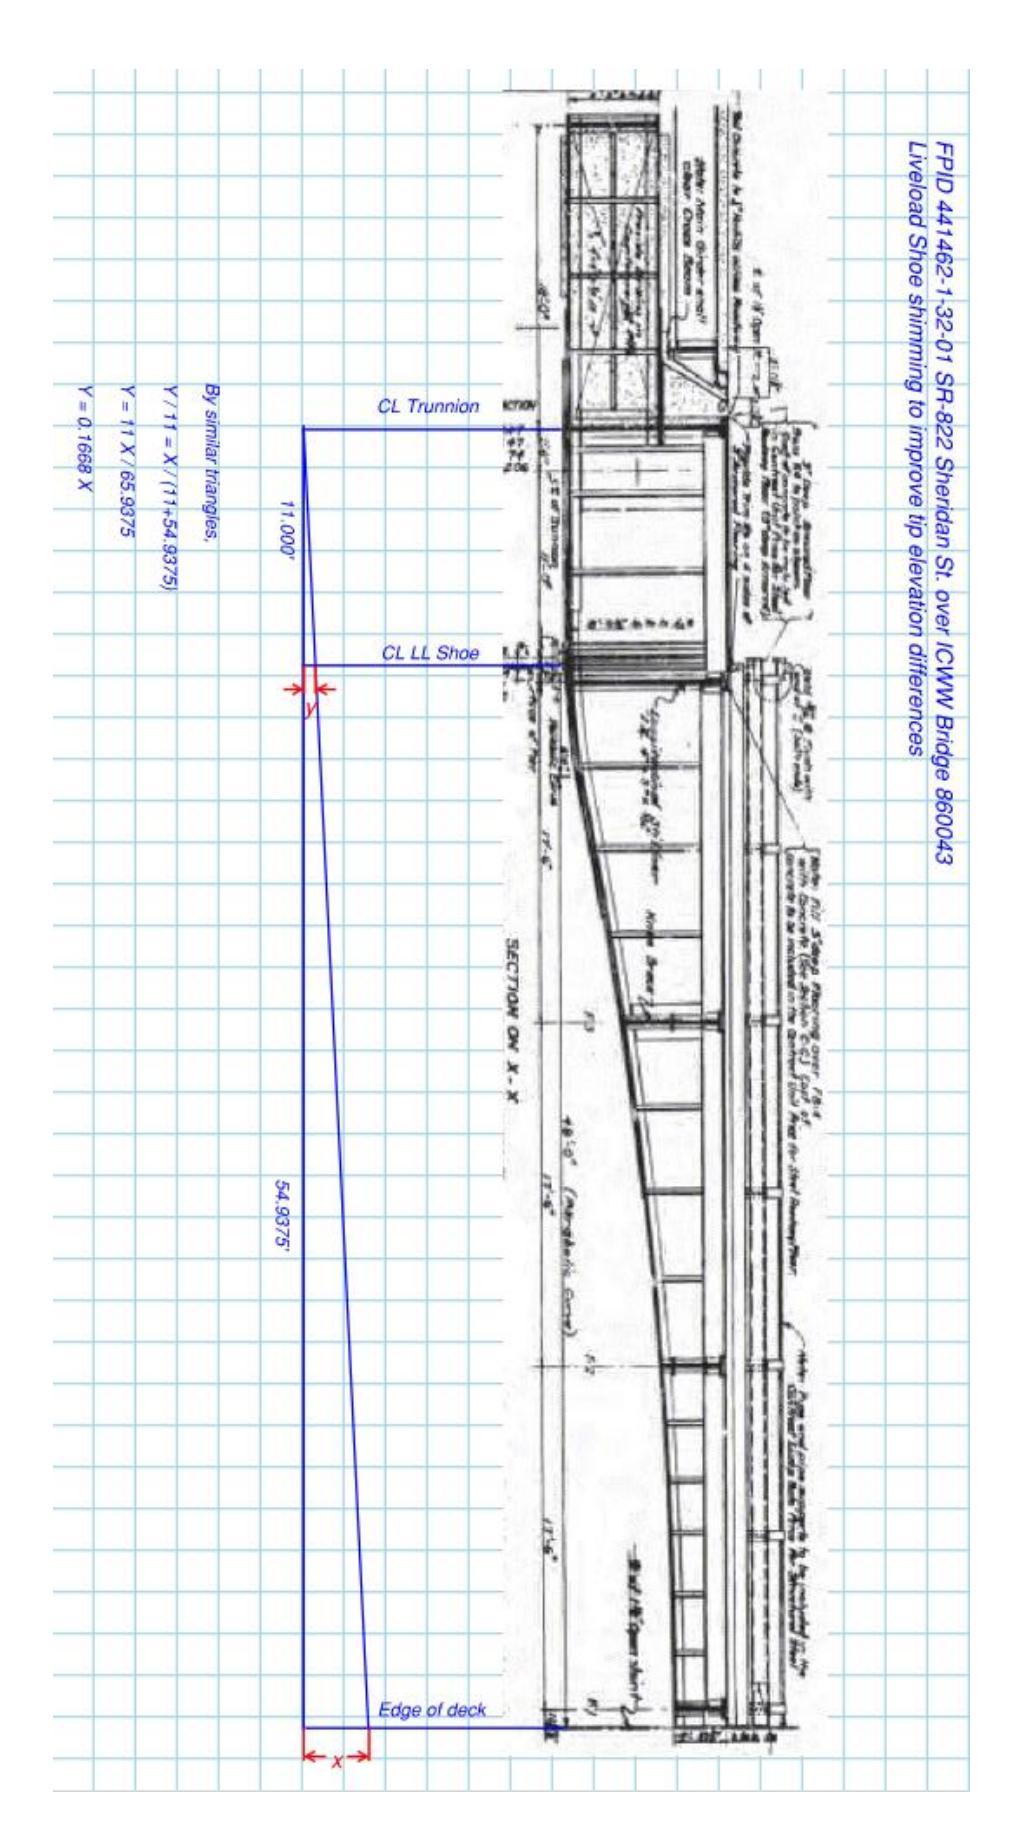
The bascule span leaves at the Sheridan Street Bridge are twisted with respect to each other and deflect significantly, producing vibration. The vibration is perceived to be excessive and is exacerbated by the impact loading received at the tip of each leaf due to the twisting of the leaves. The twist appears to be an undocumented as-built condition. The twist is such that the east leaf is higher than the west leaf at the south curbline and the west leaf is higher than the east leaf at the north curbline. This twist means that vehicles traveling in both eastbound and westbound directions impact the leaf tips as they cross the centerline floorbreak. A reasonable effort was made to correct the twist of the west leaf when the twist was discovered during the rehabilitation construction. Counterweight steel plates were installed at the north tip of the west leaf. Additional counterweight was added in the counterweight pockets behind the trunnions to balance the leaf. No tip-weighting was attempted at the east leaf as this leaf was already near its weight capacity.

On March 27, 2023, TranSystems measured the differences in elevation between the east and west leaves at the north and south curblines. This was done around midday and the ambient temperature was approximately 90 degrees Fahrenheit. Under those conditions, it was found that the east leaf was approximately ½" higher than the west leaf at the south curbline and ¼" higher at the north curbline. It was also discovered that there was slight vertical movement at the north live load shoe of the west leaf. All other liveload shoes were tight and did not move under live load.

Add a shim at the southwest LL shoe of thickness equal to ([XS + XN] x 0.1500)/2 plus a temporary shim of ¼" nominal thickness [see Table 1 below and attached sketch for "X"].

Lower the leaves using outboard cylinder adjacent to the north girder. Measure the gap at the northwest LL shoe and record in Table 1. Repeat using the outboard cylinder adjacent to the south girder. Record the measurement in Table 1. Average the two measurements to obtain G2.

- 4. Remove the temporary ¼" shim from the SW live load shoe and install at the NW live load shoe. Lower the leaves using outboard cylinder adjacent to the north girder. Measure the gap at the southwest LL shoe and record in Table 1. Repeat using the outboard cylinder adjacent to the south girder. Record the measurement in Table 1. Average the two measurements to obtain G3.

- 5. If the gaps G2 and G3 measured under the two live load shoes with the temporary shim in place are equal, no additional shim adjustment is required at this time.

- If G2 is greater than G3, additional shims must be installed under the SW live load shoe with a thickness of T= (G2-G3)/2. If G3 is greater than G2, additional shims must be installed under NW shoe with a thickness of T= (G3-G2)/2.
