HEAVY MOVABLE STRUCTURES, INC. TWENTIETH BIENNIAL SYMPOSIUM

Rehabilitation of CSX Marley Neck Swing Bridge: Construction Challenges Justin Dutreil, P.E. PCL Civil Constructors, Inc. (PCL)

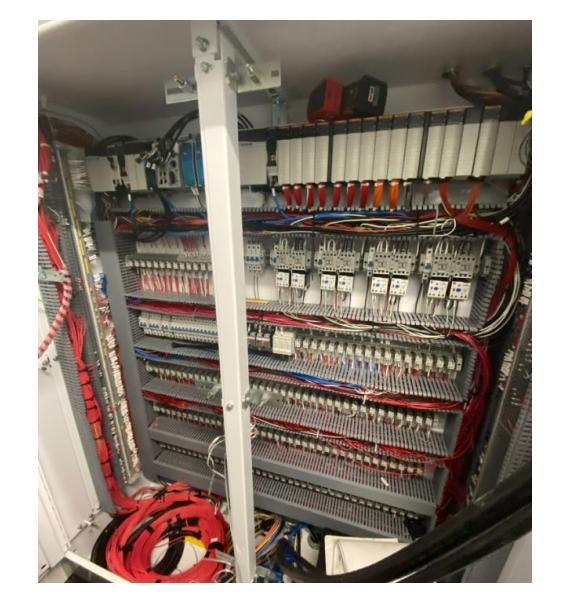
Figure 3: Existing PLC System

- PLC equipment was outdated, and unknown faults occurred during operations.
- Motor soft starters were often faulting.
- Control relays were "chattering" or failing.
- The shore stations did not have a screen to show bridge faults. If the moveable span got stuck open, a boat would need to be taken out to the bridge to troubleshoot.
- No remote capability and remote monitoring devices available.
- Navigation lighting insufficient per current federal standards.
- Signals system was outdated, and upgrades were required to enable remote capability.

- 1. Bridge Control System:
 - a. New relay & PLC cabinet.
 - b. New drive & motor starter cabinet.
 - c. Two new shore station HMI cabinets.
 - d. All new VFDs, starters, relays, switches, buttons, etc.
 - e. Addition of remote functionality.
- 2. Navigation Lighting:
 - a. New fender lighting and top truss navigation lights.
- 3. Lightning Protection
 - a. New grounding and surge protection devices installed.
- 4. Cameras
 - a. Bridge mounted cameras to view up/down track and upstream/downstream of channel.
- 5. Channel Sensors
 - a. New sensors to monitor marine traffic in the navigation channels.
- 6. Signals System
 - a. New signals bungalow, conduit, conductors, and proximity switches.
- 7. Electrical Demolition
 - a. Removal of all existing conduit, wiring, junctions boxes and related devices.

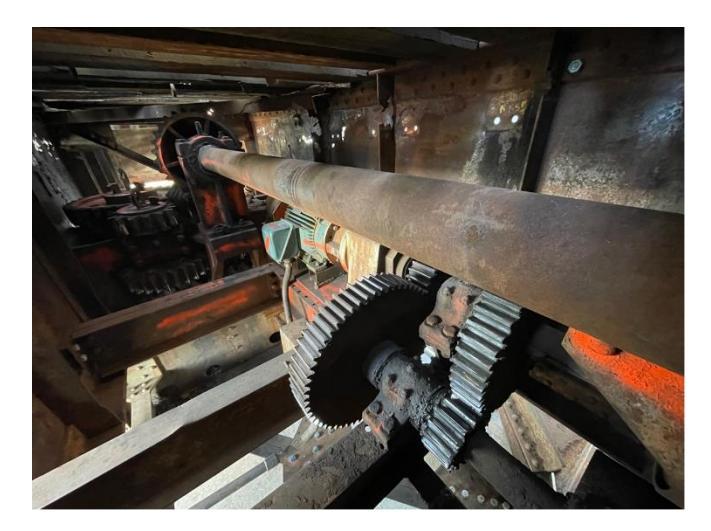
Figure 5: Existing Span Drive Machinery

- Center pivot bearing was worn, no longer centered, and leaking oil due to pieced collar system.
- Span drive system was in poor condition. Brass bushings were pushing out of bearings, gear teeth had significant wear, operations during open and closing operations were loud and movements irregular.
- Centering latch bar would often get stuck in the centering saddle preventing the bridge from opening.
- Motor brakes were unreliable and would fail often.
- Center and end wedge linkages were in incorrect positions.
- Old machinery castings were starting to crack at stress points.

- 1. Span Drive System
 - a. Demolition of existing drive machinery open gearing, bearing, shafts, and supports.
 - b. Furnish and install of new motor, gearbox, machinery supports, and turned bolts.
 - c. Replacement of existing bull gear on main drive shaft assembly.
- 2. Span Stop
 - a. Removal of existing latch bar system
 - b. Install of new span stop to align bridge when closing.

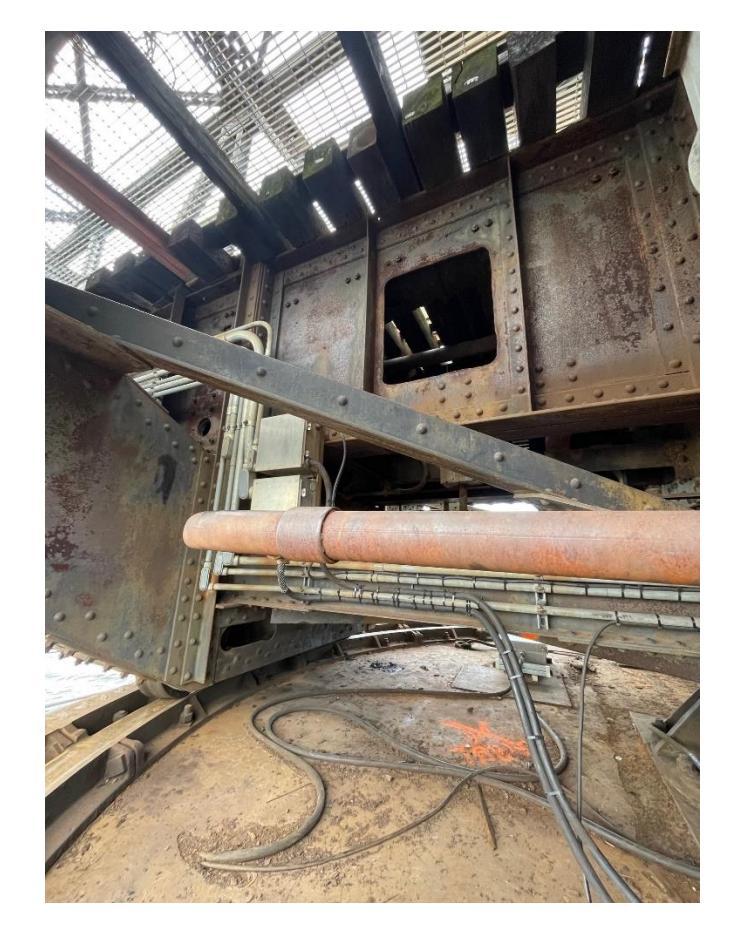
Figure 7: Web Cut Out in Stringer

The structural elements of the truss and stringers were generally in acceptable condition. The pivot girders exhibited the most section loss due to the surrounding machinery. The critical area of concern were 2 large holes that got cut through the stringers to provide access to machinery during and old rehabilitation. In addition to structural improvements, access to perform maintenance on the bridge was insufficient with many areas difficult to access.

- Lack of access to perform maintenance at the ends of the span.
- Two large holes cut out of the stringers required stiffening.
- Platforms to support and access the new controls and signals houses did not exist.
- Existing fender system was in poor condition.

- 1. Platforms
 - a. Support beams for new signals and controls housings.
 - b. End of span access for rail locks and end wedge machinery maintenance.
 - c. Various access platforms to eliminate fall hazards.
- 2. Stringer Hole Stiffening
 - a. Install of stiffening plate around existing torch cut hole.
 - b. Drilling of arrest holes to prevent existing cracks Figure 12: Stringer Hole Stiffening from growing.
- 3. Top Truss Access Platform
 - a. Install of new staircase to top of bridge.
 - b. New access platform on top of bridge to access wireless antenna equipment.
- 4. Fender Rehabilitation
 - a. Replacement of existing fender system in kind.

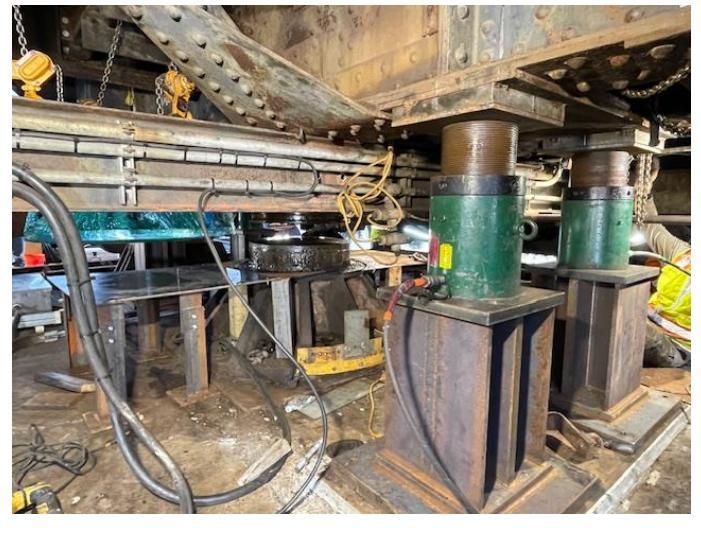
Figure 17: Jacking Bridge to Replace Center Pivot Bearing

The most unexpected issue discovered was how difficult it was to remove the bottom steel disc. A 1.5 hour planned task doubled to 3 hours when 2 ton come-a-longs with a combination of 25-T jacks refused to free the disc of the lower boss insert. The most effective method of removal utilized a series of steel wedges and sledgehammers to slowly pry the disc up. The limited access and manual nature of the method was extremely cumbersome but ultimately successful.

Replacement of the center pivot bearing was a challenging scope of work to complete. Scope included jacking of the moveable span utilizing (4) 250-T jacks, removing the old pivot bearing bronze discs and retaining collars, and installing a new fully contained pivot bearing and oil box system. Several constraints included:

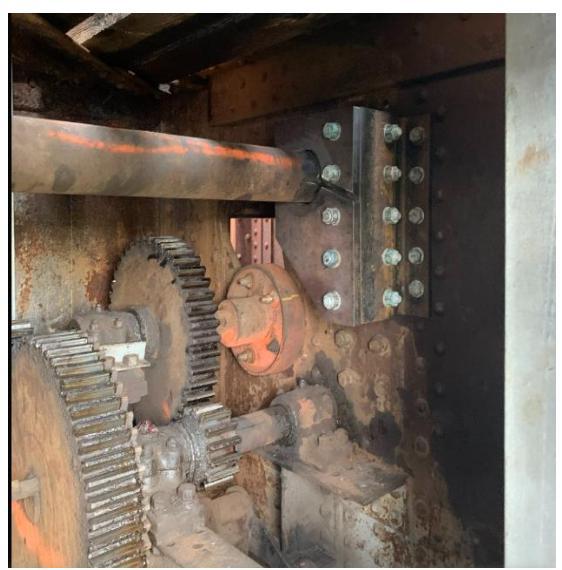
Figure 20: Torque Arm Install Around Shaft to Isolate Dual Drive Systems

To verify the bridge would be operational on a single motor, the dual drive system was isolated to a single drive system and the span was operated. The single motor test was successful; however, it was discovered that due to the additional torque on the single motor, the existing motor support would deflect significantly. This caused a poor gear mesh when operating. Additional support beams were installed temporarily to prevent the deflection. In case of motor failure, the secondary motor that was demoed was staged next to the running motor and a temporary air winch was installed on the piers to assist in closing the bridge if a major issue occurred. Lastly, an on call local tugboat service was utilized if the all other options failed to open or close the bridge.
