HEAVY MOVABLE STRUCTURES, INC. TWENTIETH BIENNIAL SYMPOSIUM

Resurrection of a Historical Turntable for ORHF

Dale Birkholz (Oregon Rail Heritage Foundation) Tim Hammer, PE (Everett Engineering) Matt McGuire, PE (HDR)

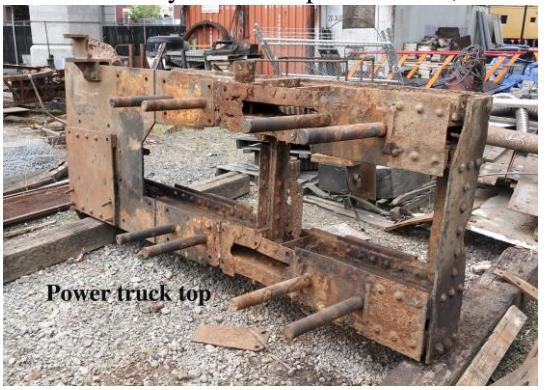
Figure 3: Original corroded end truck. Note riveted construction and areas of complete section loss on top flange.

- Review of the end truck frames to determine if repair or replacement was a better option. It was deemed prudent to completely replace the frames due to deterioration, but consideration had to be made that the geometry be maintained while fabricating the new frame with modern structural steel sections.
- Review of the center bearing roller element condition after disassembly and cleaning of the center bearing. All components were found to be in good condition and the center bearing spun quite freely by hand once cleaned and lubricated.
- Review of the existing in-service track wheel conditions compared to suspected unworn spares. The existing wheels were put back into service, deeming the spare wheels as... spare. It was decided that the level of use would probably not put further wear on the in-service wheels and that a new spare was preferred to a worn spare.

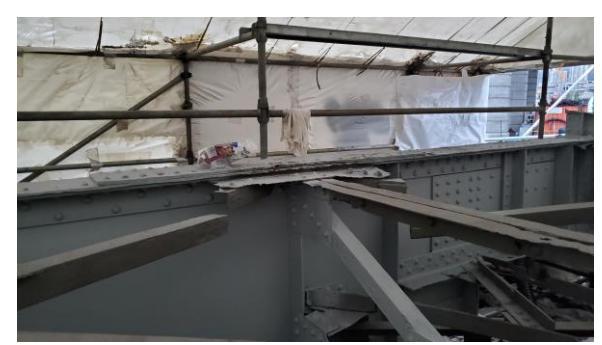
Figure 6: Deterioration of cross bracing gusset below ties.

Analysis showed that the table had an acceptable rating, with center shear being the controlling effect and yielding a Cooper E-80 rating factor of 1.0. Any deterioration of the main girders was not significant enough to affect the rating, with one exception: the end bottom flanges. Inspection of the table steel followed the AREMA Bridge Inspection Handbook and the Federal Highway Administration National Bridge Inspection Standards and was performed in August of 2020. Although at this time it was recognized that significant work would need to be performed on the cross bracing throughout and bottom flanges of the main girders where they met the drive truck due to corrosion resulting in section loss. Most affected areas were horizontal surfaces where moisture was trapped either between steel plies, or between the timber ties and interfacing steel. Similar evaluation of the existing drive trucks also concluded with the necessity of full replacement. It was also decided that the turntable steel would benefit from blast cleaning of the existing paint, remediation of any hazardous coatings, and a recoating of all steel upon completion of repairs.

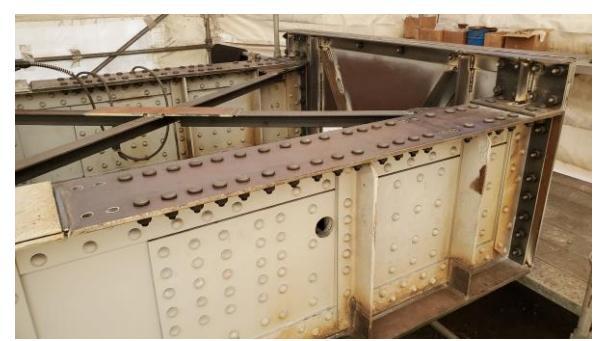
Figure 7: Rebuilt top flanges of main girders at end of table superstructure. Note rivet head bolts used for historical aesthetic.

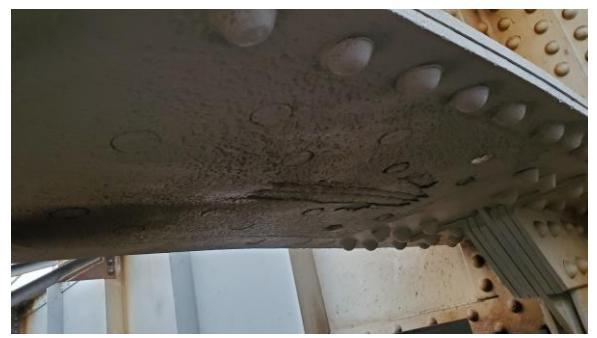
Through the course of the steel inspection, particular attention was given to the main cross girder and its condition. As early as 1933, there was documented upward deformation of the lower flange of the girder by as much as 5/8" and cracks propagating from some of the rivet holes in the vicinity of where it bore against the center bearing. Previous repairs had been developed and implemented to increase the thickness of the lower flange with additional steel and were assumed to be performed in-situ given the nature of the work. In addition to the pre-existing deformation, once the center bearing and shims were removed from the main cross girder during the storage period, areas of complete section loss were

observed in the cover plate of the bottom flange exposing the bottom of the channels and plate of the center web. Again, the deterioration was located around the portion of the girder in contact with the center bearing. The concern with the deterioration was that in resetting the turntable on the center bearing, the deformed and corroded area would not be a solid mounting surface to position the turntable on the center bearing or its new foundation. But there was not concern about further stressing the lower flange, since the deformation was measured to be the same as the initial 1930's measurement and both past repairs and the new shim plate would add further localized section to the lower flange. In addition, the degree of pitting and wear would also leave a very minimal area of contact between the girder, any shims used, and the center bearing, causing high bearing stress and the tendency to trap water and propagate further deterioration through corrosion. In pursuing a solution for the deterioration, ORHF was intent on preserving the turntable's existing steel as much as possible and finding a cost-effective solution to provide a sound connection between the cross girder and center bearing.

Figure 8: Full section loss, pitting, and distortion on the bottom of the bottom flange where it was in contact with the center bearing.

- Casting a mating shim plate Through its work on the center locomotives, certain volunteer staff had experience with small lot casting, which seemed promising. But further investigation deemed that the casting would be hard to form up around the bottom of the flange and there were concerns that any material used would not have the bearing strength needed for the application.
- Scan and CNC of mating shim plate This alternative was born out of a novel approach of having Light Detection and Ranging (LiDAR) scanning capabilities in the area for another project and was selected for further exploration. Moreover, this was ultimately the selected alternative.

The intent of the selected alternative was to scan the underside of the main cross girder and then fabricate a shim plate whose top surface matched the contour and profile of the underside of the girder while providing a bottom surface that was flat and planar to the underside of the turntable. The approach would be broken up into 3 main stages of work: scanning the existing steel, creating the custom shim plate, and fit-up and alignment with the existing steel. The work had to be completed prior to the landing of the turntable structure on the center bearing and foundation. During the work, access was facilitated by having the turntable structure sitting elevated on rail car trucks after the steel repairs, allowing clear access to the underside of the main cross girder for work.

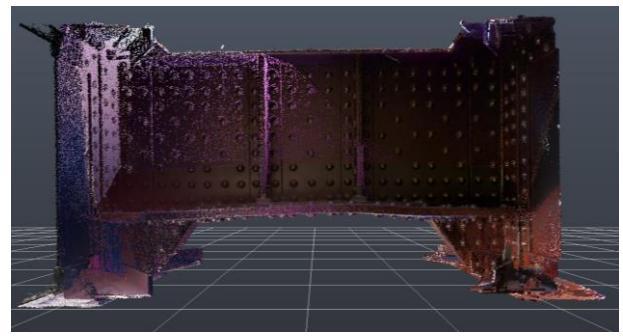
Figure 9: Photorealistic LiDAR scan showing up to 5/8" distortion at the main cross girder bottom flange.

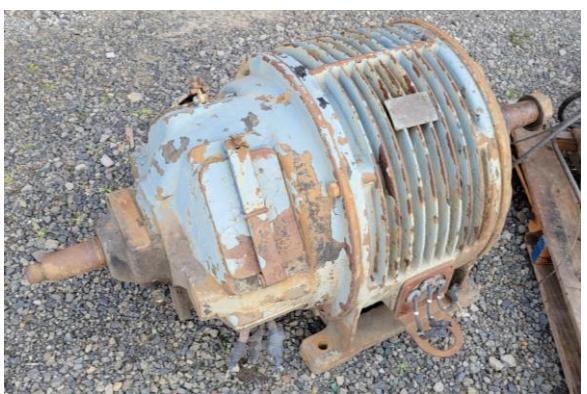
- Review of the existing motors for reuse. Anecdotally, crews who had worked on the turntable in its past operation reported that the existing cast motor housings exhibited cracks. The difficulty of repairing the castings and expected remediation of asbestos containing material inside the motor drove for the use of new motors.
- Design calculations for a new motor pinion for use with a new gearmotor. The tapered bores of the existing pinions and finding two different face widths on the motor pinions drove the need to confirm the dimensions and proposed material for a new motor pinion.

Figure 11: One of two original 25 HP, 600 RPM, 3 PH motors with tapered output shaft.

As noted earlier, in the evaluation of the existing turntable machinery, it was determined that the motors would need to be replaced. From an engineering perspective, it was also recognized that there was an opportunity to slow down operation of the turntable for a more controlled ride. Similar to other class 1 RR's, the impression of past operators was that the table had a potential for speeds higher than the comfort level of the operators.

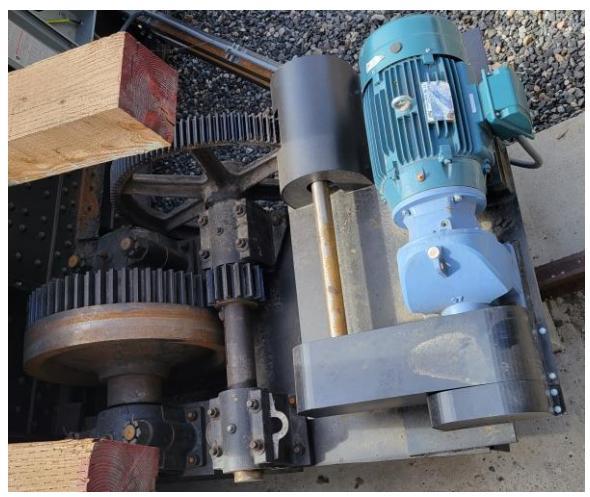
Figure 12: New gearmotor geometry on end drive truck. Also note the existing brake wheel in the drivetrain to the left of the photo.

To address the geometry concerns of the new gearmotor, a support and motor arrangement design concept was provided with an extension of the motor support inboard of the existing drive truck machinery. The new pinion would mesh with the existing gearing on the drive truck. The design was further refined in the construction phase and is discussed further below.

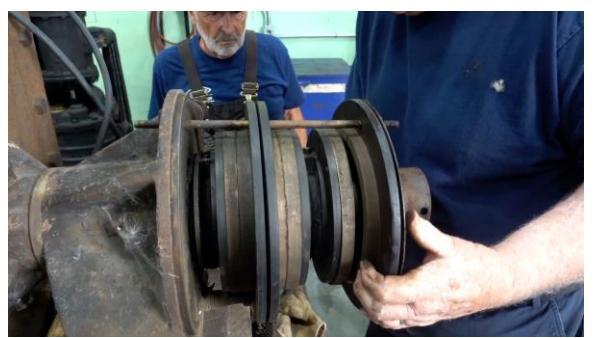
contact plate and brush for each phase the assembly had two circular contact plates pressed against each other for each phase. The entire assembly was sandwiched together, along with springs, inside a housing and the conductors were fed up through the center of the assembly via a pipe in the pedestal base. The existing slip ring was considered for replacement due to the non-standard arrangement and the fact that modern conductors would not fit in the base pipe while being compliant with the National Electrical Code (NEC). Otherwise, the contact surfaces were found to be in good condition

Figure 13: Slip Ring Assembly with cover removed. Note the series of contact plates rather that brushes and plates.

and the assembly could be kept for a display piece in later use.

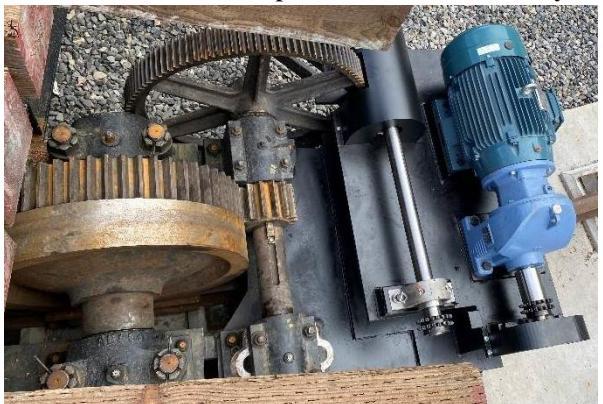
Figure 16. New powertrain integrated with original open gearing and new fabricated drive truck frame.

The new powertrain was assembled to a fabricated steel base with machined mount points for bearings, gear reducer, and motor. The mount was designed for setting in place on the existing trucks as an assembled unit, aligning the pinion with the bull gear, and welding the base in place.

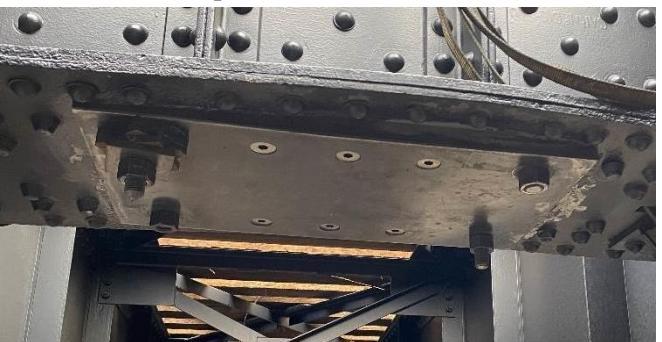
Figure 17. Adapter plate installed with temporary bolts. Note flange deformation and adapter plate contour.

The adapter plate and saddle installations were performed while the turntable was still supported by temporary trucks on a siding adjacent to the turntable pit. With telehandler support, the adapter plate was positioned underneath the center cross girder, supported by the lifting/drill jigs. The contoured surface of the adapter plate was covered in a thin layer of anti-seize, to act as a blue-fitting agent to determine rough percentage of contact with the bottom flange of the center girder. The plate was then lifted into contact with the bottom flange, the undersize bolts and countersunk bolts tightened snugly. The bolts were un-fastened and the plate lowered down to view the contact area. Several iterations of hand grinding were necessary to maximize contact between the surfaces and meet the goal of over 50% contact roughly even across the plate surface. Once the contact was achieved and the surface cleaned, the mating surface was covered in titanium putty to help seal the perimeter and around the bolt holes to prevent water ingress between the plates. The plate was raised into position and the six countersunk bolts were torqued to spec.

The saddle was lifted into position with the drill jigs and the holes aligned using pins and undersize bolts. Once the drill jigs were aligned, the holes were drilled using a mag drill setup and undersized drills. The holes were then reamed with ascending sizes of shell reamers to achieve the finished fit and diameter. The holes were drilled, reamed, and bolts installed one at a time to ensure the saddle remained in place throughout the process. The turned bolts were tightened snugly, but not torqued to final spec to allow removal for shimming as necessary once the turntable was set in the pit.

The adapter plate provided a means of re-using the existing structural members without removal of deformed components. In bridges and turntables, deformed members in similar condition would likely require replacement to mate with other components. In this case, the deformed flanges were not compromising the structure significantly, and the adapter plate allowed the load from the saddle to be more
