NINTH BIENNIAL SYMPOSIUM "Preserving Traditional Values with New Technologies"

AN OVERVIEW OF WASHINGTON STATE'S FLOATING CONCRETE PONTOON BRIDGES

Tim Benson P.E. WSDOT Bridge Preservation Office

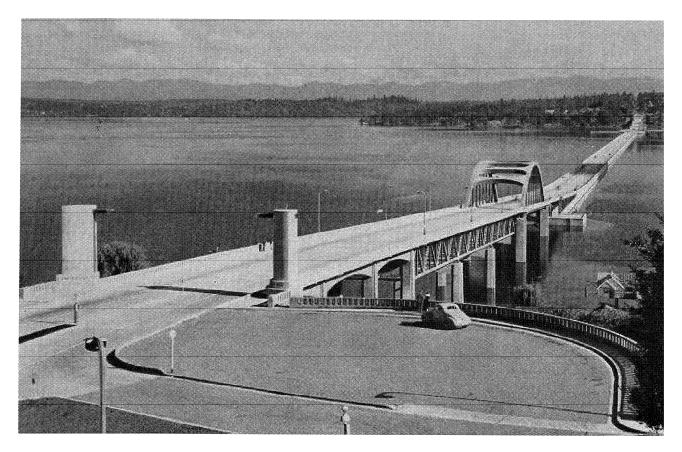
Photograph 1: Original Lacey V. Murrow Bridge. 1940.

The Lacey V Murrow Bridge (90/25S) is a floating concrete pontoon bridge. It was first opened to traffic in 1940. It consists of 20 concrete pontoons, which were floated into place, bolted together and anchored to the bed of Lake Washington between Mercer Island and the Mount Baker section of Seattle. Each pontoon typically consists of 48 watertight cells, and the pontoons at the east and west ends of the bridge consist of 32 watertight cells. The floating portion of the bridge is 6,603 feet long. It originally had a 220-foot draw span located in the vicinity of Mercer Island. This draw span could be retracted into a tuning fork shaped opening called "the bulge". This bulge obliged motorists to negotiate a sharp curve at high speed and the bridge became notorious for sometimes-fatal accidents. This section was removed in September of 1981 after completion of the east channel bridge provided sufficient vertical clearance for vessels of over 45 feet high and made maintaining the draw span with its high incidence of vehicular accidents unnecessary.

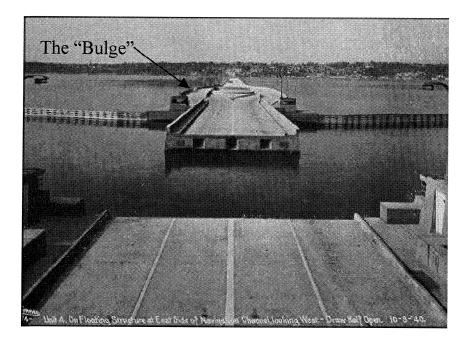
Photograph 2: Original Lacey V. Murrow draw spans. 1940.

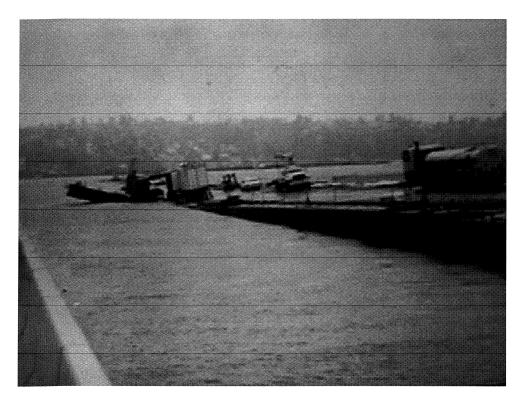
Photgraph 3: Original Lacey V. Murrow Bridge sinking after a severe storm. 1990.

On November 25, 1990 the bridge was undergoing renovation when a severe storm caused almost half of the bridge to sink due to an excess accumulation of water within the pontoons. This renovation work included the use of hydro-demolishers, which were used to remove concrete to allow the roadway to be widened. Holes were also cut into the sides of the pontoons to allow installation of new interior hatches. Fortunately no one was injured or killed when the bridge sank. The bridge was removed from the National Register of Historic Places when it sank. It was rebuilt in 1992 at which time it was converted from two-way traffic to east bound traffic only. The bridge is anchored to the lake bottom with steel anchor cables and concrete anchors. It is equipped with an anchor tensioning system consisting of permanently installed hydraulic jacks, which allow adjustment of the anchor cables. Adjustment of the anchor cable tension is performed routinely on all of the Lake Washington floating bridges because the lake level is lowered two feet each winter by releasing water from the Ballard locks to allow for spring

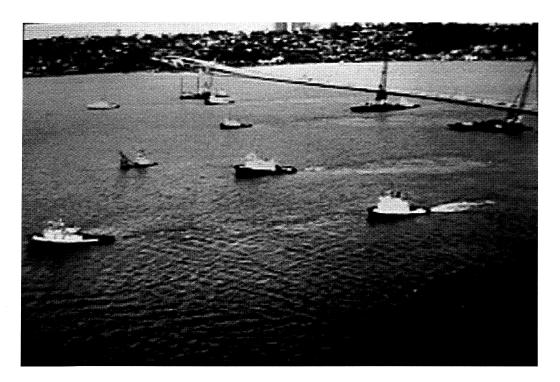
Photograph 4: Tugboats holding the new Homer Hadley Bridge in place after anchor cables were damaged by the sinking Lacey V. Murrow Bridge.

The Third Lake Washington or Homer Hadley Bridge (90/25N) is a floating concrete pontoon bridge, which was opened to traffic in 1989. It consists of 18 concrete pontoons, but it does not have a draw span. Each pontoon typically consists of 60 watertight cells, and the pontoons at the east and west ends of the bridge consist of 45 watertight cells. The floating portion of the bridge is 5,811 feet long. It is anchored parallel to and just north of the Lacey V Murrow Bridge. It originally carried east and westbound traffic of Interstate 90 during the renovation and the subsequent sinking and replacement of the Lacey V Murrow Bridge. It now carries westbound traffic and reversible HOV lane traffic. When portions of the Lacey V Murrow Bridge sank, a number of the anchor cables for the Homer Hadley Bridge were damaged. A fleet of tugboats were tied to the south side of the Homer Hadley Bridge for several weeks to maintain the bridge alignment until the anchor cables could be replaced.

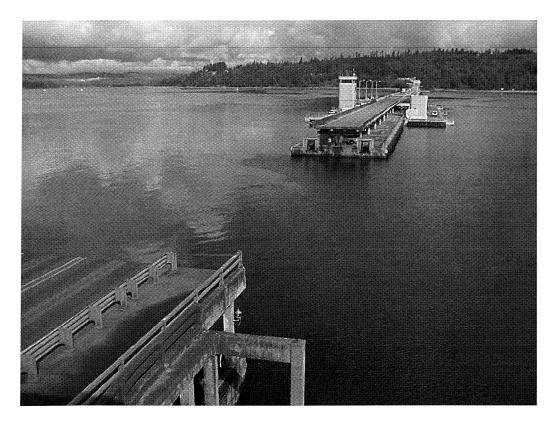
Photograph 10: Draw spans open 600 feet.

The bridge has two retractable draw spans, when opened together they provide a 600-foot opening for marine traffic. This bridge is one of busiest both for recreational boaters and Navy ships and nuclear submarines. The east half of the bridge has a tuning fork shaped opening into which the draw span is retracted. The west half originally had the same tuning fork shaped opening but when it was rebuilt it was equipped with a series of three hydraulic lift decks. These lift decks raise a portion of the roadway approximately nine feet to allow the draw span to be retracted beneath it. The west half of the bridge is designated bridge number104/5.1. It consists of 11 floating concrete pontoons, which are anchored by steel cables and concrete anchors to the bottom of the Hood Canal and a single draw pontoon. In the draw pontoon area the flanking pontoons on the north and south side of the draw span are connected by three submerged cross struts. These struts provide structural integrity to the draw span area and provide a path for routing electrical cables. The east half of the bridge is designated bridge number 104/5.2. It consists of eight floating concrete pontoons, which are anchored to the bottom of Hood Canal and a single draw pontoon. The anchor cables are protected from corrosion by an impressed current cathodic protection system. There is also a permanently installed hydraulic anchor cable adjustment system. There is a control tower on each half of the bridge with duplicate control desks. The bridge control system consists of a combination of relay based controls and a Square D PLC system which communicates between the two halves of the bridge over a microwave system or by way of a submarine telephone line.

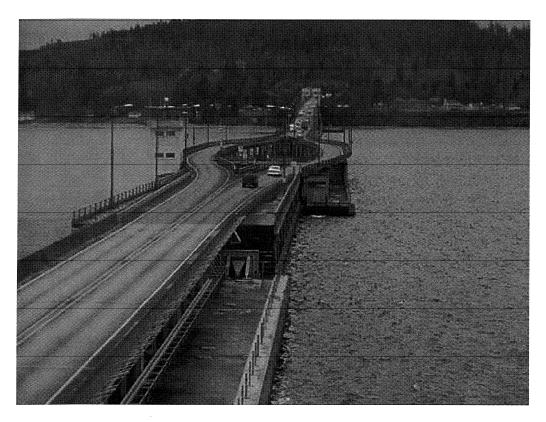
Photograph 11: "Tuning Fork" at East Half for retracting draw span.

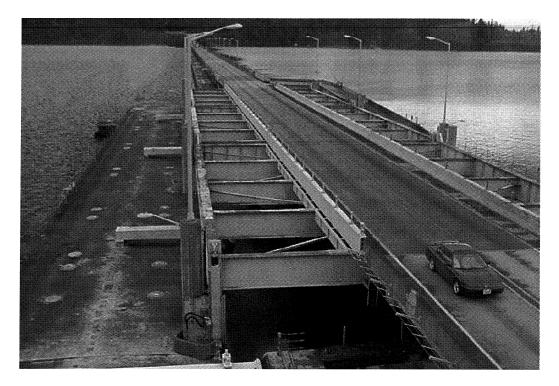
Photograph 12: Hydraulically operated lift spans at West half.

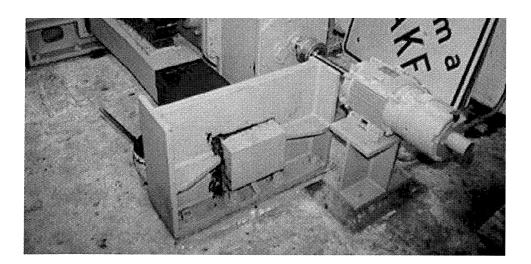
Photograph 16: End lock machinery for West half.

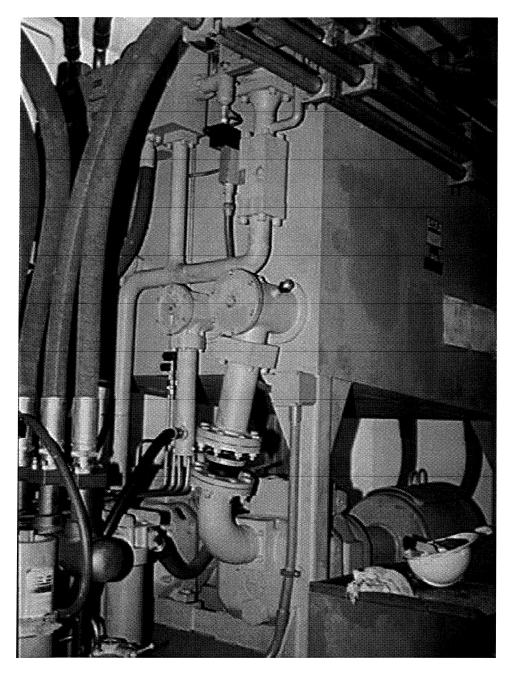
Photograph 17: Lift deck HPU.

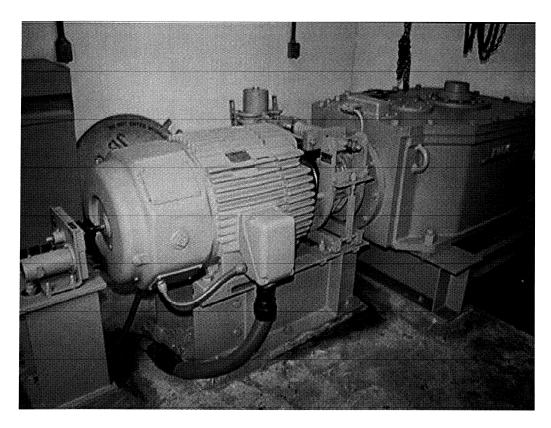
Photograph 18: West draw span drive machinery.

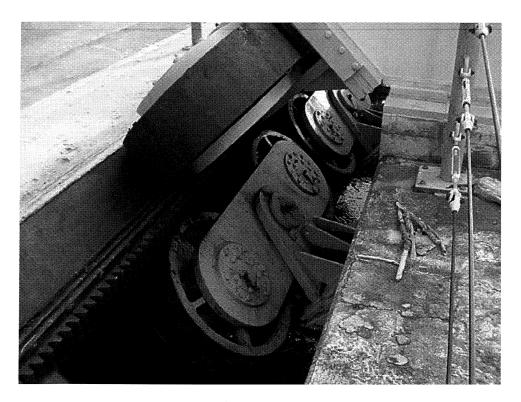
Photograph 19: West draw span guide rollers, guide track, and rack.

To open the bridge advance warning lights and red traffic lights are turned on. When traffic stops a traffic gate on the east half and two traffic gates on the west half are lowered. The west half also has a swing barrier mounted in the median barrier, which is swung open to provide a physical barrier. On the east half of the bridge this physical barrier is provided by the draw span when it retracts. The two longitudinal locks which hold the east and west half draw spans together are operated hydraulically to unlock the two draw spans. In this same area there are two span alignment pyramids. The end locks on each corner of the draw span are withdrawn by a rack and pinion operated by an electric motor and a gear reducer on the west side and by a motor and gear reducer operating a cam on the east side. The east end lock bar receiver is slotted to allow bridge expansion. The west bridge lift decks are raised by hydraulic cylinders until they are clear of the draw span. Each of the three decks has an HPU skid powered by two 75 horsepower motors. The two draw spans are each retracted by four motors operating gear reducers and pinions, which act of the rack, which is mounted along the north, and south faces of the draw pontoons. On the east half the motors are 40 horsepower DC operated by motor generator sets. They are equipped with electric solenoid operated brakes. On the west half the motors are 75 horsepower wound rotor motors operated by Square D thyrister drives. They are equipped with thrustor brakes. Draw span alignment is maintained by vertical and horizontal guide rollers. On the west half the horizontal and vertical guide rollers are combined in a roller set at 45 degrees.

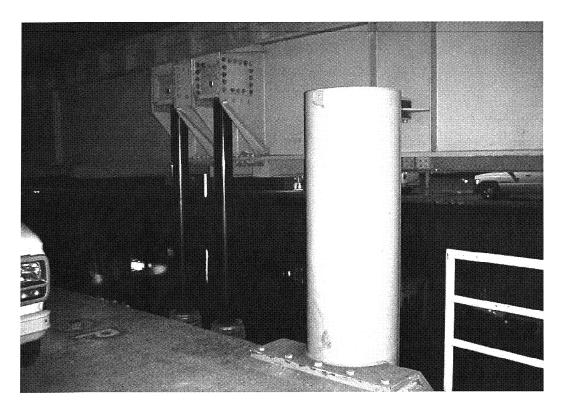
Photograph 21: Hydraulic lift cylinders and lift deck guides.

The Albert D Rosellini or Evergreen Point Bridge (520/8) is a floating concrete pontoon bridge across Lake Washington about 3 miles north of the Lacey V Murrow Bridge and Homer Hadley Bridge. It was opened to traffic on August 23, 1963. It carries two east bound and two west bound lanes of State Route 520 traffic. It consists of 35 separate pontoons, which are anchored to the bed of Lake Washington. It has two retractable 100 foot draw spans, which provide a 200-foot opening. Unlike the Hood Canal Bridge access for maintenance is through hatches at the roadway level or from the aprons at the draw spans. This bridge receives fewer marine opening requests than any of our other bridges and it is one of our most heavily traveled roadways. As a result we schedule monthly maintenance openings in the night during off peak traffic times in order to perform operator training and essential maintenance. The floating portion of the bridge is 7,578 feet long. The anchor cables are equipped with permanently installed hydraulic jacks to facilitate cable tension adjustment. Cable tension is adjusted annually to account for the seasonal lowering of the lake level to allow for spring flooding. Unlike the Hood Canal Bridge, the Lacey V Murrow Bridge and the Homer Hadley Bridge there is no cathodic protection installed on this bridge. The original design consisted of lift spans which were raised by electric motors operating chains and counter weights to allow the draw spans to be retracted beneath them. Replacement chains were installed in 1986. The new chains were of slightly different pitch which resulted in cracking of the welds in the chain segments. This raised concern that a failure of the chains could result in the counterweight puncturing the bottom of the pontoon and sinking the bridge. In 1994 a major electrical and mechanical renovation occurred and the counterweight system was replaced with hydraulic lift cylinders.

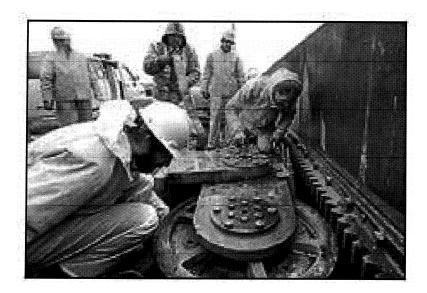
Photograph 22: Repairing damaged horizontal guide roller. 1999

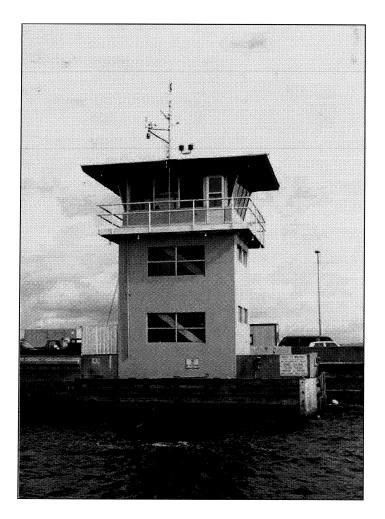
Photograph 23: Evergreen Point Bridge Control tower.

There is a control tower on the west half of the bridge. A Square D Programmable Logic Controller is used to control the operation of the bridge. The bridge is also equipped with a redundant manual control system, which allows manual operation of the bridge in the event of a malfunction of the PLC. To open the bridge, traffic is stopped by turning on the advance warning lights and traffic lights. Oncoming and then Offgoing traffic gates are lowered and traffic barriers, which are mounted in the median barriers are swung out and secured. The lift decks are raised approximately eight feet by hydraulic cylinders. Unlike the Hood Canal Bridge each half of the Evergreen Point Bridge has a single lift deck. There are two cylinders in each corner of the lift deck to provide redundancy. There are two hydraulic power units on each half of the bridge with two 40 horsepower motors and pumps on each unit. One unit provides power to the two sets of cylinders on the north side of the bridge and the other provides power to the cylinders on the south side of the bridge. Control of the lift deck level is provided by a Rexroth digital loop circuit and temposonic position sensors mounted inside each of the cylinders, which automatically keeps the lift deck level. The endlocks are then withdrawn by motor operated jack screws and the center locks are unlocked by hydraulically extending the three center lock hooks located in to east draw pontoon and hydraulically lifting a lock bar located in the west draw pontoon. The two draw spans are then retracted beneath the raised lift decks to create a 200-foot opening. Each draw span is operated by four 15 HP DC motors operating gear reducers, pinions and racks which are mounted along the north and south faces of the draw pontoons. Each motor is equipped with electric solenoid type brakes and are controlled by Saftronic DC drives. Draw span alignment is maintained by vertical and horizontal guide rollers.

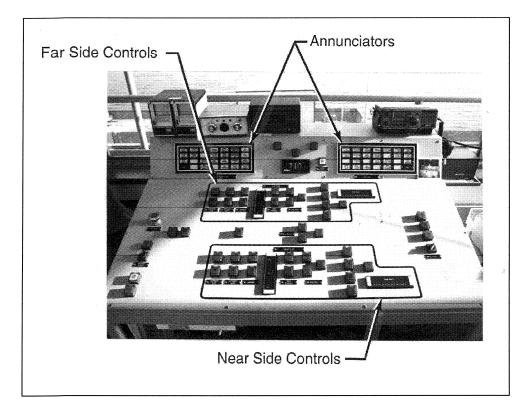
Photograph 24: Evergreen Point Bridge Control Desk.

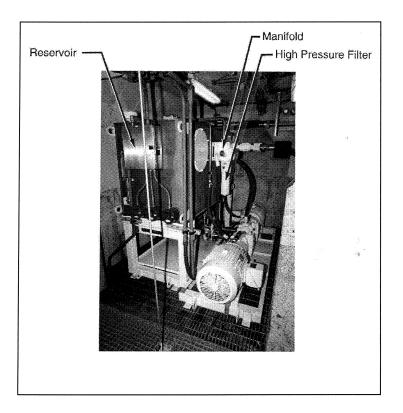
Photograph 25: Typical lift deck HPU.

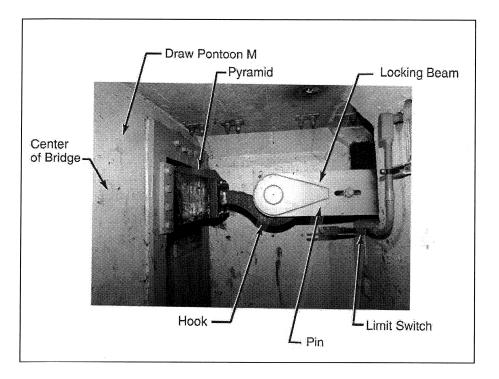
Photograph 27: Center lock hook engaged with lock bar.

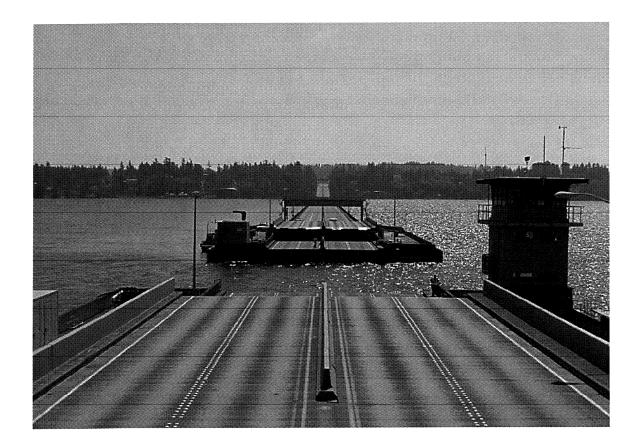
Photograph 28: Draw spans retracted for a 200 foot opening.
