NINTH BIENNIAL SYMPOSIUM
"Preserving Traditional Values with New Technologies"

THE HISTORY AND FUTURE OF THE CITY
WATERWAY LIFT BRIDGE

Duane Stone, PE,
Washington State Department of Transportation
&
Frank Marzella, PE,
Hardesty & Hanover, LLP

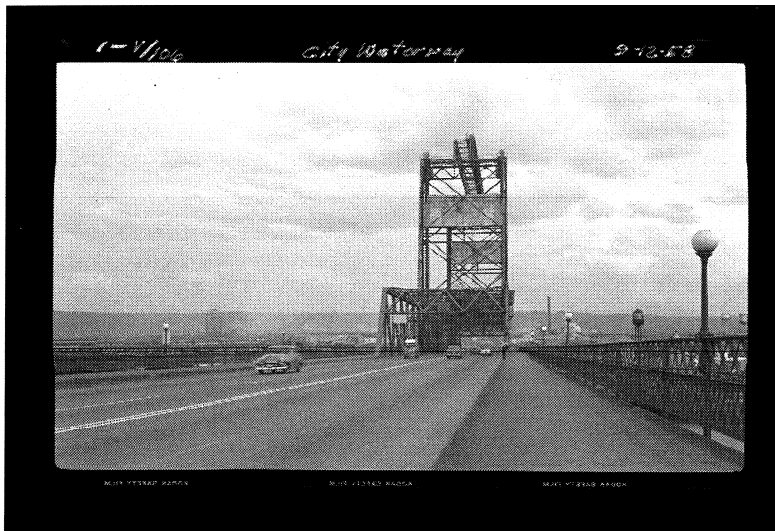
Roadway looking east, late 1950's.

construction was performed in stages, maintaining traffic through the reconstruction period. The street car tracks were removed.

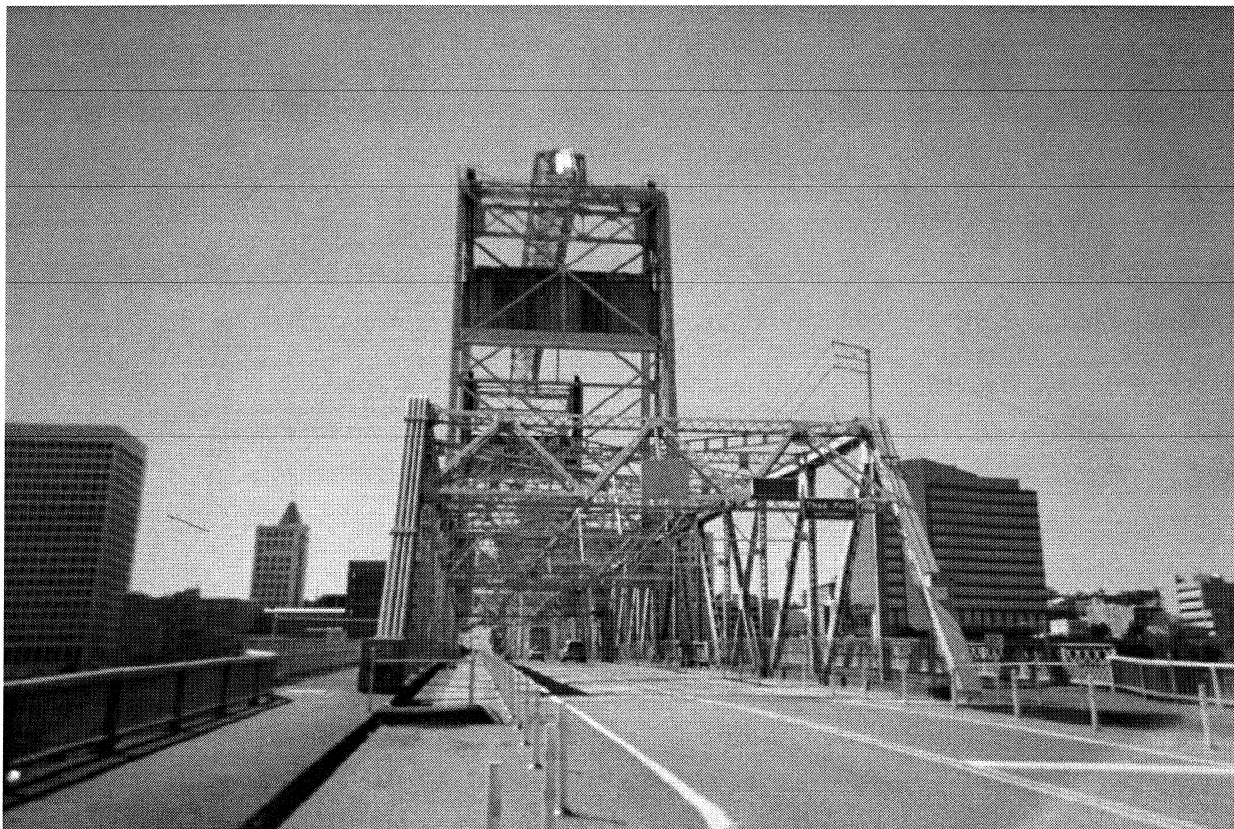
Present day. Sidewalks closed due to heavy deterioration.

Corrosion is starting to take its toll on the bridge steel. Both upper and lower chords of the lift span and side span trusses exhibit section loss, resulting in the need reduce the load rating of the bridge to a maximum vehicle weight of 10 tons. There is heavy section loss of the side walk support bracket steel on the steel approach trusses on both sides of the bridge. Currently, both sidewalks are closed and the bridge is restricted to only one lane of traffic in each direction. The two closed lanes are now being utilized as sidewalks.
