**HEAVY MOVABLE STRUCTURES, INC.
FOURTEENTH BIENNIAL SYMPOSIUM**

**Hydraulic System for Spillway Gate Hoist
Rehabilitation**

Michael Hanley
Electro Hydraulic Machinery Co.
www.ehmcompany.com

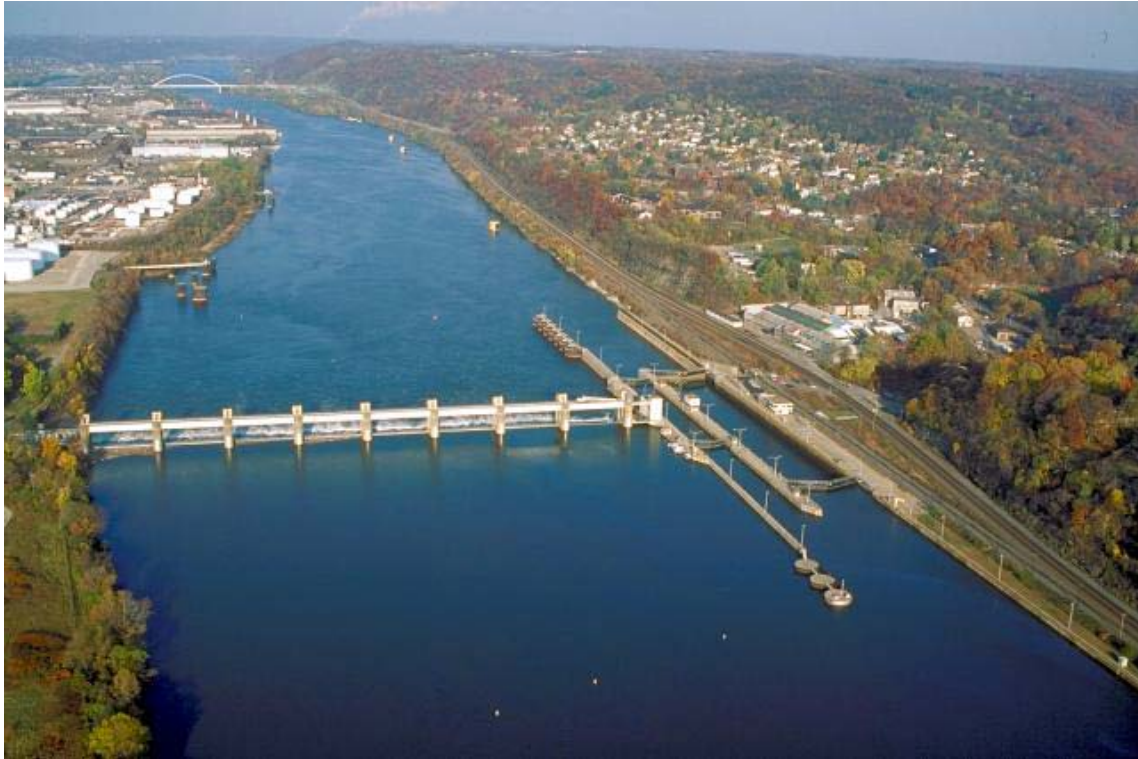
Figure 2. Emsworth Lock and Dam Main Channel

The Emsworth Spillway Dam is a strategic water control structure for protection of lives and commerce in the Pittsburgh area. The spillway controls water pool levels for the city which is located at the confluence of the Monongahela and Alleghany rivers. These two rivers meet at the pinnacle of downtown Pittsburgh and form the beginning of the Ohio River. The river then flows to the Emsworth Dam which is the first lock and dam structure for the Ohio River located just Northwest of Pittsburgh (Figure 2 below).

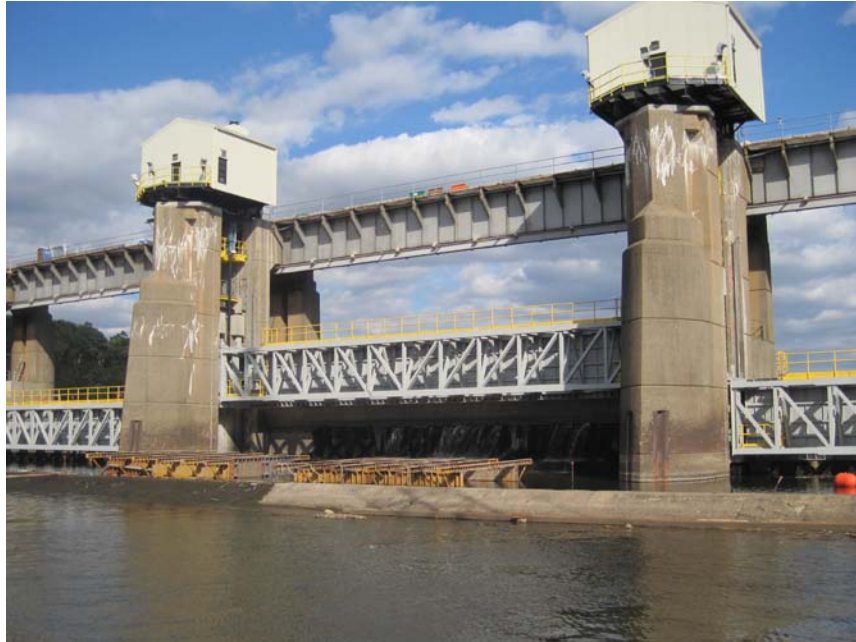
The 13 steel spillway gates are fabricated in a truss type construction. Five gates are located on the back channel of Neville Island and eight main channel gates are integrated with the navigational lock structure from Neville Island to the mainland. Each gate is 9 feet wide x 12 feet tall x 105feet long weighing approximately 198,000 pounds.

Figure 3. Spillway gate

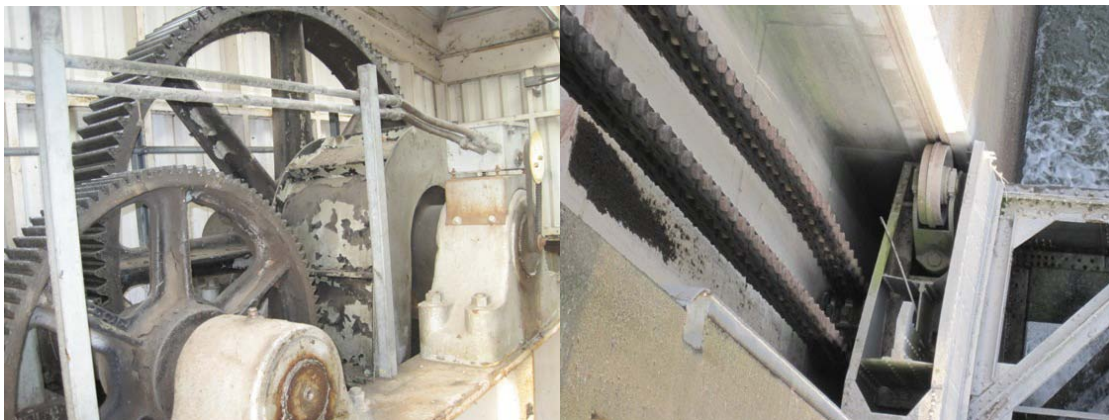
The original gate drive systems were electro-mechanical chain drive system that powered the gates since 1937. In recent years, the old systems started failing and became harder to repair. Operation of the gates required several crew and was dangerous work during inclement weather conditions. With the constant changes in gate openings through any given day on a 24 hour basis, the operating costs had grown exponentially. The Army Corps started looking for a more modern and cost effective solution.

Figure 4. Electromechanical chain-drive system

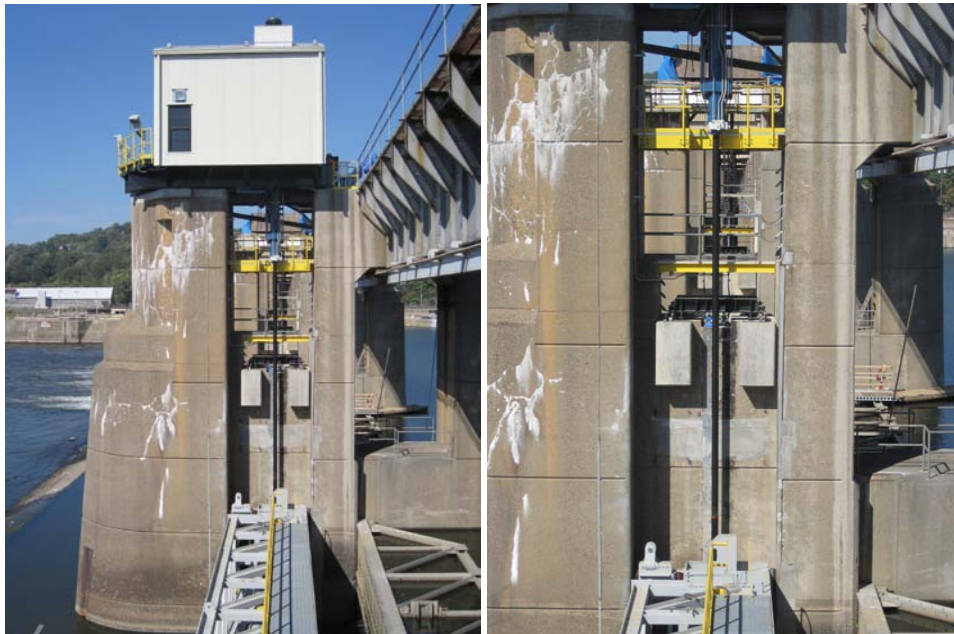
Each gate hydraulic drive system is comprised of two completely independent hydraulic cylinders 320mm bore, 160mm rod, and 30 foot stroke. The two cylinders must raise and lower the gate level within 1.5 inches across 105 feet. The new gates still use existing roller tracks that allow significant lateral gate movement. Therefore the cylinder drive had to be capable of swinging in several planes at once.

Figure 5. Gate lift hydraulic cylinder

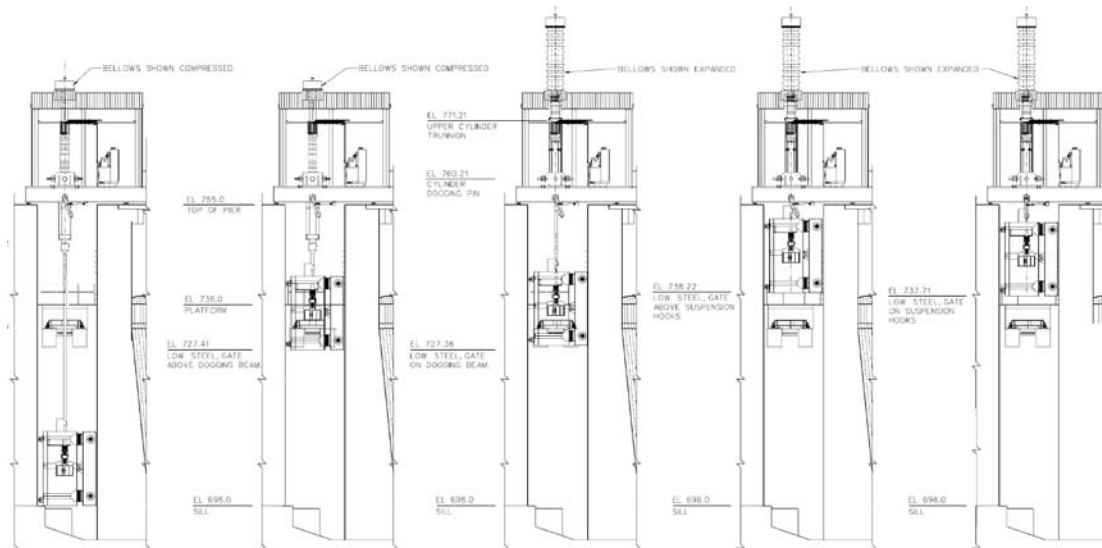
One very unique aspect of the hydraulic drive design is the capability to raise the gate a total of 40 feet with 30 foot stroke hydraulic cylinders. The Corps used a custom made cylinder with trunnion pin mountings in two locations. This dual pin design allows for the entire cylinder to be lifted by itself to the secondary trunnion location for the additional 10 feet of required gate travel. A typical gate is lifted 29 feet where it is rested on dogging beams which are hydraulically extended underneath each side of the gate. Lifting cylinder trunnion pins are then released from the upper cylinder trunnion position such that the cylinder can now be pushed upward to the secondary or lower trunnion position. Once located in the secondary trunnion position the cylinder trunnion pins are reinserted with hydraulic cylinders and the lifting cylinder is ready to raise the gate an additional 11 feet. Now that the total 40 feet of gate movement has been accomplished the gate is rested on hooks that are automatically extended and the gate lowered into the hooks for storage as required. Figure 6 shows the progression of these steps with the hydraulic cylinders pushed through the roof at final extension.

Figure 6. Progression of spillway gate lift sequence

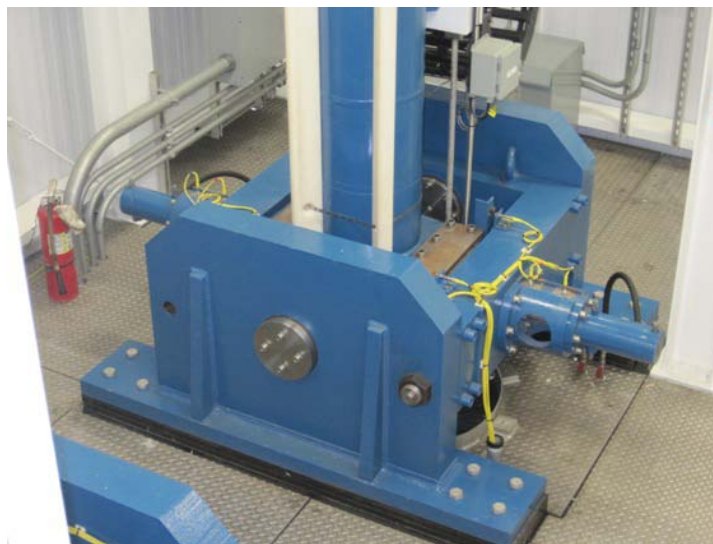
Another unique aspect of the drive design is the ability of the hydraulic cylinder to swing back and forth as it travels. This is accomplished using a Cardanic Ring type mount (similar to a universal joint) for the main lift cylinder. This ring allows the cylinder to move in two directions at once. When used in conjunction with a spherical bearing at the piston rod connection to the gate, the system becomes very flexible and does not side load the cylinder rod in any way.

Also incorporated into this cardanic ring is the ability to release the trunnion pins for the extension of the cylinder body through the roof as described above. The removable trunnion pins are retracted at the proper sequence of operation and then reinserted via small hydraulic cylinders on each side of the cardanic ring. Figure 7 shows the main lift cylinder located inside the cardanic ring with the smaller trunnion pin cylinders.

Figure 7. Main lift cylinder in cardanic ring with trunnion pin cylinders

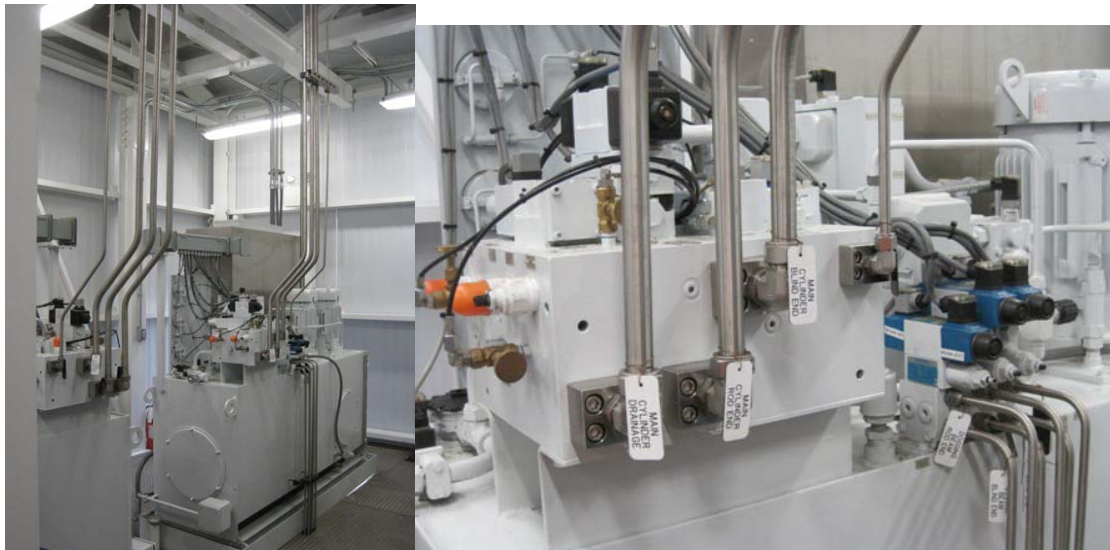
The hydraulic oil supply system is a relatively simple and low horsepower hydraulic power unit (HPU) that uses common gear pumps. The HPU has multiple redundancies with dual electric motors and double hydraulic gear pumps. The HPU units are assembled with stainless steel piping and situated in climate controlled rooms with ample room for service. Considering the low duty cycle and limited complexity, these units are expected to last in excess of 50 years just like the lift cylinders.

Figure 9. Hydraulic power units

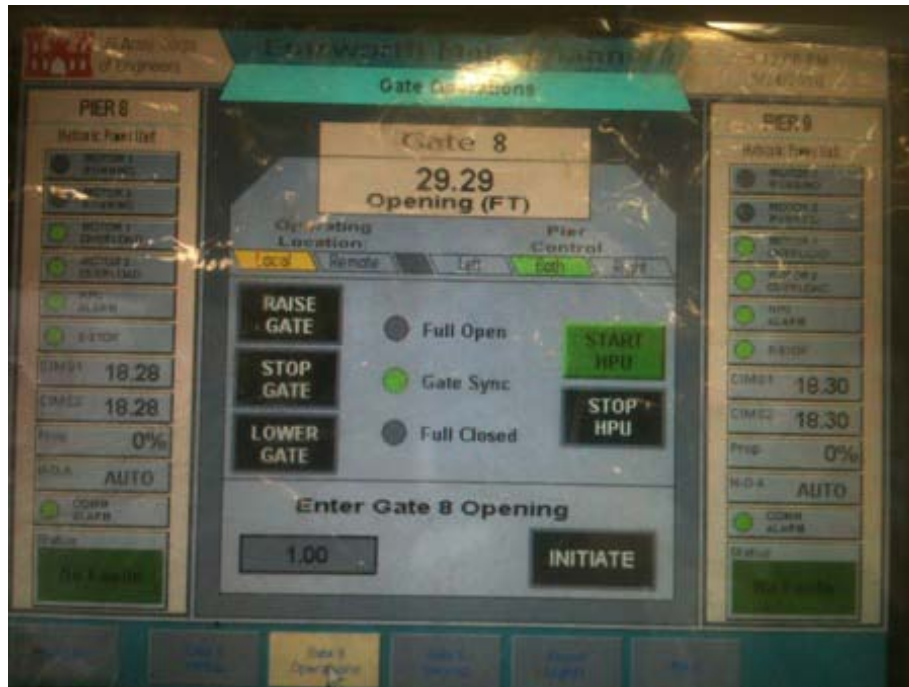
Each gate has an industrial grade programmable logic control PLC system that provides operator control and maintenance troubleshooting assistance. In addition to the automated PLC control of each gate there is a relay based emergency manual control system. The Corps is using modern PLC automation and fiber optics to safely control all 13 gates from remote locations. There is an operator interface touch screen located at each gate that provides not only local control and gate condition but information about the status of all gates in the system.

Figure 8. Operators touch screen

The PLC monitors cylinder position and will not allow a gate to move out of level within 1.5 inch across the 105 foot width of the gate. Getting gates askew in the piers was a serious problem for the old system. Changes in multiple gate positions are made several times a day from remote locations with confidence that the gate is being moved safely.

The system is constantly checking the status of limit switches, gate position, direction of travel, and HPU condition. Using automation technology in this way allows a single operator to lift a gate automatically to the 40 foot level and setting it securely on the resting hooks. This operation, as described earlier in this article, requires setting the gate on dogging beams, disconnecting trunnion pins, pushing the cylinder body through the roof, reconnecting trunnion pins, and setting the gate onto hooks. All of these functions are powered by the hydraulic system and monitored by the controls. The control system sends commands to simple proportional hydraulic valves that provide ramping and inching capability. This advanced control allows the operator to rest a typical 200,000 pound gate down on a set of hooks 40 feet in the air without the slightest bump.
