**HEAVY MOVABLE STRUCTURES, INC.  
FOURTEENTH BIENNIAL SYMPOSIUM**

**Machinery Replacement for the Port Severn  
Swing Bridge (Bridge 60) over the Port-  
Severn Waterway in Ontario, Canada**

Krishna H. Mehta, P.E.  
Stafford Bandlow Engineering, Inc.

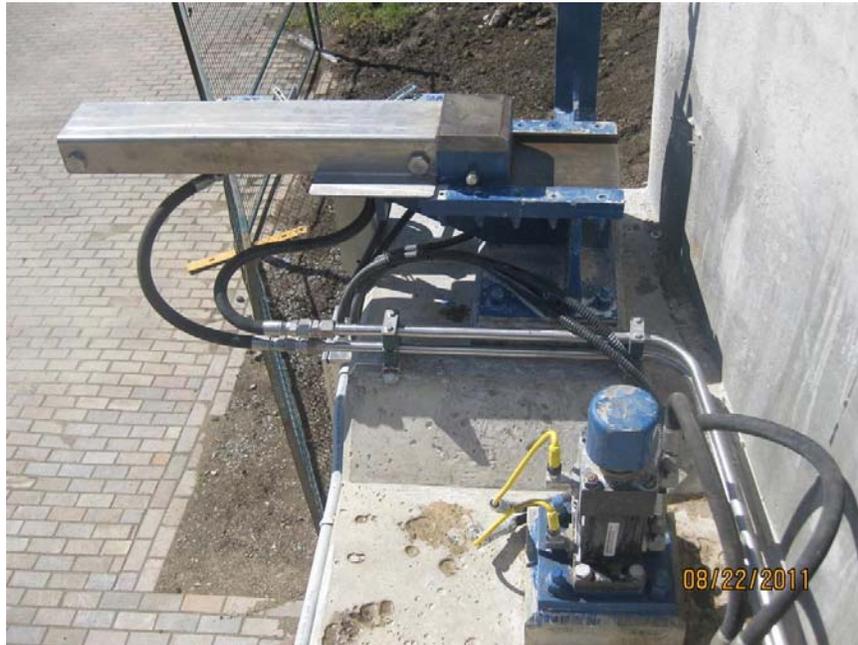
Photo 3: New Installation of the End Jack and End Wedge

The existing end lift/support machinery was a hydraulic jack that raised the span and held it there by maintaining pressure in the cylinder. This did not meet CAN/CSA-S6-06 and therefore a new system was developed where the span is supported on end wedges and hydraulic jacks are used to lift the span temporarily so that end wedges can be inserted or removed.

- The end wedges are designed so that they will center the span with the approach as the end wedges are engaged. This eliminates the need for a locking pin or other centering devices.

The end lift at the west end of the bridge was modified completely. The existing end lift consisted of an end jack that remained pressurized to take the live load. The new design has an end jack as well as end wedges. The new design first jacks the leaf up and then slides the end wedge into or out of engagement. This design allows the hydraulic cylinders to be removed during the winter closure without any impact to the road traffic. The end wedge cover and hydraulic piping are made of stainless steel as they are installed out in the elements.

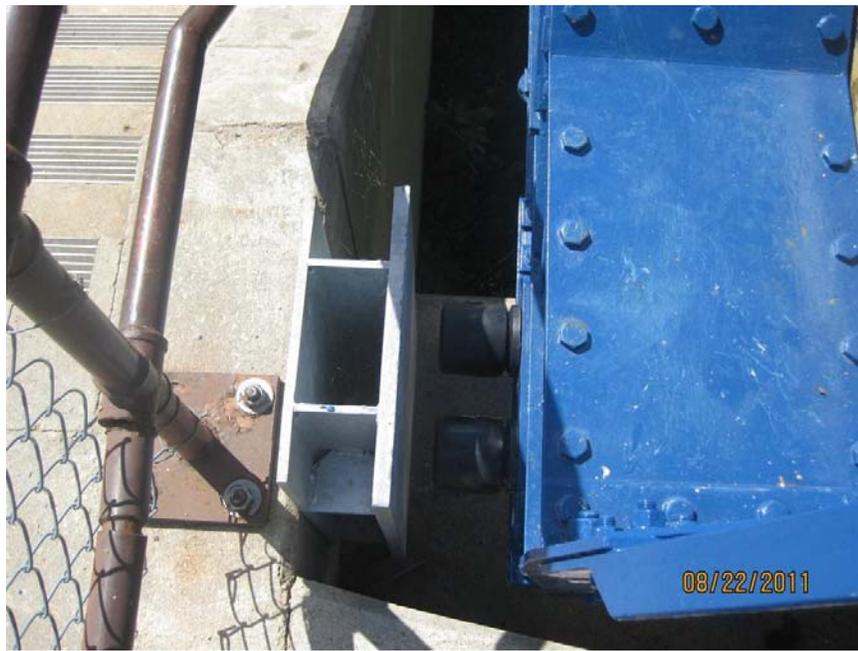
Photo 5: Energy Absorbing Bumpers at the Channel Open Position

The energy absorbing bumpers were installed to stop the span in the event that the span over traveled the limit switches. The channel open position has two bumpers next to each other that engage with the rest pier strike plate. The channel closed position has two bumpers one at the northeast corner and the other at the southwest corner and they engage with the east abutment strike plate and the southwest end wedge support, respectively. These bumpers are sized to take the impact of the span traveling at full speed towards the bumper. The wearing component of the bumper is an elastomeric shape made by Miner and is an off the shelf product. This makes the bumper an efficient design as it is strong enough to take the load and the wearing components are readily available if replacement is necessary.

Energy absorbing bumpers were provided to prevent damage to the span in the event of an over travel condition. The wearing component of the bumpers is an elastomeric shape that is an off the shelf product that allows for ease of replacement if needed.
