**HEAVY MOVABLE STRUCTURES, INC.
FOURTEENTH BIENNIAL SYMPOSIUM**

**Adaptive Re-use of the C&WI RR Vertical
Lift Bridge
Chicago, Illinois**

ADAPTIVE REUSE OF THE C&WI RAILROAD VERTICAL LIFT BRIDGE, CHICAGO, IL

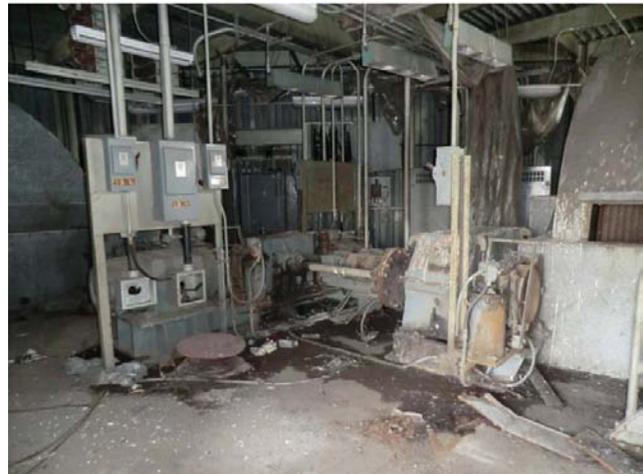
Tower Control Room showing main motor, reducer and main sheave

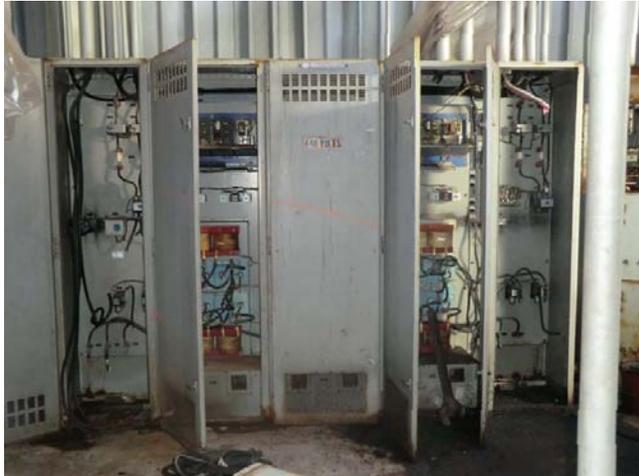
Condition of Motor Generator Set in Bridge Tower

Collins conducted an initial inspection of the bridge's structural, mechanical and electrical systems in July of 2011. Our initial inspection found that the motors, generator sets, gearing, bearings, brakes and other key components of the bridge's electrical and mechanical systems were all still in place with relatively little evidence of vandalism. There was, however, significant water damage to the electrical systems, particularly the motor generator sets, and that much of the connecting wiring was damaged or missing. Portions of the tower machinery rooms' roofs were missing allowing water and pigeons to enter into the machinery rooms. The control system for the bridge located in the bridge house had been vandalized and could not be salvaged. The only access to the tower machinery rooms was via ship's ladder since the elevators had been extensively vandalized. All span locks, movable span guides and span buffers were still in place although their condition could not be readily assessed.

Since there was extensive water damage in the towers and most control wiring had been damaged, it was decided to replace all of the motor generator sets and connecting wiring. The new motor generator set basically were replacement “in kind” of the existing water damaged equipment. The work generally followed the existing plans with necessary upgrades to comply with current codes. It was suspected that

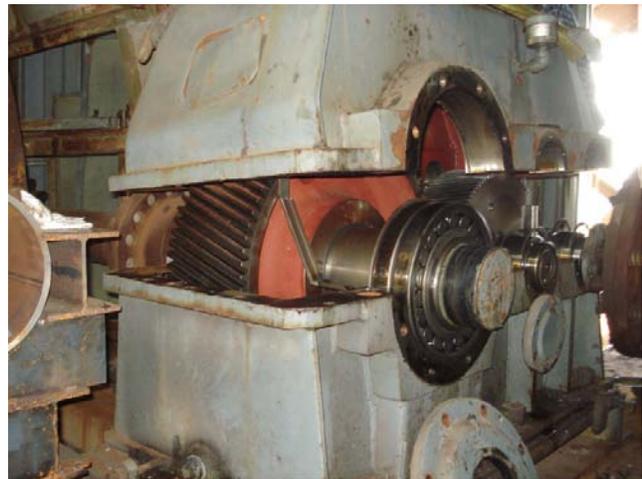
Gear Reducer before Rehabilitation

The mechanical work was relatively simple compared to the electrical work. All gear boxes were opened and drained of oil, inspected

and refilled. Where gearing was found to be rusted, the teeth were cleaned and lubricated. All grease fittings were cleaned and new grease pumped into the bearings until grease could be seen flowing from the bearings. The main lift cables were inspected for deterioration and then cleaned and greased. The span locks were rehabilitated to ensure reliable operation. Brakes cylinders were dressed and new pads installed. Brake thrusters were rebuilt to ensure reliable operation.

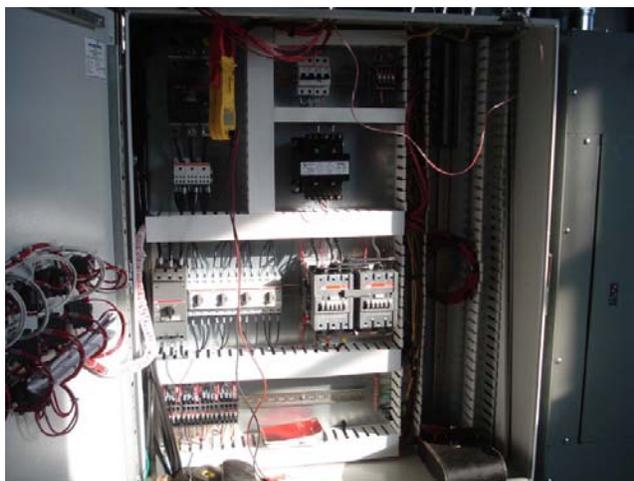
New Tower Motor Control Generator Sets

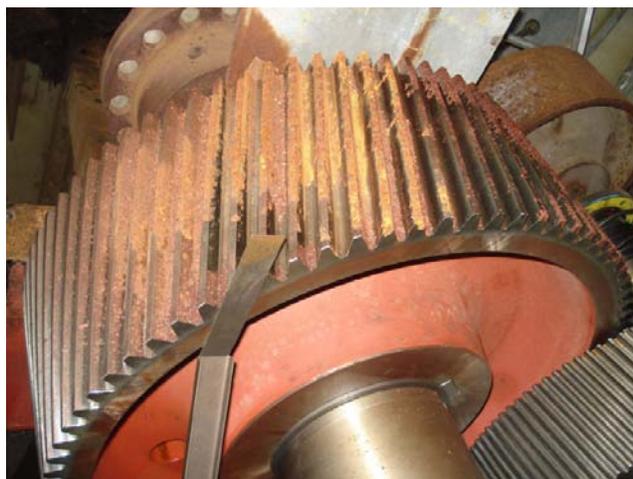
Reducer Gear before Rehabilitation

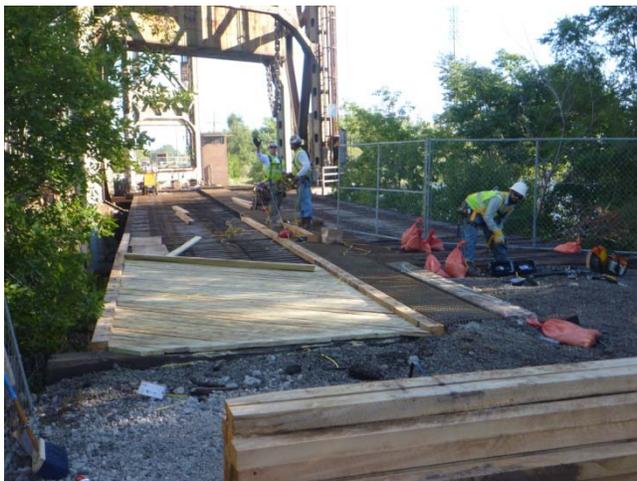
Installation of timber roadway decking on existing ties, approach spans

Collins recommended installing 2 x 8's at a 45 degree angle to the existing railroad ties on the approach and movable spans and lagging the 2 x 8's to the ties. Timber curbs were then installed and a 2 ½ inch asphalt topping applied to serve as roadway. Since the bridge would only be used by Ford, two single lane paths were created, one for each former track position on the bridge. Steel guard rails were installed at the ends of the ties to prevent the cars from running off the roadway on the bridge. To provide safety for vehicular traffic, lighting was added to the roadway and barrier gates were installed at each end of the bridge. The barrier gates are interlocked with the movable span to ensure that the bridge cannot be opened without the gates in the closed position. Similarly, the gates cannot be opened until the bridge is fully seated and the span locks are set. Final balance adjustments were made to the counterweights and the bridge was placed into full service by the end of November, 2011. Since placing the bridge into service, there has been little or no problems with the bridge operation.
