THE APPLICATION OF CURRENT TRANSDUCER TECHNOLOGY

BASCULE BRIDGES
as the basis of

A COMPUTERIZED PREDICTIVE MAINTENANCE PROGRAM

MOVABLE BRIDGE DESIGN & TECHNOLOGY

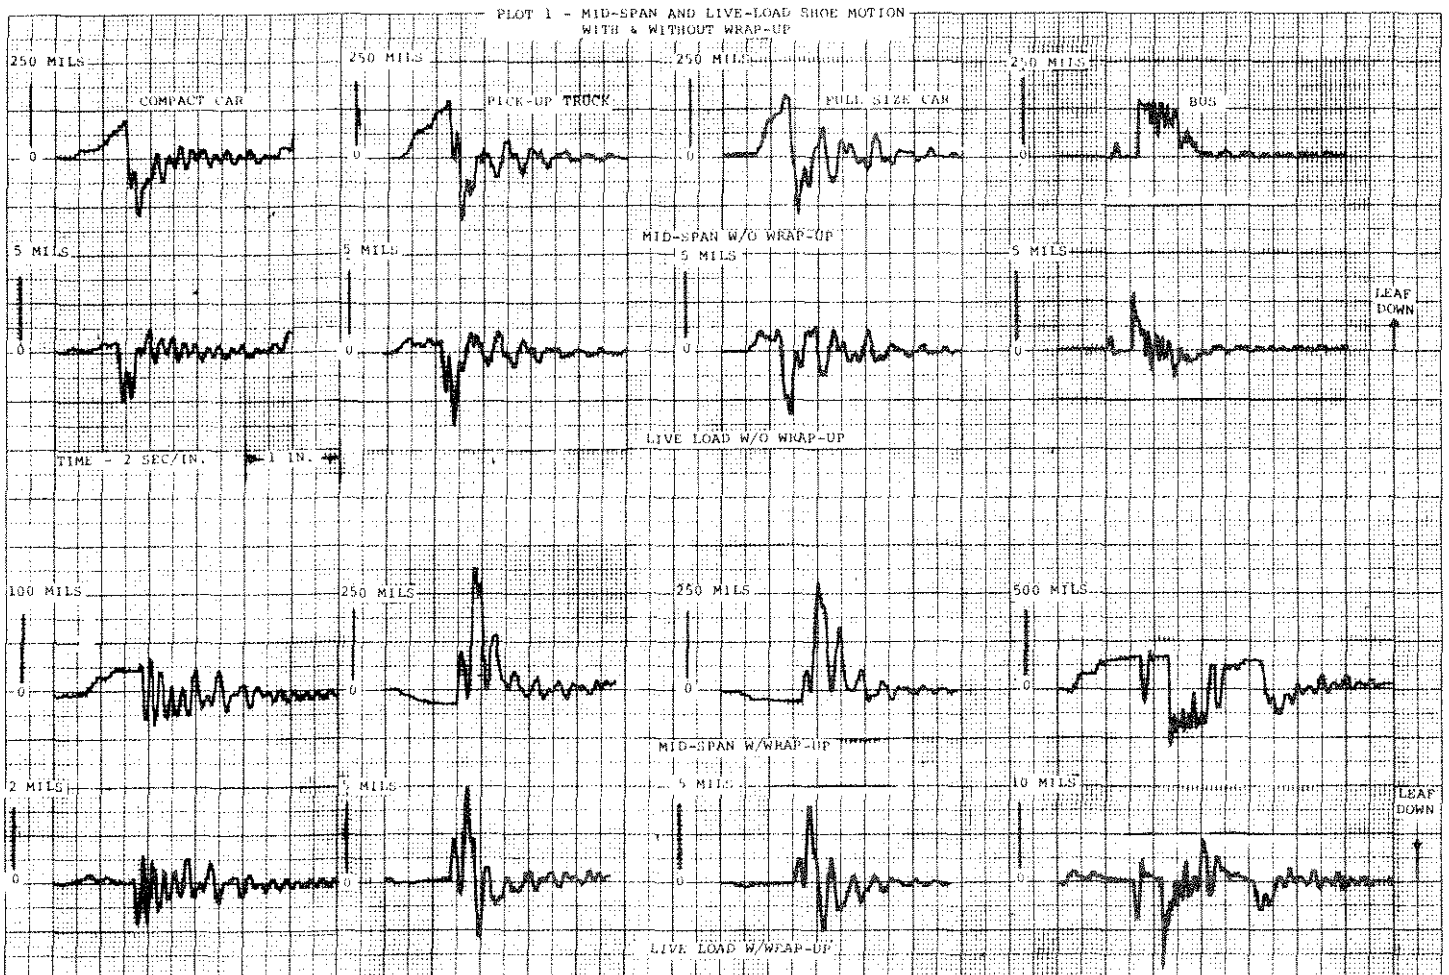
Both the mid-span and live load shoe motion data are presented on Plot 1. Two operational modes are included. One reflects a response with gearing wrap-up and the other with no wrap-up. Wrap-up refers to a condition that occurs when the bridge is lowered to contact the live load shoe with motor torque maintained before applying the brake. A closed bridge with wrap-up is generally preferred, as it tends to assure a more positive contact at the live load shoe area.

Interestingly, there was generally more motion at the mid-span in the wrap-up condition. Values ranged from 30-460 mils (1 mil = 0.001 inch) with wrap-up to 115-220 mils without wrap-up. The response was significantly different in pattern with the larger vehicles as well as with the two modes. The non wrap-up mode response was typical of

resonant elements with the characteristically log-decrement decay pattern. The wrap-up mode tended to reflect a dampened response.

The limited test data confirms the responsiveness of the proximity probe to the mid-span motion. Due to the probe mounting, the dc component had no real significance in relation to prototype system. Hence, dc information is not provided.

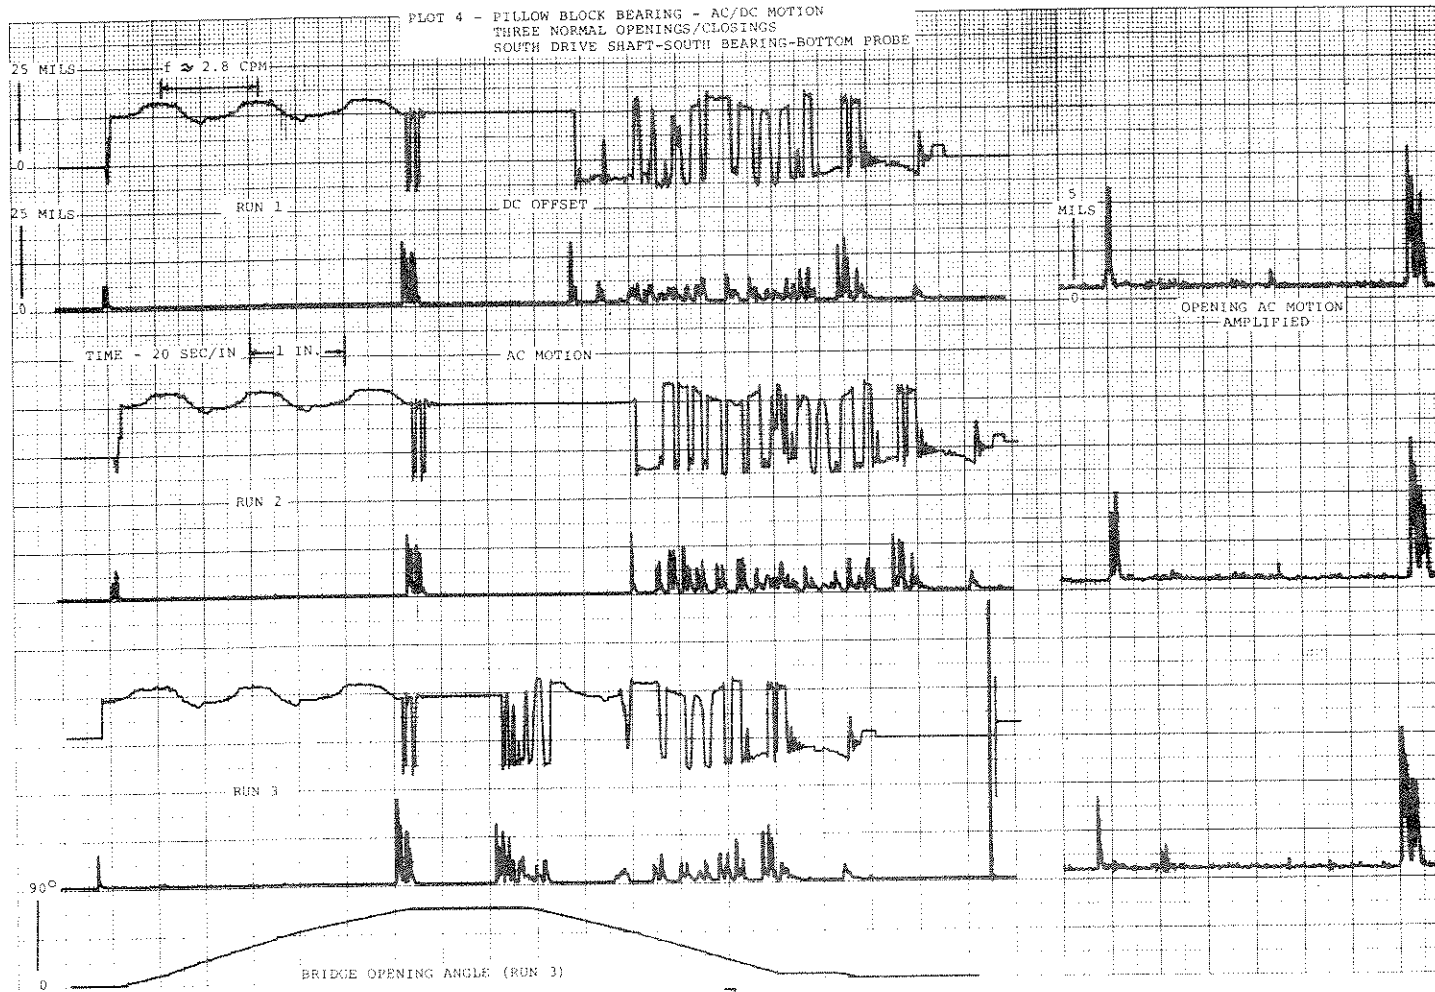
PLOT 4 - PILLOW BLOCK BEARING - AC/DC MOTION
 THREE NORMAL OPENINGS/CLOSINGS
 SOUTH DRIVE SHAFT-SOUTH BEARING-BOTTOM PROBE

Plot 4 is of data from a bearing on the final drive shaft. Note the substantially lower dc offset frequency response and the varied opening/closing pattern.

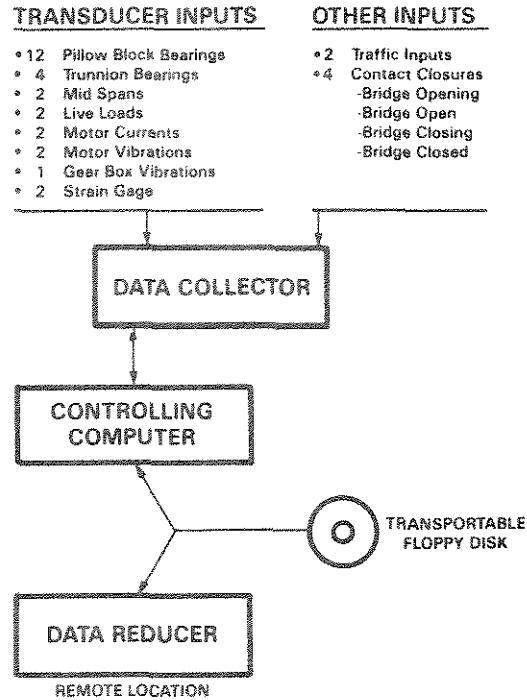
Figure 10. System block diagram.
