**HEAVY MOVABLE STRUCTURES, INC.
THIRTEENTH BIENNIAL SYMPOSIUM**

**Thames River Bridge Replacement –
Amtrak Railroad**

Gary Peters
HNTB Corporation

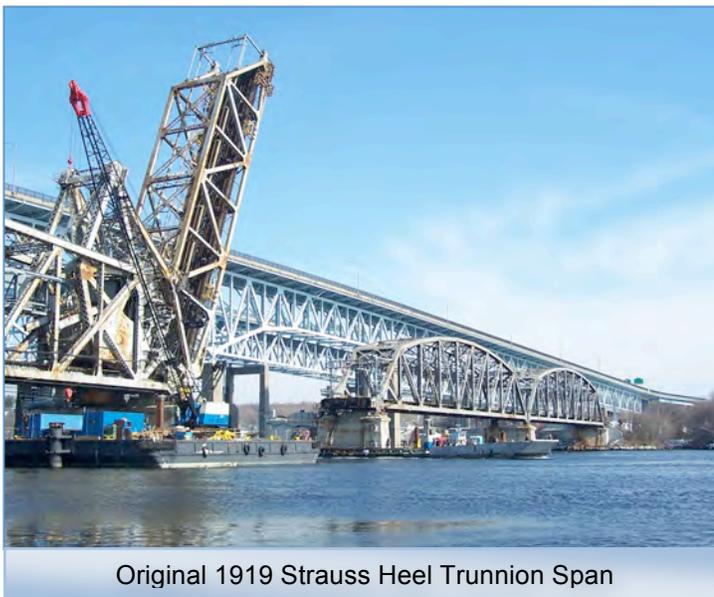
Original 1919 Strauss Heel Trunnion Span

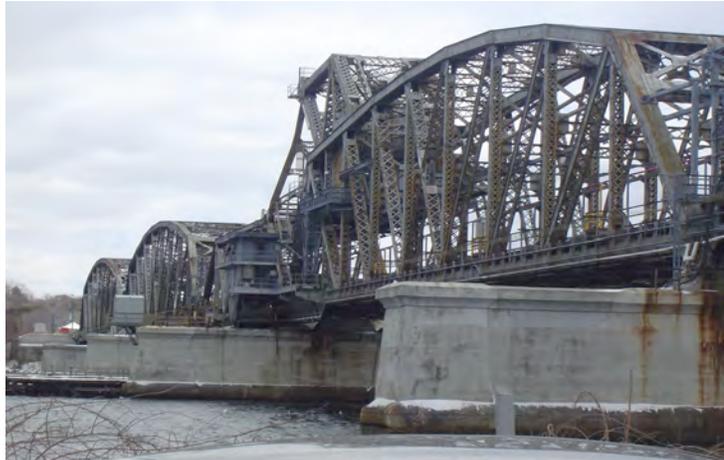
Original location of the control house on the pier.

span in and minimize the marine traffic outage. With the design and locations of the new lift span towers, the current location of the control house, which was not being replaced, would conflict with new tower locations. The existing control house would need to be moved outward on the pier approximately 19 feet from the existing location. Since the original piers were built to accommodate a double bridge structure, the space available on the pier top would allow the movement of the control house early in the construction period. The movement would need to occur with minimum disruption to the operation of the bridge and to the trains that cross the bridge. This would require that the electrical cables between the bascule span and the control house would need to be “stretched” in advance of the actual movement. The contractor pre-staged the power, control, signal and communication cables on the pier and began the process of terminating each of the conductors over several days. Termination of the new cables

was accomplished during the period of time between the last train in the evening around 11:15pm and the first train in the morning around 6:30am. Once all of the new conductors had been terminated, movement of the control house was made by picking the entire structure up and moving it over the required 19 feet. Relocation of the control house was accomplished without disruption to the operation of the bridge or to operation of the trains. Once the control was moved, construction of the new towers could begin.

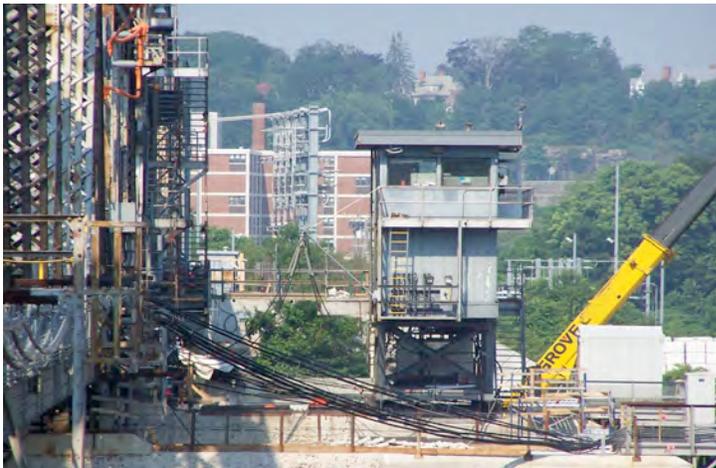
Control house after being moved on the pier.

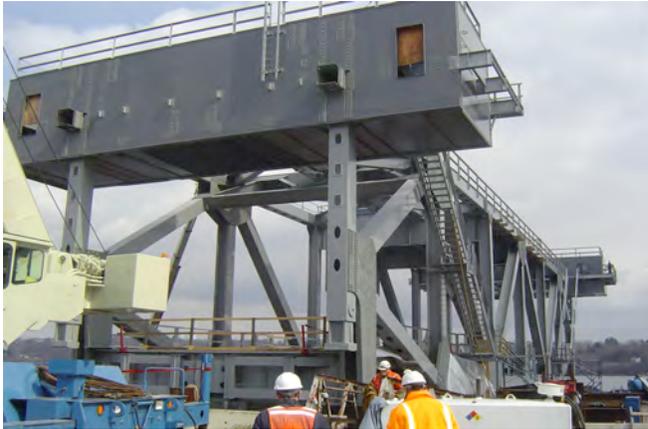
New lift span on barge near completion

The new lift span was erected upstream from the bridge and was erected on a barge. With all of the operating machinery and the majority of the electrical equipment being located on the lift span, this allowed the span to be pre-wired prior to the actual float in of the span.

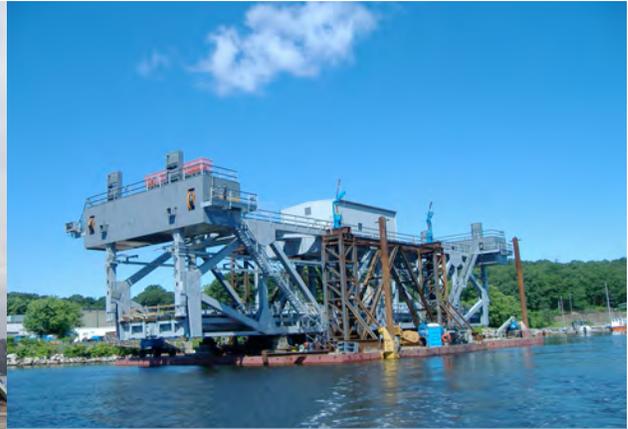
New lift span ready for float in

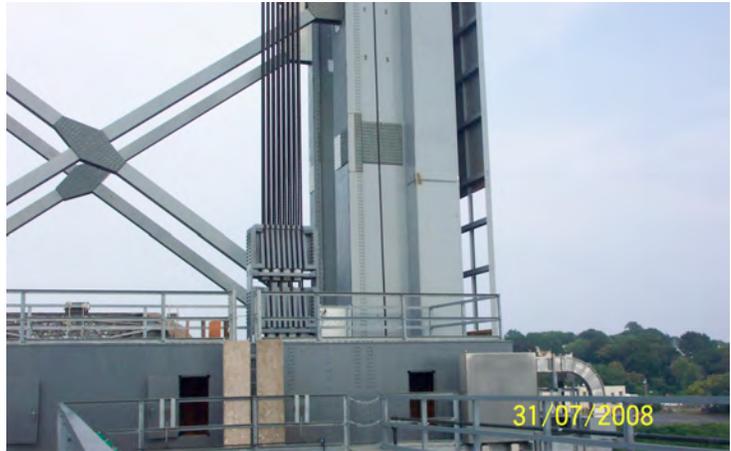
One of the two cable chases on the lift towers

provisions to operate the span from the machinery room on the lift span was included as a part of the control system design. The control system was designed on the assumption that even if the primary power cables consisting of 10 #250MCM conductor’s were not installed, placement a generator on the lift span and operation the bridge could be accomplished if it became necessary during the span change out. Because of good planning by the electrical contractor’s team, the electrical work was completed well before the lift span was ready for movement and the electrical work never became a part of the critical path work. The contractor pre-terminated all of the conductors on the lift span and staged the cables on the lift span prior to the span change out. Once the span was set in place between the towers, the electrical contractor hung the cables within the cable chase and terminated the conductors in the cabinets

on the towers while the counterweight concrete was being poured and the counterweight ropes were being connected on the lift span.

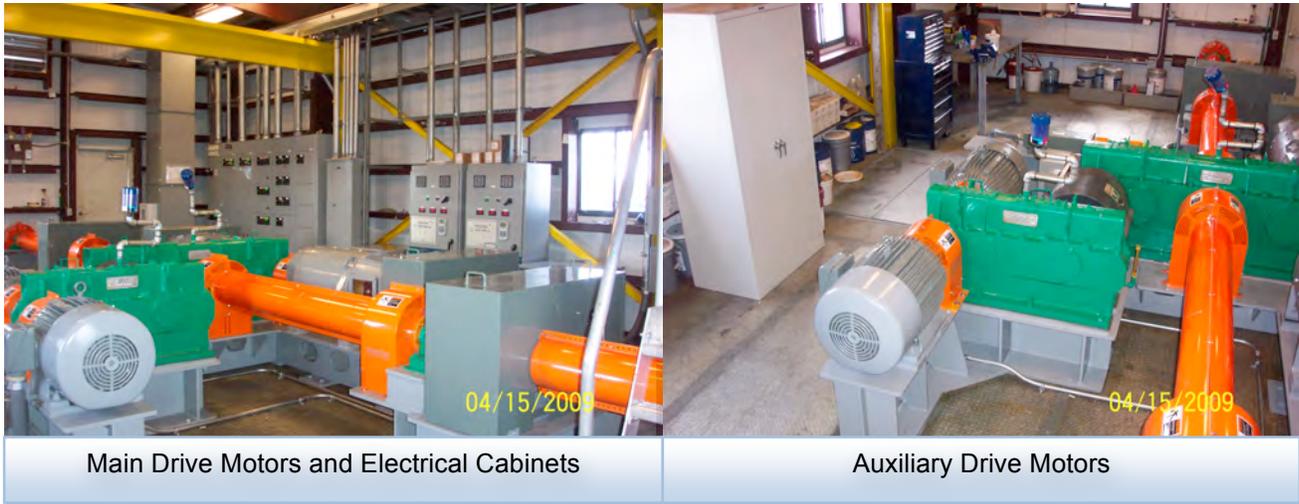
The advance work accomplished with the tower to span cables allowed the electrical crew to begin the preliminary check out of the control system to insure the system was ready to move the span when it became time to actually do so. Each of the drive motors were activated and rotated. The machinery was rotated without moving the line shafts or operating drums. This allowed the rotary limit switches to be pre-adjusted and the position monitoring equipment calibrated.

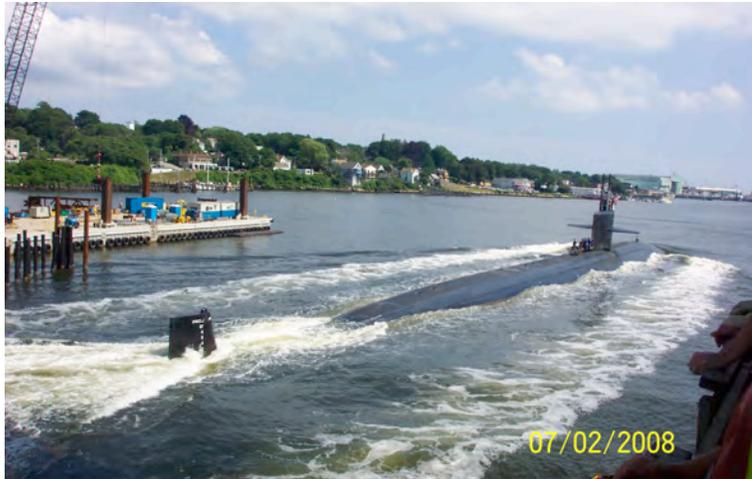
First to transit beneath the new lift span was a U.S. Naval Submarine going out on patrol.

The first day of testing met all the requirements to have the lift span functioning to a point that the span can be lifted to clear the channel for marine traffic. With this requirement established by the U.S. Navy, a submarine was scheduled to depart the Groton Naval Station during the mid morning hours of the first day of testing. Approximately 9:15am, the Navy’s submarine approached the bridge and the new lift span was raised to the mid level height without incident or delay to the Navy’s embarkation schedule.
