**HEAVY MOVABLE STRUCTURES, INC.
THIRTEENTH BIENNIAL SYMPOSIUM**

**Removing a Bascule Counterweight
Thames River Bridge
New London, Connecticut**

Alan D. Fisher, PE
Cianbro Corporation

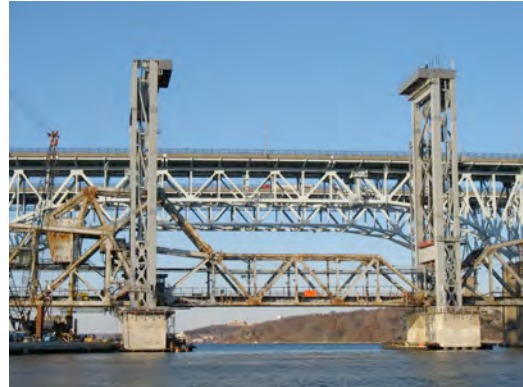
Figure 1: Existing bascule during construction of the new vertical lift towers.

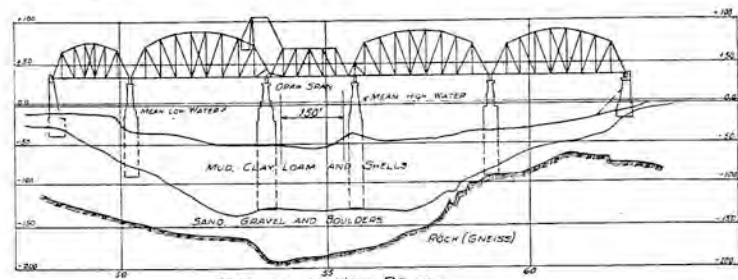
Span A Span B Span C Span D Span E

Pier 1 Pier 2 Pier 3 Pier 4

Figure 2: 1917 Thames River Bridge

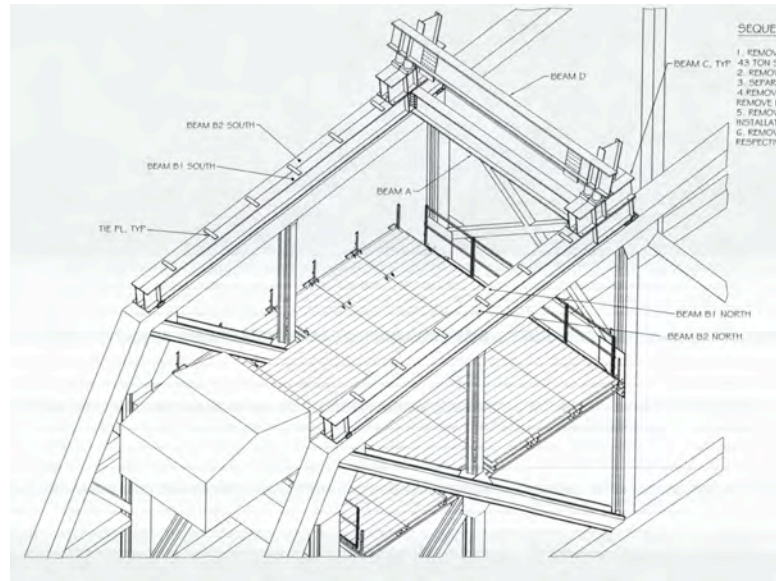
Figure 4 shows the configuration of the support frame. Its design was simplified to permit the rapid fabrication that was required. A W40x397 lifting girder was attached to the rear of the counterweight. Four 430 ton rams were positioned under the lifting girder. Each pair of rams were in turn supported on a pair of W40x397 transfer girders which spanned between two main upper chord panel points. The existing truss upper chords were stiffened at these panel points to accept the anticipated 700 kip loads and deliver them into the gusset plates at the panel points and thereby into the truss main members.

Figure 4: The temporary frame to support the counterweight.

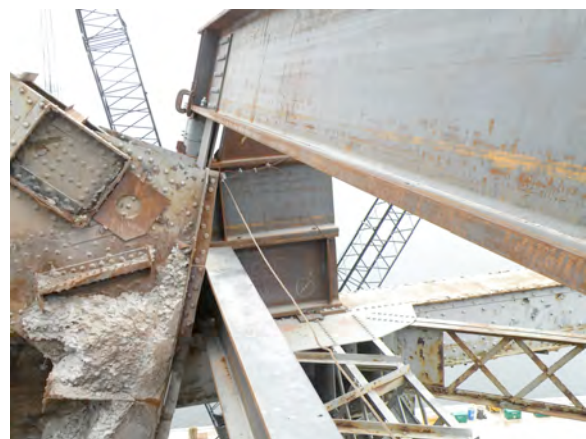
The most difficult design issue, and the one that almost stopped our progress, was the connection between the counterweight and the lifting girder. The rear of the counterweight sloped at about a 12 degree angle to the vertical and the top chord sloped at about a 6 degree angle to the horizontal. These angles added together so that the rear plane of the counterweight was at about 18 degrees off a perpendicular to the support girders. Many different methods of attaching to the rear plates of the counterweight were considered and rejected. The final solution was to set the lifting girder web at the same angle to the vertical as the rear plates of the counterweight. The idea to address this problem resulted in the unusual application of hydraulic rams applying a significant load while in a sloped configuration. This required thoughtful detailing to consider all the forces that had to be resisted.

Figure 5: The connection of the lifting girder to the counterweight.

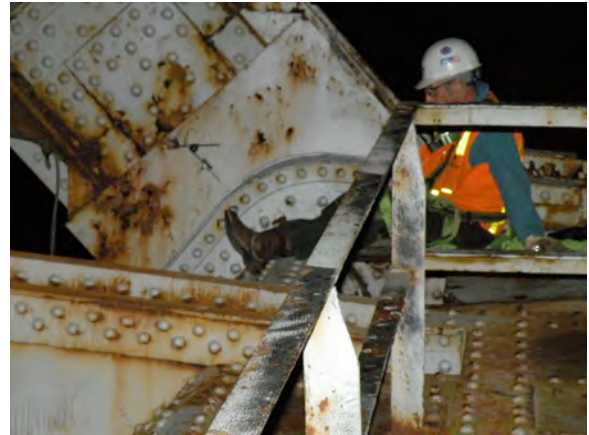
be performed. It always seems like tasks such as this get performed in the middle of the night. We monitored the jacking forces, the amount we lifted the counterweight and the amount the counterweight link frame moved relative to the bascule span. We predicted that the bearings where the counterweight links attached to the bascule span would have significant play in them and that we would know we were fully supporting the counterweight when the links moved without the addition of more load to the jacks. We were concerned that we stop jacking at that point because once the links bottomed out at the bearings we would perceive that we had not unloaded the links, when in fact we would be jacking load into the links. Not only would this lead to un-desired behavior of the links when initially cut for their removal, but the additional load of the link pushing against the bascule span would be resisted at the bascule heel trunnions which were never designed to resist loads applied in this direction. We didn't want to find out what might happen if they were.

Figure 6: The lonely job of monitoring the counterweight link at the bascule span.

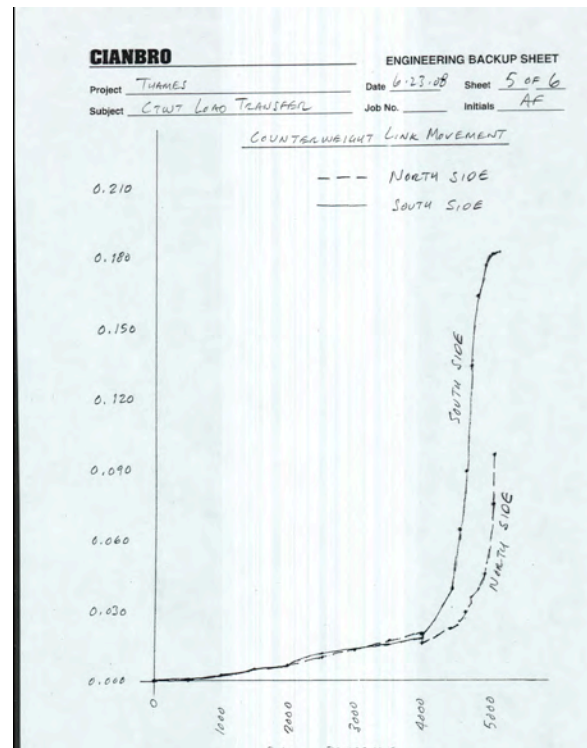
As can be seen in Figure 7, the counterweight link moved very little until we reached an average ram pressure of about 4500 psi. This corresponded with our anticipated jacking load and we terminated our jacking efforts. Not much later, the steel demolition crews set to work and removed the counterweight connecting link, the operating struts and the front parts of the counterweight upperworks. With this work done the four day rail outage began the next day.

Figure 7: Link movement vs. jack pressure

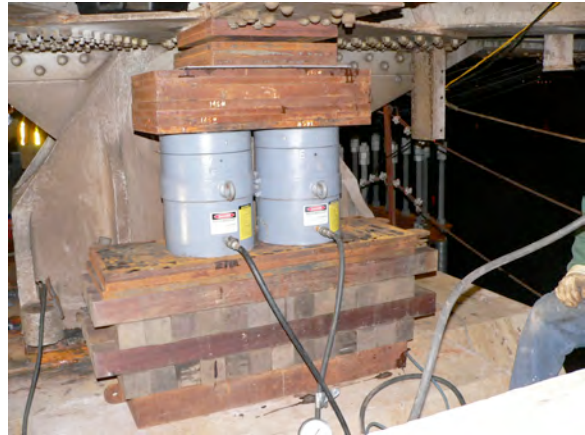
The vertical jacking system for the end of Span B we needed to lift required eight 430 ton rams. We based our ram size on an estimated load-to-lift of 1600 tons which would keep jacking pressure under 5000 psi. Ram selection was also based on the availability of finding eight rams of this size available for short term rent. It required some effort to fit all the rams into places where they could direct load safely into the truss above. Jacking stiffeners were built into all jacking points using an estimated load of 400 kips per ram.

Figure 8: Two 430 ton capacity rams.

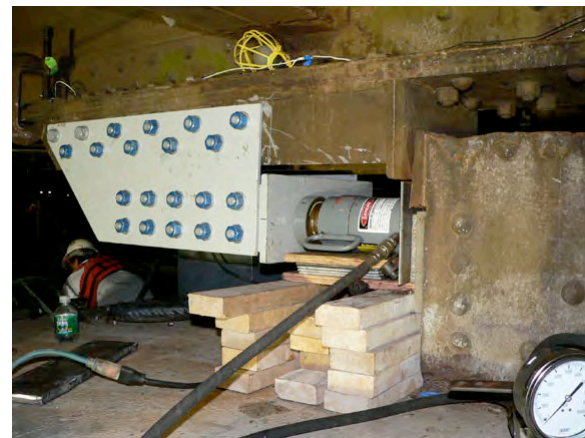
We provided three 55 ton rams for moving Span B north at Pier 2. We provided eight 50 ton rams, four at Pier 2 and four at Pier 1, to move Span B east. We provided rams at both Pier 1 and 2 since for Span B to move east, all four bearings would have to slide at the same time. Usually more is better when it comes to moving something that isn't supposed to move. We decided to perform the needed jacking over two successive weekends. In addition to lateral moving, Span B needed to be raised up about an inch so that the final rail grades would meet the lift span

Figure 9: Lateral Jacking bracket.

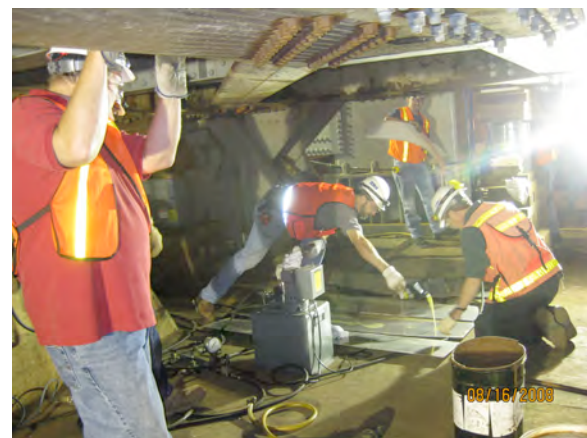
Figure 10: Always use plenty of lubrication.

The lateral jacking was a bit more eventful than desired. The fact that we had to clean under the bearings obviously didn't sink in to our planning as much as it should have. We had located our lubricated Teflon and stainless steel sliding bearing below the bridge main bearings, and as we found out, our cleaning efforts of the previous weekend had not been extensive enough. Additional grit, like we had removed the previous weekend, contaminated our sliding bearing system such that it took nearly 100% of our lateral jacking capability to get the span moved. There was so much resistance that we tore the 10 gage stainless sheets of our bearings in direct tension. Once again we learned that slide bearings don't like grit.

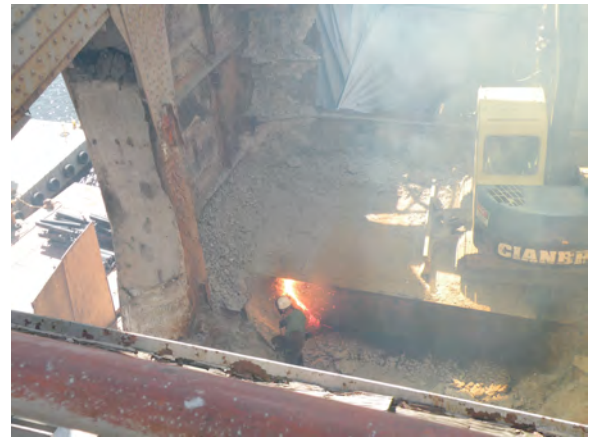
With the bridge in its correct position and the bridge open for double track service all that was left to do (almost) was the completion of the counterweight removal. With solid planning and good erection engineering all the rest of the counterweight disappeared in large chunks. Essential to doing that was the use of exothermic oxygen lances which can cut through steel and concrete. It was very satisfying to watch that counterweight, the removal of which had almost stopped the project at its most critical point, disappear piece by piece.

Figure 11: Cutting steel and concrete.
