# Heavy Movable Structures, Inc. Thirteenth Biennial Symposium

## Amtrak's Thames River Movable Bridge Replacement

## **Abstract**

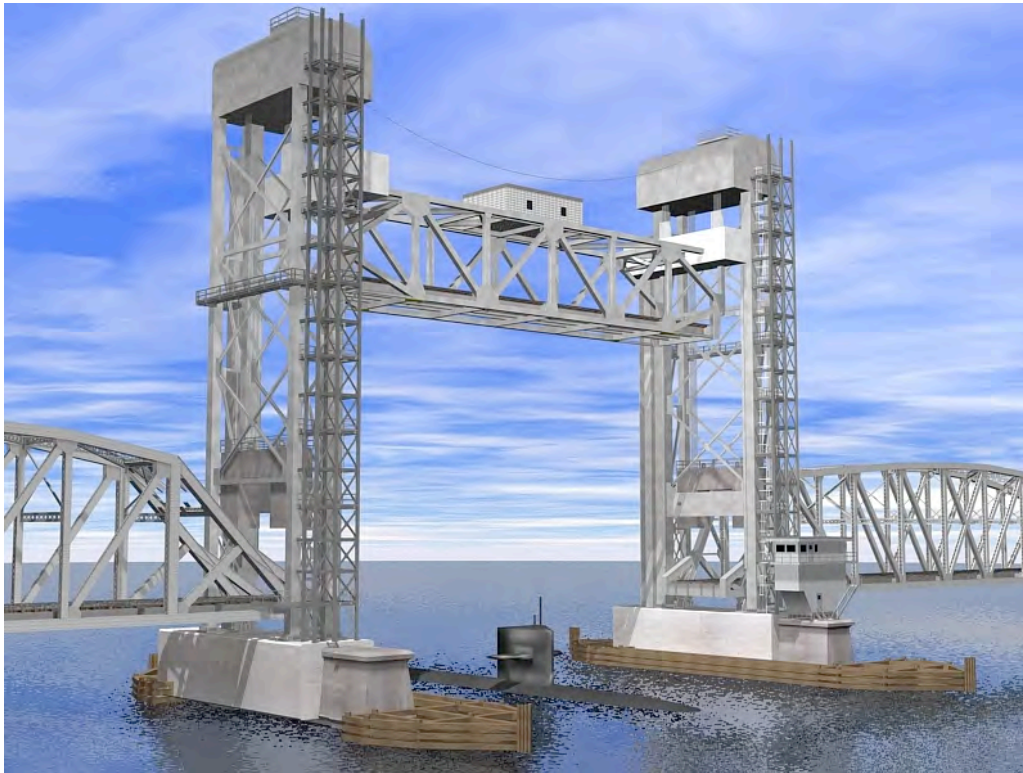
**Figure 3 - Rendering of New Lift Span**

- Suggested construction sequence including a method of temporarily supporting the existing 4 million pound counterweight, removal of existing bascule span, and installation of new vertical lift span, within a 10 day marine outage and 4 day rail outage.
- Enlarging 2 existing channel piers to support the lift towers. Utilize existing approach spans, modifying existing lift span bearing supports for the new lift span.
- A two track through truss span driven vertical lift with twin 75 HP DC SCR Drive electric motors, twin 40 HP auxiliary drive motors, and an emergency back up generator.
- 222 ft high lift towers providing 135 ft maximum vertical clearance over the water.
- Four 16 ft diameter tower sheaves with roller bearings; 64 each 2 ¼ in. diameter steel wire counterweight ropes; 8 uphaul and downhaul ropes.

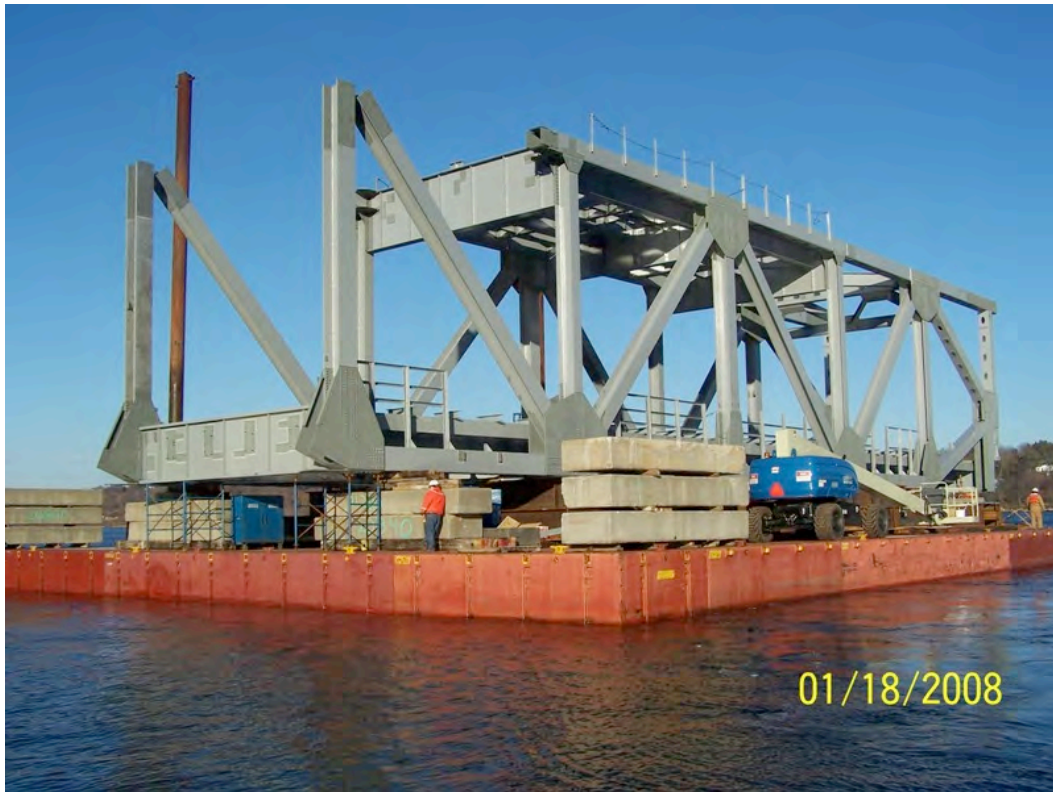
**Figure 4 - Lift Span Erection**

During erection of towers and counterweights it was anticipated that a small amount additional pier movement would continue to occur during the grouting program so Cianbro set the tower anchor bolts in sleeves to allow for horizontal adjustment. Cianbro also placed shim packs and jacking systems under the tower bases to allow for tilt adjustment. Cianbro commenced erection of the tower at Pier 3 on August 2, 2007, while the grouting program continued at Pier 2. Tower erection at Pier 2 commenced on November 7, 2007 utilizing their Manitowoc 4100 ringer crane (with boom lengths varying between 240 and 280 feet) mounted on a barge. Cianbro set up areas to pre-assemble a number of larger structural components such as sheave hoods, counterweights, lifting girders, and portions of the tower framing, as well as platforms, stairways, and ladder assemblies. Cianbro assembled the lift span on a flexi-float barge positioned along the shoreline adjacent to their staging area utilizing a Manitowoc 4000 crane mounted on a concrete pad.

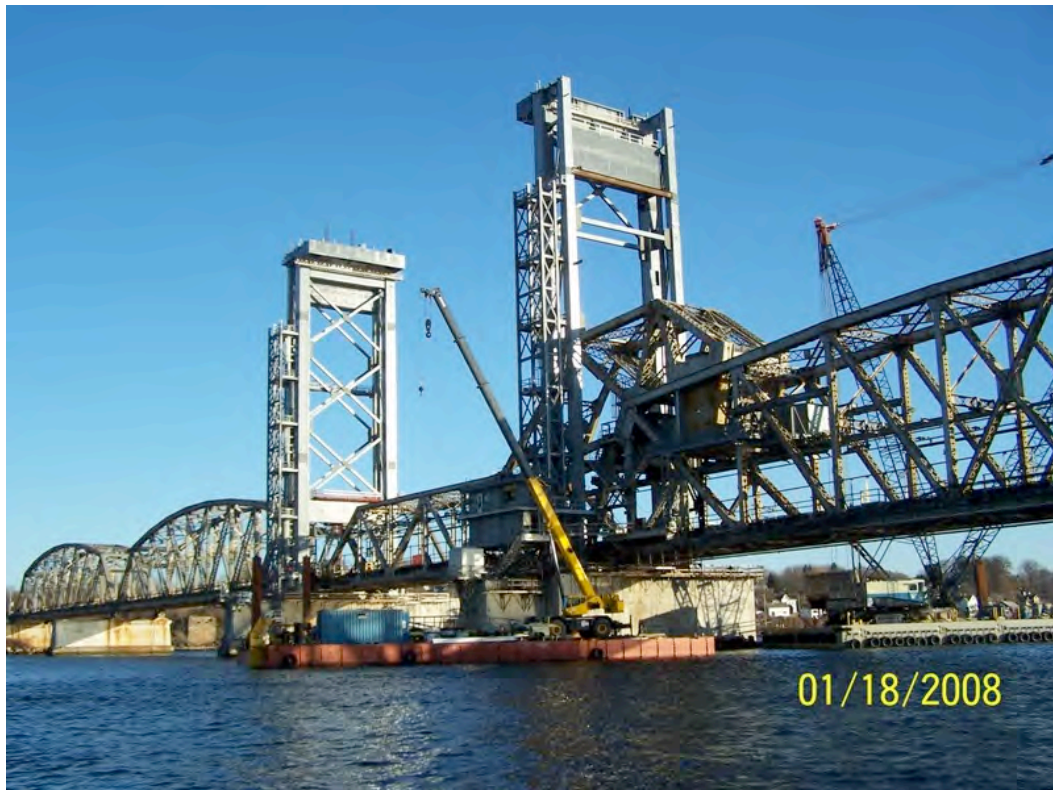
**Figure 5 - Tower Steel Erection**

As erection of the new tower steel progressed, Cianbro expressed concern over potential wind loads and eccentric loading from the new counterweights that the piers may experience during construction prior to float in of the new lift span. The existing piers below the new pier extensions are composed of five rows of granite block in the tidal zone between Elevation +4.75 and -5.25 and unreinforced concrete with a width of 12 feet between Elevation -5.25 and -20.00. WGI contracted with Ocean and Coastal Consultants of Trumbull, Conn., to perform an underwater inspection of Pier 3. The inspection found no indications of tensile cracking in the dimension stone or unreinforced concrete. To lower the potential wind loads, Cianbro opted to defer erection of the sheave hoods until after float in and connection of the lift span to the counterweight ropes. As Cianbro completed assembly of the lift span, their preliminary weight calculations indicated that the lift span weighed significantly more than had been anticipated. Additionally, the heavyweight concrete was not as dense as anticipated in the mix design. Cianbro placed a significant amount of steel billets in the counterweight to overcome these differences.

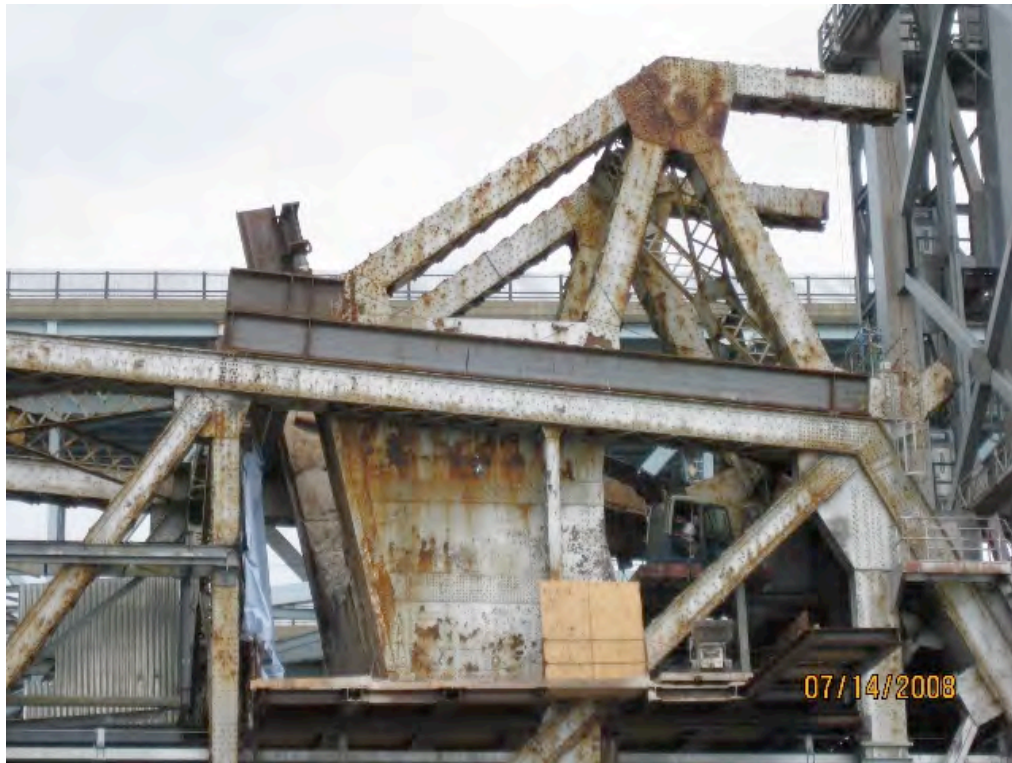
**Figure 6 - Temporary Support of Existing Counterweight**

Now began the fast tracking of an alternate method to separate the counterweight from the bascule span so that the span could be removed and the new lift span erected as quickly as possible. The change in demolition method required Cianbro to rapidly develop plans for temporary support of the counterweight onto Span B. It was determined that approximately 60 percent of the counterweight could be supported by the existing Span B truss, requiring removal of 285 cubic yards of concrete and steel weighing about 1.4 million pounds. Initially the hoe ram demolition rate was too slow to afford a span change out much before early July. Given that the navigation channel was now height restricted, impacting commercial marine traffic, US Navy vessels, and recreational craft, a July 4<sup>th</sup> weekend float-in was out of the question. Cianbro would have to step up their demolition and debris removal methods. Employing a larger hoe ram and devising a chute large enough to convey extracted material to a barge below, Cianbro doubled the demolition rate. At the same time, Cianbro engineers completed design and procurement of necessary support beams to affix to the top chord of Span B to support the counterweight remnant and allow the bascule span to be disconnected and removed.

By June 19, 90 percent of the targeted concrete had been removed and Cianbro began installing counterweight support beams on the top chords of Span B. Installation of the temporary supports was completed on June 21. That Saturday evening, using four 430 ton hydraulic jacks, Cianbro began the load transfer of the counterweight from the counterweight link to the Span B support frame. This process was carried out with meticulous precision, with careful monitoring of the dial indicators to ensure that the anticipated loads were properly removed from the link between the counterweight and the bascule span. Within two hours, the counterweight load had been transferred. On June 22 the counterweight link and upper portions of the counterweight frame were removed in preparation for the start of the four day rail outage on June 24.

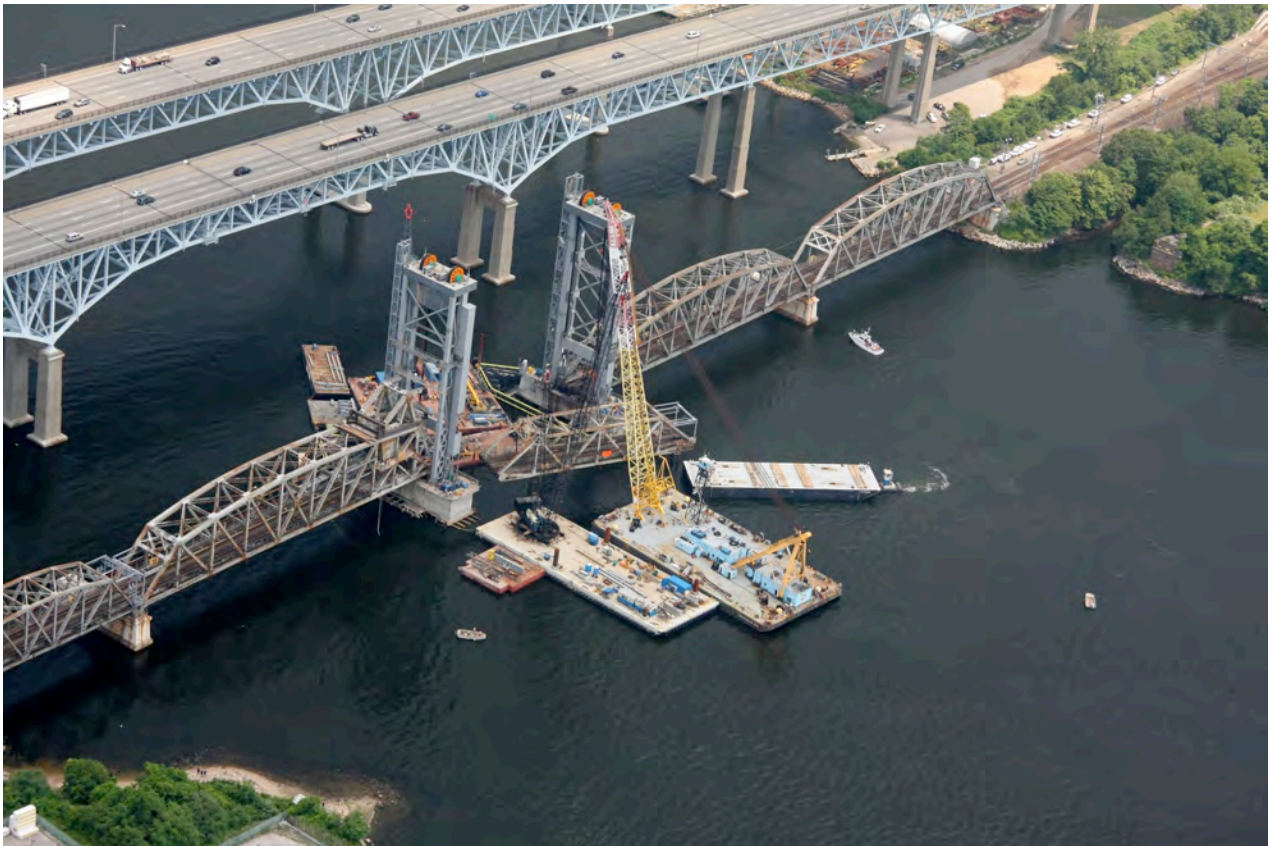
**Figure 7 - Removal of Bascule Span C**

The Chesapeake 1000 was mobilized in the channel and after top truss bracing was removed from the bascule span, shackles weighing 600 pounds attached to a 4 part sling were lowered onto the deck level and attached to lifting eyes that had been previously installed into the floor system. As the crane picked up the 1.2 million lb bascule span, the main trunnion bearing cap bolts were removed with a thermic lance, and slowly the span was freed up from its home for the last 89 years. A barge was positioned so that the span could be lowered onto it. By 4:00 PM on June 24<sup>th</sup>, the channel was cleared for several marine vessels that had been impacted by the delayed outage.

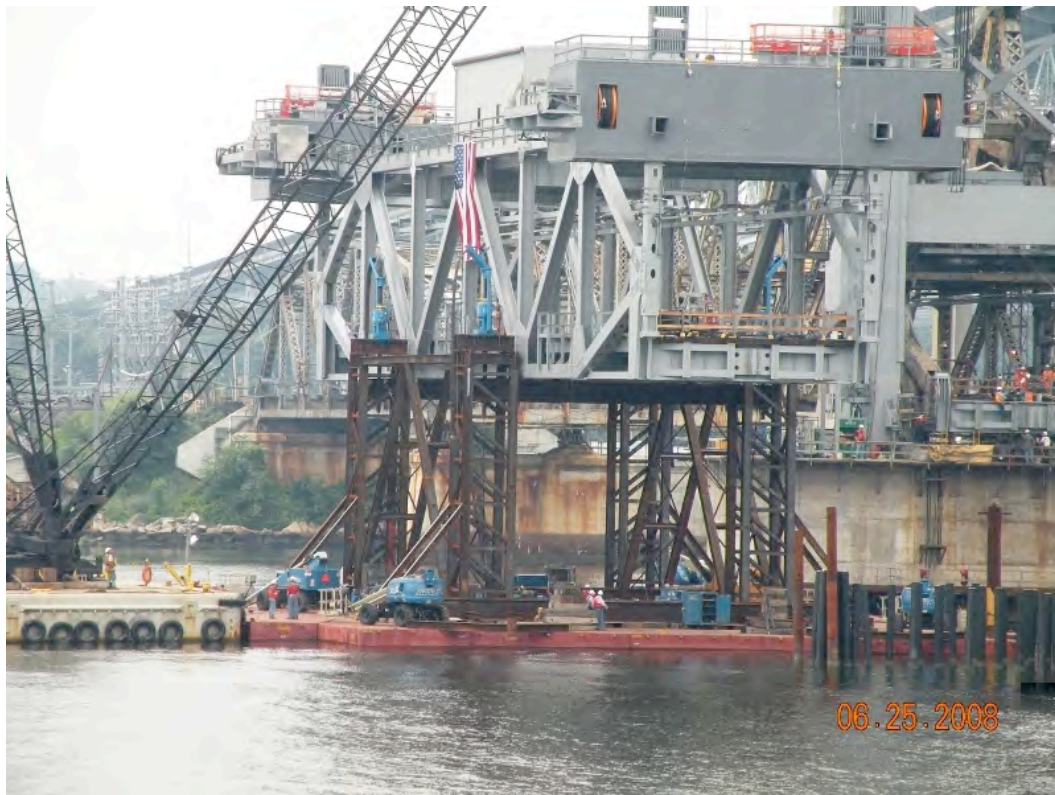
**Figure 8 - Float-In of New Lift Span**

With the existing bascule span removed, channel users were provided with a period during which the channel was open and they were able to pass on June 25<sup>th</sup>. The new lift span was floated from its erection site into the channel after the last marine vessel passed at 5:00 PM June 25<sup>th</sup>. In consideration of the small swing in the tides at the site and to provide vertical adjustment, Cianbro designed and constructed a vertical jacking system with four towers and 1000 ton strand jacks that were used to raise the lift span about 30 ft from the deck of the flexi float barge to clear float-in interferences, and then lower the span onto its bearing supports.

Cianbro utilized wire rope winches mounted on two spudded crane barges located on both ends of the lift span barge to maneuver the new lift span into position. At 6:00 PM June 26<sup>th</sup>, the new lift span

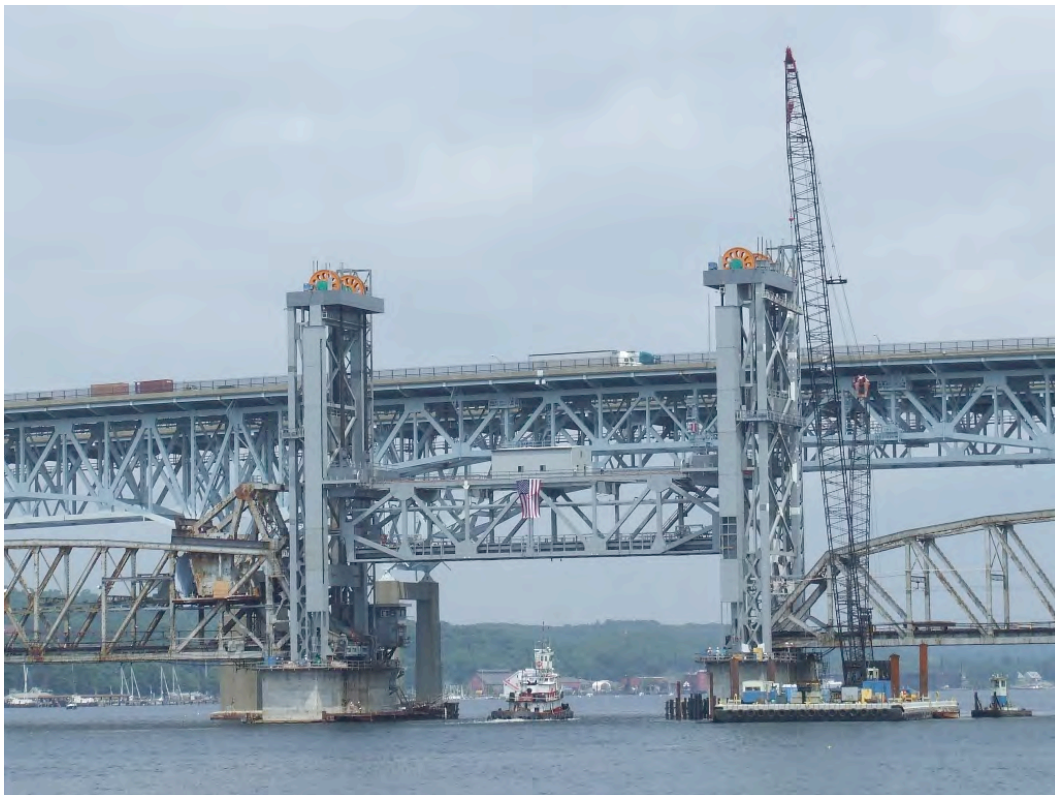
**Figure 9 - Lift Span Partially Opened**

After initial span balancing by removal of several counterweight balance blocks during a night time rail outage, Cianbro was successful in making several test lifts using the auxiliary drive. The lift span was put into limited operation for scheduled openings using the main drive system on July 1. The bridge operated with no significant problems during the July 4<sup>th</sup> weekend, and was put into normal operation on July 10<sup>th</sup>. Additional fine tuning with balance blocks was done prior to the first full lift for 135 ft clearance on July 15<sup>th</sup>.
