HEAVY MOVABLE STRUCTURES, INC. FOURTEENTH BIENNIAL SYMPOSIUM

Aluminum Bridge Decks Mounted to Galvanized Steel: Potentially a Superstructure With An Indefinite Life

by: Kurt Thompson, P.E.

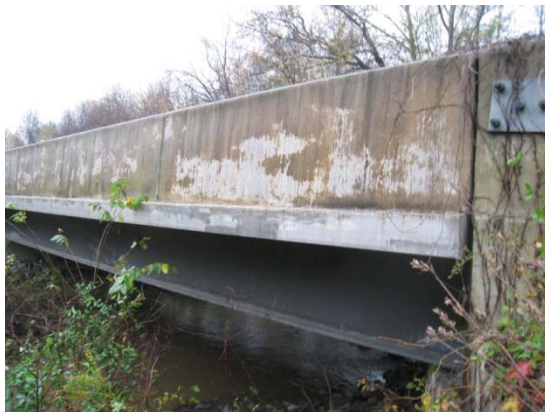
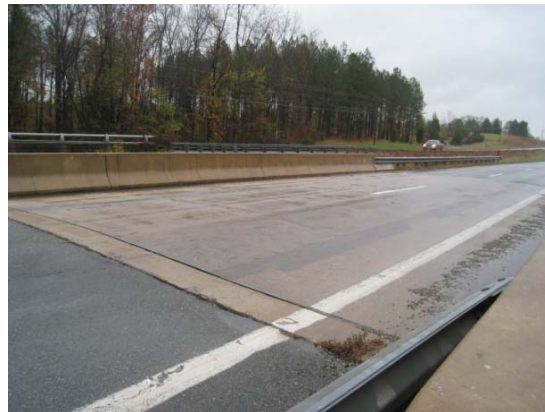
Little Buffalo Creek Bridge - US 58E (Pictures taken in November of 2010)

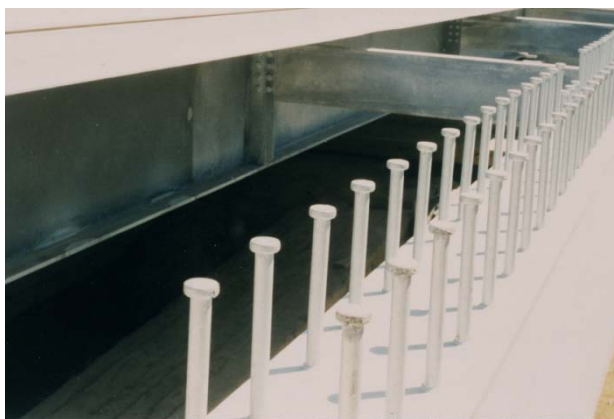
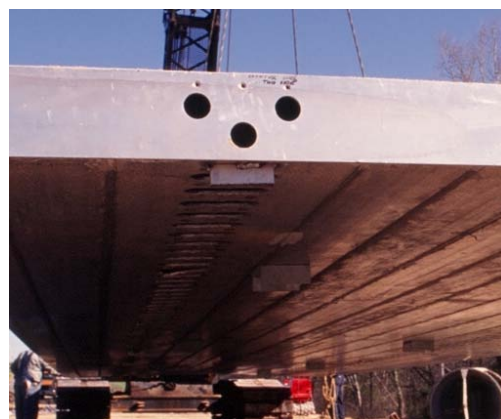
Little Buffalo Creek Bridge - US 58E (Shear studs on left and opening through which grout was pumped is on the right. Pictures taken in spring of 1997)

The deck to girder composite connection was acquired through the use of shear studs embedded inside three aluminum voids flooded with grout. The photographs that follow illustrate how the shear studs were used with the girder (just as they are with concrete) and how they were allowed to penetrate the bottom of the deck. The three holes at the end of the aluminum deck allowed the three voids to be pumped full of grout in the field to complete the connection.

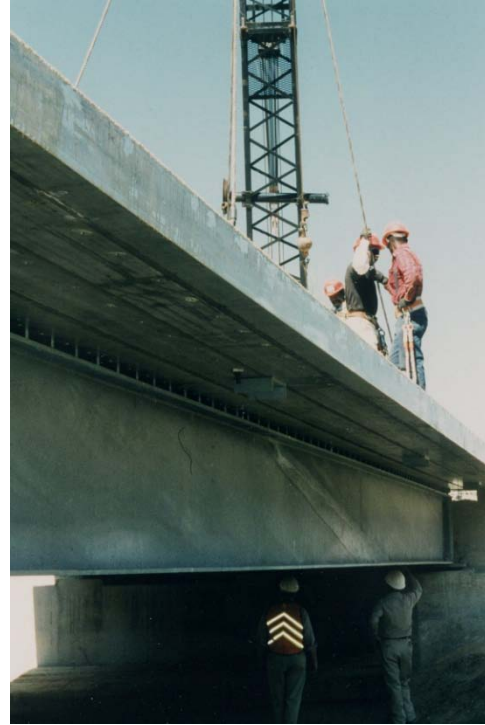
Little Buffalo Creek Bridge - US 58E (Center deck panel being positioned in left photo, deck to girder connection without grout in right photo. Pictures taken in spring of 1997)

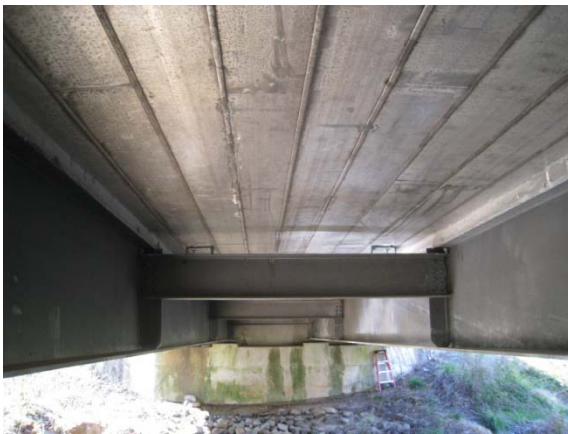
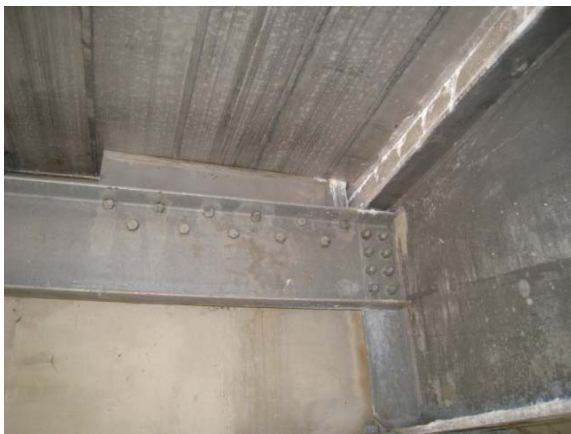
Little Buffalo Creek Bridge - US 58E illustrating the grout condition at the deck to girder connection. Pictures taken in March of 2011

Overall the grout condition in 2011 appears to be good; however, this grouted connection is believed to be the weak link in the design. Whenever the grout fails the bridge deck will need to be removed, the grout removed from inside the voids (expected to be very difficult) and then reinstalled. The time involved will cause major user costs and thus this design is not believed to be an indefinitely sustainable system. The grout also requires a cure time which elongates the installation time.

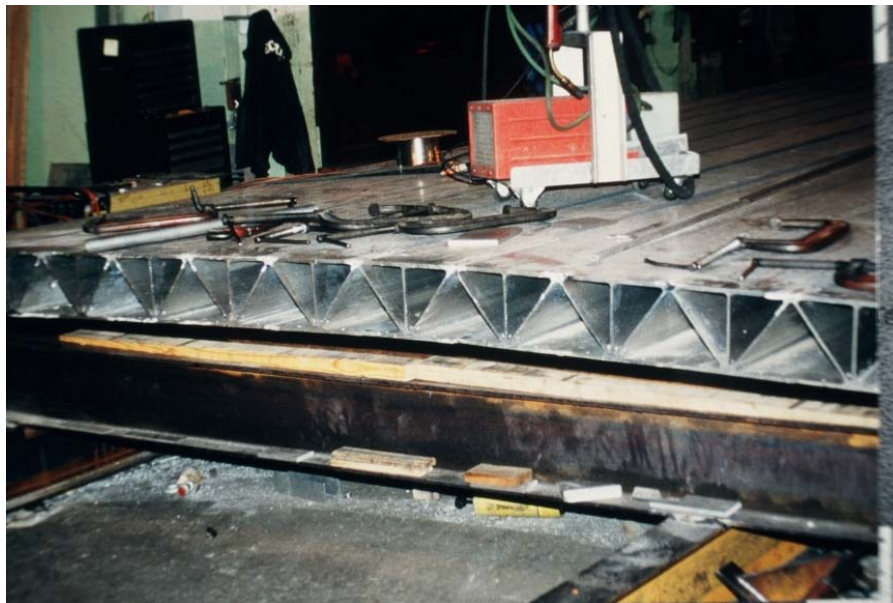
Arc welded deck being fabricated in late 1996

The aluminum deck for the Little Buffalo Creek Bridge was arc welded together in such a way that a category C weld detail was accomplished on both the top and bottom flanges. The thickness provides compliance to meet an infinite fatigue life. It is because the top and bottom flanges are continuous in both directions that the deck behaves isotropically being 90% as strong transversely as it is longitudinally.

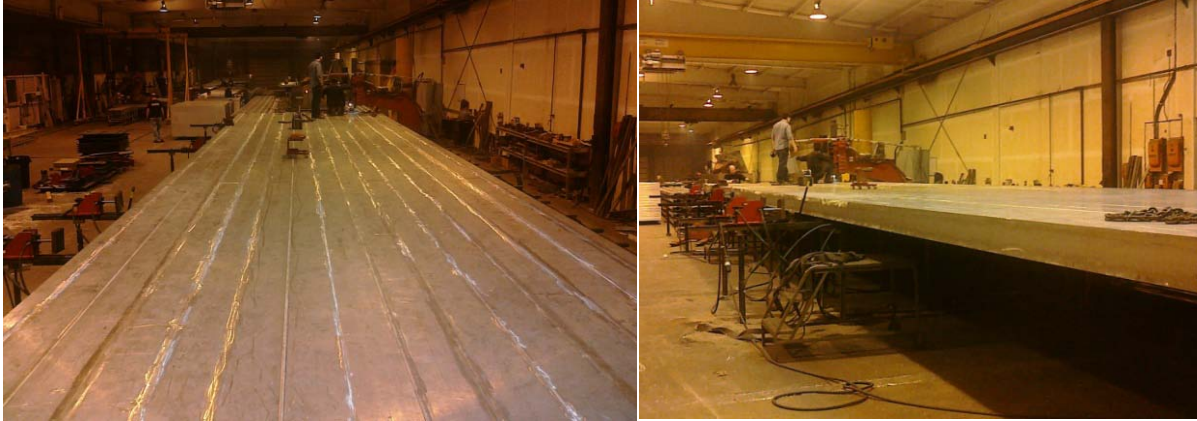
Aluminum bridge deck being Friction Stir Welded together.

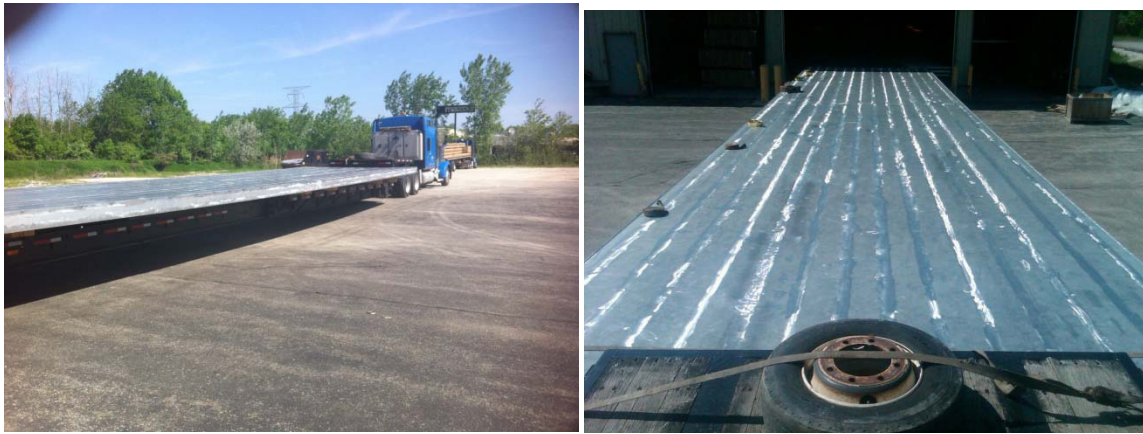
Aluminum bridge deck after fabrication using Friction Stir Welding

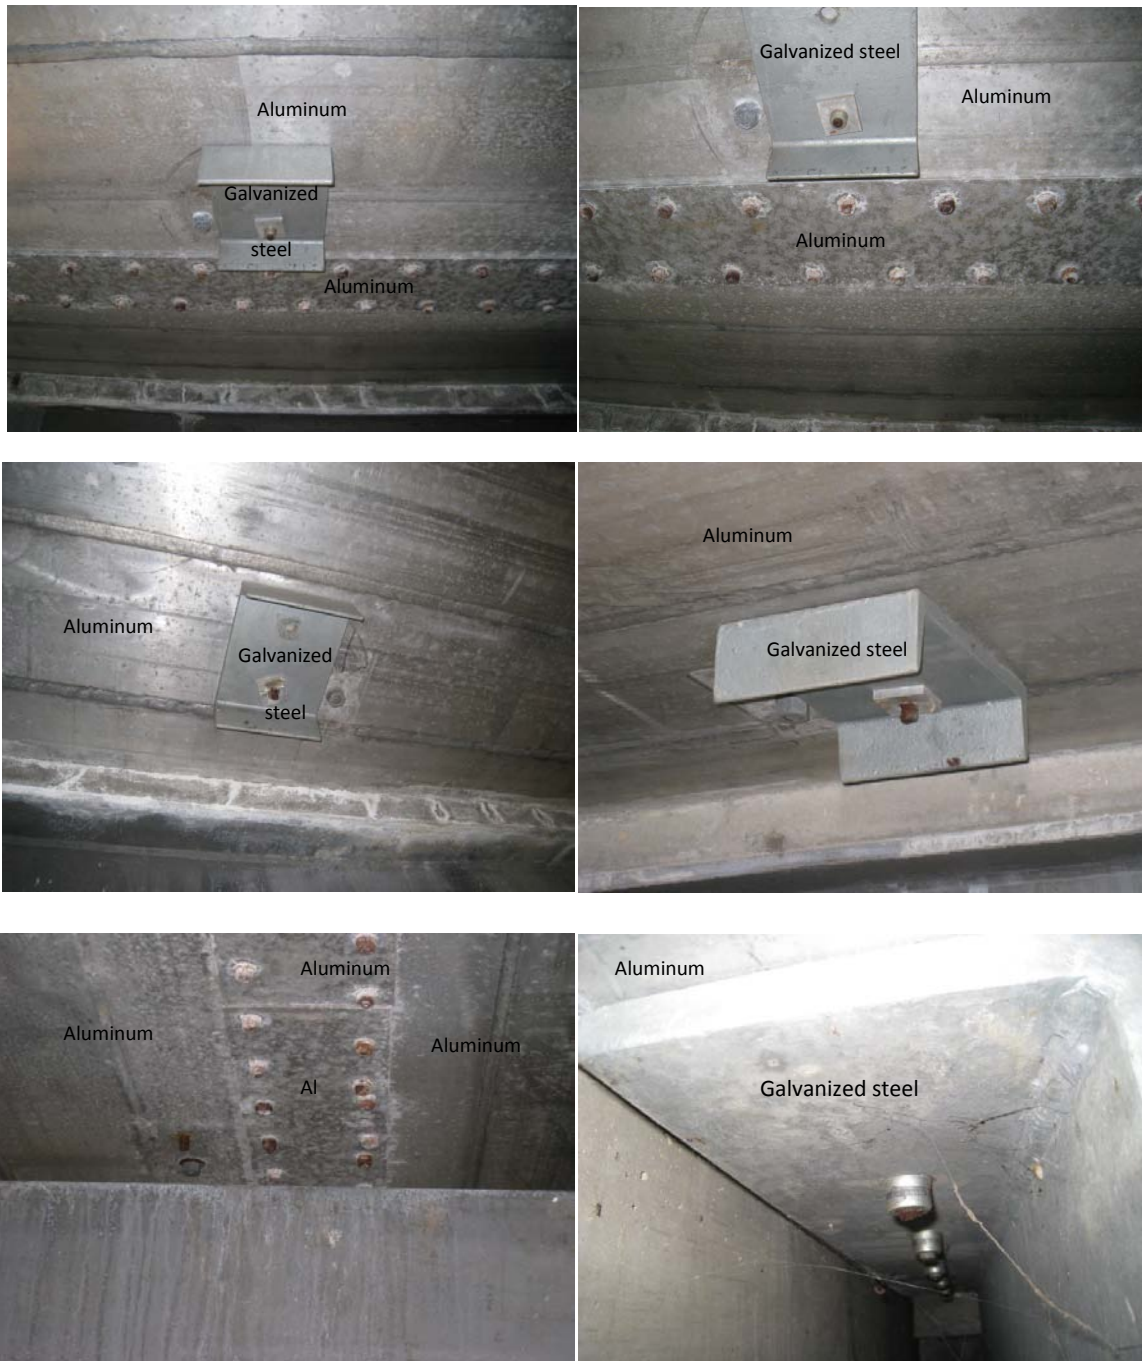
Corrosion observations: Note the way the corrosion differs in regard to the Huck bolts (large rivet like fasteners common to all pictures above). In the case of the aluminum to aluminum splice plates (top left, top right, bottom left), it is the aluminum that is the anode and corrosion is present around the Huck bolts now that the mechanical galvanizing has been consumed. Note the absence of corrosion associated with the same identical fastener through the galvanized steel channel, and at the aluminum to galvanized steel interfaces (in all pictures above except bottom left).

The following pictures illustrate the use of Huck bolts in the Little Buffalo Creek Bridge splice. As good fortune would have it, the same Huck bolts were also used to hold galvanized steel channels to the bottom of the deck. Eyebolts were used in the shop and in the field to move the deck assemblies from above and the eyebolt lifting points were reinforced with these galvanized channels to prevent damage to the deck. It is likely there was a mistake with the eyebolt length because it is evident the channels were pivoted out of the way to allow the eye bolt to have sufficient thread length for the nut to be installed beneath the deck. It is noteworthy that all of the Huck bolts, splices and galvanized channels have been subjected to the same environmental exposure since deployment with dramatically different corrosion results.

The galvanic series relationships are very apparent from a review of the following photographs and the lesson learned is that a bolted connection between aluminum and galvanized steel can be expected to be corrosion free so long as the zinc is present. Through periodic thickness checks combined with field metalizing it is possible to replenish the zinc coating whenever it becomes too thin. Therefore, an attachment system where aluminum is bolted to galvanized steel with a galvanized fastener can be made to last indefinitely.

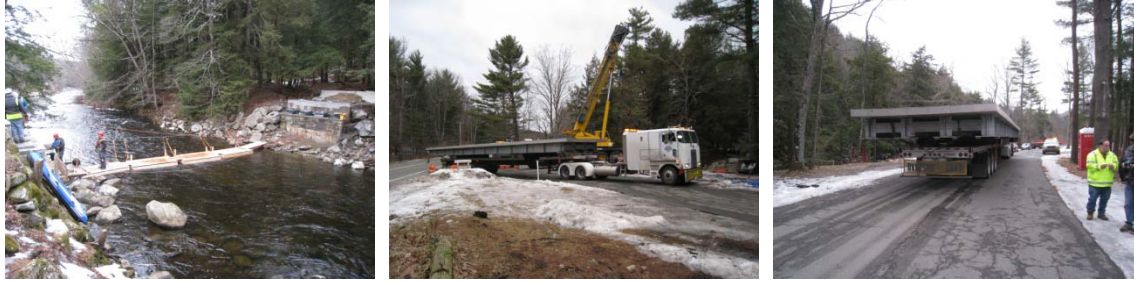
Alan Road Bridge installation (3 picture sequence): 1st picture is where old bridge has been demolished and the abutments repaired awaiting the PBES delivery, 2nd picture the aluminum deck to galvanized steel girders PBES arrives after over the road shipment, 3rd picture, PBES in position to be lifted and placed.

In 1st of nine pictures above the contractor readied the site by demolishing the bridge and reworking the abutments. Then the PBES arrived on the afternoon of February 2, 2012 after having been shipped from eastern Ohio on January 31, 2012. The PBES was lifted and set over the bearings early the morning of February 3, 2012. Note the way the crane is able to boom out extensively due to the lightweight PBES. The crane's ability to pick and place the entire PBES from the shoreline is very enabling to contractors.

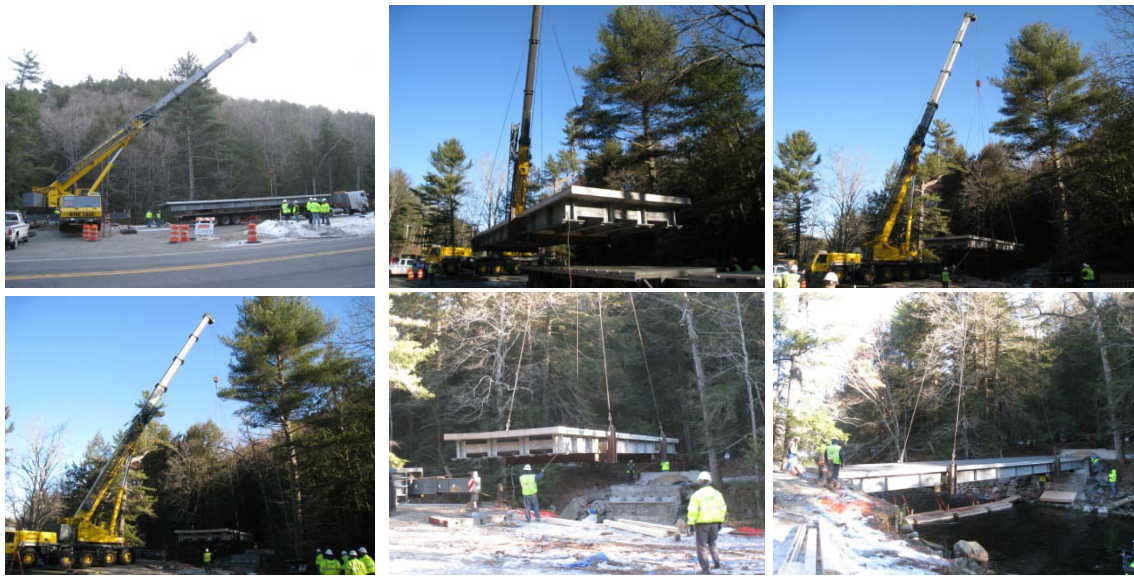
Alan Road Bridge installation (6 picture sequence) from top left to right: PBES being readied for lifting (note extreme 'boom out' condition of the crane), PBES being lifted with ease and moved toward abutments, then moved to its final position. From the initial crane lift until the deck was placed over the bearings, total elapsed time = 30 minutes.

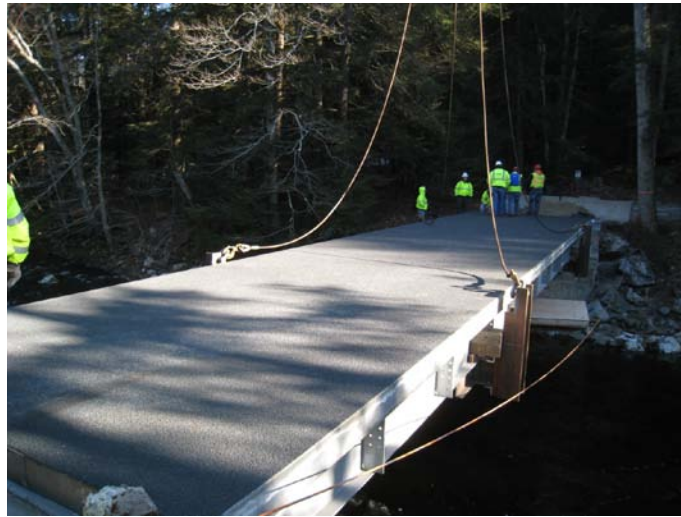
Alan Road Bridge over the Farmington River near Sandisfield, MA immediately after being placed over its bearings. This PBES + lifting apparatus + cables < 58 tons.

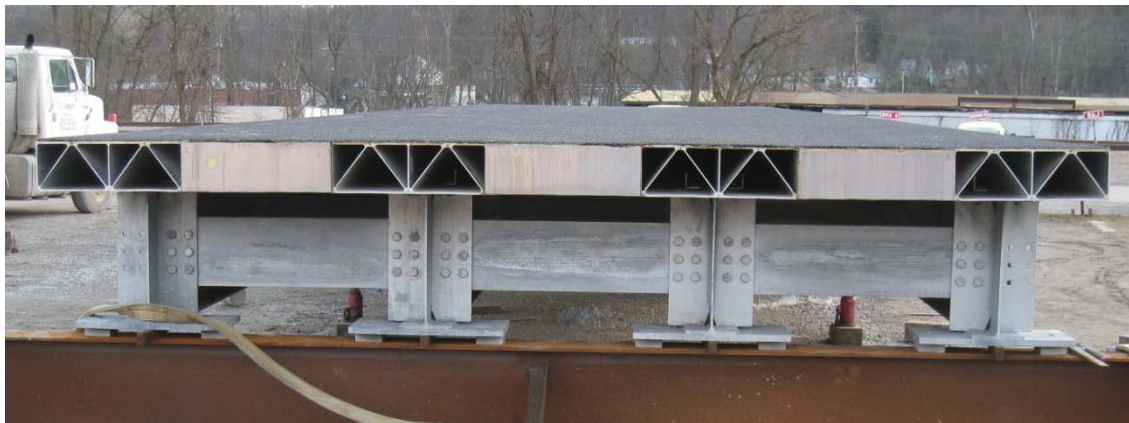
Cross section of the PBES shipped over the road from Cambridge, Ohio to Sandisfield, MA. The girders are spaced at 4'. The aluminum deck system is capable of supporting HS-20 loads with a 9' spacing and a 3.5' cantilever. (The weight could have been less).

As stated previously, the new deck system makes use of essentially the same cross section with the same isotropic properties as that used on the Little Buffalo Creek. It is a very efficient design with a proven track record.

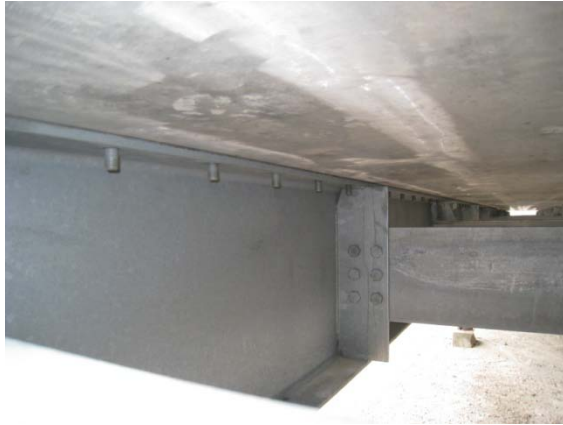
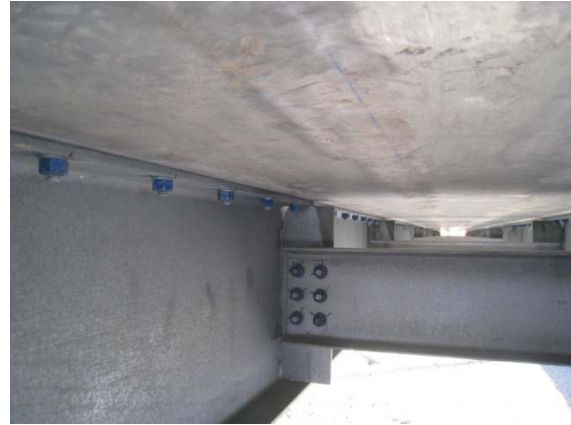
Slip Critical Connection using A-325 Bolts (Friction connections work with aluminum)

The bolts shown in the two photographs above are 3/4" diameter, A-325 galvanized steel high strength bolts that are heavy with galvanizing which provide a substantial amount of material for corrosion consumption. These bolts combined with the galvanized coating provide a long lasting, replaceable and thus sustainable corrosion preventive system.

The composite connection is now achieved using aluminum to steel friction connections as the deck is bolted directly to the steel using A-325 bolts. This has eliminated the non sustainable grout and allows for bolt replacement and connection serviceability in the unlikely case it is needed.

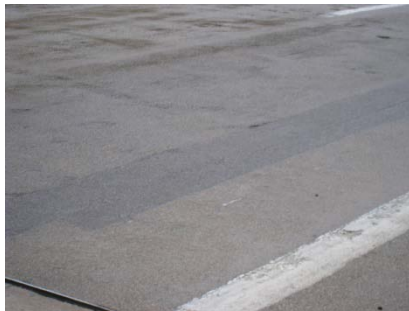
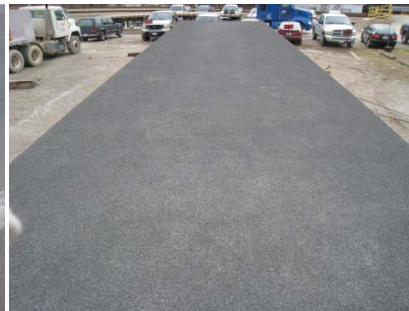
Examples of polymer concrete wearing surfaces - the first is of a system installed in 1997 and subsequently repaired using silica sand. The picture is after 13.5 years of use. All of the above differ only in the type of aggregate used with basalt in the center photograph, and flint and basalt shown on the sample in the far right photograph.

The wearing surface remains the same. The following three photographs illustrate what was placed on the 1997 Little Buffalo Creek Bridge, what was placed on the Alan Road Bridge over the Farmington River near Sandisfield in 2012, and what else can be supplied in the last slide. Where the field applied wearing surface on the 1997 Little Buffalo Creek Bridge was installed is apparent in the picture to the left below in that it is of a different color. It is surprising that the color is so different in that all of the wearing surfaces use the same polymer and the only difference is the aggregate. All of the wearing surfaces used on the Little Buffalo Creek use silica sand aggregate. Nevertheless, where the wearing surface color is darker and 12" wide the field applied wearing surface was installed and where it is wider than 12" there was a repair.

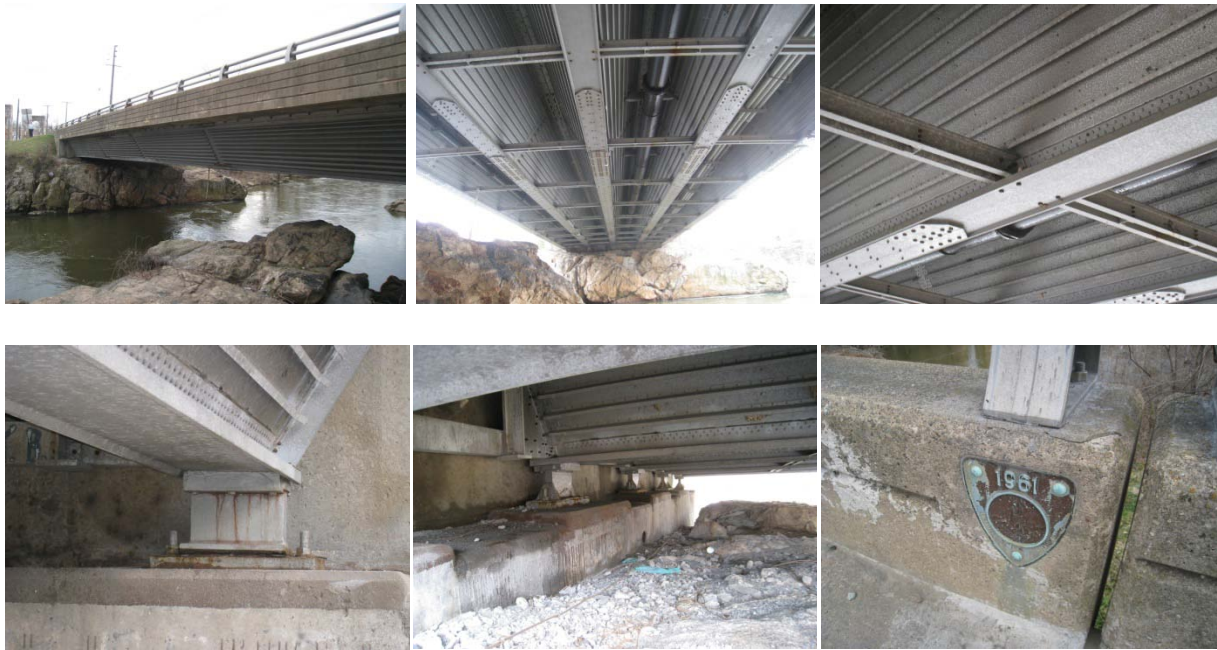
Route 36 Bridge over the Appomattox River in Petersburg, VA which was installed in 1961. The bridge has never been painted. The aluminum girders are bolted directly to the steel bearings. The lesson being provided is keep the water out then the galvanic cell is never developed and it will not corrode.

In 1961 an aluminum girder bridge was installed over the Appomattox River in Petersburg, VA (see photos on next page). It is still in place, works compositely with the concrete deck, has the aluminum girders bolted to steel bearings, and has never been painted.

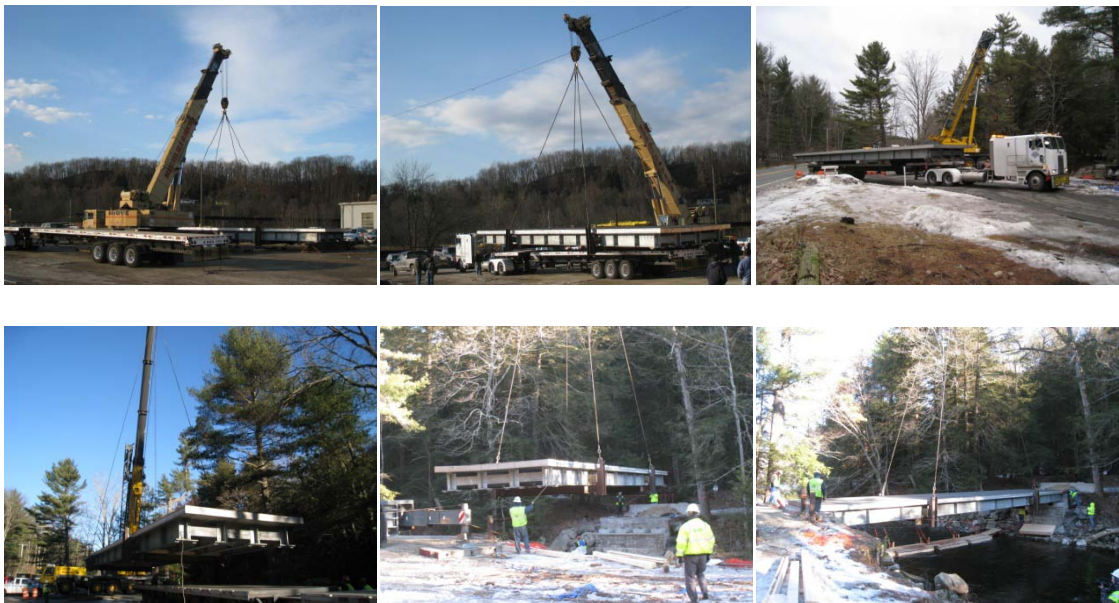
This final sequence of photos illustrates unequalled ABC capabilities through the use of an unequalled 28 ton PBES (essentially one lane of a 64' long bridge). From loading in eastern Ohio, to delivery and placement in western Massachusetts.
